**MINERALS PROGRAM INSPECTION REPORT**  
**PHONE: (303) 866-3567**

<b>MINE NAME:</b> Pikeview Quarry	<b>MINE/PROSPECTING ID#:</b> M-1977-211	<b>MINERAL:</b> Limestone (general), granite, granite gneiss and dolomite	<b>COUNTY:</b> El Paso
<b>INSPECTION TYPE:</b> Surety-Related Inspection	<b>INSPECTOR(S):</b> Timothy Cazier, P.E., Zach Trujillo	<b>INSP. DATE:</b> November 5, 2020	<b>INSP. TIME:</b> 10:00
<b>OPERATOR:</b> Continental Materials Corporation	<b>OPERATOR REPRESENTATIVE:</b> Jerry Schnabel	<b>TYPE OF OPERATION:</b> 112c - Construction Regular Operation	
<b>REASON FOR INSPECTION:</b> Surety Related	<b>BOND CALCULATION TYPE:</b> Complete Bond	<b>BOND AMOUNT:</b> \$15,000,000.00	
<b>DATE OF COMPLAINT:</b> NA	<b>POST INSP. CONTACTS:</b> None	<b>JOINT INSP. AGENCY:</b> Mined Land Reclamation	
<b>WEATHER:</b> Clear	<b>INSPECTOR'S SIGNATURE:</b>

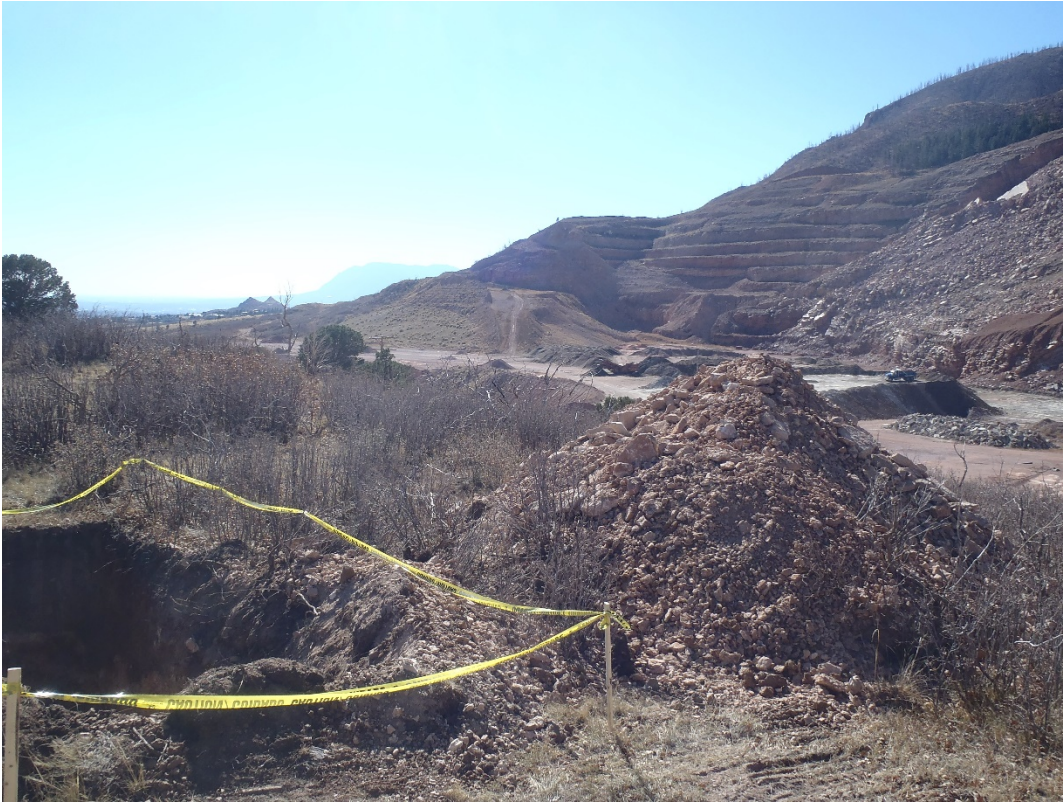
**Backfilling and Grading:** Backfill material is being imported as approved by TR-19. As part of the grading plan initiated by the City of Colorado Springs, test pits were dug northwest of the existing maintenance shop. No competent bedrock was encountered (to ~ 14 feet deep) and all material had been removed with an excavator (see **Photo 1**). Mr. Schnabel stated the material encountered in the test pits would be acceptable backfill material for the highwall stabilization. Imported material continues to be placed in "Area H" at the toe of the highwall (see **Photo 2**). Mr. Schnabel pointed out a test pit in the backfill placed prior to approval of AM-04 showing no deleterious or oversized material was encountered in the test pit (see **Photo 3**)

Photo 1. Typical test pits northwest of existing maintenance shop (looking south).

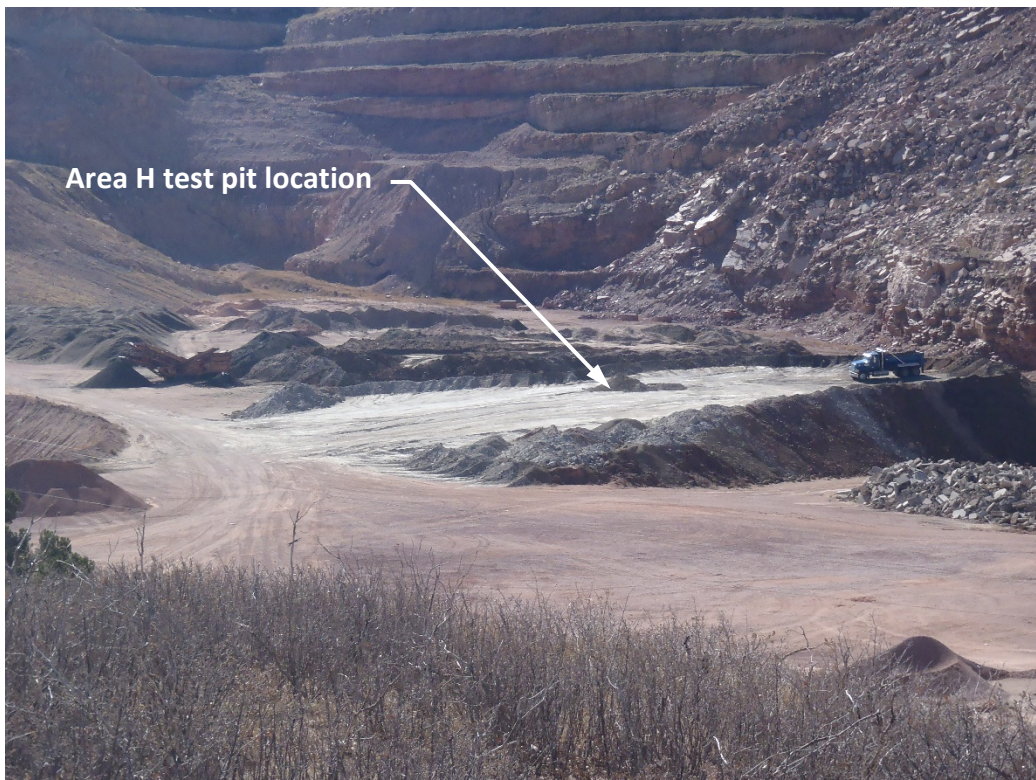
Photo 2. "Area H" backfill (looking south).

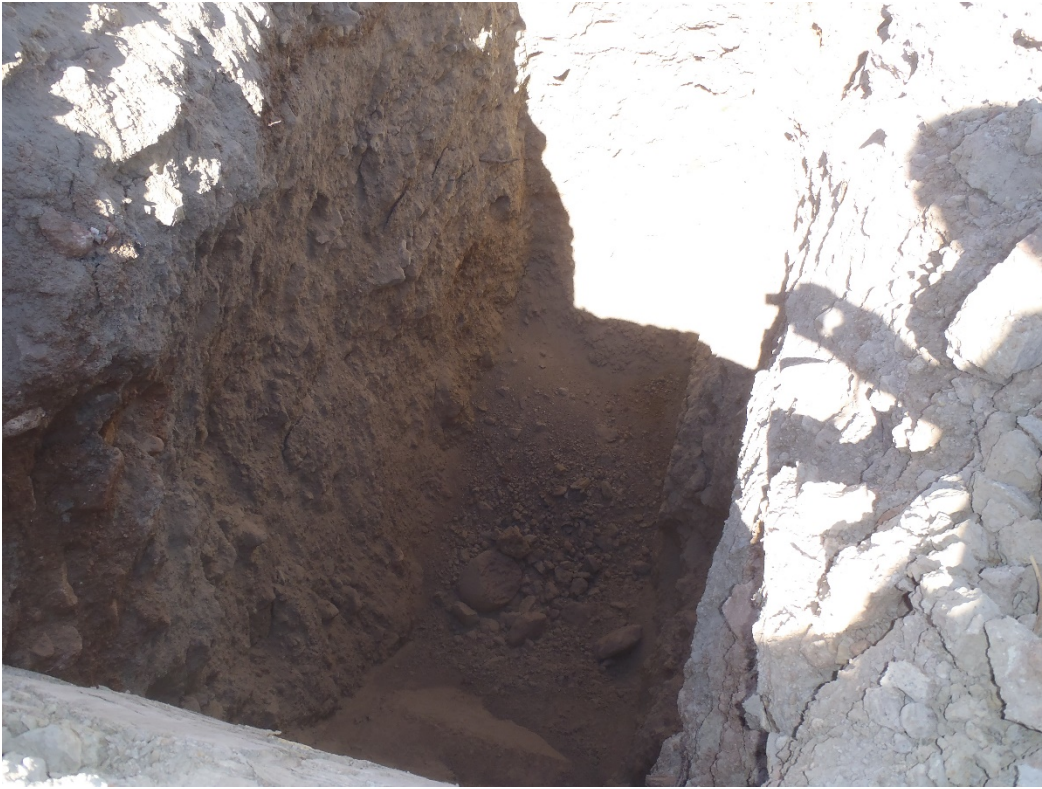
Photo 3. Test pit in "Area H" backfill (~12 feet deep).

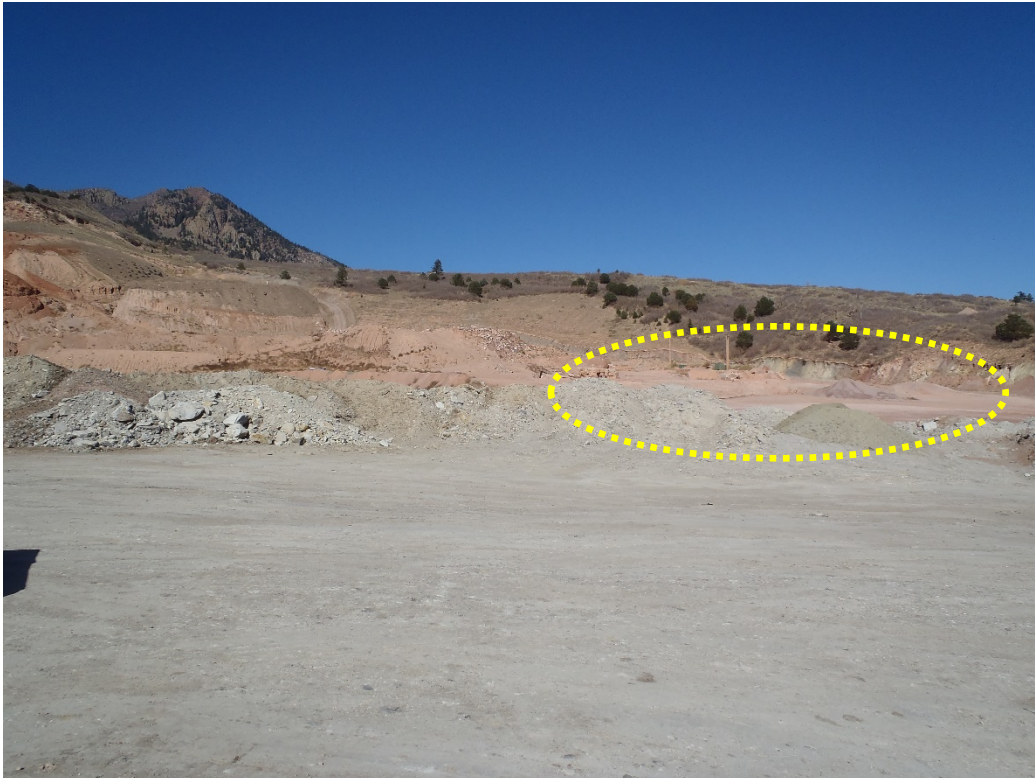
**Gen. Compliance with Mine Plan:** The operation has entered their final reclamation phase. Active excavation for product has ceased, although some sale of processed material in stockpiles will continue until depleted. Mr. Schnabel stated MSHA ceased regulatory oversight the day prior to this inspection. It was noted the crushing and screening equipment observed during previous inspections had been removed (see **Photo 4**). No changes were observed in the highwalls.

Photo 4. Screen plant, crusher, conveyors removed (looking north from Area H backfill).

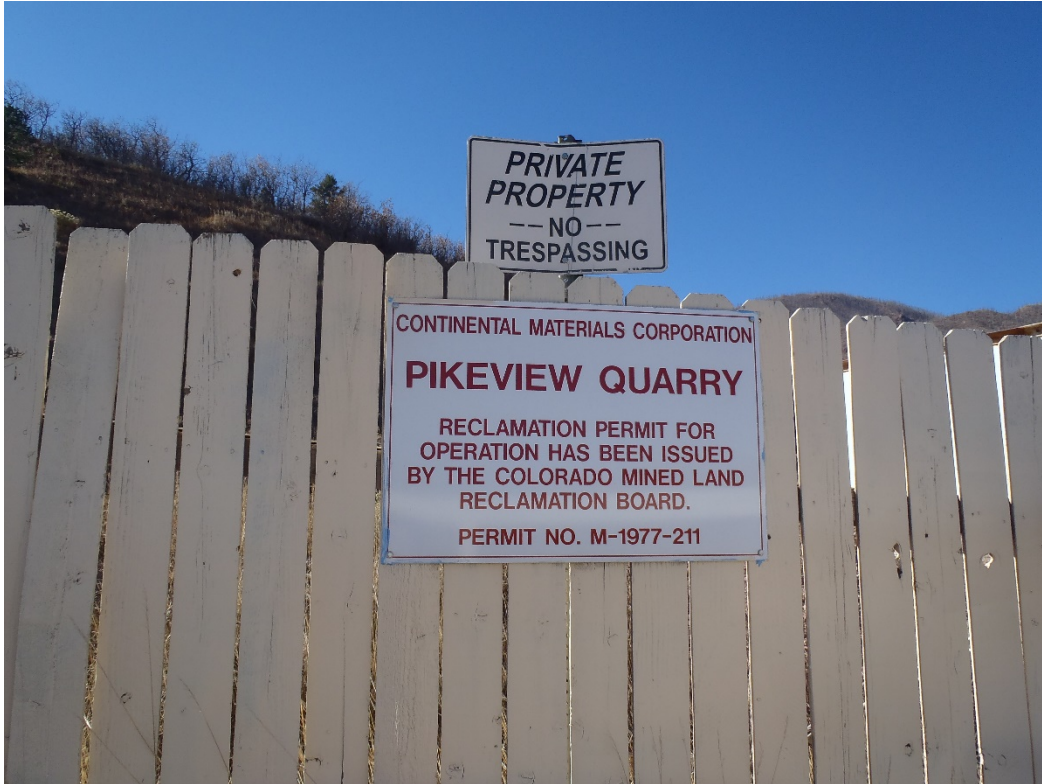
Signs and Markers: The permit sign was properly posted (see **Photo 5**) and boundary markers were observed on the north end to delineate the permit boundary (see **Photo 6**).

Photo 5. Permit sign (at entrance).

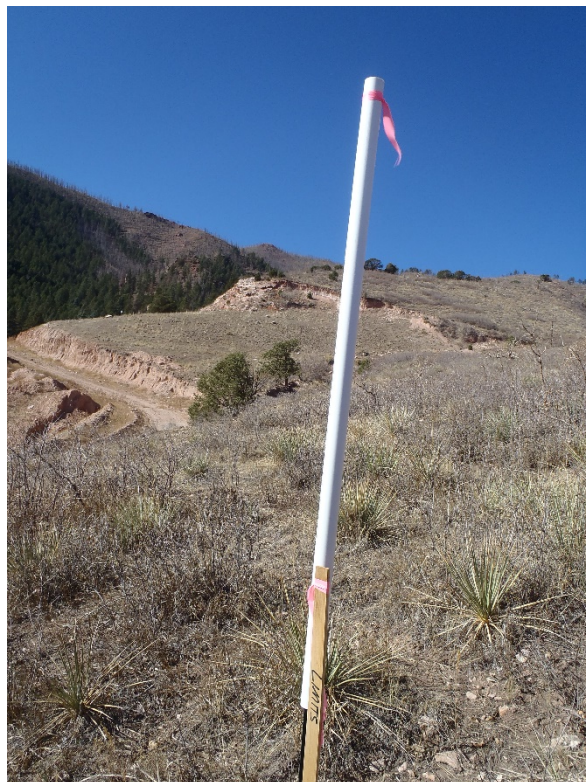
Photo 6. North end boundary marker (looking NW).

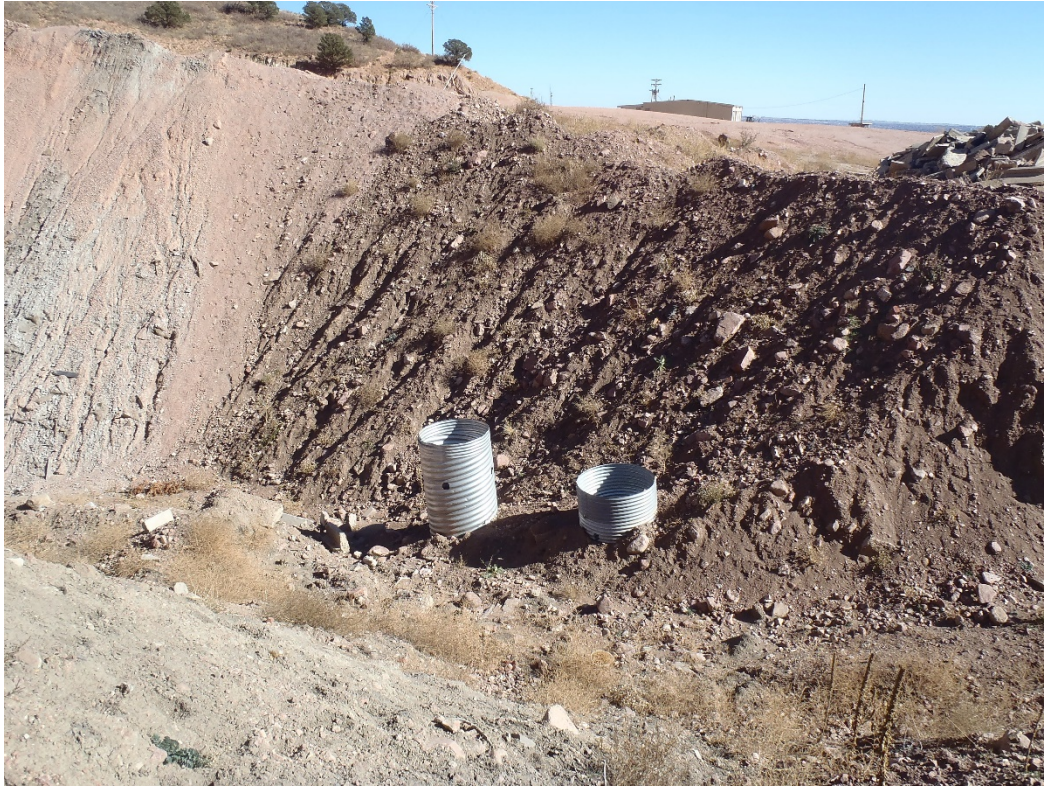
Storm Water MGT Plan: No oil or fuel spills observed. Stormwater within the pit area drains to the riser area (see **Photo 7**) and is captured by the French drain system. Other stormwater is/or will be either diverted or captured and directed to the three other existing sediment ponds.

Photo 7. Sediment pond #1 riser pipes (looking east).
