## MINERALS PROGRAM INSPECTION REPORT

<b>MINE NAME:</b> Kauffman Pit	<b>MINE/PROSPECTING ID#:</b> M-1978-327	<b>MINERAL:</b> Sand and gravel	<b>COUNTY:</b> Larimer
<b>INSPECTION TYPE:</b> Monitoring	<b>INSPECTOR(S):</b> Amy Eschberger	<b>INSP. DATE:</b> November 17, 2020	<b>INSP. TIME:</b> 14:00
<b>OPERATOR:</b> Jake Kauffman & Son, Inc.	<b>OPERATOR REPRESENTATIVE:</b> Troy Kauffman, Dan Giroux	<b>TYPE OF OPERATION:</b> 112c - Construction Regular Operation	
<b>REASON FOR INSPECTION:</b> Normal I&E Program	<b>BOND CALCULATION TYPE:</b> None	<b>BOND AMOUNT:</b> \$14,727.00	
<b>DATE OF COMPLAINT:</b> NA	<b>POST INSP. CONTACTS:</b> None	<b>JOINT INSP. AGENCY:</b> None	
<b>WEATHER:</b> Clear	<b>INSPECTOR'S SIGNATURE:</b>

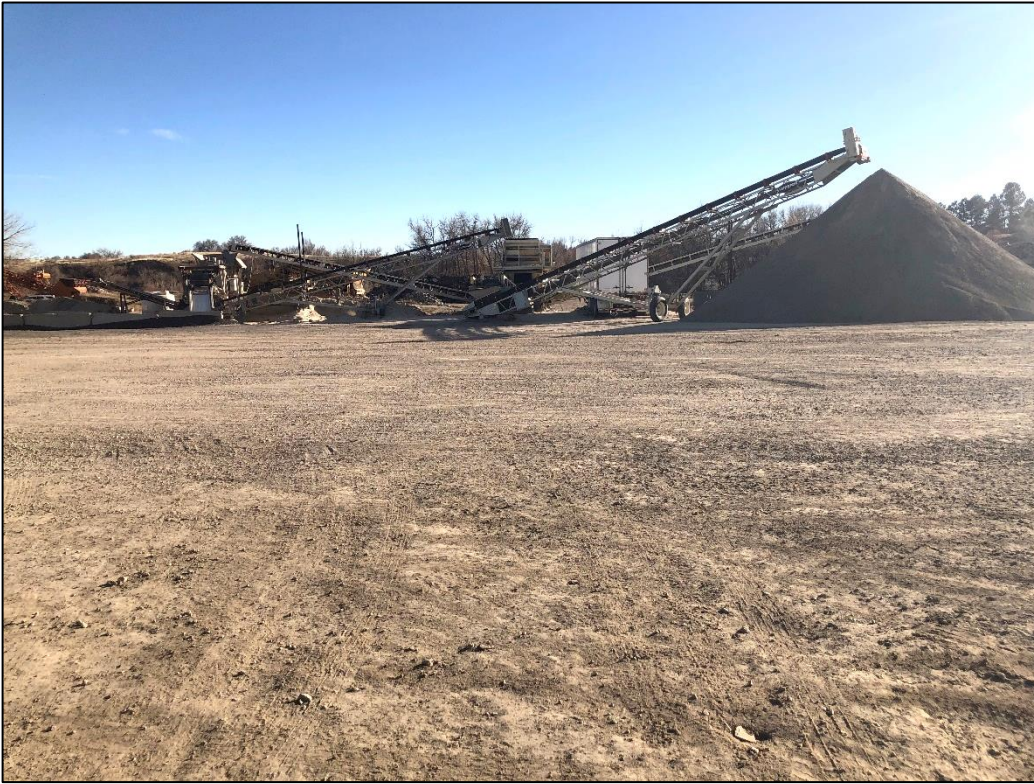
**Photo 1.** View looking south across recycled materials plant which operates in eastern portion of permit area.

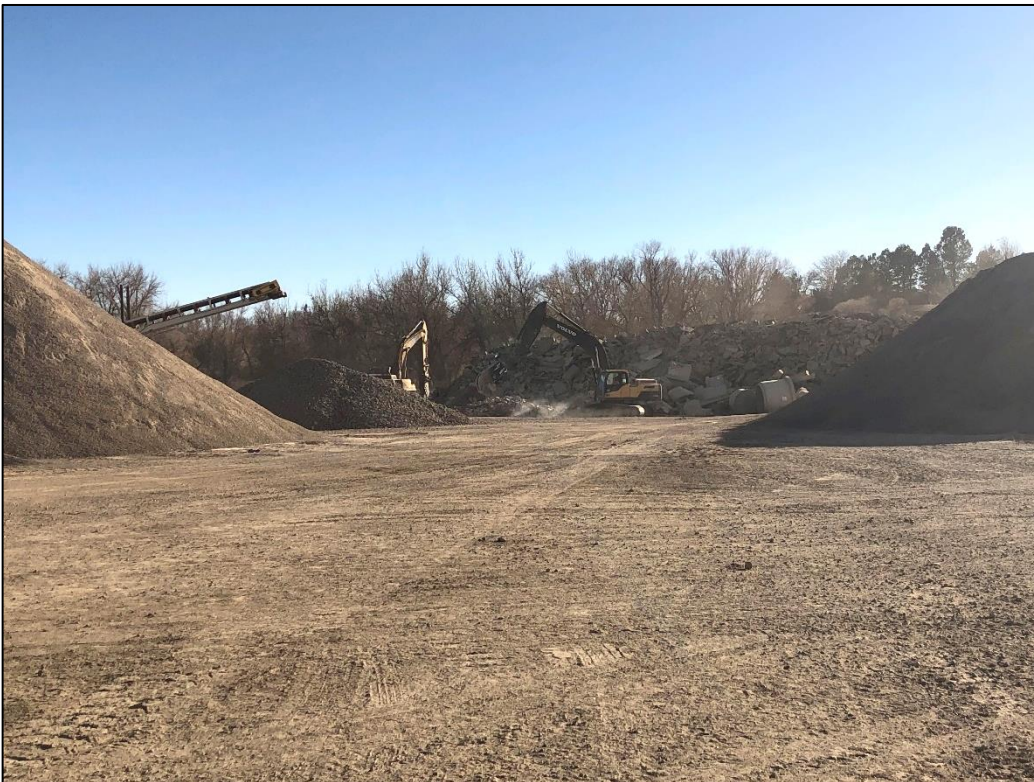
**Photo 2.** View looking southeast across recycled materials plant which operates in eastern portion of permit area.

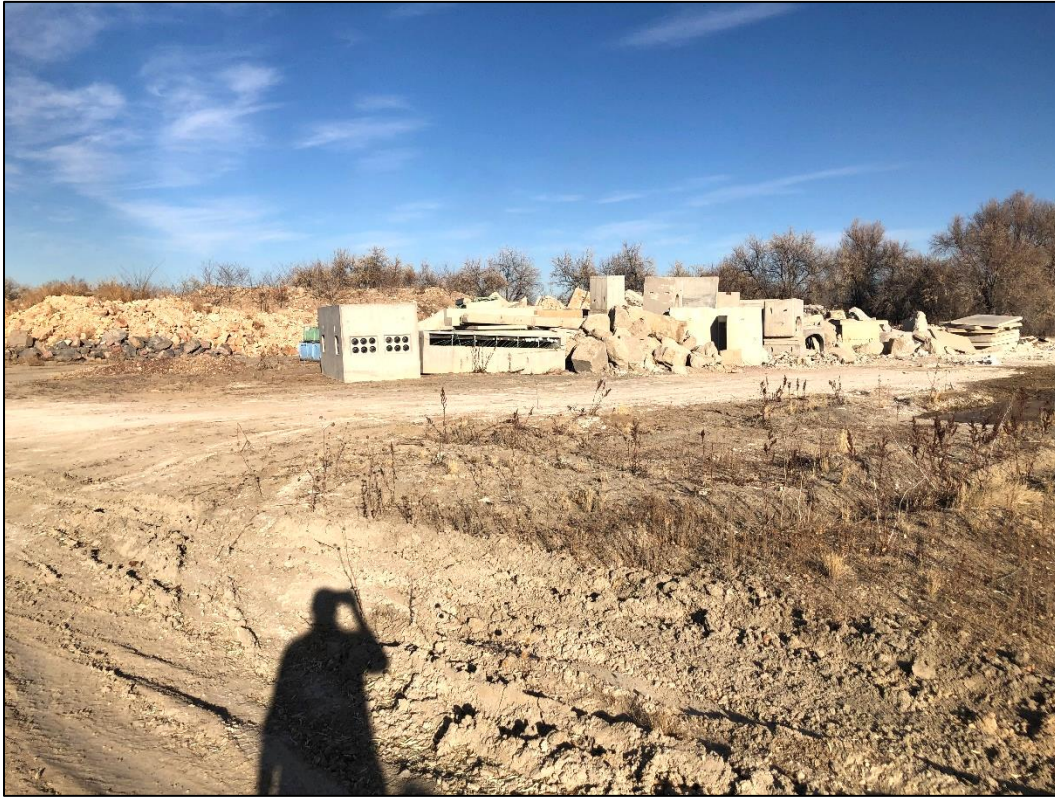
The two storage areas are currently being leased out for industrial/commercial use. The southern storage area is currently utilized for storage of various types of materials (e.g., concrete debris, rock, lumber) and equipment. It appeared that very little additional backfilling, if any, has occurred along the eastern shoreline of the southern pond since the Division's last inspection on July 11, 2019. The northern storage area is currently leased out for truck and equipment storage.

**Photo 3.** View looking southeast across outdoor storage area located adjacent to and east of southern pond. This area is currently utilized for storage of various materials (e.g., concrete debris, rock, timber) and equipment.

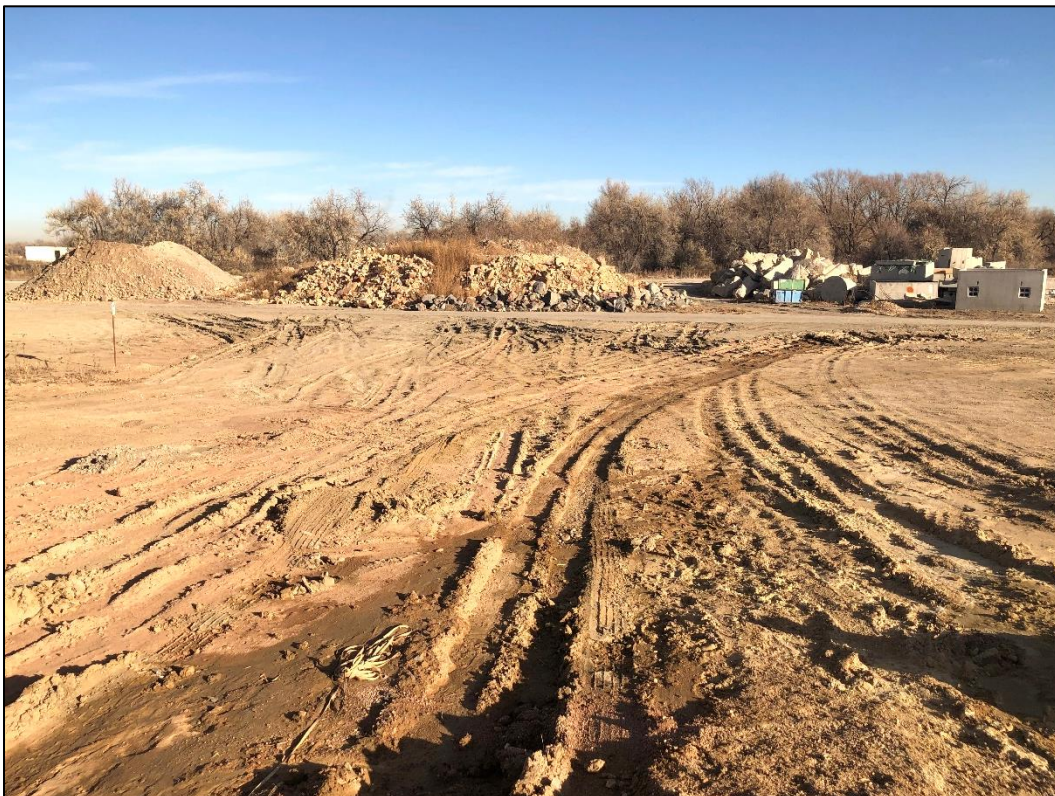
**Photo 4.** View looking east across outdoor storage area located adjacent to and east of southern pond. This area is currently utilized for storage of various materials (e.g., concrete debris, rock, timber) and equipment.

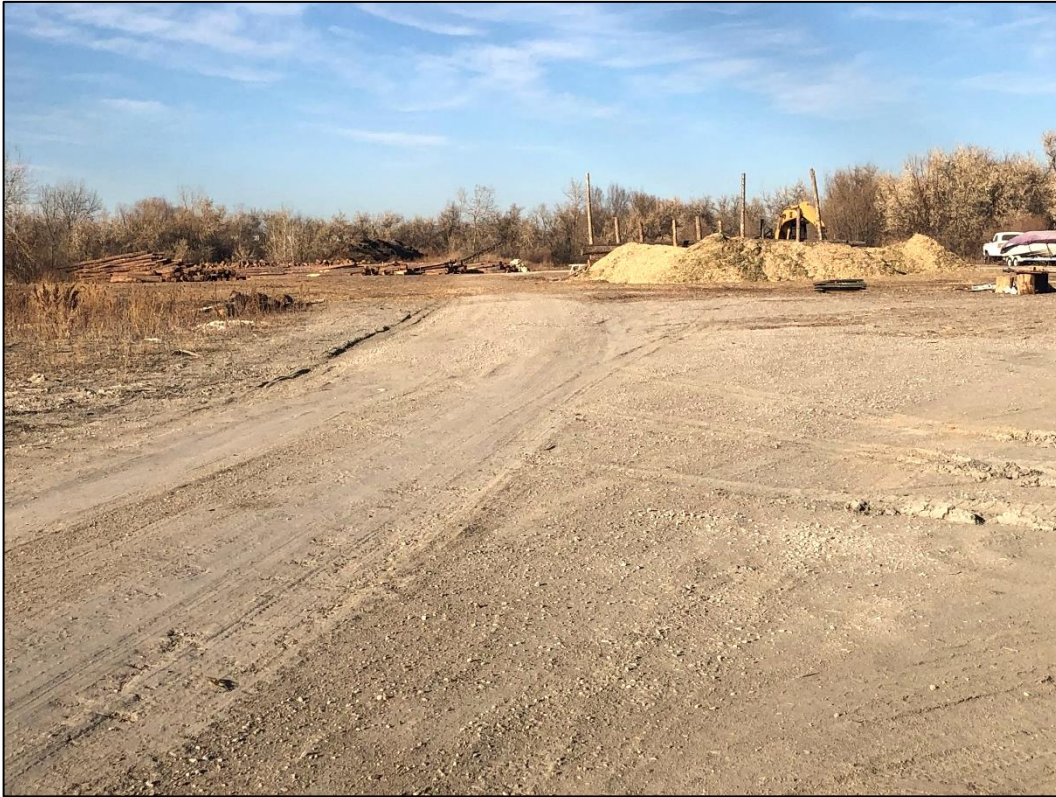
**Photo 5.** View looking north across outdoor storage area located adjacent to and east of southern pond. This area is currently utilized for storage of various materials (e.g., concrete debris, rock, timber) and equipment.

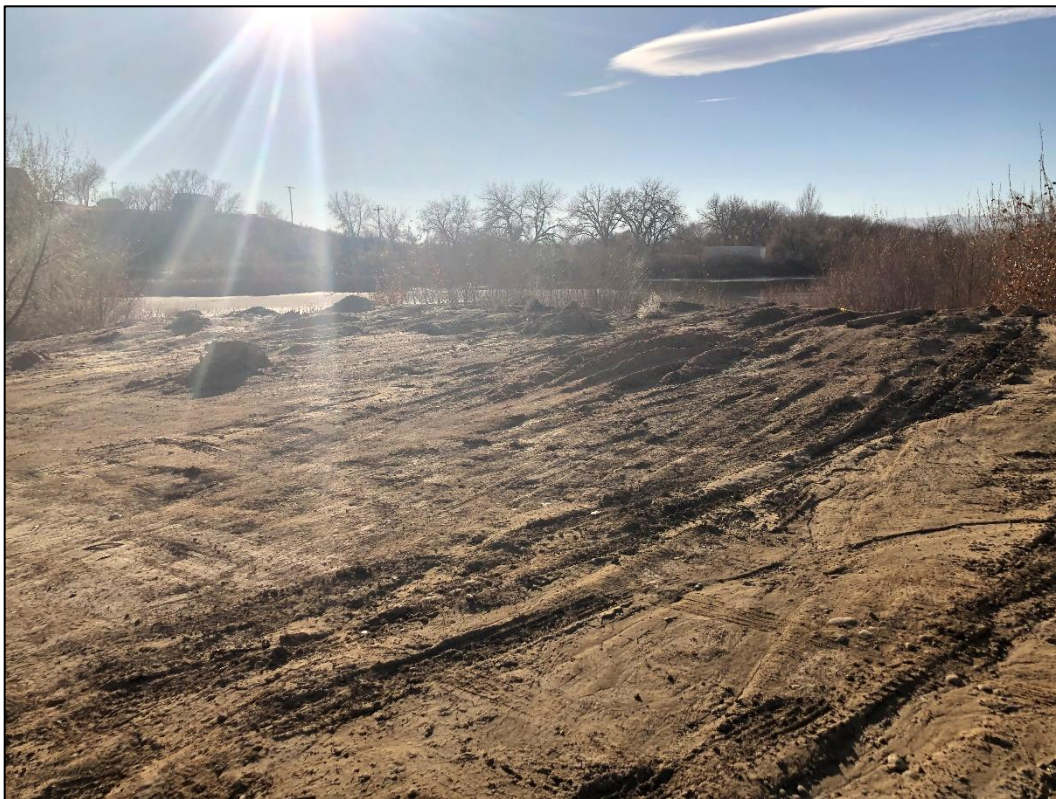
**Photo 6.** View looking south across active backfill area along eastern shoreline of southern pond.

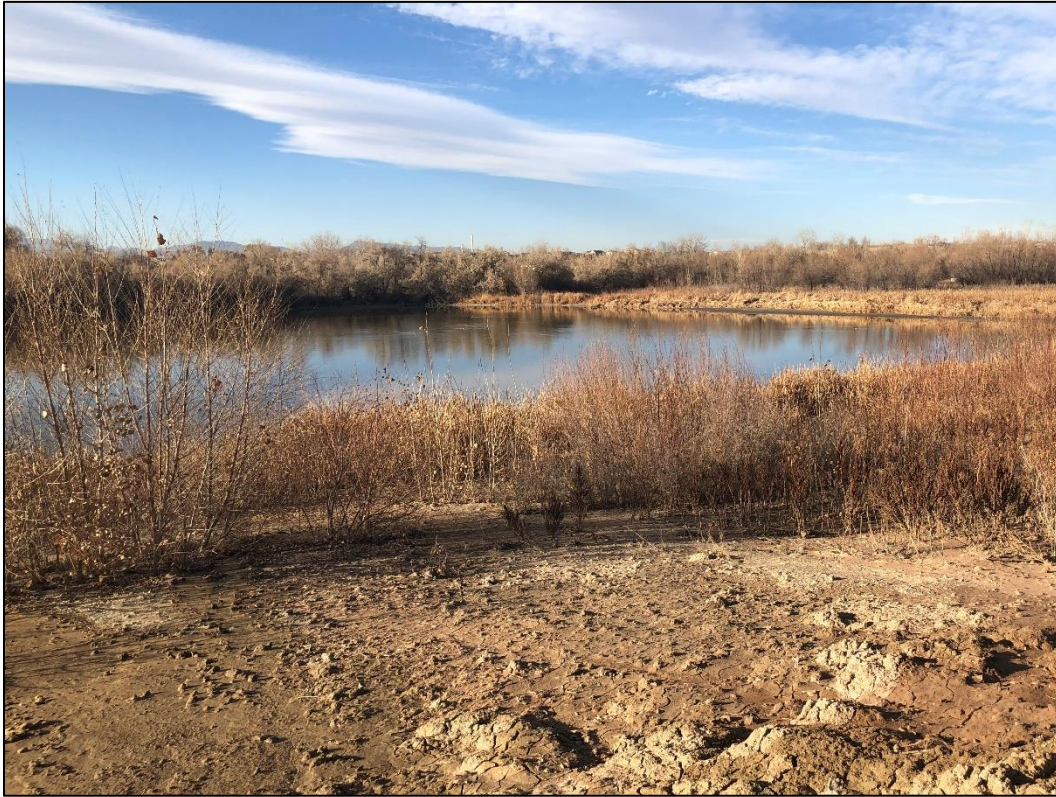
**Photo 7.** View looking west across southern pond from its eastern shoreline. All shorelines of this pond, except for the active backfill area along the eastern shoreline, are reclaimed with slopes at 2.5H:1V or flatter and good vegetative cover.

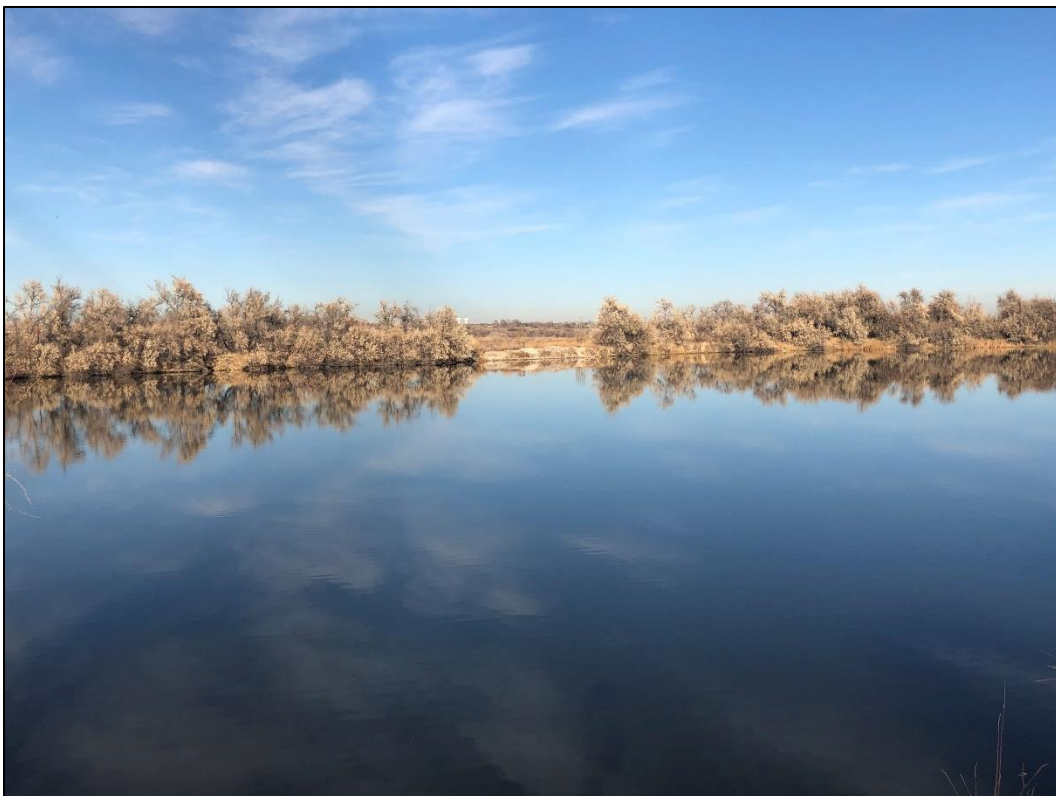
**Photo 8.** View looking north across larger northern pond from its southern shoreline. All shorelines of this pond, except for the portion along the outdoor storage area, are reclaimed with slopes at 2.5H:1V or flatter and good vegetative cover.

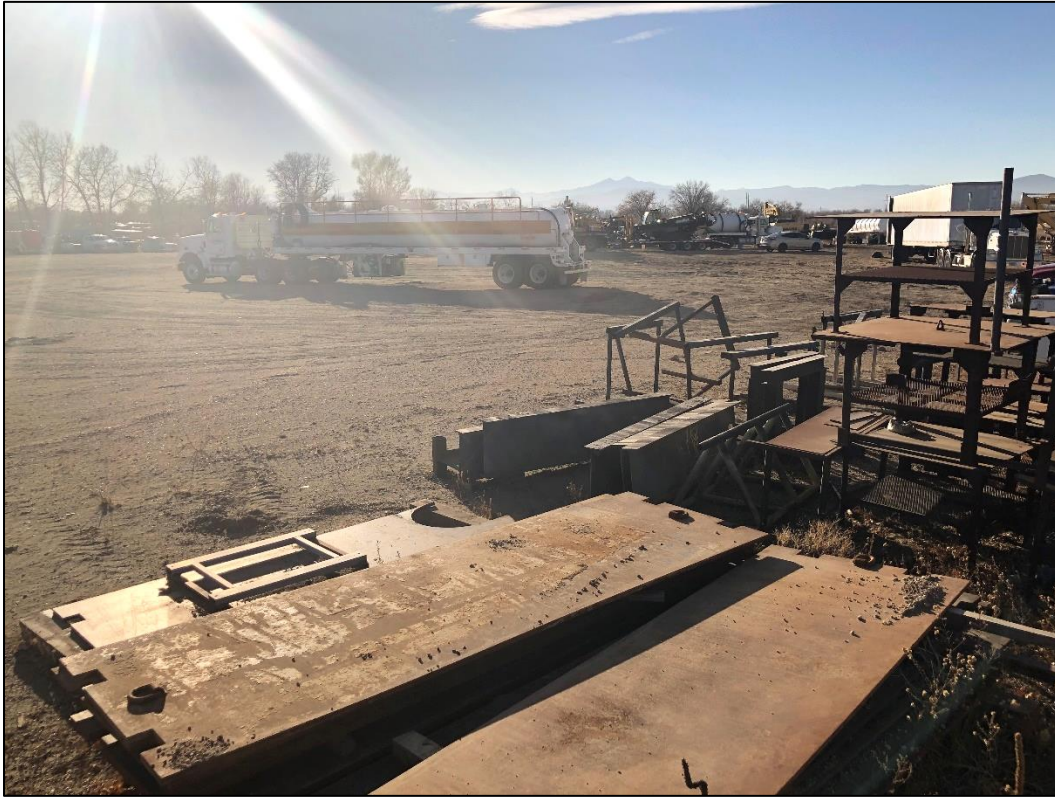
**Photo 9.** View looking southwest across outdoor storage area located adjacent to and south of northern pond. This area is currently leased out for truck and equipment storage.

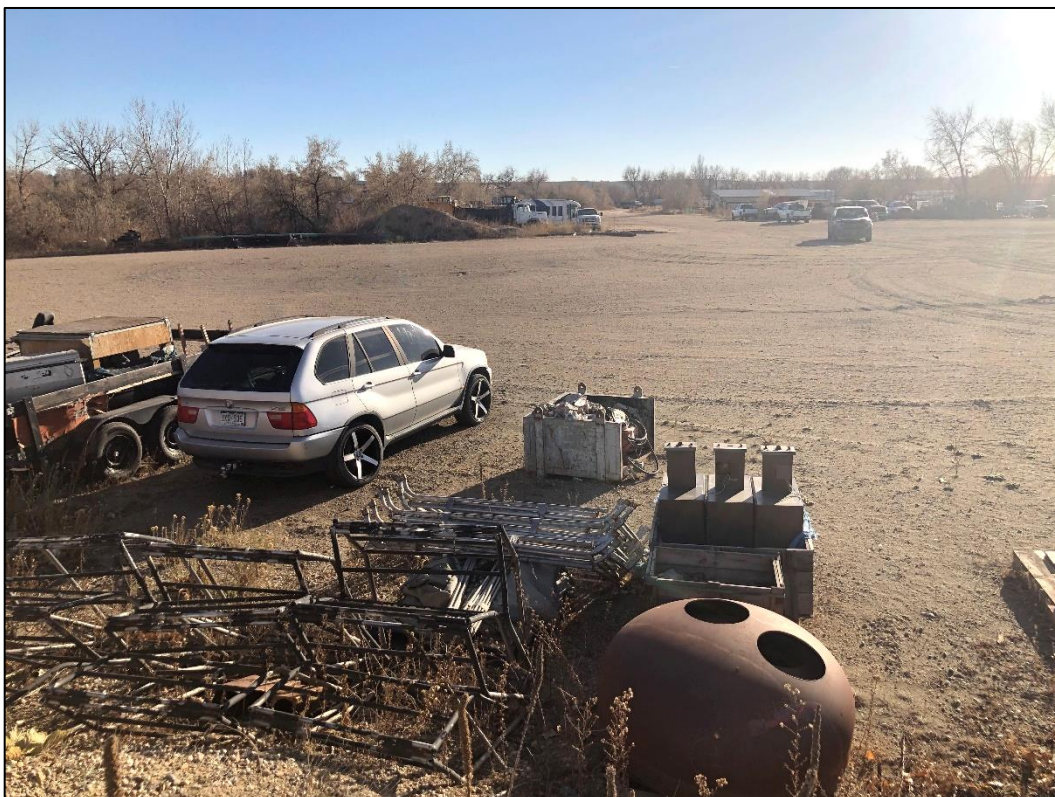
**Photo 10.** View looking southeast across outdoor storage area located adjacent to and south of northern pond. This area is currently leased out for truck and equipment storage.
