Minerals Exploration/Sampling/Testing Inspection

U.S. Department of the Interior Bureau of Land Management Royal Gorge Field Office

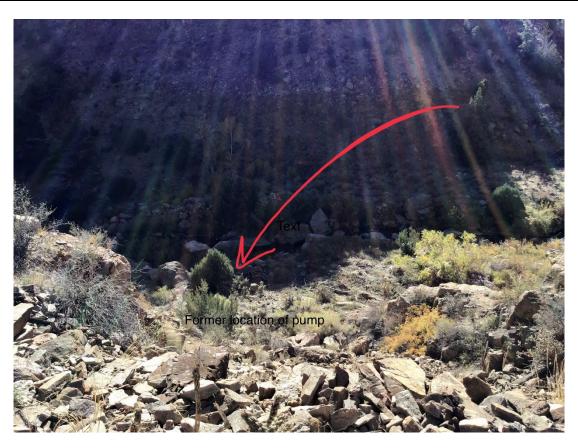
Image 1:

Comment: Former location of pump alongside creek

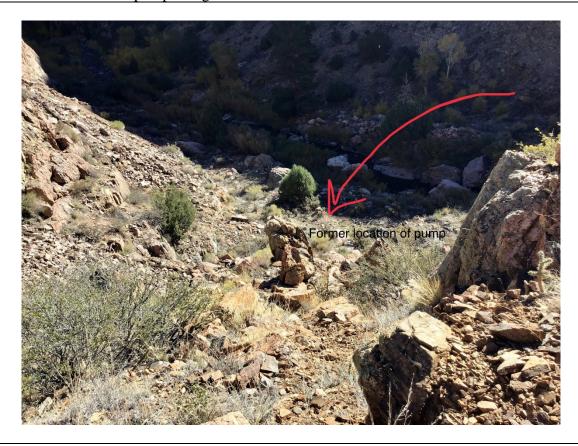
Image 2:

Comment: Former location of pump alongside creek

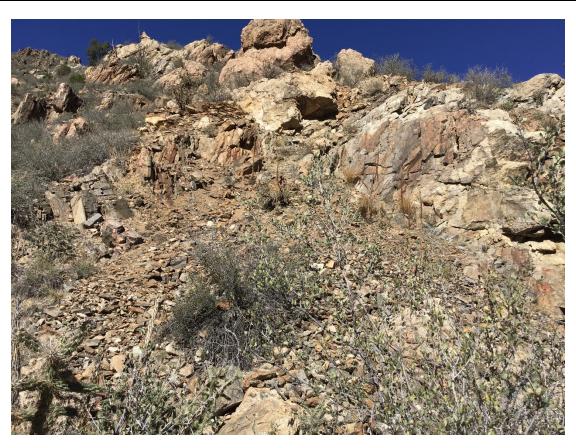
Image 3:

Comment: Area where water hoses were previously located

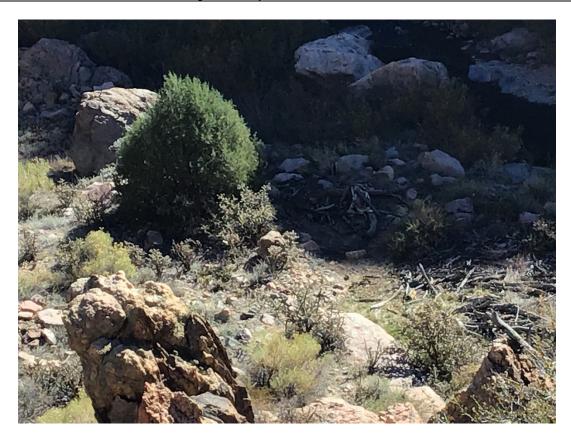
Image 4:

Comment: Area where water hoses were previously located

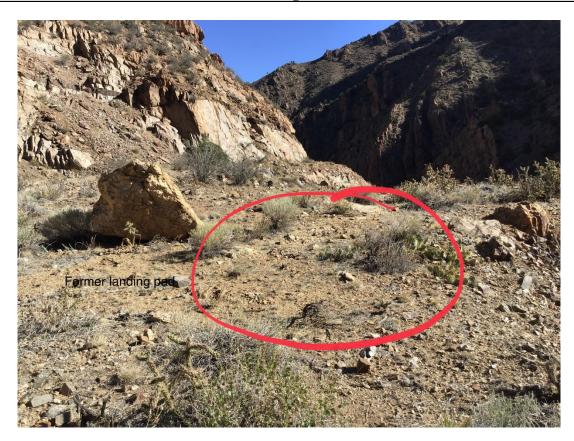
Image 5:

Comment: Former helicopter landing pad

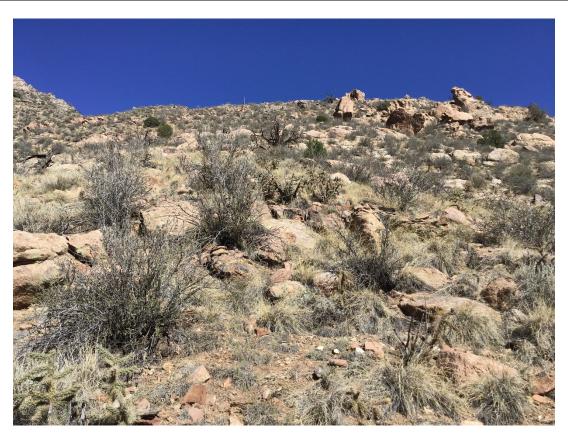
Image 6:

Comment: Overall picture of former drill site

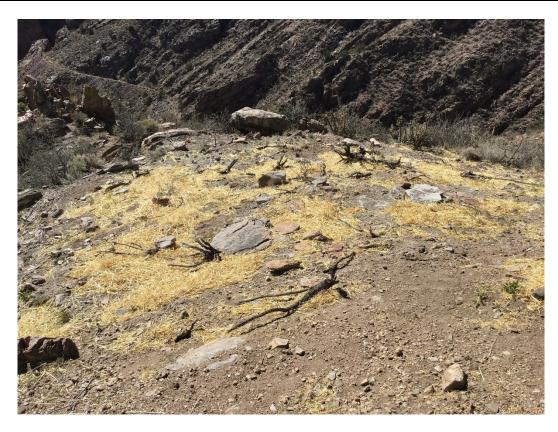
Image 7:

Comment: Former drill site with visible straw

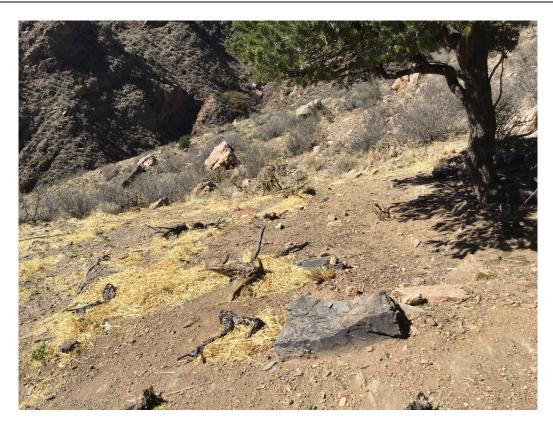
Image 8:

Comment: Former drill site with visible straw

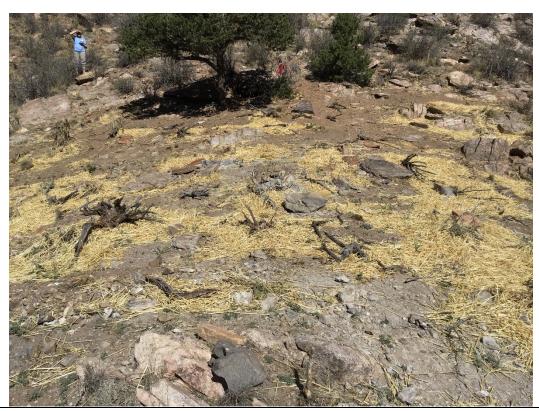
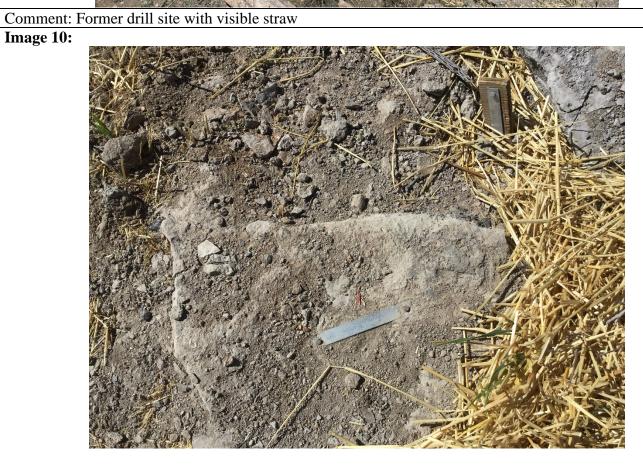
Image 9:

Comment: Abandoned drill hole

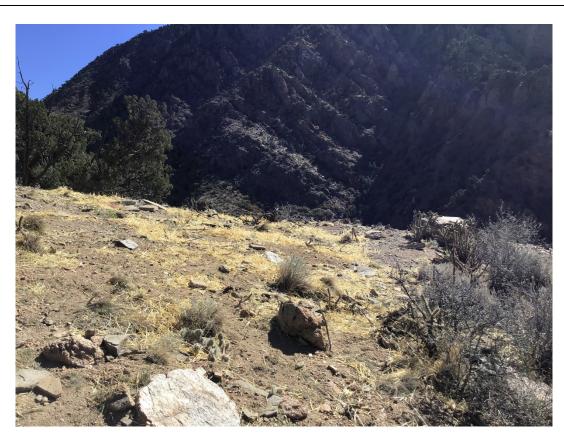
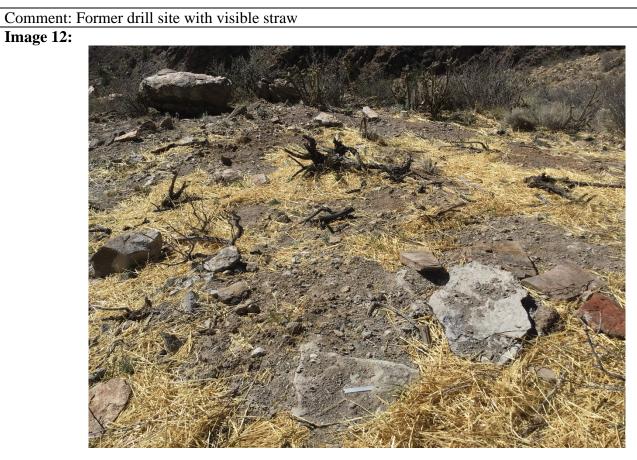
Image 11:

Comment: Former drill site with visible straw

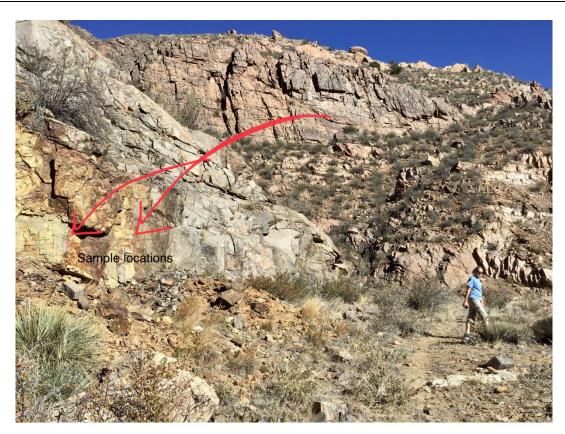
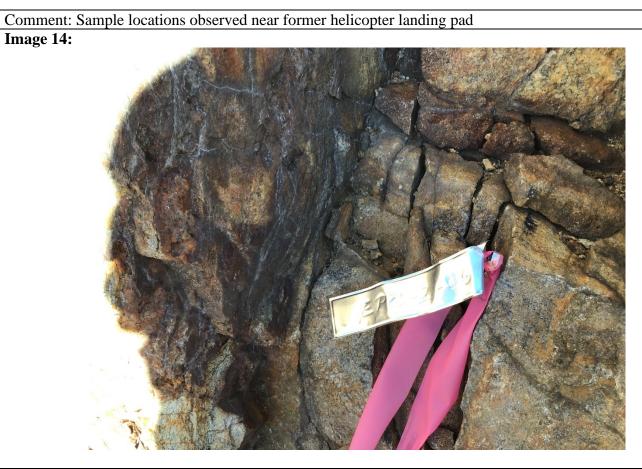
Image 13:

Comment: Close up of one sample location
