Minerals Exploration/Sampling/Testing Inspection
U.S. Department of the Interior
Bureau of Land Management
Royal Gorge Field Office

Date: Aug 18, 2020 Time: 11:15 Weather: Sunny	Operation Name: Dawson-Green Mtn., El Plomo section Operator: Zephyr Case Number: N/A CDRMS Number: P-2020-002
<u>Attendees</u> BLM: S. Carter, K. Berger, S. McClernan Operator(s): Not Present Other(s): Tim Cazier (CDRMS), Two drillers with Godbe Drilling	<u>General</u> Operation(s) are in compliance with documentation on file <input checked="" type="checkbox"/> Yes <input type="checkbox"/> No <input type="checkbox"/> N/A Operation(s) and disturbance on-site coincide with the operations and access on file <input type="checkbox"/> Yes <input type="checkbox"/> No <input checked="" type="checkbox"/> N/A

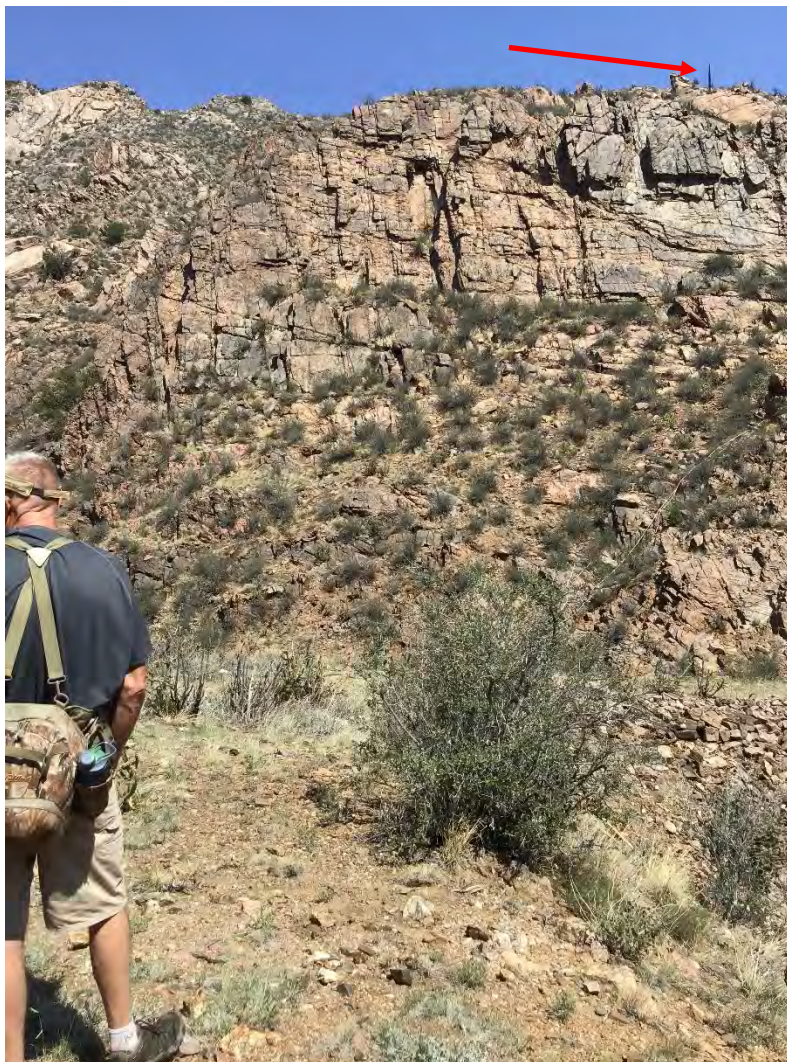
Image 1:

- 1.a.
- i. The drilling structure for EP-20-01 that was constructed onsite on 8/1/2020, is still in place. Images 1 and 2.
 - The water pump was operating during the site visit and still runs continually. Image 3.

Comment: Overall EP-20-01; red arrow indicates the rig location

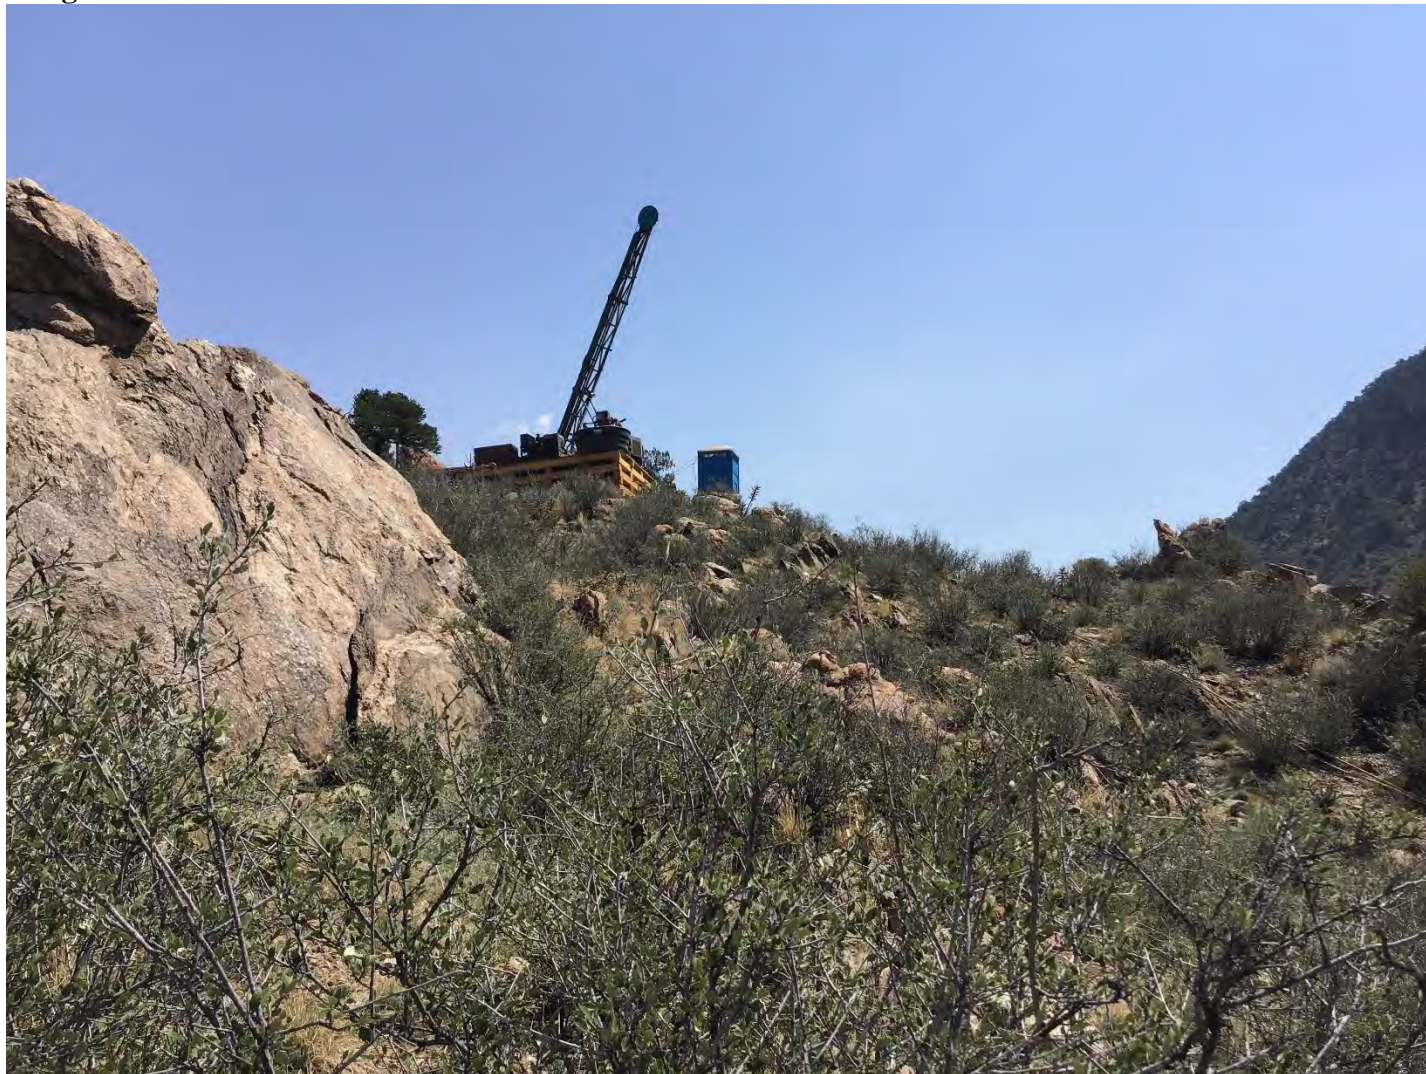
Image 2:

- There is still vegetation visible below and around the drilling platform. Images 2 and 10.

Comment: General overview of EP-20-01 drill site

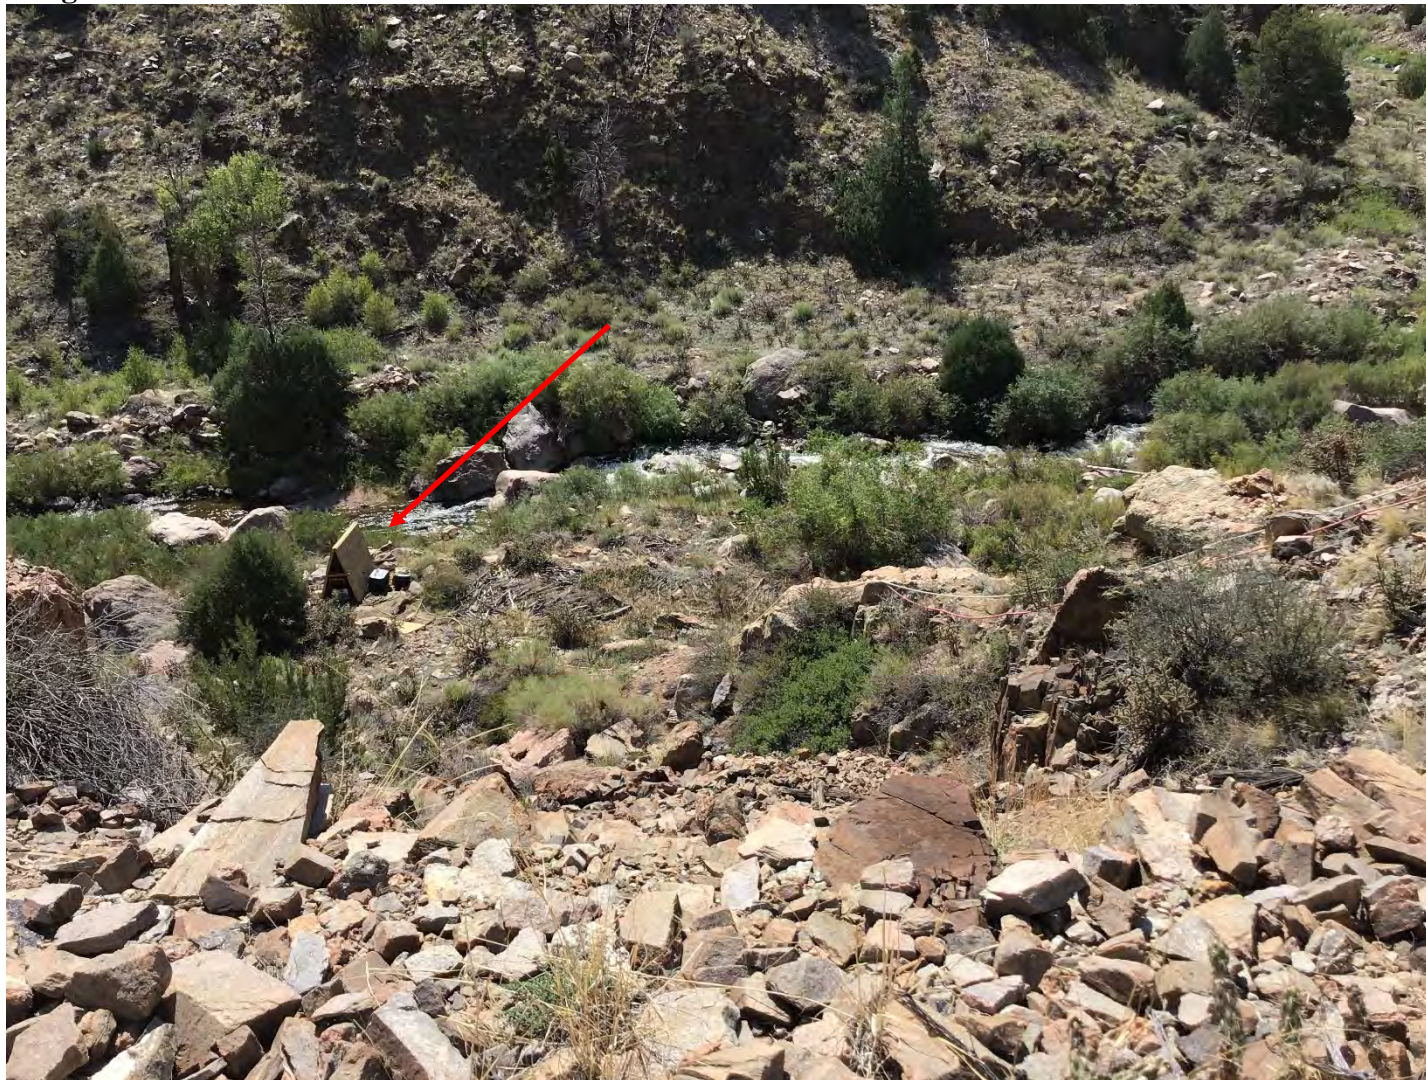
Image 3:

- A stock tank is used for secondary containment of the water pump, and is located in the same position adjacent to the creek. A plywood roof has been installed over the pump. Image 3.

Comment: Red arrow indicates water pump, with new roof, location along creek

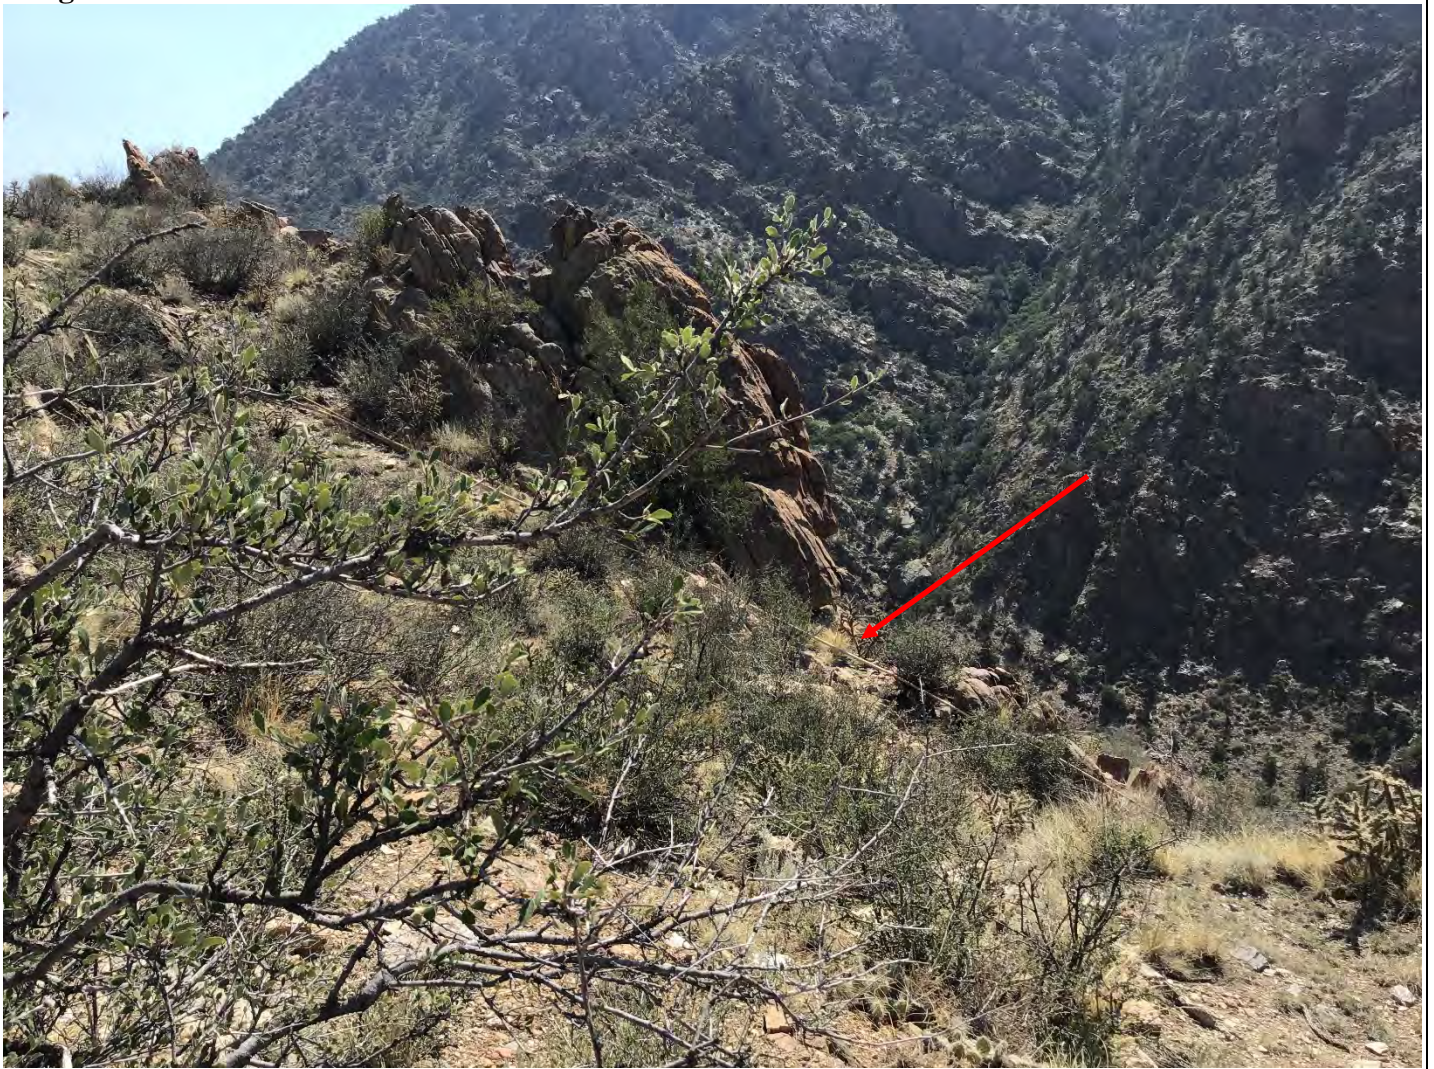
Image 4:

- There are two hoses, each with a diameter of <2", that extend from the water pump to the rig platform. These hoses displayed little movement vertically (none laterally) and were mostly extended across rocky areas and a small drainage. No disturbance associated with the hoses was observed. Image 4.

Comment: Red arrow indicates water hoses

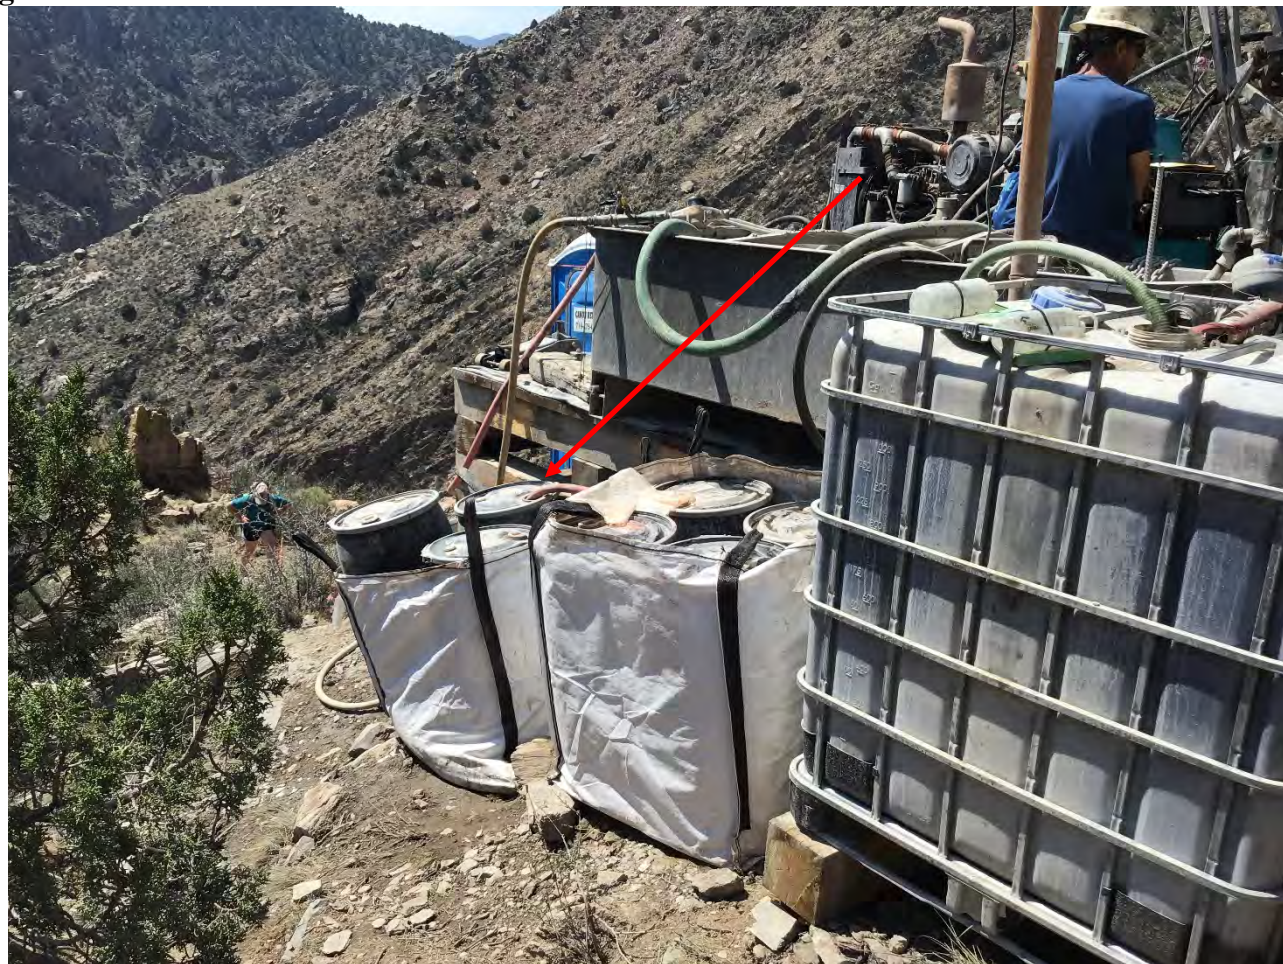
Image 5:

- There are still no additives being used in the drilling fluids at this time, just water. Water is pumped up from the creek to use for a drilling lubricant. Any excess water is filtered through a separator, which is a centrifuge that separates the solids or drill cuttings from the drilling water that is then recirculated. Any cuttings are stored in a drum off to the side of the platform. This configuration has changed from last time, but the process is still the same as the last visit. Images 5 and 6.

- 3.a.
- The drum containing cuttings (after being filtered through the separator) has been replaced. The new one is a plain black drum, with no previous labeling visible. The separated cuttings are stored in this drum until they are of sufficient quantity to be removed from the site. Empty drums are located in a tote on the side of the platform. Image 5. **These drums need to be labeled with contents and can be done manually with a permanent marker.**

Comment: Red arrow indicates drum that is receiving the sediment after the separator

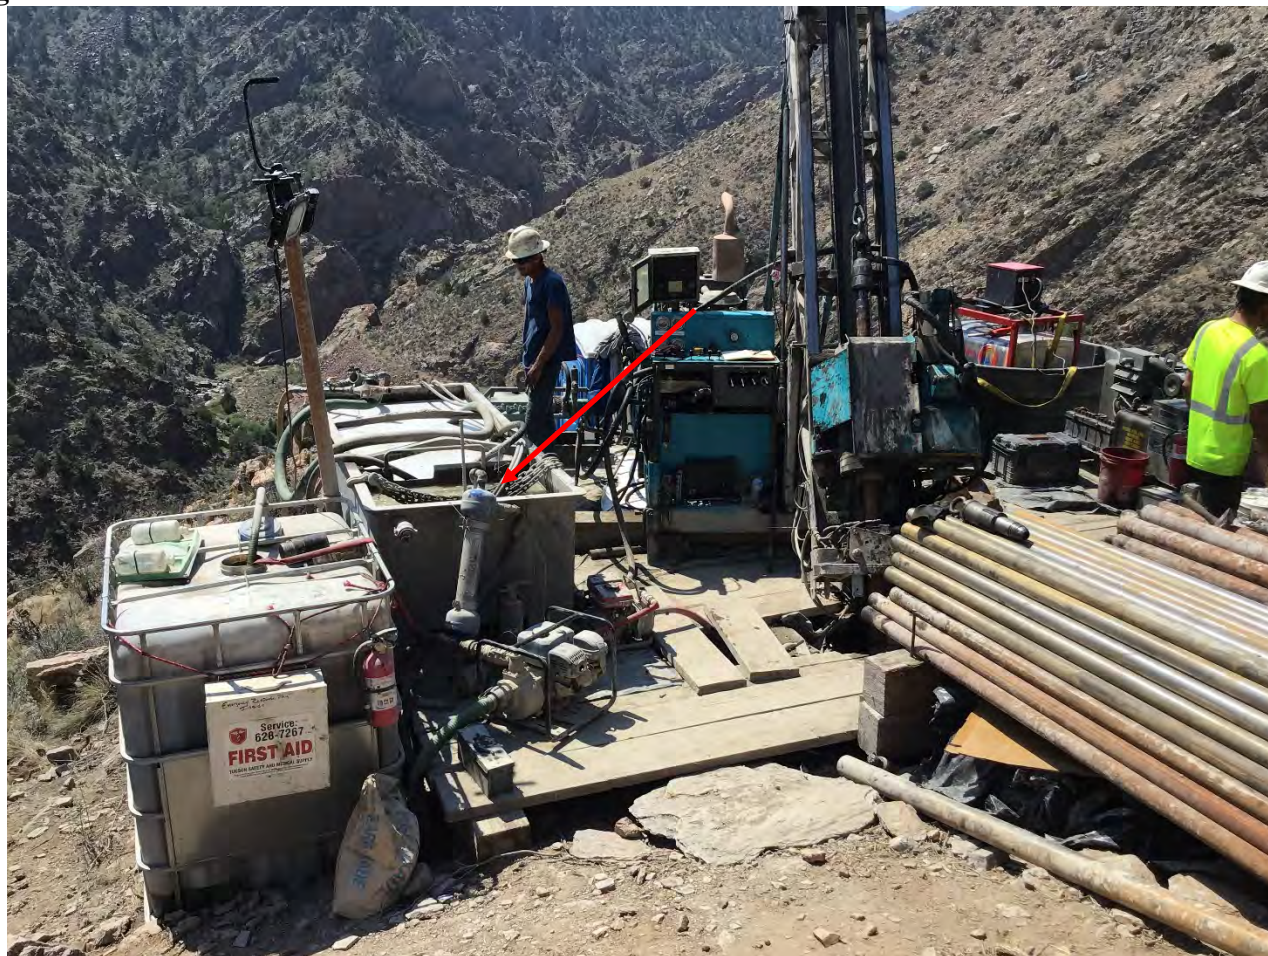
Image 6:

Comment: Red arrow indicates separator

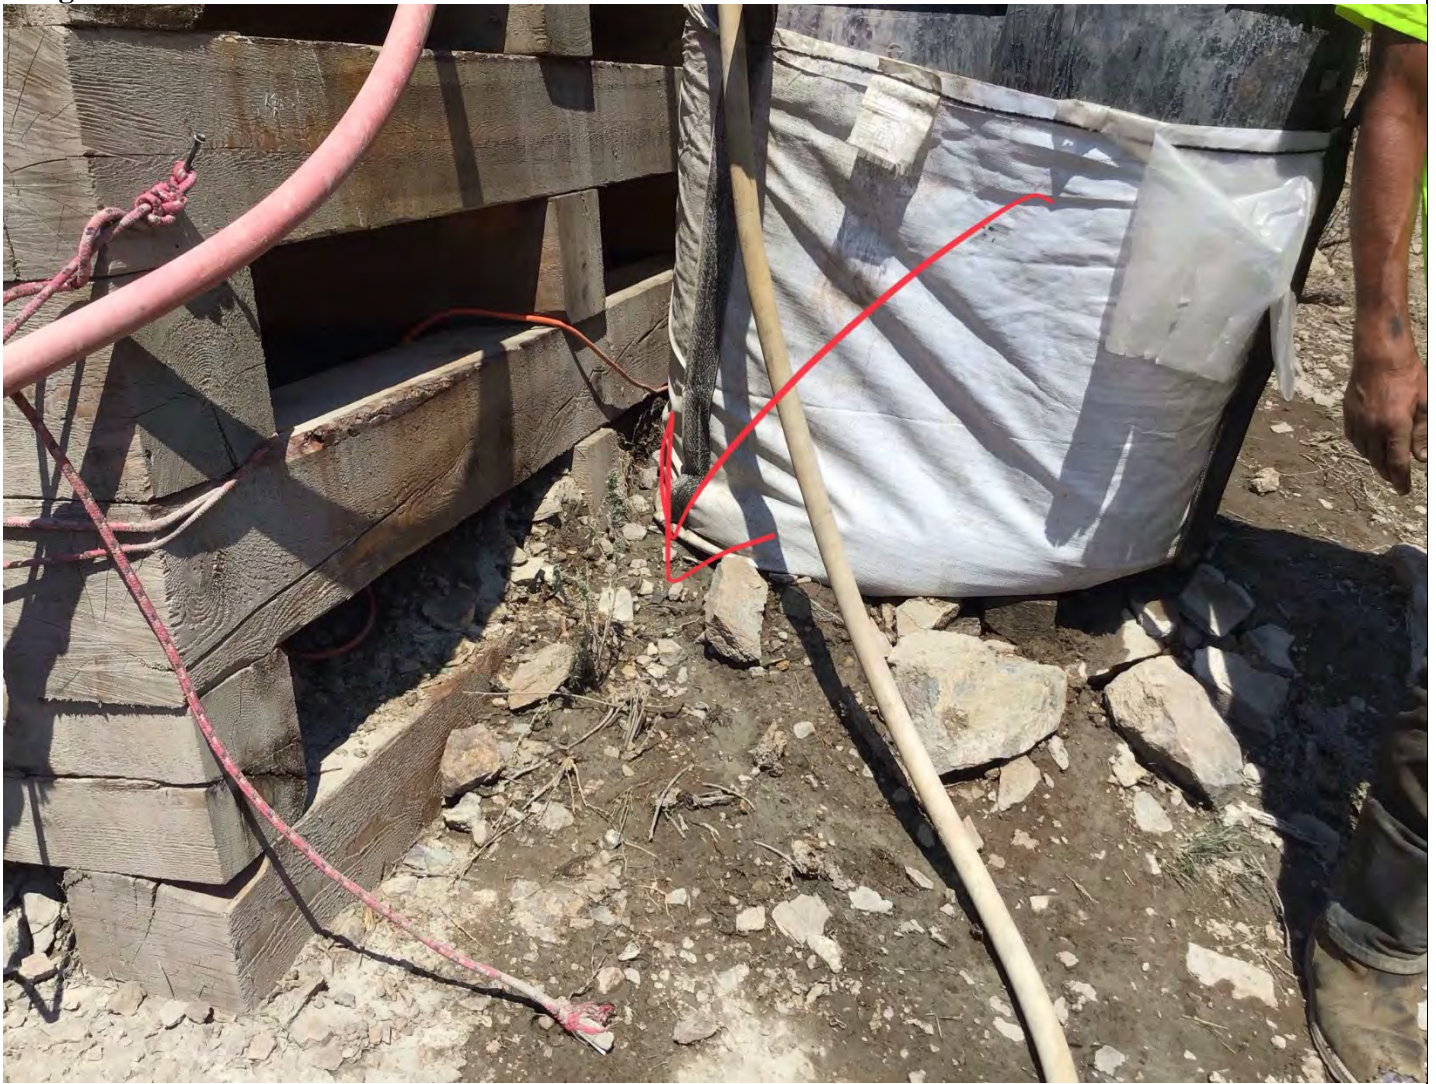
Image 7:

- 2.b. There was a waterline blowout that just occurred prior to our arrival at the platform. After looking at the ground around the platform where this occurred, no erosional features were observed. Image 7.

Comment: Close-up of ground just after water line break

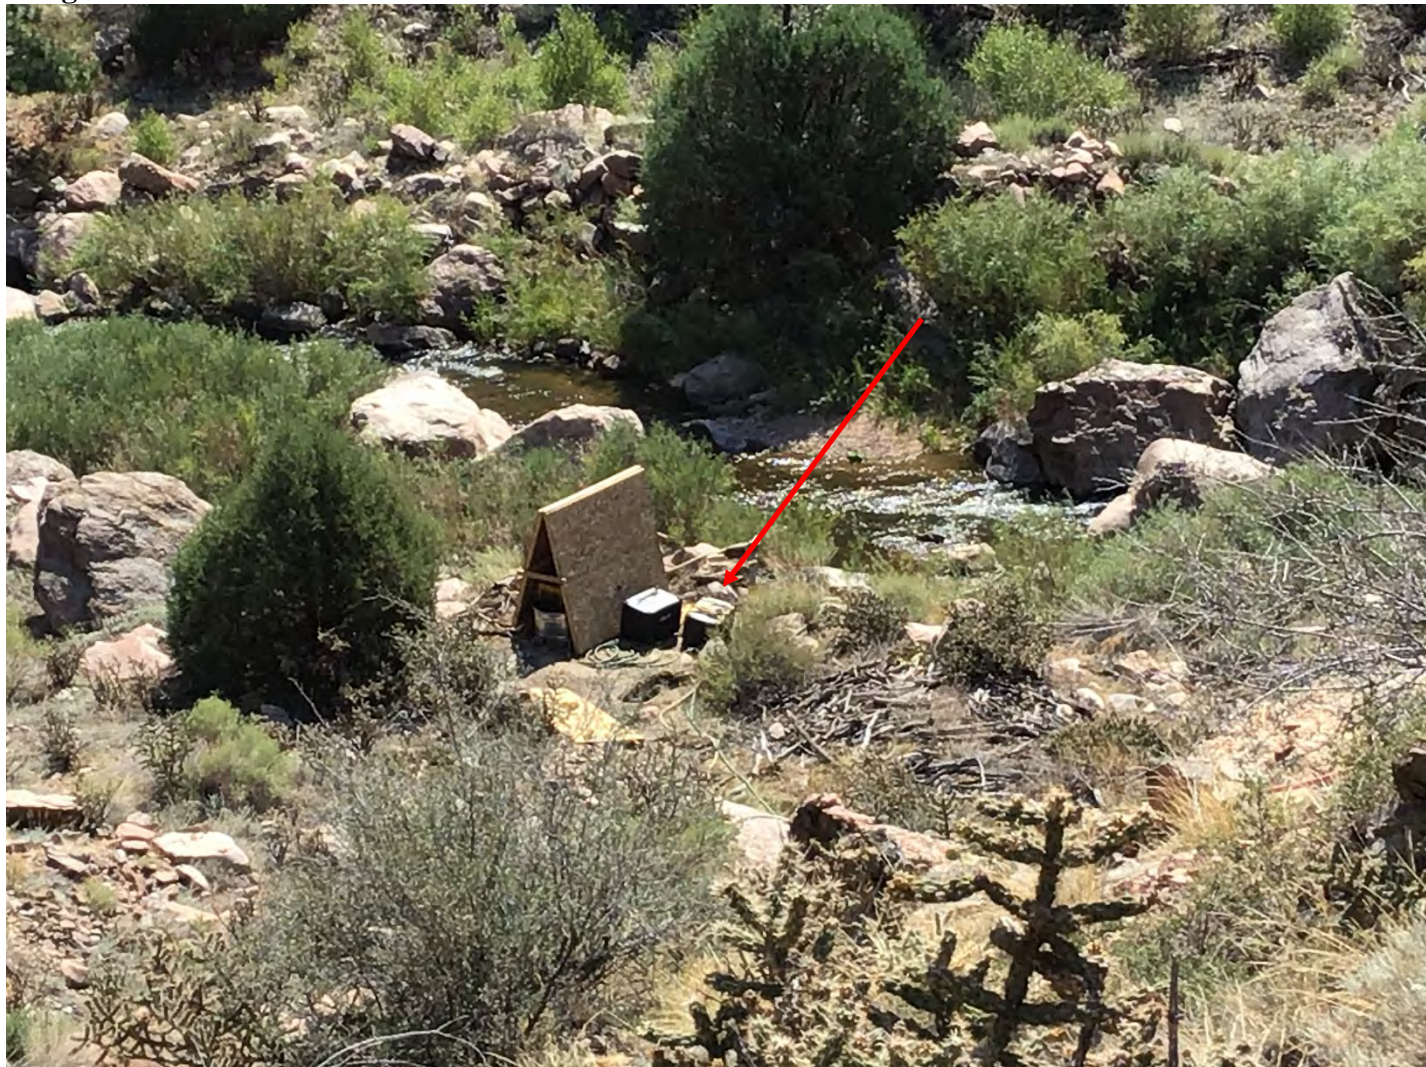
Image 8:

- Diesel fuel for the water pump is still being sourced from a 50-gallon, lined container adjacent to the pump. An additional lined container is now also located adjacent to the container in service. This was done in case fuel runs out sooner than expected. Image 8.

Comment: Additional lined, diesel container

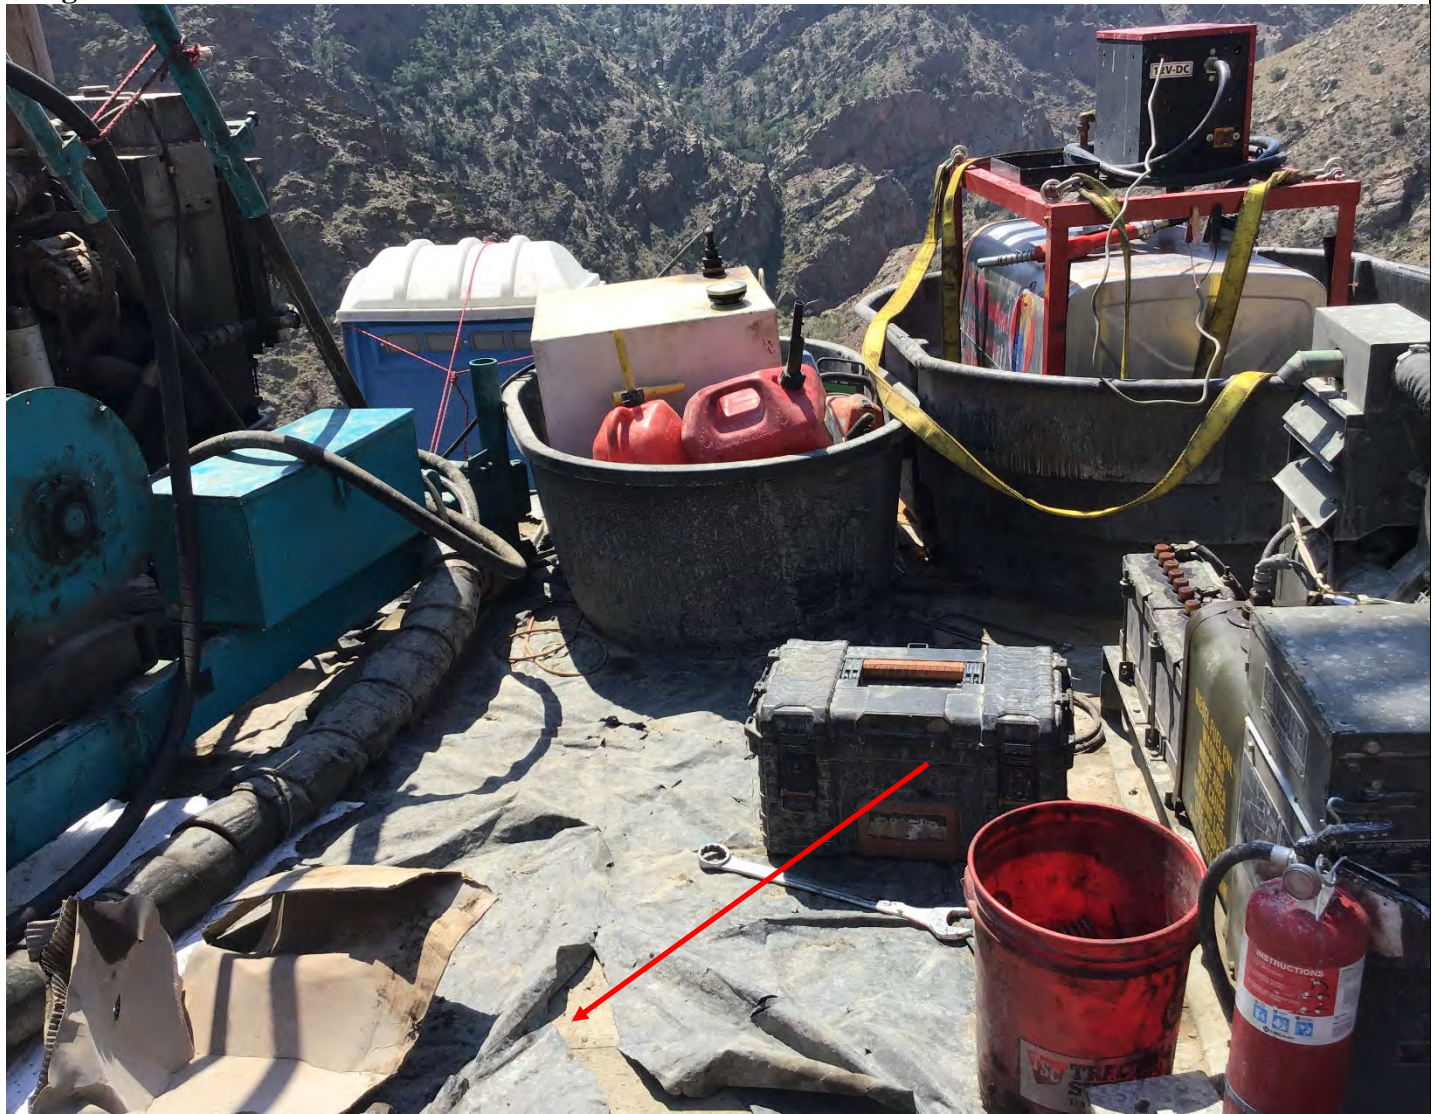
Image 9:

- Secondary containment/tubs still being used for equipment on platform.
 - Visqueen still lines the top of the wooden platform, as a barrier from the working site to native ground below. However, there are some evident holes in the liner. The drillers stated they are waiting on the right supplies, in order to repair the liner. The ground underneath did not show any staining or issues that could be associated with operations on the platform, other than the water line blowout. Images 9 and 10.

Comment: Rig platform, red arrow indicates Visqueen barrier that needs repaired

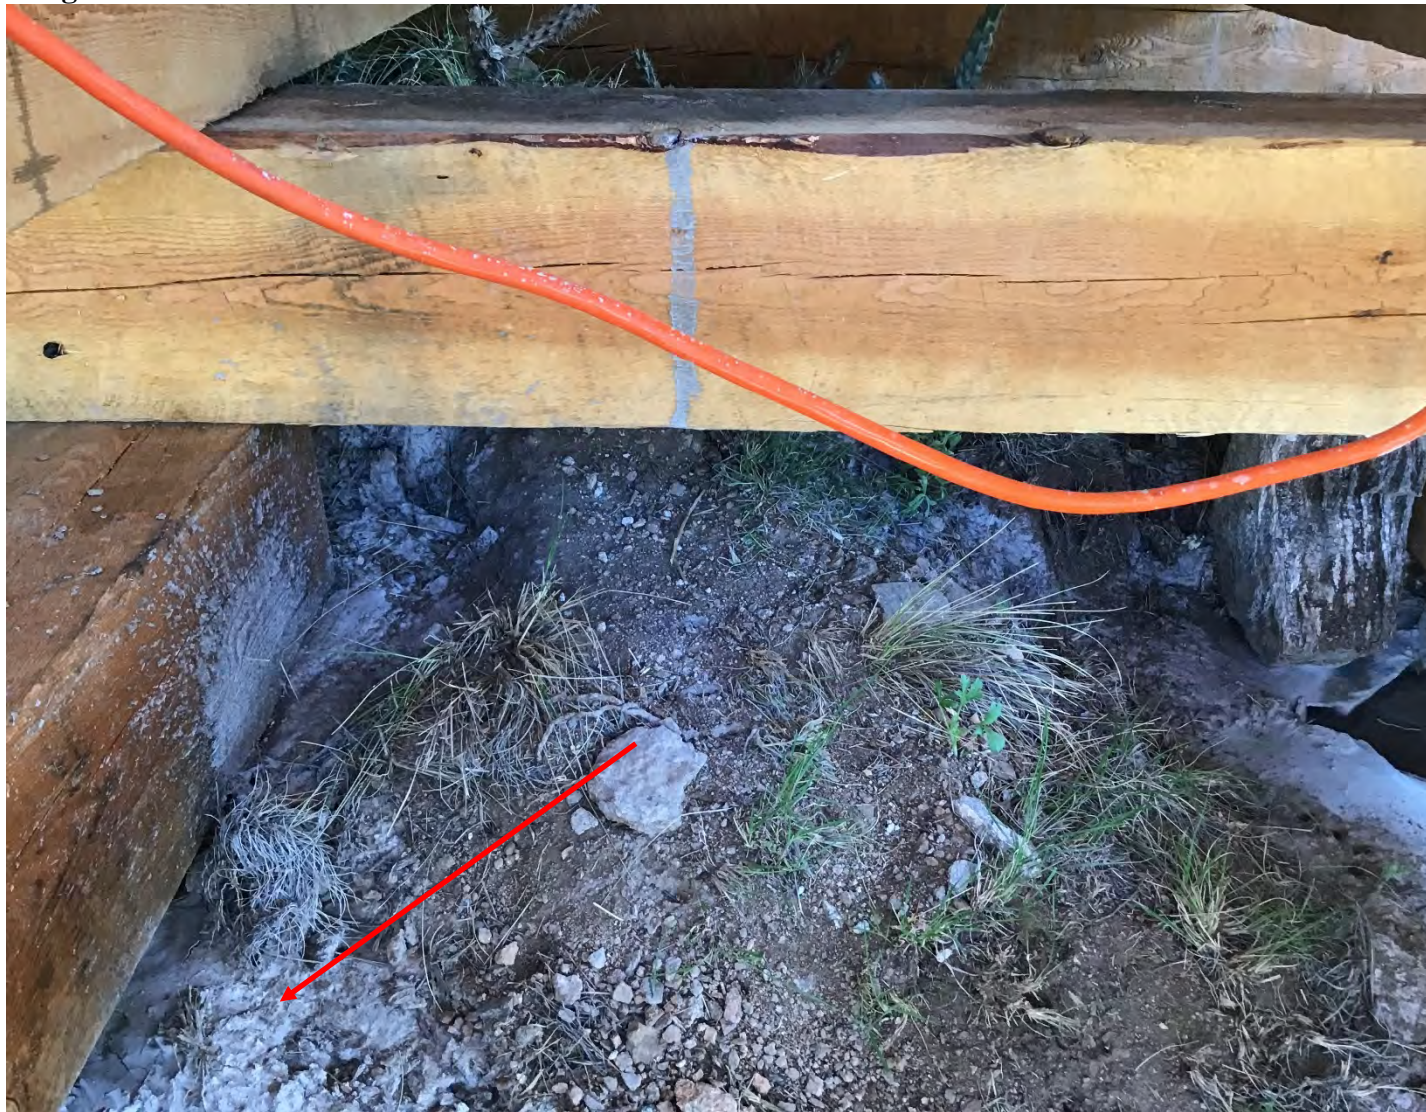
Image 10:

Comment: Below rig platform, red arrow indicates area affected by recent water line blowout

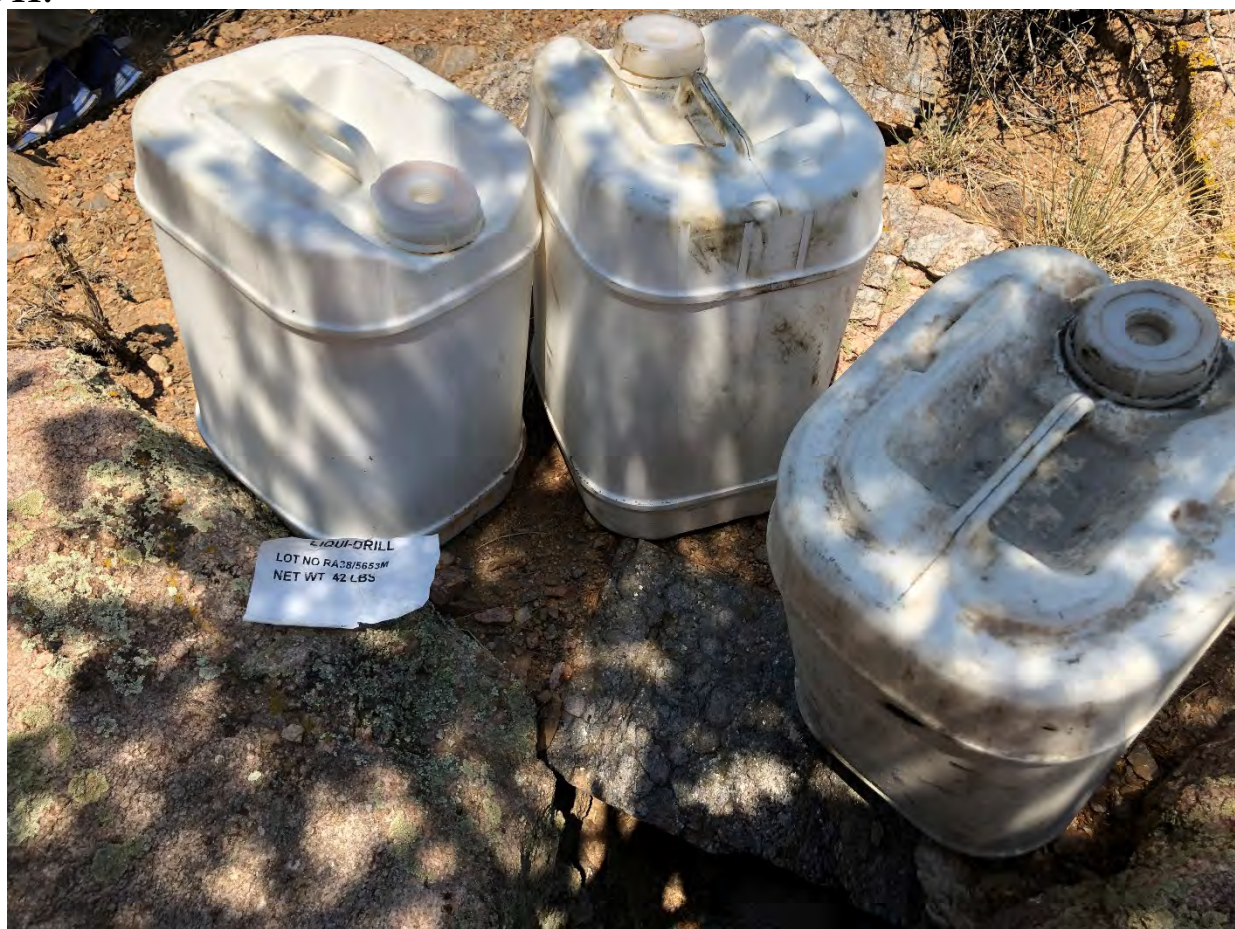
Image 11:

- Three small plastic containers containing Liqui-Drill are onsite, in case it is required as an additive during the drilling process. The SDS sheet is available, as needed. The labels marking these containers have fallen off (but were still located onsite). **These containers need to be labeled with their contents.** Image 11.

Comment: Liqui-Drill containers

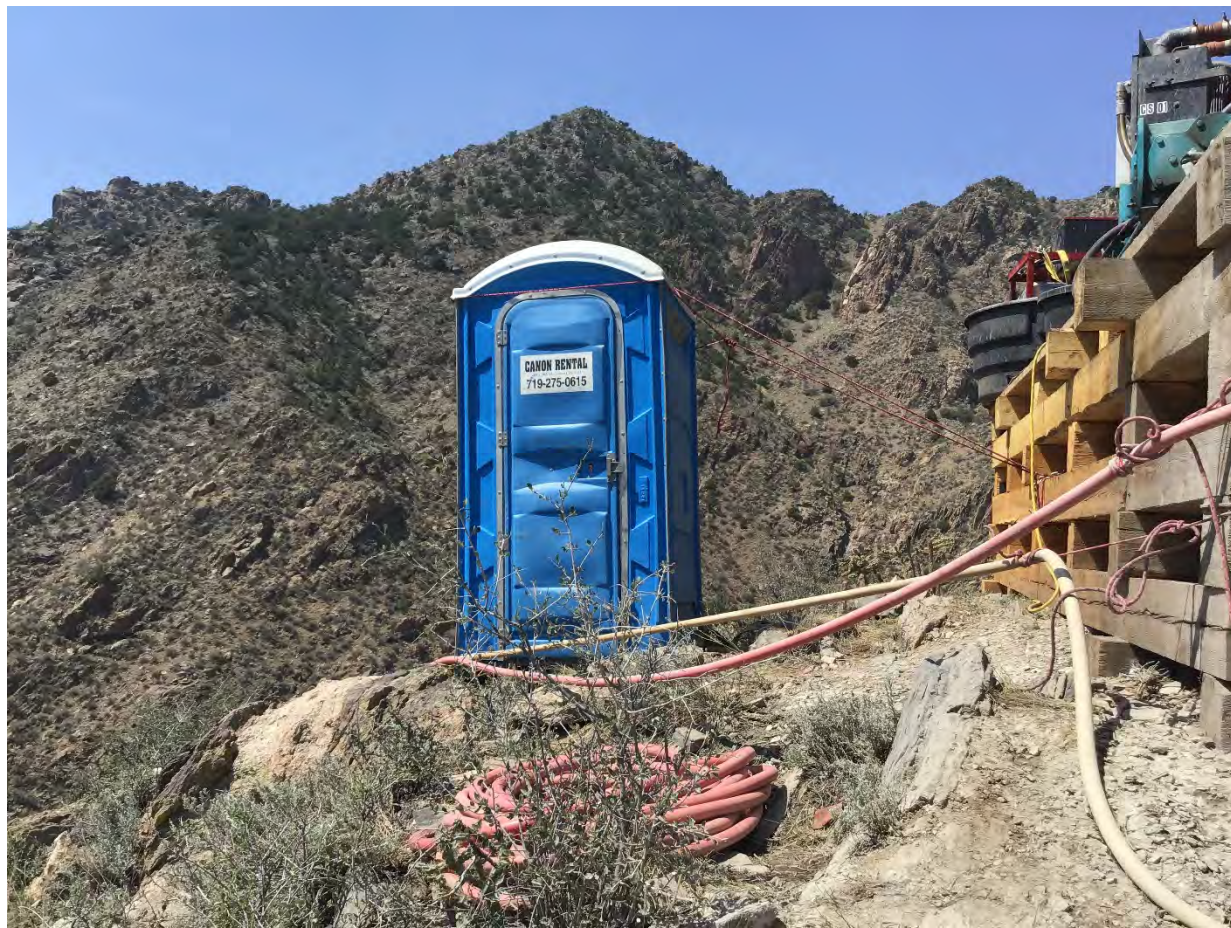
Image 12:

- 3.d. The porta potty is contained. Routine servicing has not been needed yet. When it is required, it will be conducted by helicopter. The tank is removed and replaced with an empty one, as needed. No staining or discharge was observed in the area around the porta potty. Porta potty is still tethered to the platform and appeared stable. Image 12.

Comment: Porta Potty at EP-20-01

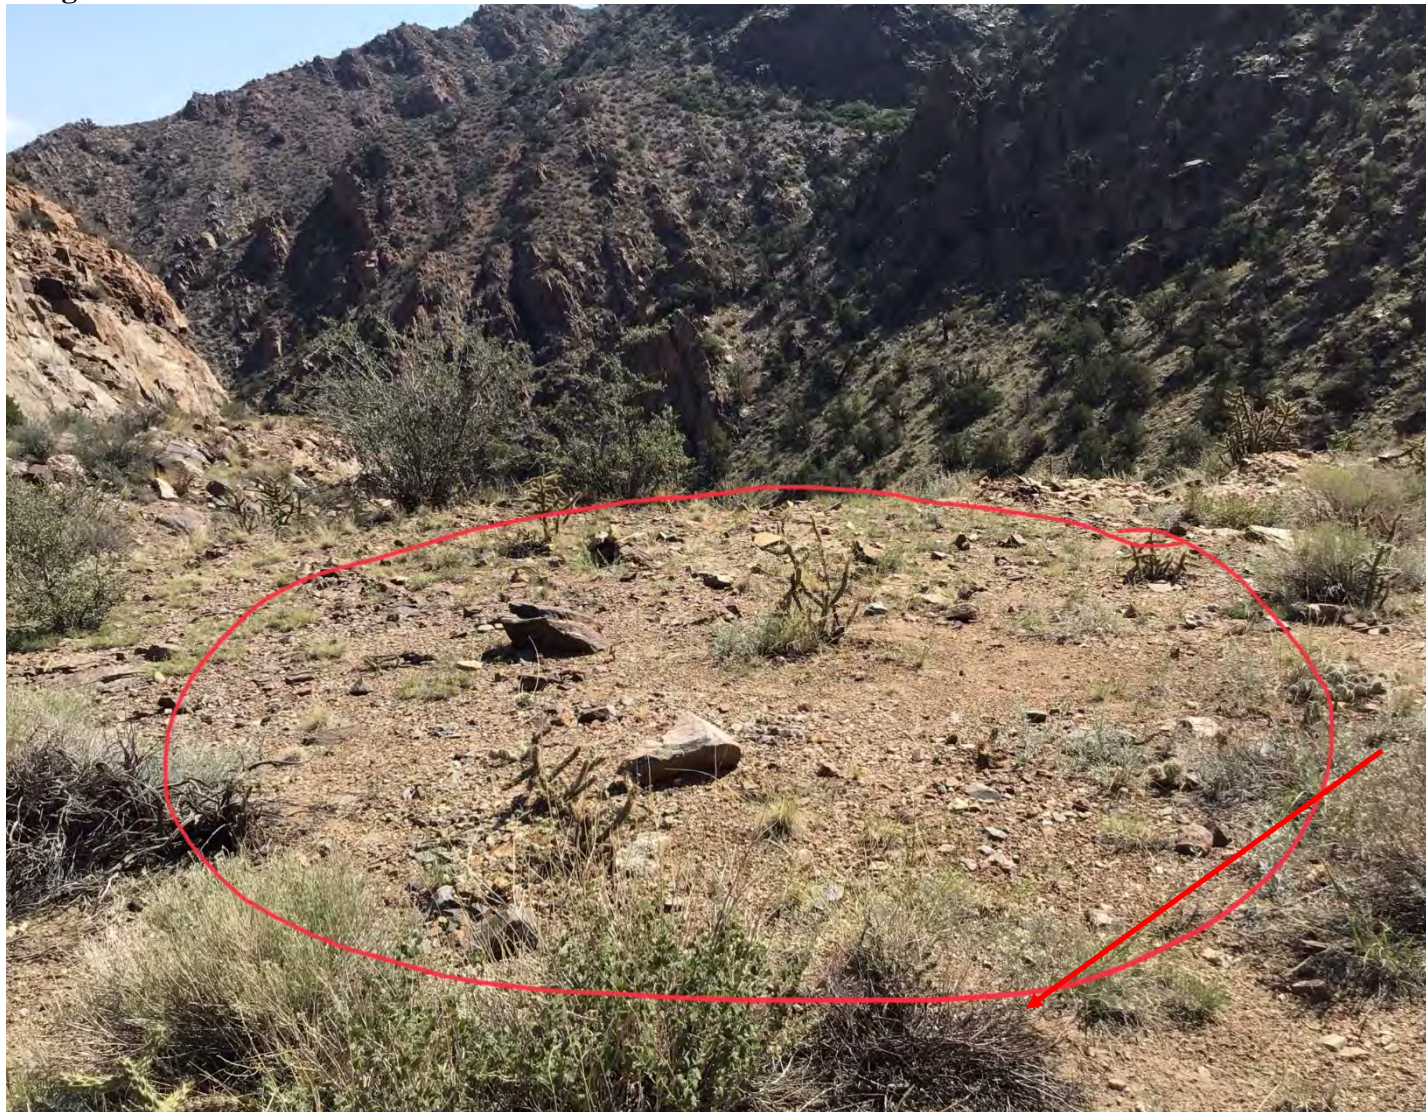
Image 13:

4. All access is still being conducted by a walking a trail from the Grape Creek Trail Head (north of the State section) or by helicopter. There is still only one landing site identified for use with EP-20-01, which does not include a portable structure. There is no visible disturbance from the landing activity in this area. Images 13 and 14.

Comment: Helicopter landing area for EP-20-01

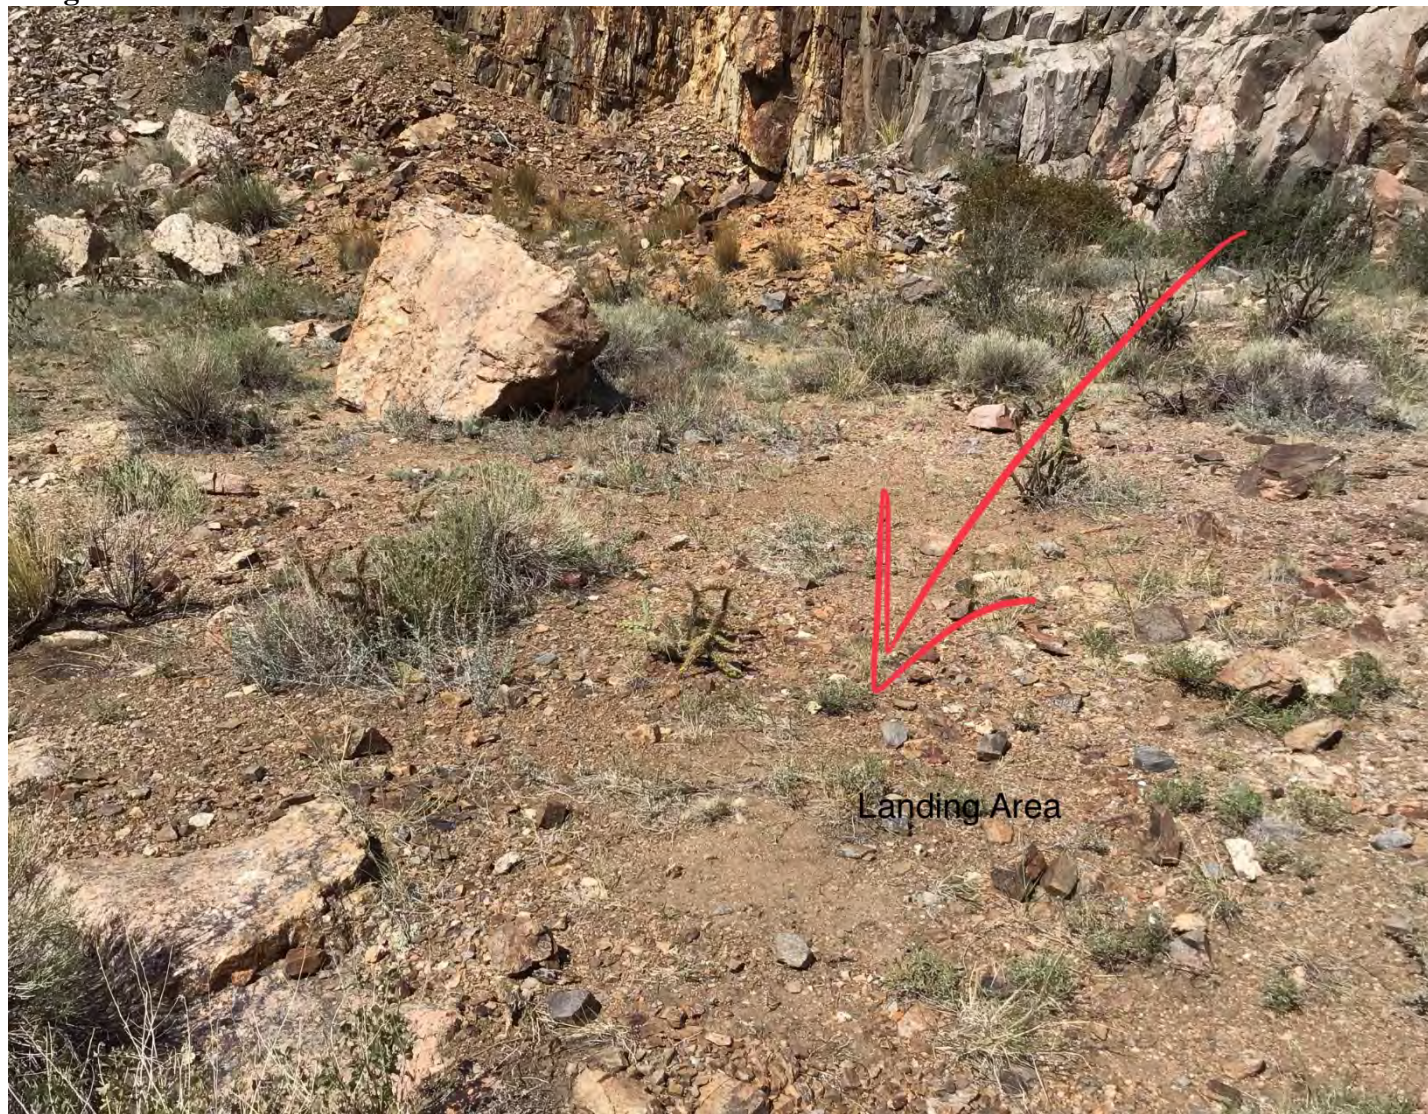
Image 14:

Comment: Close-up view of the helicopter landing area for EP-20-01
