**MINERALS PROGRAM INSPECTION REPORT**  
**PHONE: (303) 866-3567**

| <b>MINE NAME:</b><br>Maverick Placer | <b>MINE/PROSPECTING ID#:</b><br>M-1979-206 | <b>MINERAL:</b><br>Anhydrite, gypsum<br>and evaporites | <b>COUNTY:</b><br>Fremont |
| <b>INSPECTION TYPE:</b><br>Monitoring | <b>INSPECTOR(S):</b><br>Timothy Cazier, P.E. | <b>INSP. DATE:</b><br>November 7, 2019 | <b>INSP. TIME:</b><br>10:55 |

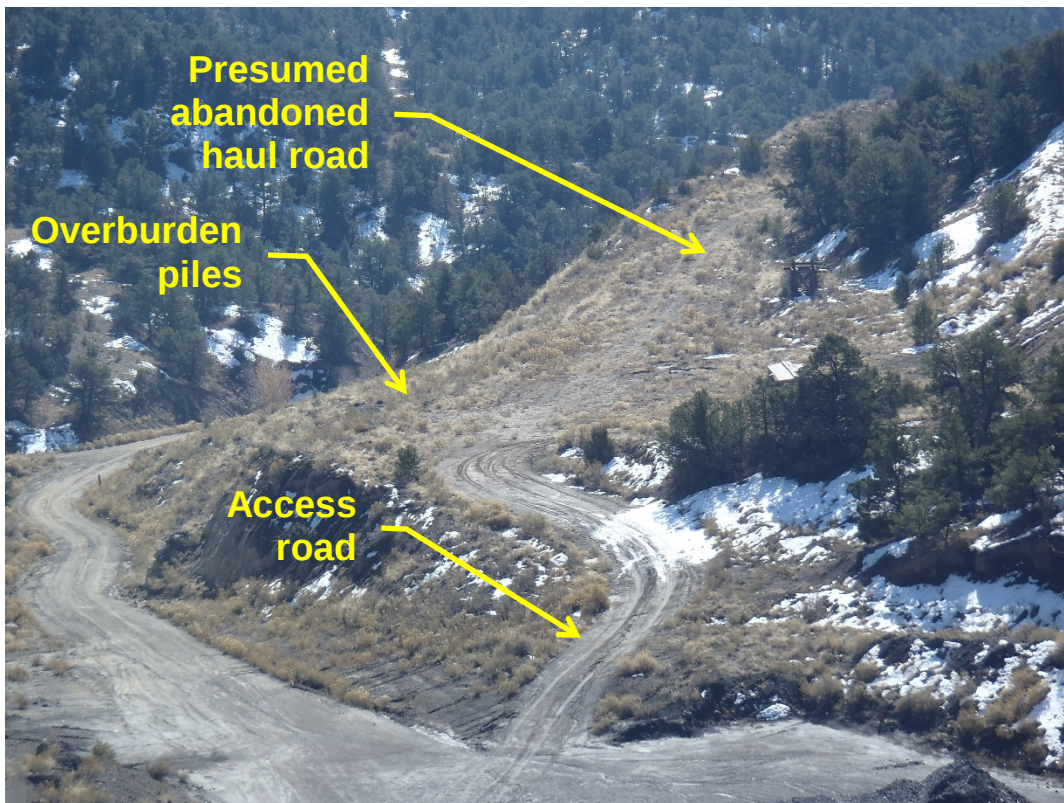
Excess Spoil and Dev. Waste: Mr. Lionelle pointed out revegetated overburden piles on the west side of the access road (see **Photo 1**).

Photo 1. Revegetated overburden piles on the west side of the access road and presumed abandoned haul road (looking south).

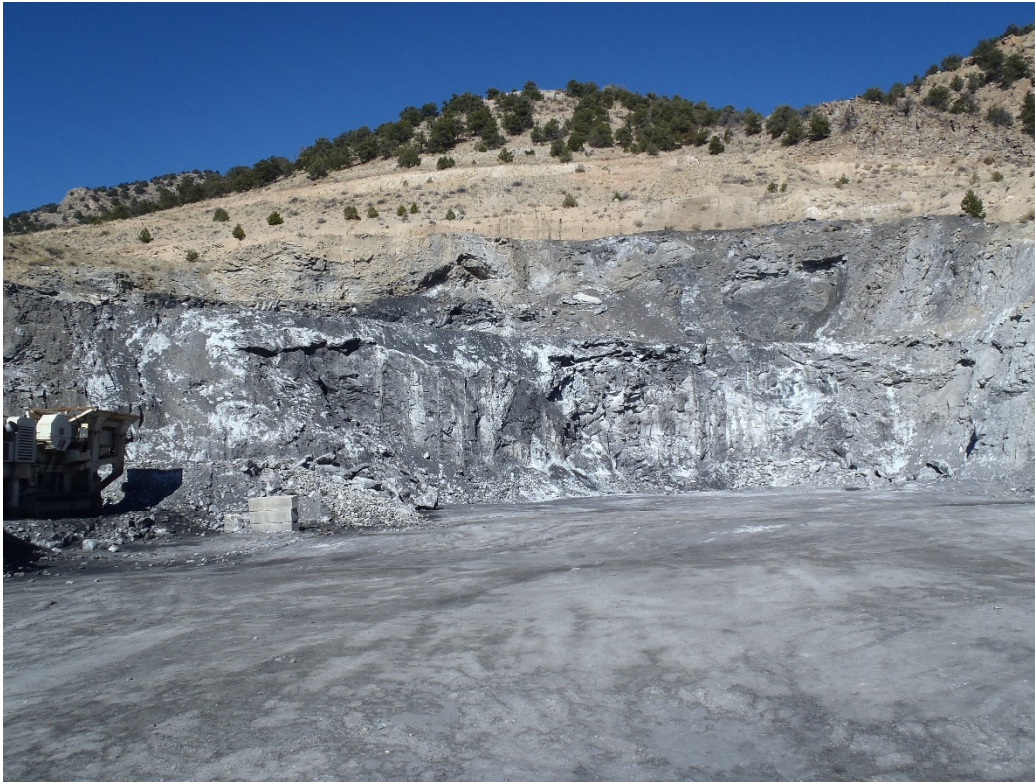
Photo 2. Active pit highwalls (looking north from pit floor).

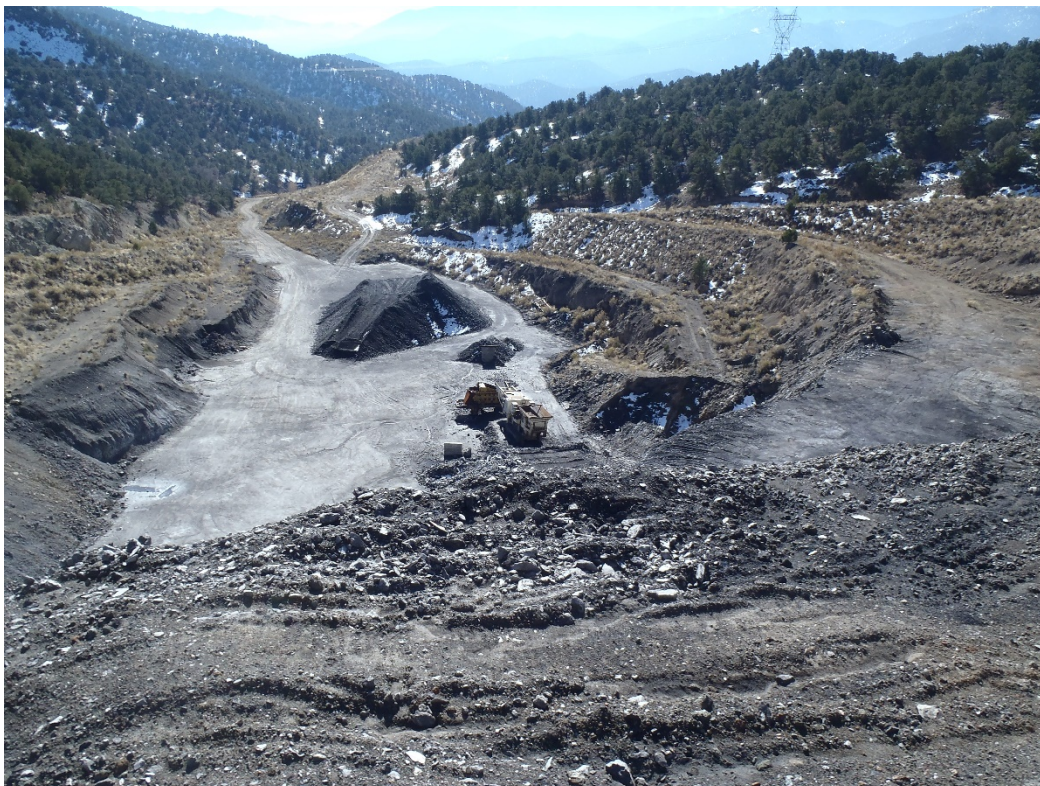
Reclamation Success: As stated in Backfilling and Grading above Zone 1 is for the most part, shaped and blended to the natural terrain. (see **Photos 3 and 5**).

Photo 3. Mostly reclaimed benches on west side of pit (looking south).

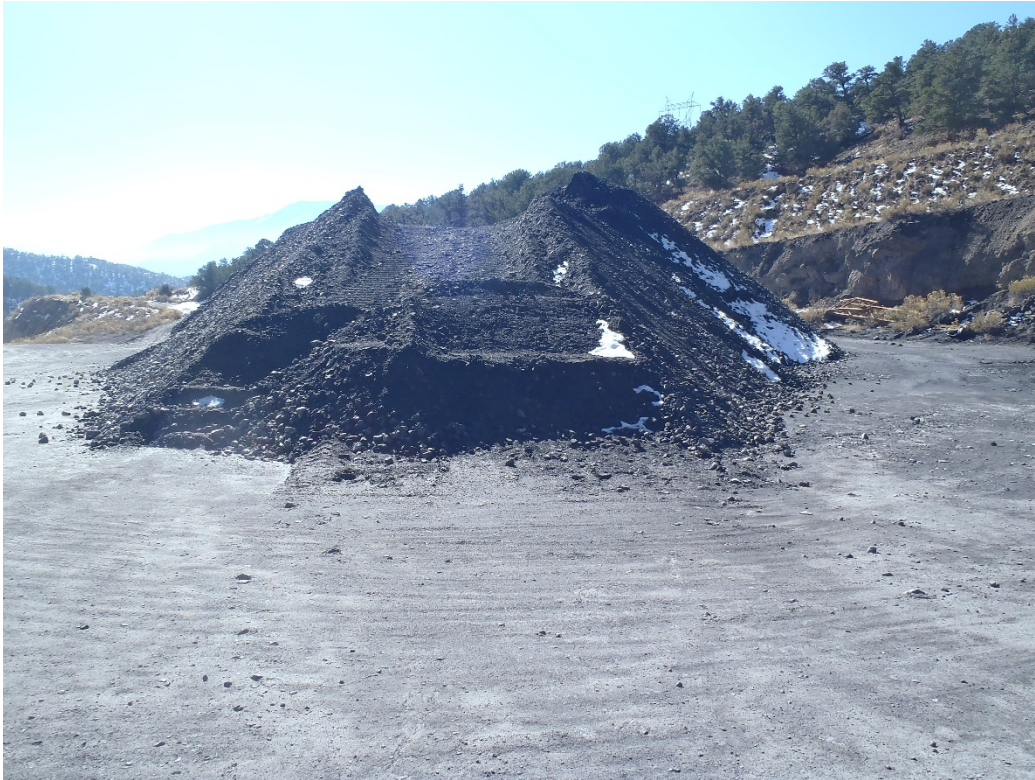
Processing Waste: No processing waste was observed. Mr. Lionelle stated all blasted material (see **Photo 4**) containing product is trucked to the Wellsville plant for processing.

Photo 4. Blasted, crushed & screened material containing product awaiting haul to Wellsville plant.

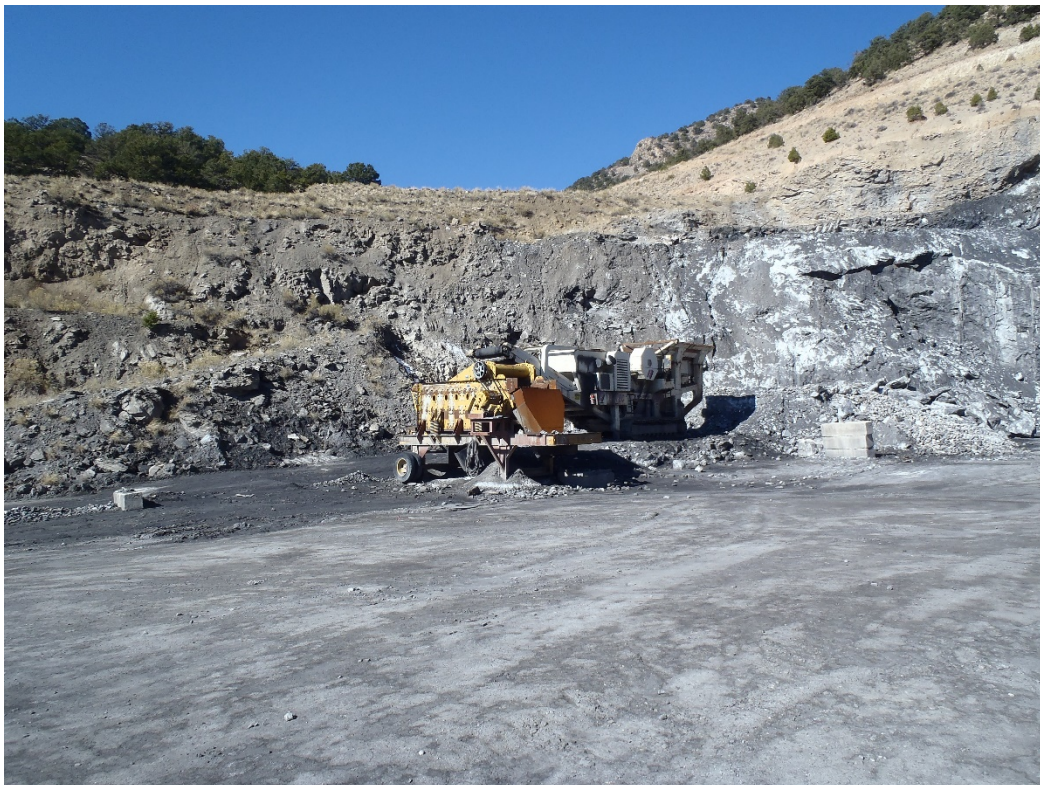
Support Facilities On-site: A portable screen and crusher were observed on site (see **Photo 5**).

Photo 5. Screen and crusher (looking north).

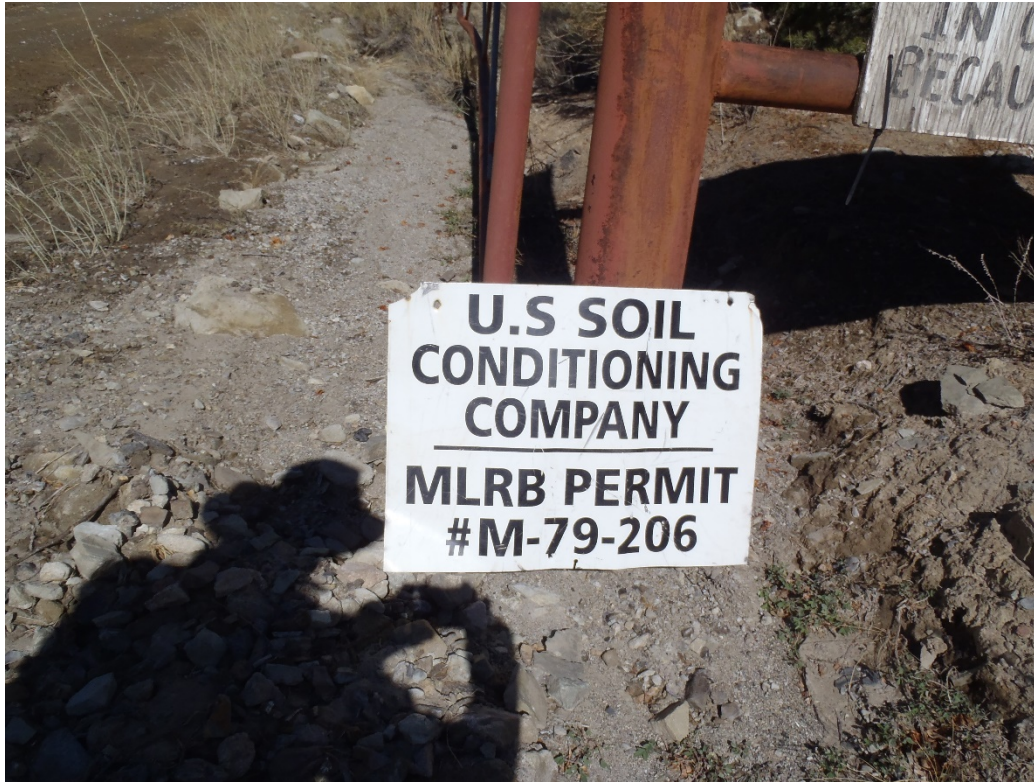
Signs and Markers: The permit sign was properly posted (see **Photo 6**) and the affected area boundary is delineated by adjacent roads (inside the permit boundary).

Photo 6. Permit sign.

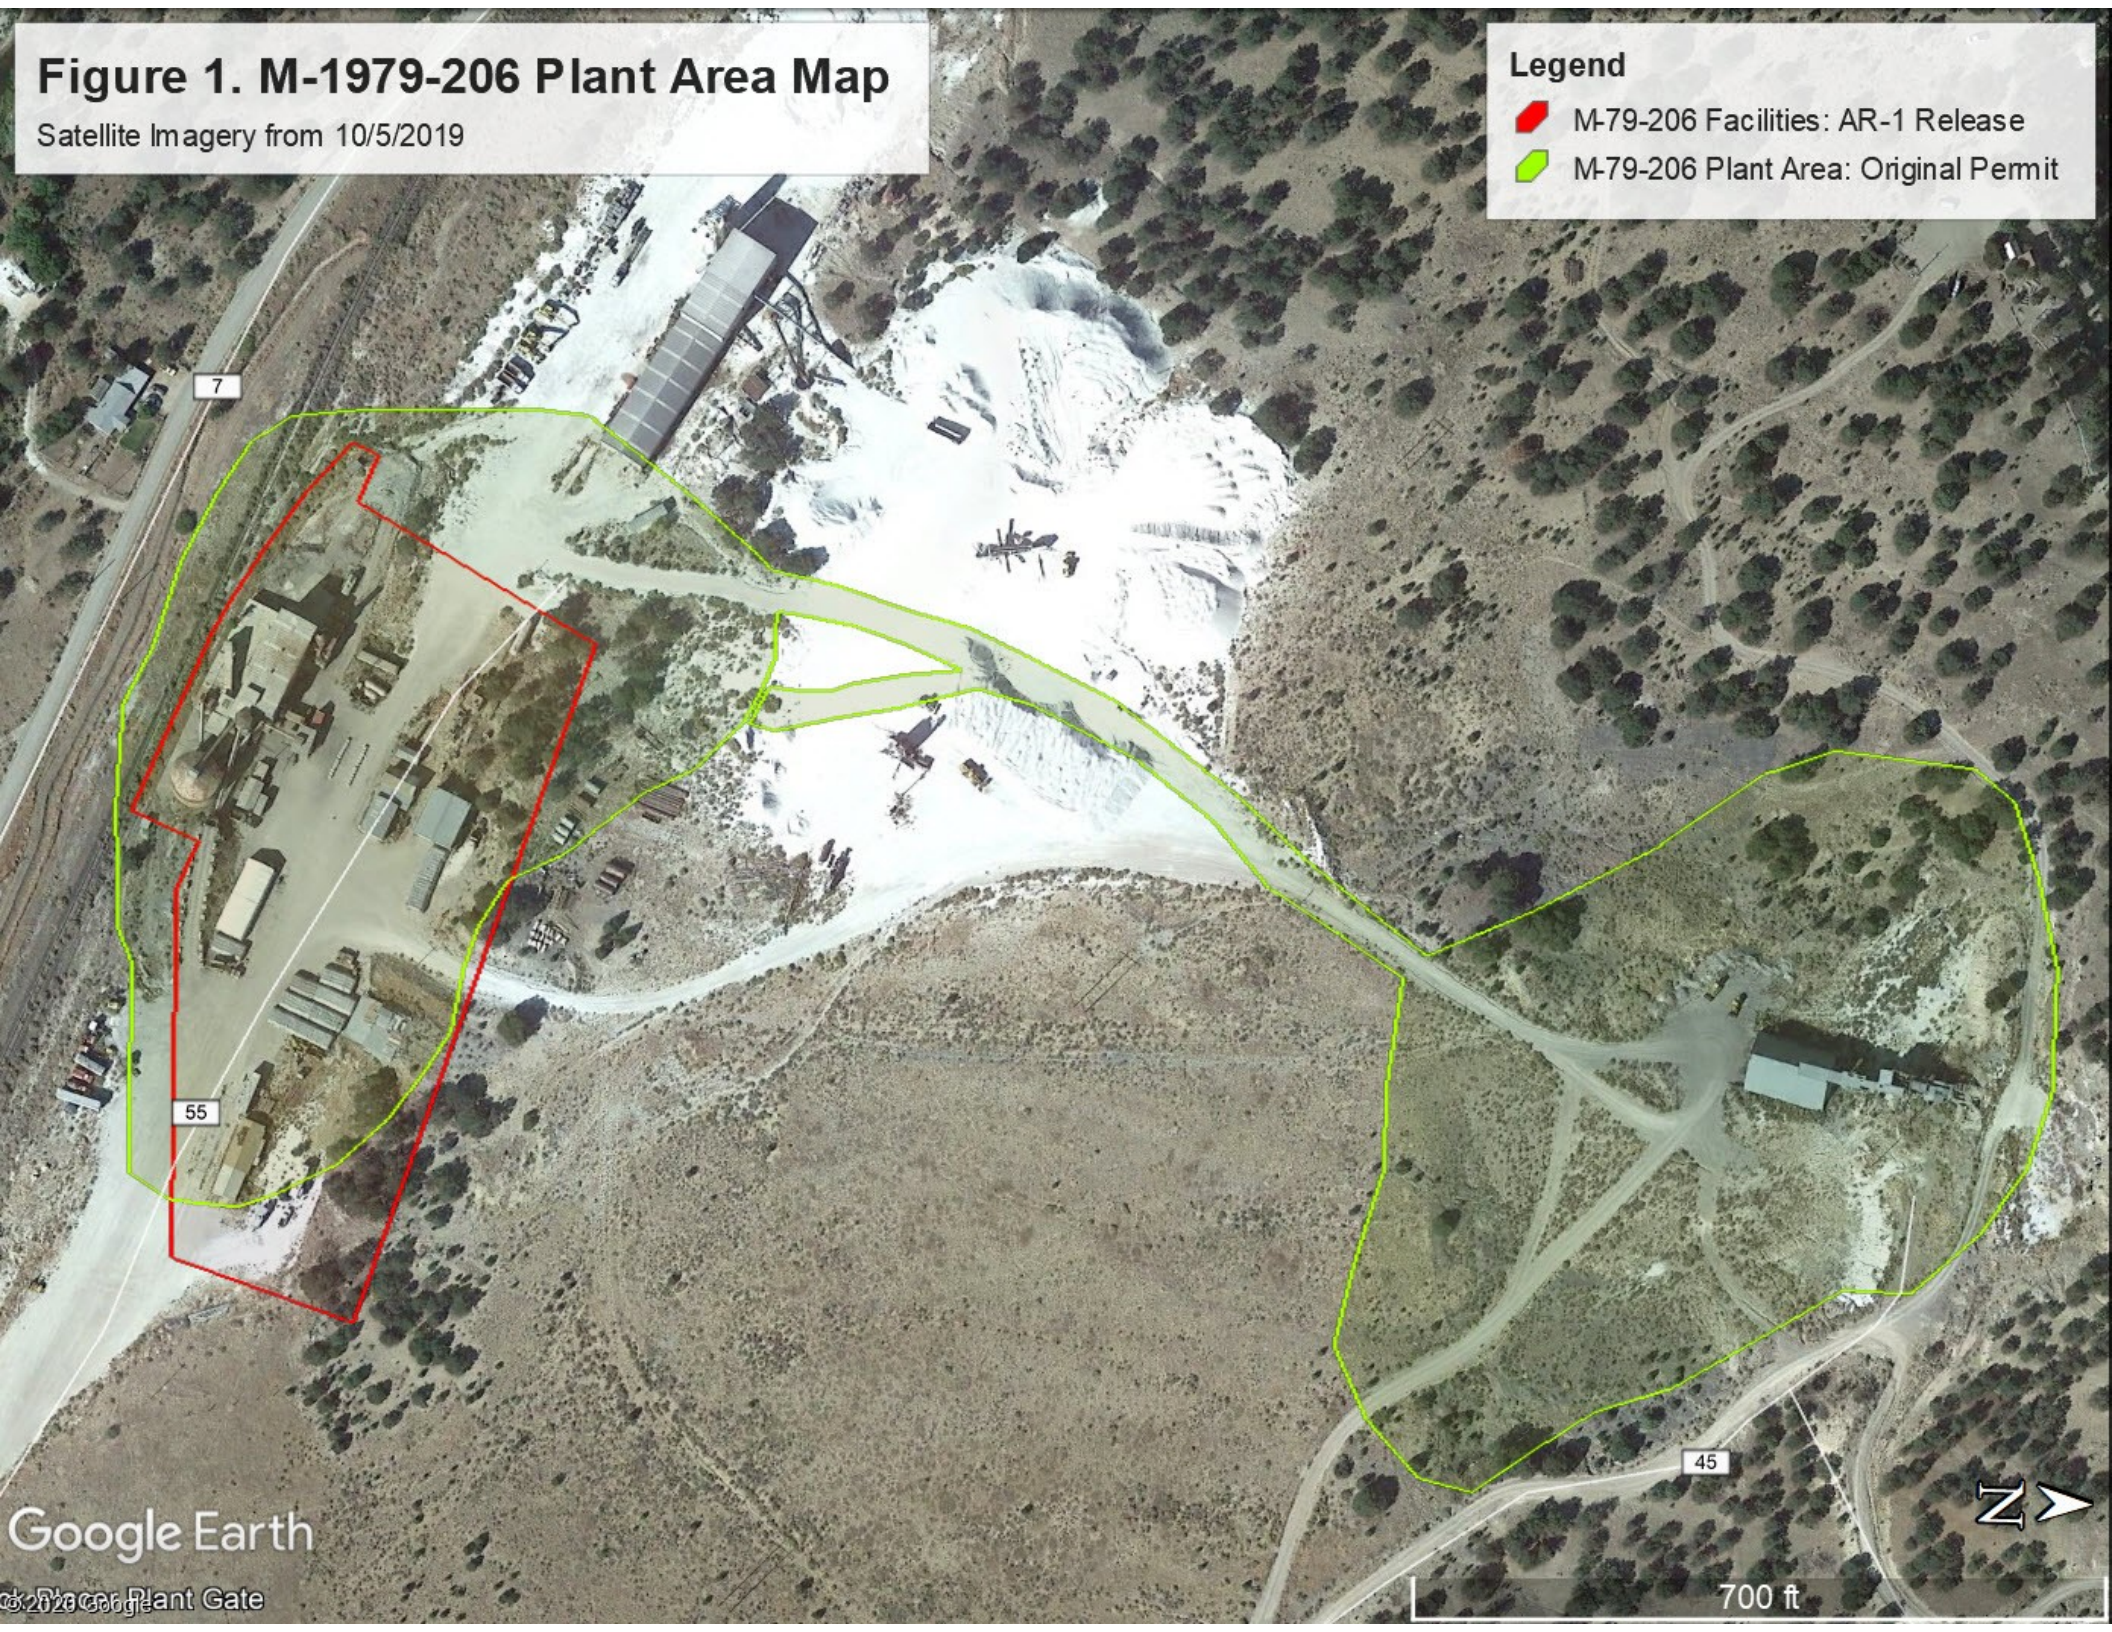
# Figure 1. M-1979-206 Plant Area Map

In 1999, the Division approved a requested acreage reduction (AR-01) for the plant area and released 5.9 acres

around the Wellsville plant (see area outlined in red on **Figure 1**), leaving 37 acres in the permit area. All the annual report maps going back to at least 2012 show only the 19.8-acre pit area around the pit. It is unclear from the record where the additional 17.2 acres of the permit are. **This inconsistency in the mapping records is cited as Problem #2 on page 1 of this report.**

**CORRECTIVE ACTIONS:** Submit a Technical Revision and the \$216 fee to include a complete record of the permit and affected area boundary depicting the unreleased Plant Area, Quarry Area and 800-foot abandoned haul road area by the corrective action due date
