MINERALS PROGRAM INSPECTION REPORT

MINE NAME: Oak Creek Gravel Pit	MINE/PROSPECTING ID#: M-1989-084	MINERAL: Gravel	COUNTY: Fremont
INSPECTION TYPE: Monitoring	INSPECTOR(S): Timothy Cazier	INSP. DATE: February 13, 2020	INSP. TIME: 10:15
OPERATOR: Rockbottom, LLC	OPERATOR REPRESENTATIVE: Beckie Kagan	TYPE OF OPERATION: 112c - Construction Regular Operation	
REASON FOR INSPECTION: Normal I&E Program	BOND CALCULATION TYPE: Partial Bond	BOND AMOUNT: \$60,232.00	
DATE OF COMPLAINT: NA	POST INSP. CONTACTS: None	JOINT INSP. AGENCY: None	
WEATHER: Clear	INSPECTOR'S SIGNATURE:

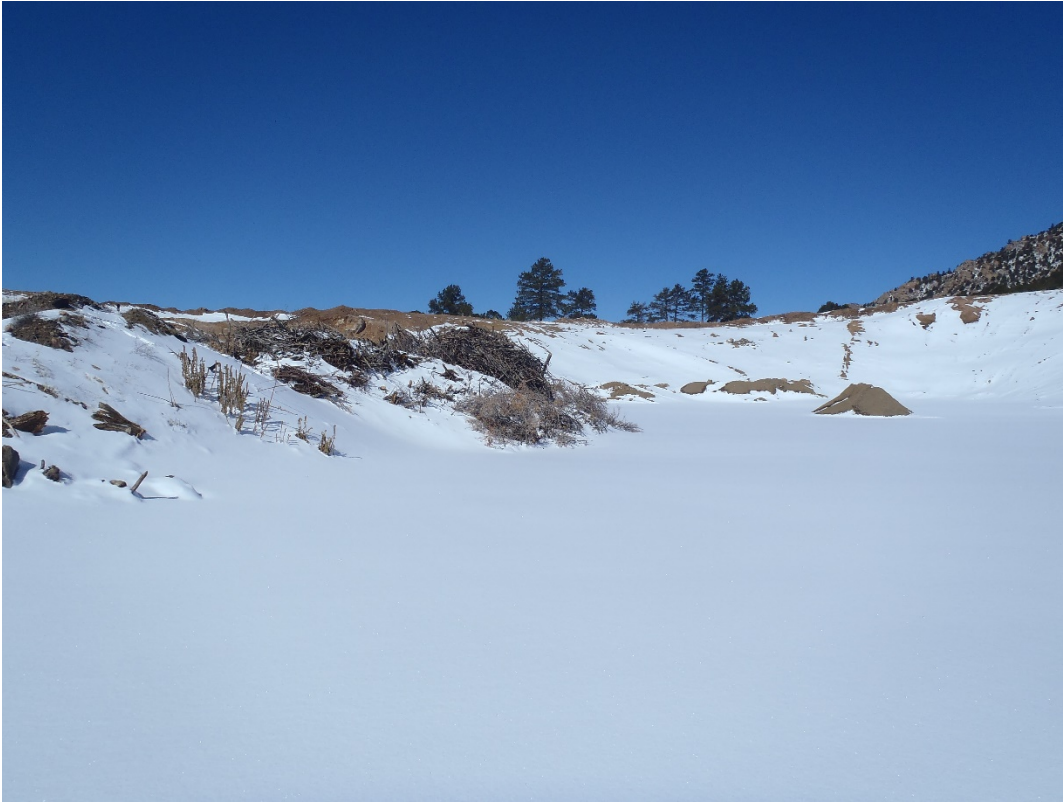
This inspection was conducted as part of the Division's regular monitoring program. The Operator (Rockbottom) was represented during the inspection by Ms. Beckie Kagan. The Oak Creek Gravel Pit is accessed from Fremont Co Rd 143 approximately 11.5 miles southwest of Cañon City. This is a 112c gravel mine. It was not operating at the time of the inspection. There was evidence of recent activity. Ms. Kagan reported the site received 14 inches of snow on February 10th. It was 19°F at the time of the inspection and most of the site was covered with snow (**#73, 74** see **Photos 1** and **2**), limiting observations.

Photo 1. West side of pit (looking NW).

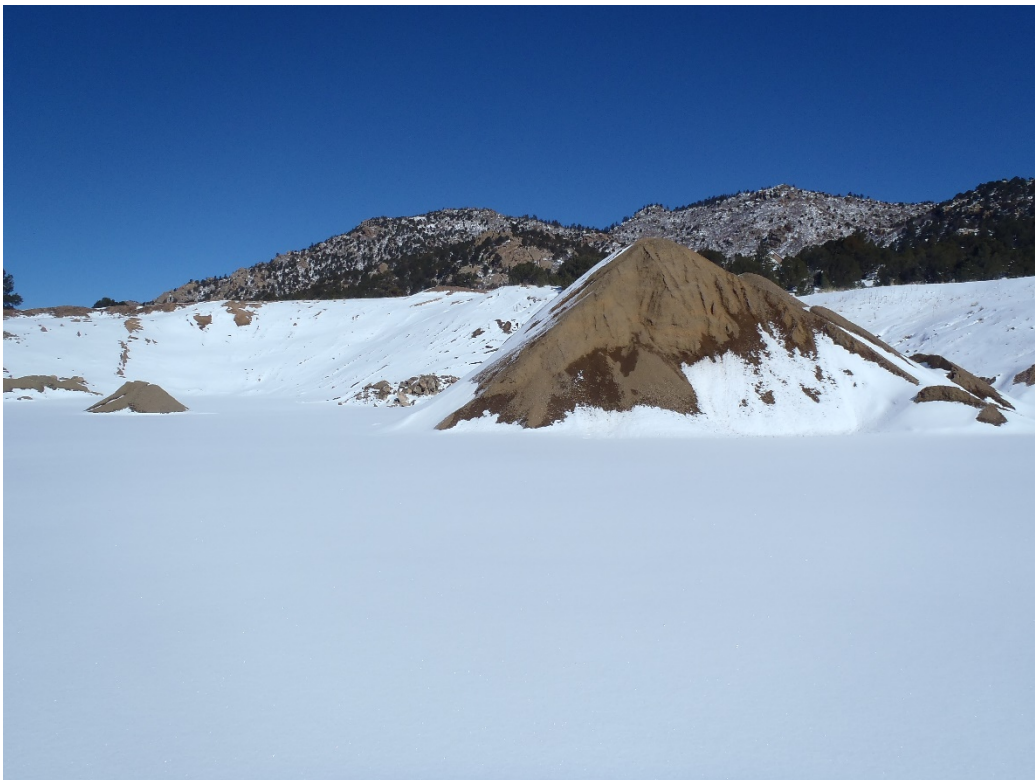
Photo 2. East side of pit (looking north).

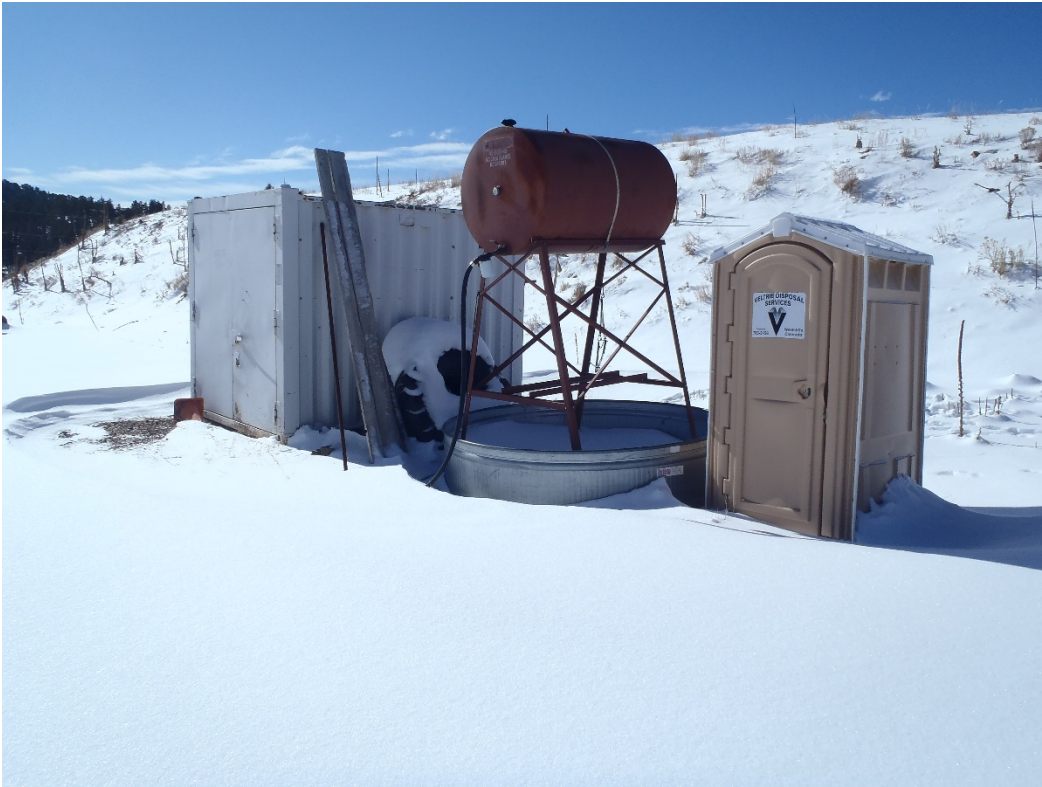
Acid And Toxic Materials: No acid or toxic materials are involved in this operation. An empty above ground fuel/oil storage tank was observed (**#79** see **Photo 3**) and had adequate secondary containment. Ms. Kagan stated it belonged to the previous operator and had been empty for years.

Photo 3. Empty AST with secondary containment and portable storage shed. (west side, looking SW).

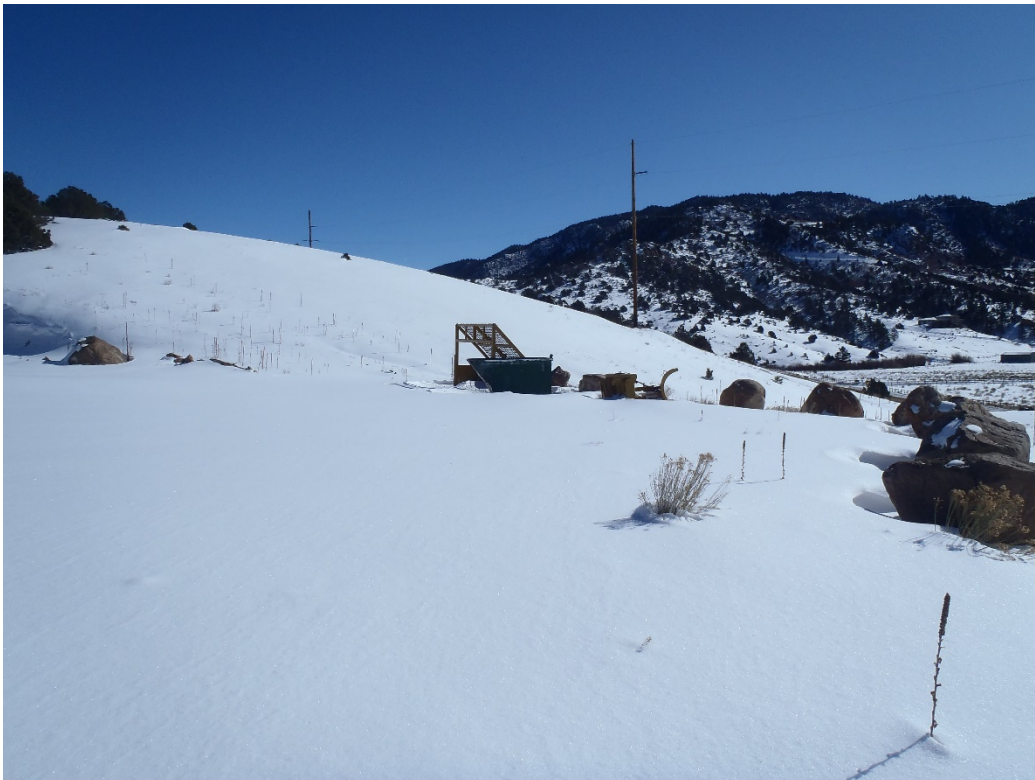
Support Facilities On-site: A screen was observed on the SE corner of the site (**#80** see **Photo 4**).

Photo 4. Screen on SE corner of pit (looking SE).

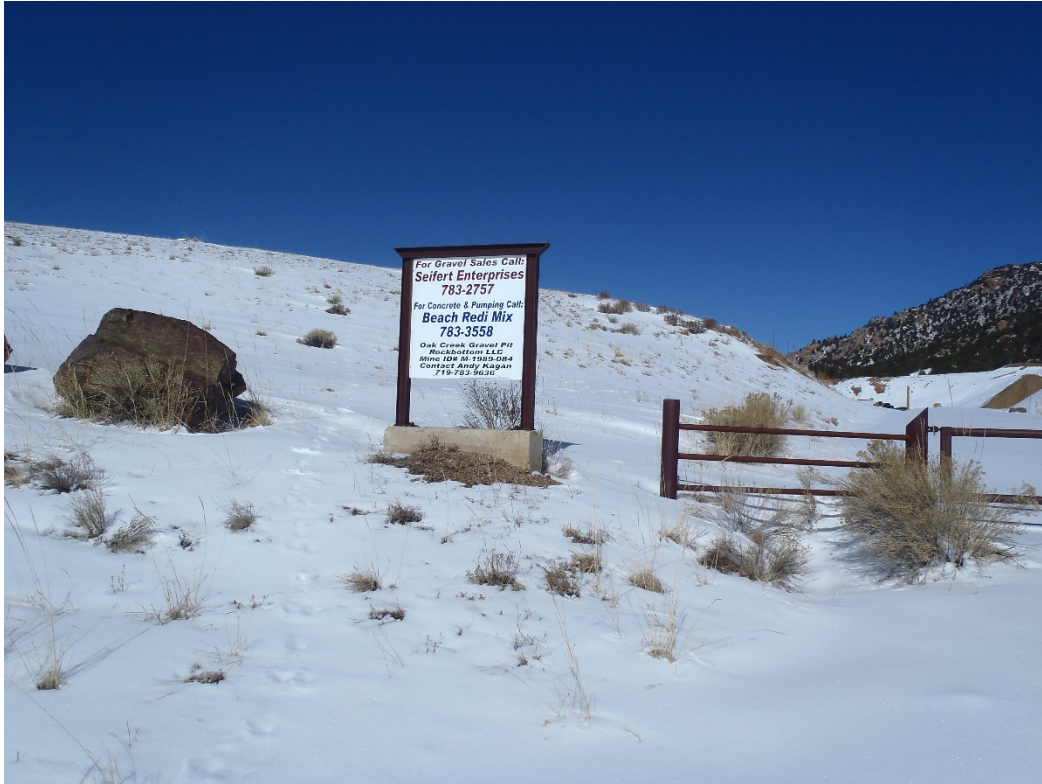
Signs and Markers: The permit sign was properly posted (**#70** see **Photo 5**).

Photo 5. Permit sign at entrance off CR 143.
