COLORADO
Division of Reclamation,
Mining and Safety
Department of Natural Resources

Permit Number: C-1981-041 Mine Name: Roadside Portals Operator: Snowcap Coal Company, Inc Operator Address: Ms Tonya Hammond P.O. Box 1430 Palisade, CO 81526	County: Mesa Operation Type: Underground Permit Status: Active Ownership: Private
	Operator Representative Present: NA
Operator Representative Signature: (Field Issuance Only)

Inspection Start Date: November 30, 2020 Inspection Start Time: 12:00 Inspection End Date: November 30, 2020 Inspection End Time: 12:05		Inspection Type: Aerial Inspection Inspection Reason: Normal I&E Program Weather: Clear	
Joint Inspection Agency: None		Joint Inspection Contacts: None	
Post Inspection Agency: None		Post Inspection Contacts: None	
Inspector(s): Clayton Wein Brock Bowles	Inspector's Signature: <i>Clayton Wein</i>		Signature Date: 12/2/2020

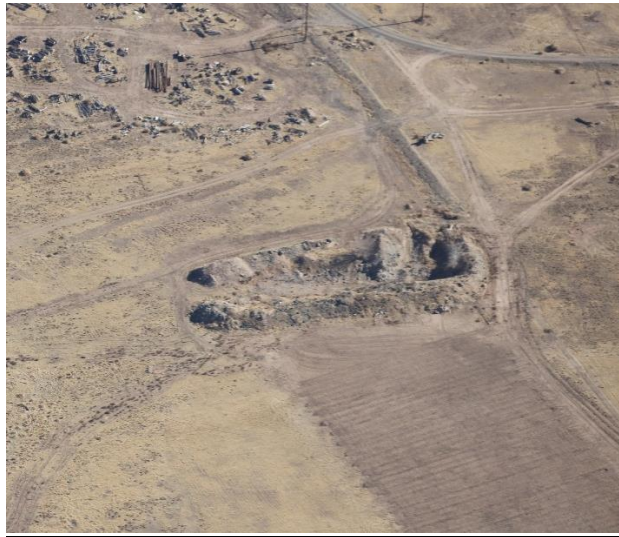
Ground conditions during the inspection were dry. There was no evidence of water in the Carey Pit (Photo 1). The Landowner's field located to the east of the TR-69 repair area appeared to be dry (Photo 2). There was no evidence of recent water applications to the site. The trenches on top of the Tract 70 Mesa were dry at the time of the inspection (Photo 3). There was no evidence of recent flow through the trenches.

Photo 1: The Carey Pit located to the south of the TR-69 repair area.

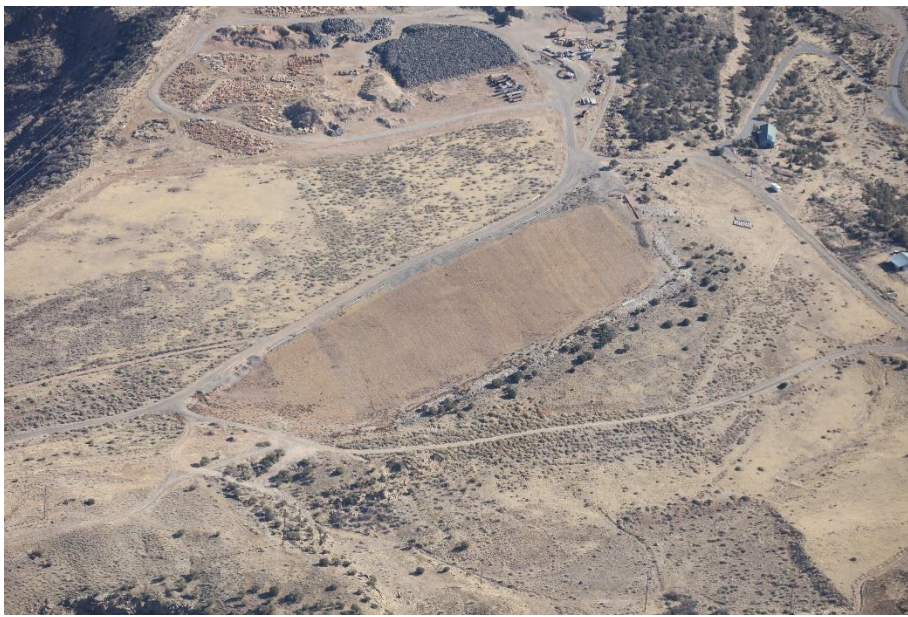
Photo 2: The landowner's field located to the east of the TR-69 repair area was dry.

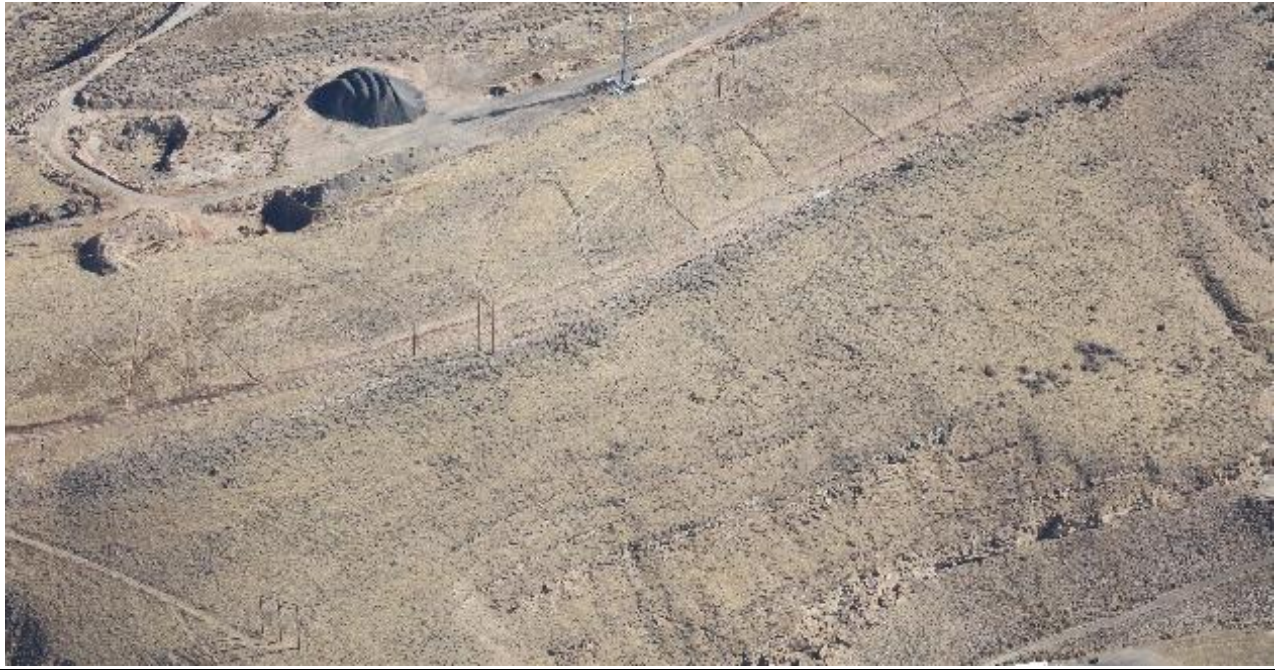
Photo 3: The Tract 70 Mesa. North is to the right side of the photo. The trenches in this area were observed to be dry.

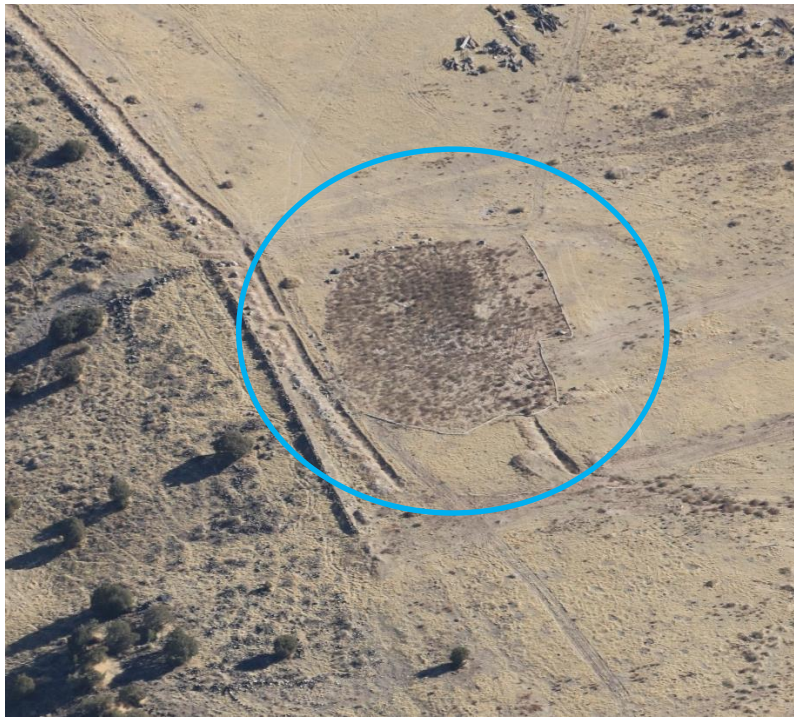
The TR-69 repair area is located in Tract 71 just southwest of the reclaimed refuse pile. The site is approximately 0.4 acres in size. The reclamation work was completed in the fall of 2019. The site was backfilled and graded to approximate original contour. The site was stable and vegetated (Photo 4). There were no indications of surface settling. There were no erosional features identified. The sediment logs were intact and located in the correct position. Disturbance boundary markers were observed in the correct locations.

Photo 4: The TR-69 repair area outlined in the blue circle in the photo.
