MINERALS PROGRAM INSPECTION REPORT
PHONE: (303) 866-3567

MINE NAME: Incas Mine	MINE/PROSPECTING ID#: M-1986-076	MINERAL: Gold and silver	COUNTY: La Plata
INSPECTION TYPE: Monitoring	INSPECTOR(S): Lucas West	INSP. DATE: November 5, 2020	INSP. TIME: 11:15
OPERATOR: Michael McClure	OPERATOR REPRESENTATIVE: None	TYPE OF OPERATION: 110d - Designated Limited Impact	
REASON FOR INSPECTION: Normal I&E Program	BOND CALCULATION TYPE: Complete Bond	BOND AMOUNT: \$29,902.68	
DATE OF COMPLAINT: NA	POST INSP. CONTACTS: None	JOINT INSP. AGENCY: None	
WEATHER: Clear	INSPECTOR'S SIGNATURE:

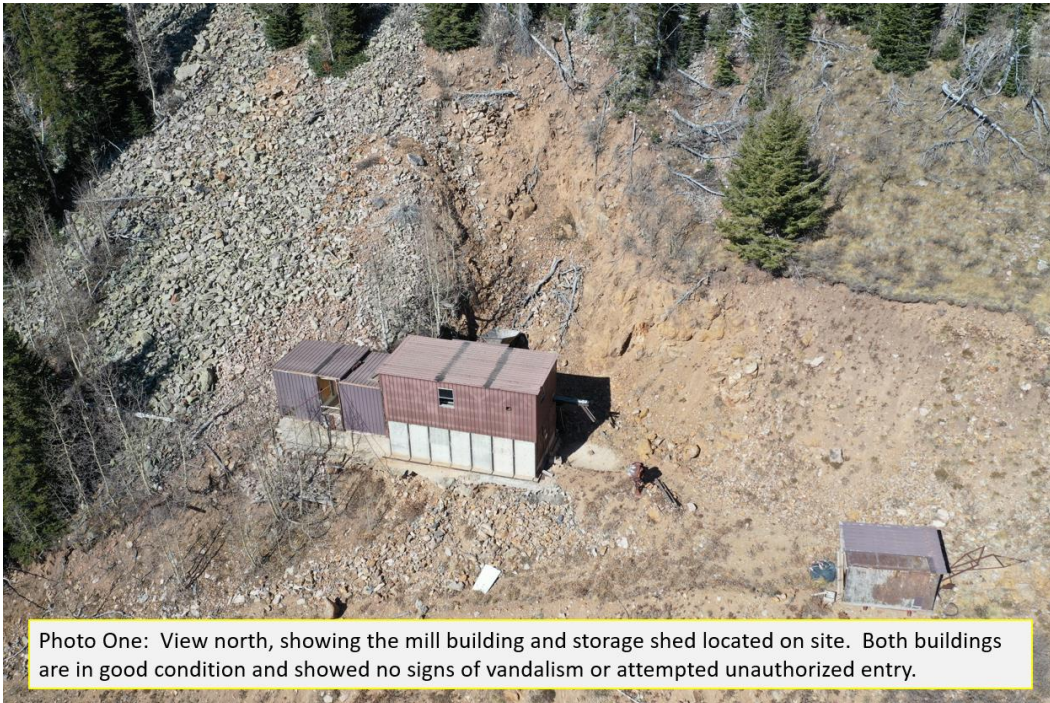
Photo One: View north, showing the mill building and storage shed located on site. Both buildings are in good condition and showed no signs of vandalism or attempted unauthorized entry.

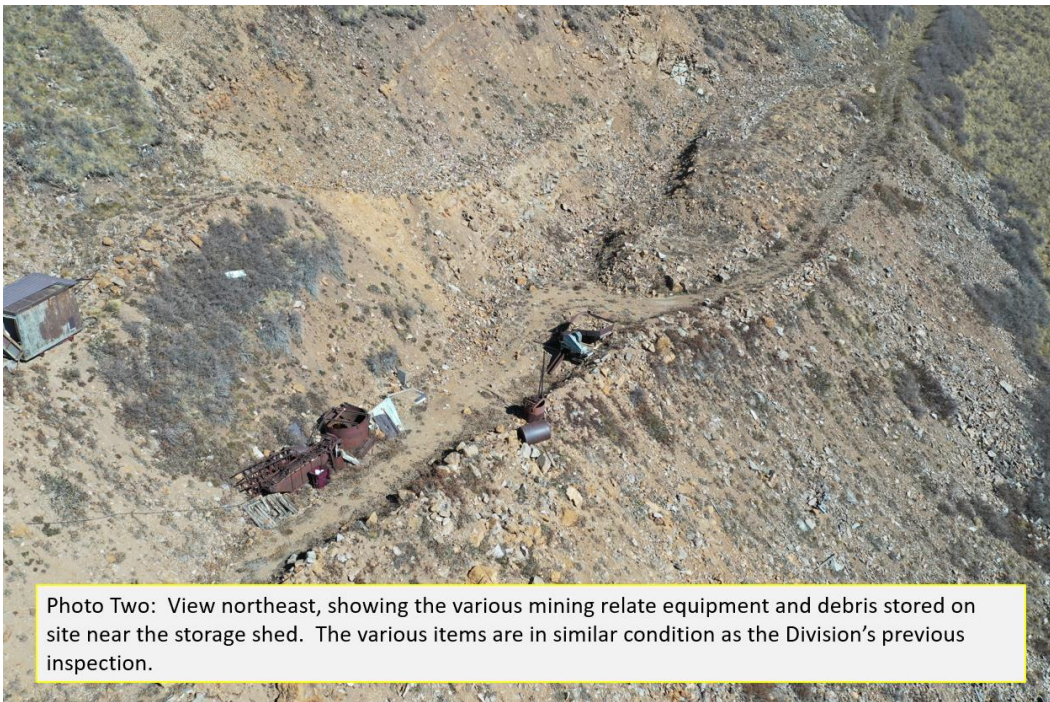
The site was not active during the inspection and no Operator representative was present at the time of the inspection. The site is in similar condition to the previous inspections conducted by the Division. A faded Mine Identification Sign was posted at the entrance to the site. The facilities on site consist of a small storage shed and mill building. The mill building is in good condition, however the storage shed has suffered damage to the door. The shed and mill facility can be seen in Photo One. The various pieces of equipment, scrap metal and other mining related debris on site were observed and in similar condition as the Division's previous inspection. Those items are fairly centrally located near the storage shed and can be seen in Photo Two.

Photo Two: View northeast, showing the various mining relate equipment and debris stored on site near the storage shed. The various items are in similar condition as the Division's previous inspection.

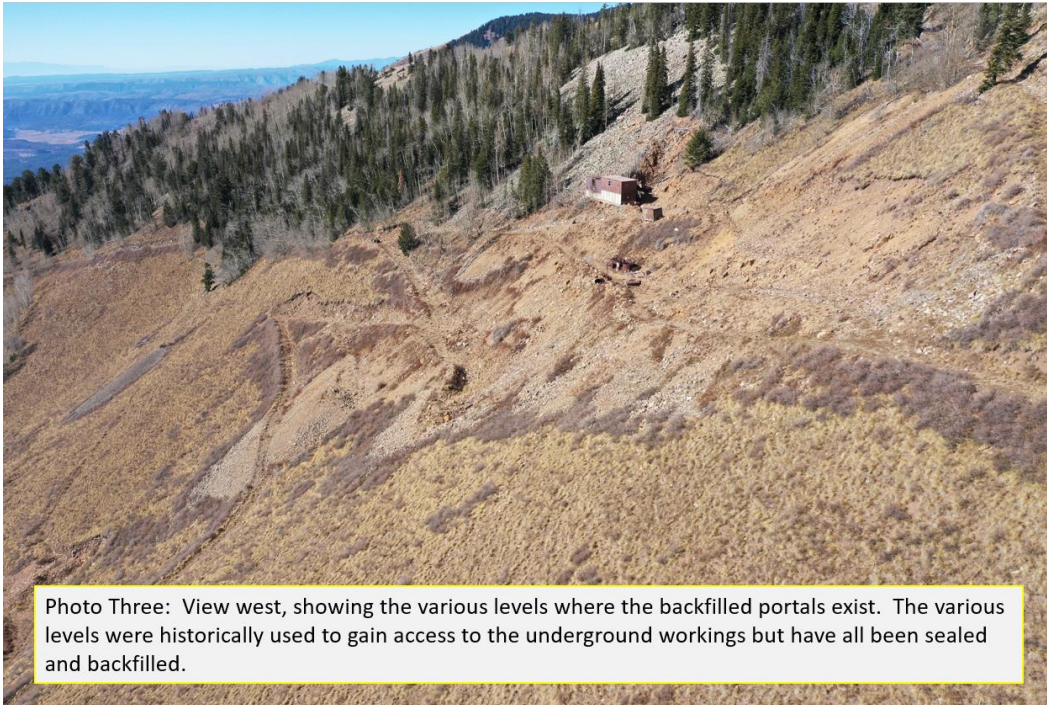
Photo Three: View west, showing the various levels where the backfilled portals exist. The various levels were historically used to gain access to the underground workings but have all been sealed and backfilled.

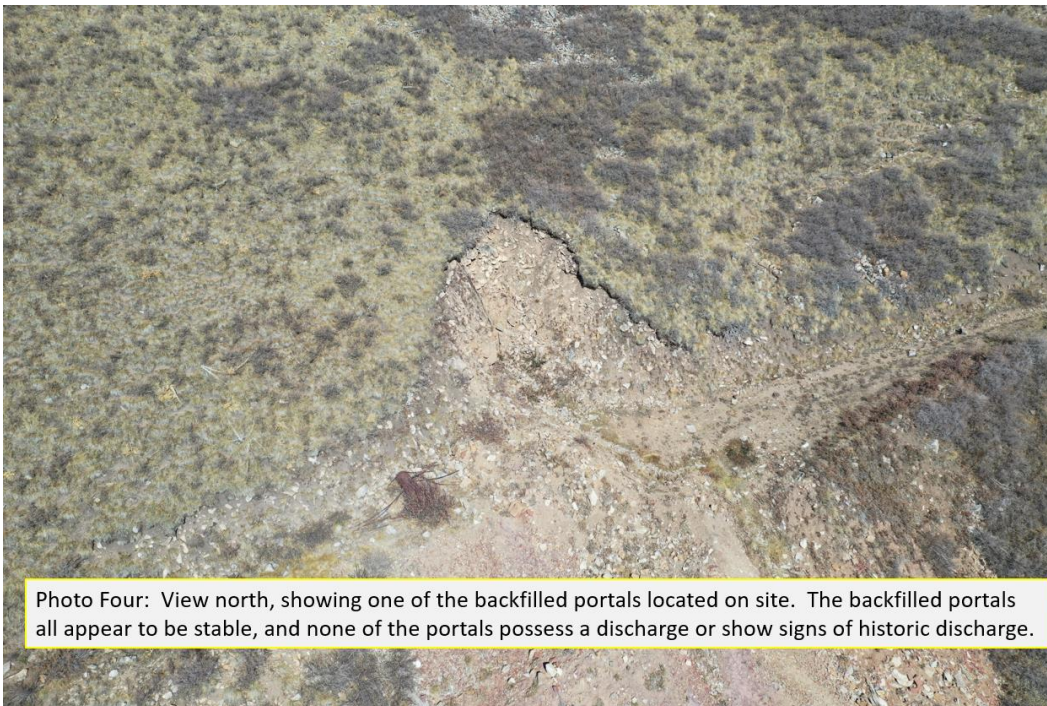
The previous mining operations utilized several portals at various levels throughout the site to gain access to the underground workings. All portals have been backfilled, are secure and appeared stable at the time of the inspection. No signs of settling, slumping or erosion of the earthen backfill material was noted. The various levels can be seen in Photo Three and an example of the earthen backfill used to secure the portals can be seen in Photo Four. The main excavation area remains to be reclaimed, however the slopes and piles associated with the main area appeared stable at the time of the inspection and in good condition. Several areas throughout the site have revegetated themselves with volunteer species. The vegetative cover in this area is somewhat sparse but is to be expected given the aspect and elevation. No State listed noxious weeds were observed during the inspection.

Photo Four: View north, showing one of the backfilled portals located on site. The backfilled portals all appear to be stable, and none of the portals possess a discharge or show signs of historic discharge.
