**RE: Geotechnical Review Memo, Native/Pierre Mine, Permit No. M-1977-321,  
Conversion Application (CN-01)**

Re: **Native/Pierre Mine; M-1977-321; Kidd Engineering Report for 1224 Ruppel Street;  
Geotechnical Review Memo**

The Division of Reclamation, Mining and Safety (Division/DRMS) reviewed the Kidd Engineering (Kidd) report dated August 8, 2020 for the alleged house damages at 1224 Ruppel Street, Pueblo, CO 81001 due to Summit Brick's nearby mining operation.

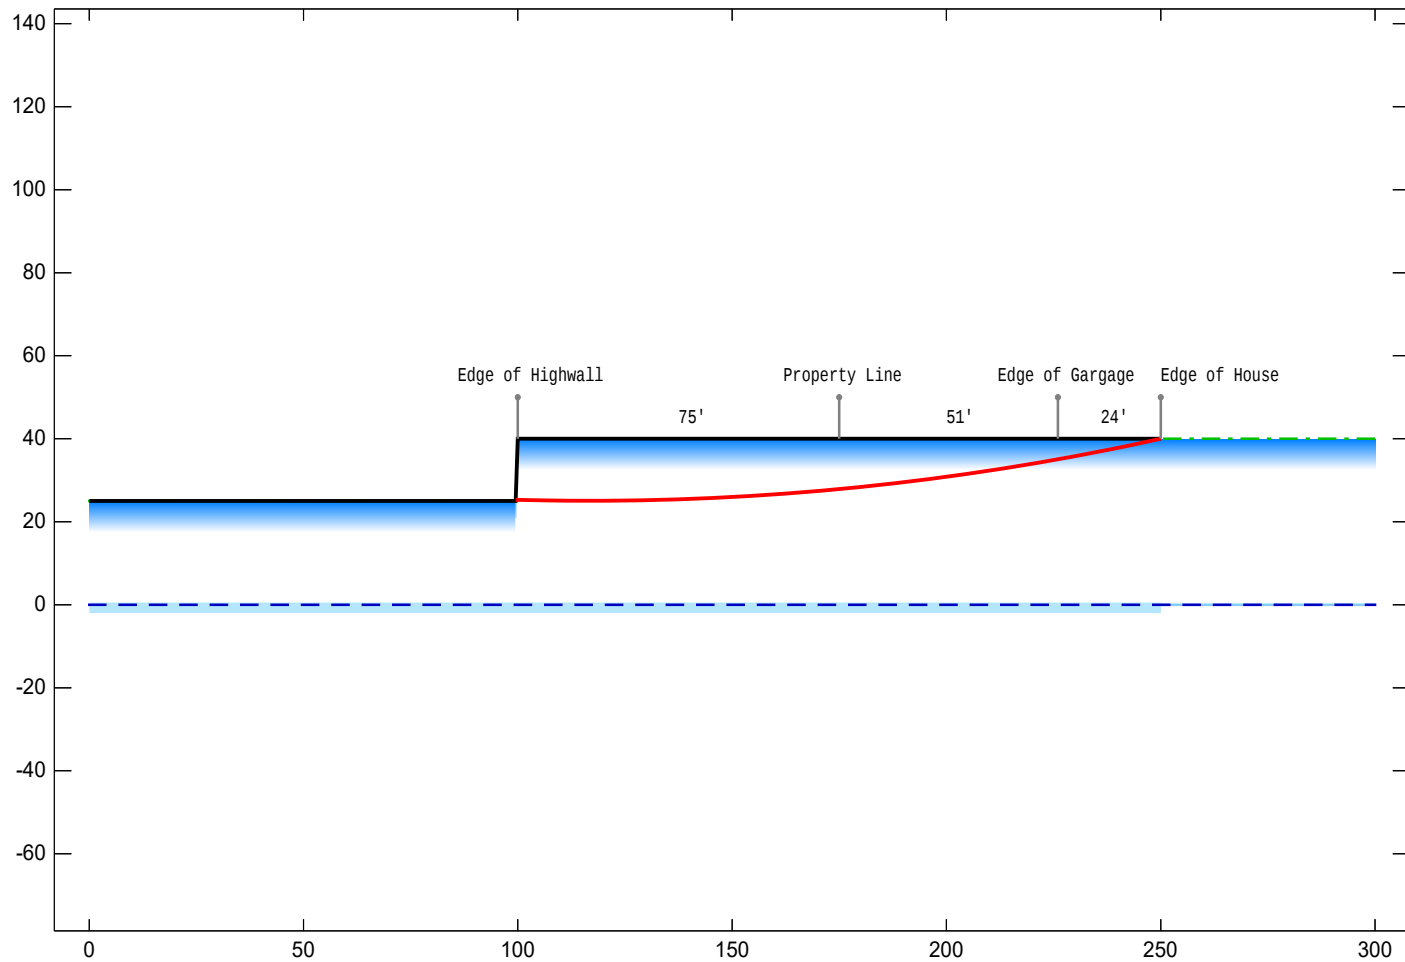
Project Native/Pierre  
1224 Ruppel Street House

The Division modeled a slope stability analysis using Clover Technologies Galena Slope Stability Analysis System, Version 7.2, based on the information presented in the Kidd report with generic clay soil properties. The analysis resulted in a Factor of Safety (FOS) of 6.05 from the south edge of the house to the existing mining highwall. A copy of the results from the analysis are attached.

Based on the information presented in the report and the results of the Division's slope stability analysis, the Division agrees with the conclusions of the Kidd report that the house damages appear to be caused by differential settlement and are not due to the mining operation.

Factor of Safety: 6.05
