**MINERALS PROGRAM INSPECTION REPORT**  
**PHONE: (303) 866-3567**

<b>MINE NAME:</b> Spotted Burro Pit	<b>MINE/PROSPECTING ID#:</b> M-1979-192	<b>MINERAL:</b> Sand and gravel	<b>COUNTY:</b> Fremont
<b>INSPECTION TYPE:</b> Preoperation Inspection	<b>INSPECTOR(S):</b> Timothy Cazier	<b>INSP. DATE:</b> August 11, 2020	<b>INSP. TIME:</b> 09:30
<b>OPERATOR:</b> Rockbottom, LLC	<b>OPERATOR REPRESENTATIVE:</b> Rebecca Kagan and Ken Klco	<b>TYPE OF OPERATION:</b> 112c - Construction Regular Operation	
<b>REASON FOR INSPECTION:</b> Preoperation Inspection	<b>BOND CALCULATION TYPE:</b> Complete Bond	<b>BOND AMOUNT:</b> \$45,978.00	
<b>DATE OF COMPLAINT:</b> NA	<b>POST INSP. CONTACTS:</b> None	<b>JOINT INSP. AGENCY:</b> None	
<b>WEATHER:</b> Clear	<b>INSPECTOR'S SIGNATURE:</b>

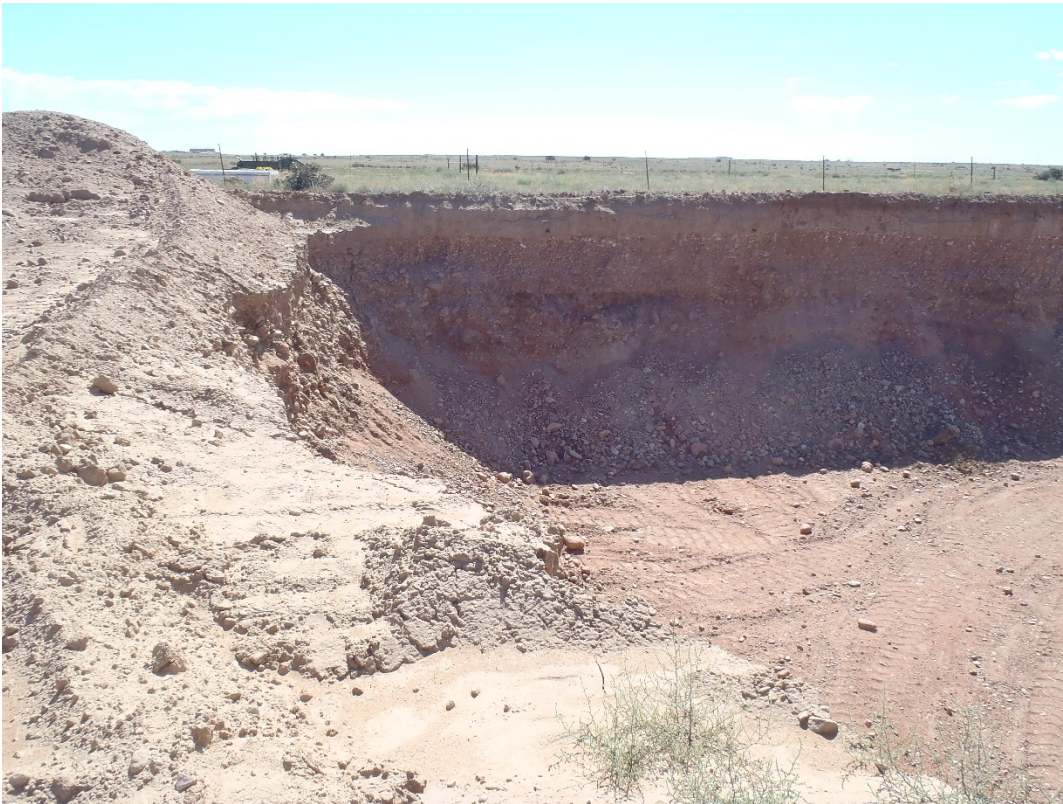
Gen. Compliance with Mine Plan: The operation appeared to be in compliance with the approved mine plan. The maximum allowed disturbed area is increased from 15 acres to 27.3 acres. Google Earth was used to measure the disturbed area, which was estimated to be approximately 18.5 acres, based on 2019 imagery. Highwalls were estimated to vary between 15 and 20 feet in height (see **Photo 1**).

Structures: Observed structures requiring damage compensation agreements include: a power line running north-south through the site (see **Photo 5**), a Century Tel line along CR 123, property fences along the east side of the operation (see **Photo 1**), and several outbuildings on the Osborn property. All damage compensation agreements were provided to the DRMS.

Photo 1. Northeast highwall, note property fences beyond highwall crest (looking east).

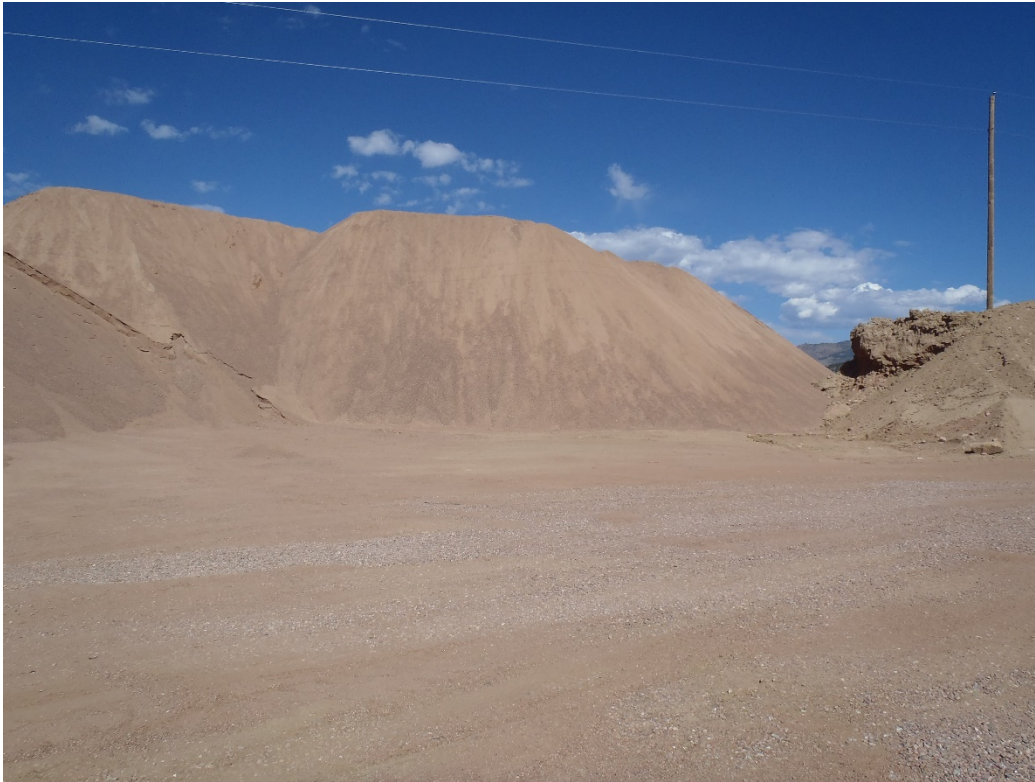
Processing Waste: A stockpile of crusher fines was observed on the west side of the north pit (see **Photo 2**).

Photo 2. Crusher fines stockpile on the west side of the north pit (looking west).

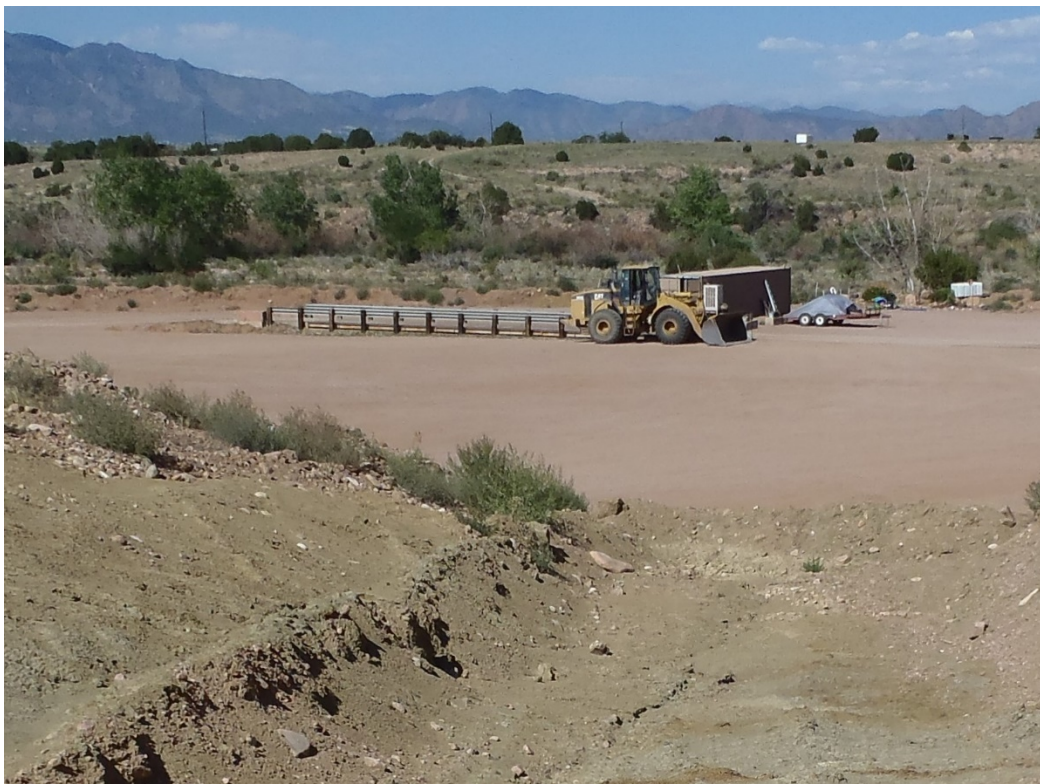
Support Facilities On-site: Only the truck scale and a loader were observed during the inspection (see **Photo 3**).

Photo 3. Truck scale & loader (looking west from N-S powerline).

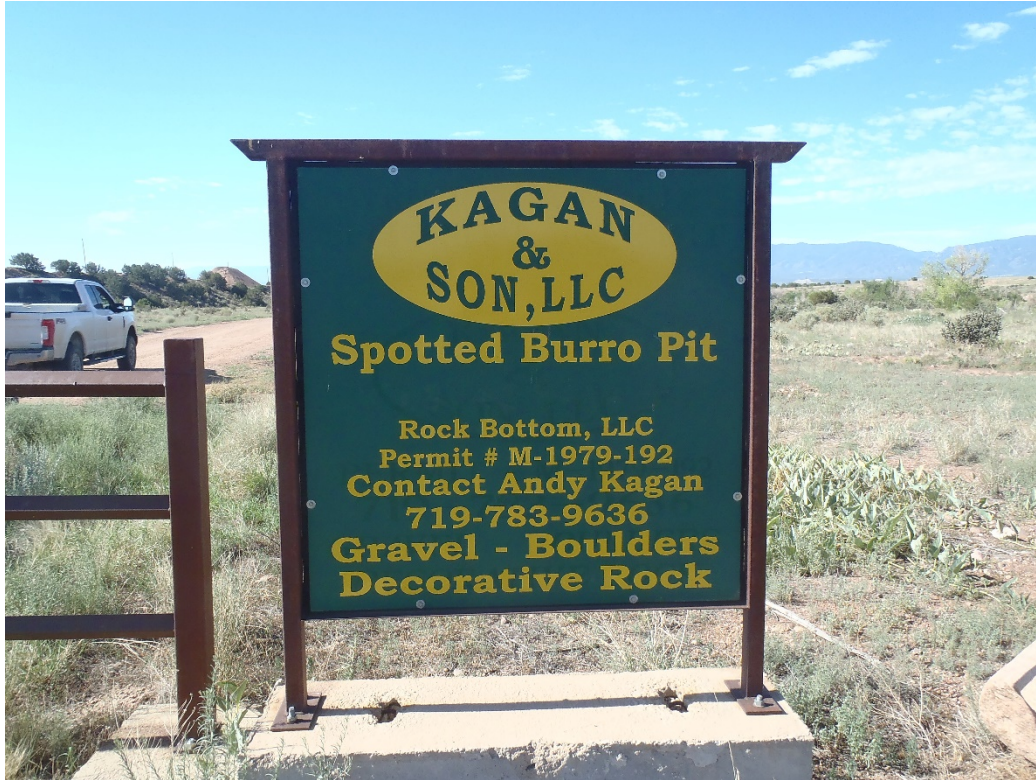
Signs and Markers: The permit sign was properly posted (see **Photo 4**). Fences and berms markers permit boundary.

Photo 4. Permit sign at entrance off CR 123.

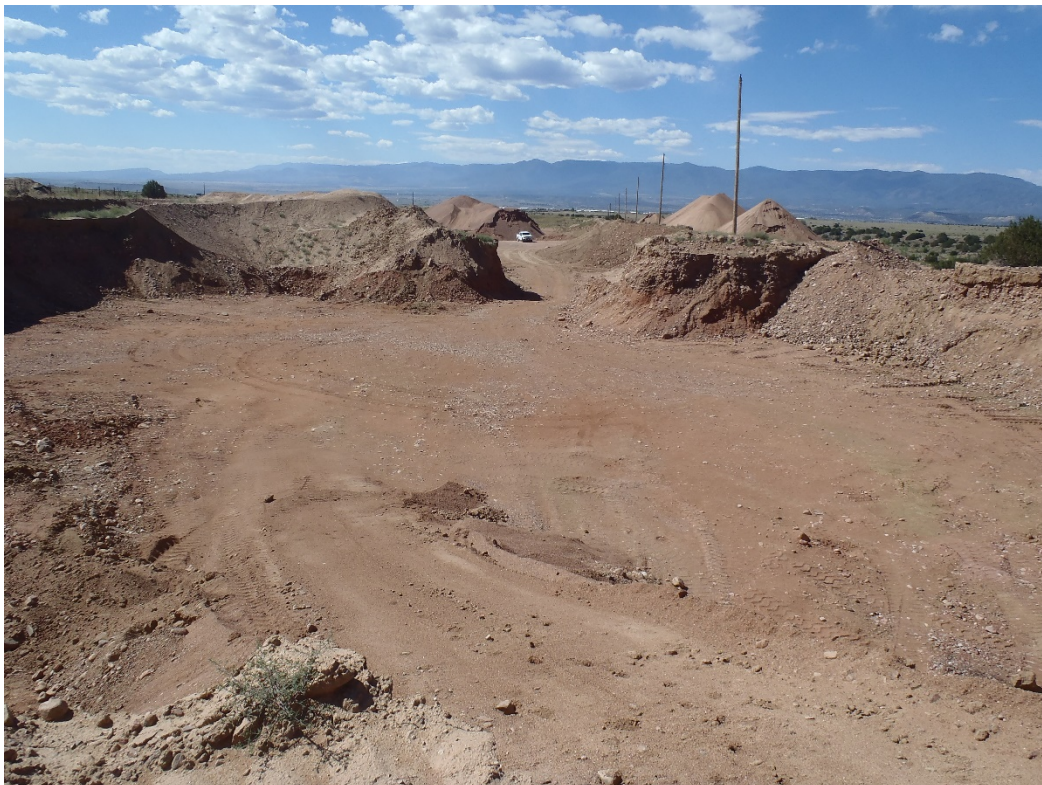
Photo 5. North end of pit, note powerline on right (looking south).
