MINERALS PROGRAM INSPECTION REPORT
PHONE: (303) 866-3567

MINE NAME: Canyon Rim Stone Quarry	MINE/PROSPECTING ID#: M-2006-053	MINERAL: Stone	COUNTY: Las Animas
INSPECTION TYPE: Monitoring	INSPECTOR(S): Daniel Cunningham	INSP. DATE: November 3, 2020	INSP. TIME: 10:45
OPERATOR: Canyon Rim Stone, LLC	OPERATOR REPRESENTATIVE: None	TYPE OF OPERATION: 110c - Construction Limited Impact	
REASON FOR INSPECTION: Normal I&E Program	BOND CALCULATION TYPE: Complete Bond	BOND AMOUNT: \$30,009.00	
DATE OF COMPLAINT: NA	POST INSP. CONTACTS: None	JOINT INSP. AGENCY: None	
WEATHER: Clear	INSPECTOR'S SIGNATURE:

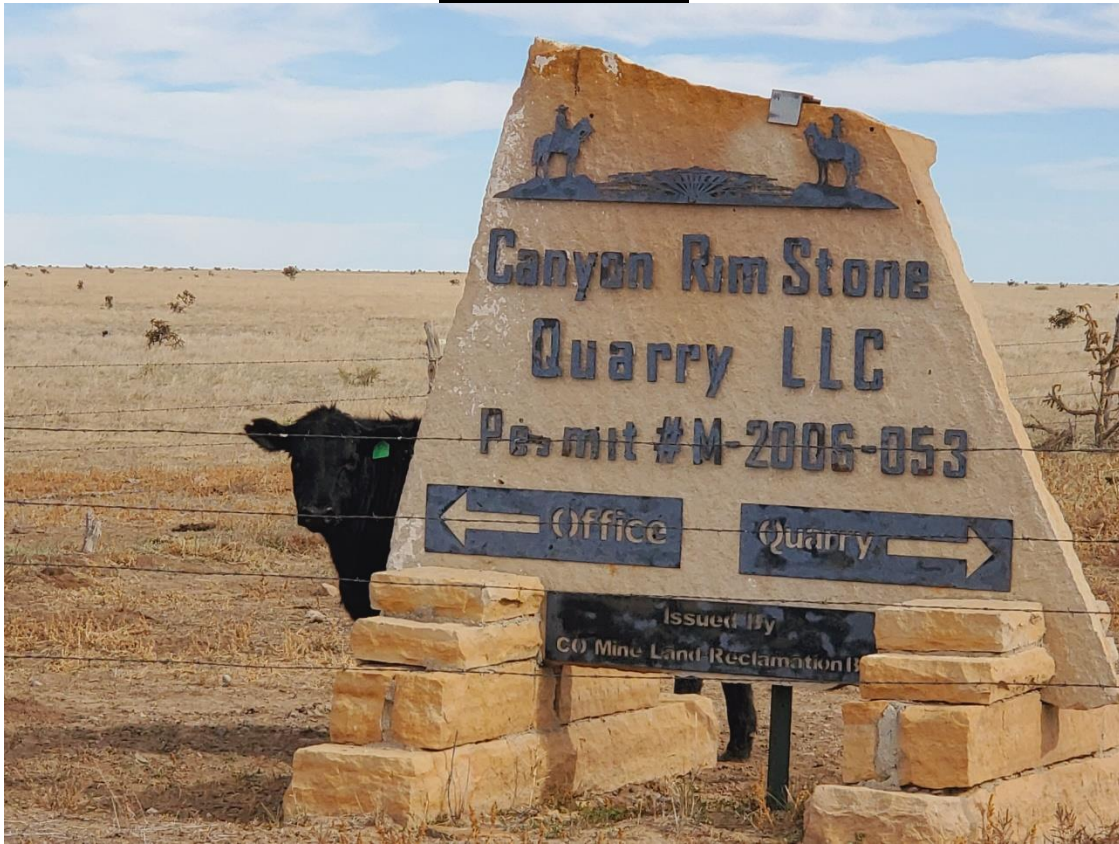
Mine Entrance

The site identification sign was posted at the mine entrance and the boundary was marked. Mining is being conducted in benches, with each bench being between one and two feet high. Stock material was being stored on pallets throughout the permitted area. Topsoil is being stored along the permit boundary.
