MINERALS PROGRAM INSPECTION REPORT
PHONE: (303) 866-3567

MINE NAME: Bulkley Pit No 17	MINE/PROSPECTING ID#: M-1981-138	MINERAL: Sand and gravel	COUNTY: Baca
INSPECTION TYPE: Monitoring	INSPECTOR(S): Daniel Cunningham	INSP. DATE: November 2, 2020	INSP. TIME: 14:30
OPERATOR: Baca County	OPERATOR REPRESENTATIVE: Shiloh Freed	TYPE OF OPERATION: 112c - Construction Regular Operation	
REASON FOR INSPECTION: Normal I&E Program		BOND CALCULATION TYPE: \$0.00	
DATE OF COMPLAINT: NA		JOINT INSP. AGENCY: None	
WEATHER: Clear	INSPECTOR'S SIGNATURE:

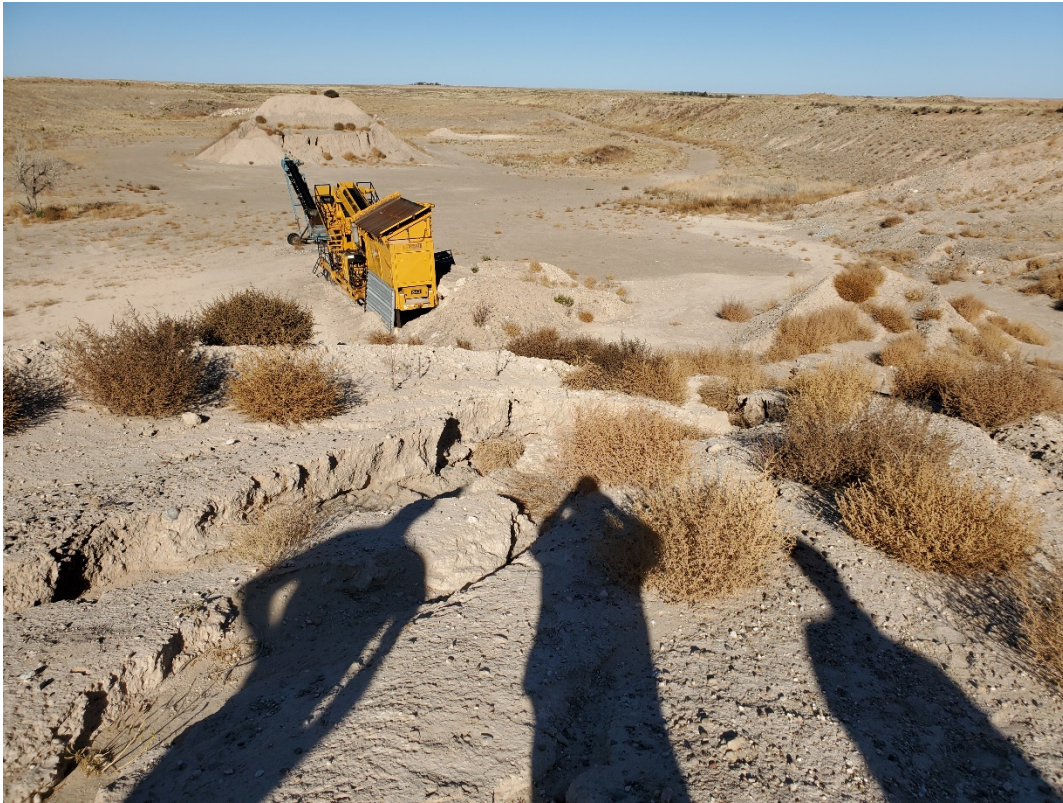
A medium size erosional issue could be located near the eastern end of the permit on a road to the bottom of the pit. This is not being noted as a problem at this time. However, it is highly recommended that the Operator shape and regrade the road to remove the issue and prevent material from being brought off site.

Erosional issue that needs to be fixed
