MINERALS PROGRAM INSPECTION REPORT PHONE: (303) 866-3567

MINE NAME:		MINE/PROSPECTING ID#:	MINERAL:	COUNTY:	
Hinds Pit #35		M-2003-070	Sand and gravel	Baca	
INSPECTION TYPE:		INSPECTOR(S):	INSP. DATE:	INSP. TIME:	
Monitoring		Daniel Cunningham	November 2, 2020	15:30	
OPERATOR:		OPERATOR REPRESENTATIVE:	TYPE OF OPERATION:		
Baca County		Shiloh Freed	112c - Construction Regular Operation		
REASON FOR INSPECTION:		BOND CALCULATION TYPE:	BOND AMOUNT:		
Normal I&E Program		None	\$0.00		
DATE OF COMPLAINT:		POST INSP. CONTACTS:	JOINT INSP. AGENCY:		
NA		None	None		
WEATHER:	INSPECTOR'S SIGNATURE:		SIGNATURE DATE:		
Clear	Danith Culputer		December 4, 2020

PERMIT #: M-2003-070 INSPECTOR'S INITIALS: DC1 INSPECTION DATE: November 2, 2020

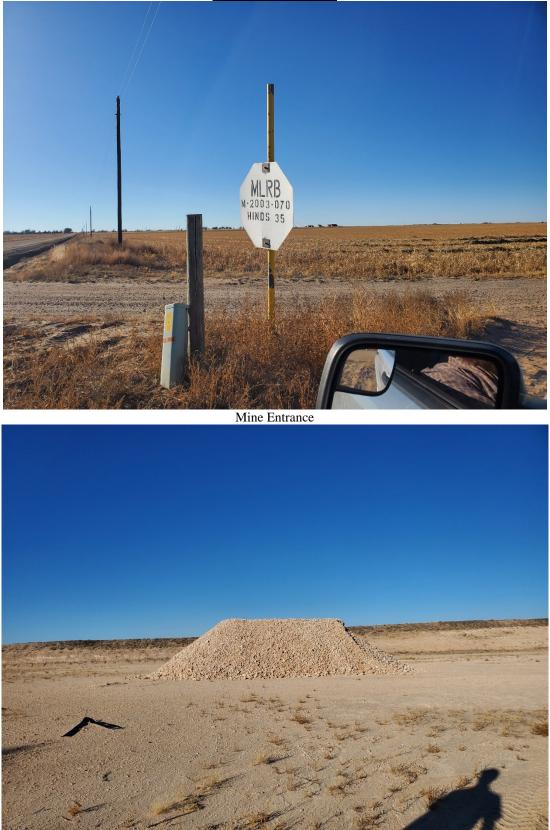
The site identification sign was posted at the mine entrance and the boundary was marked. Several large stockpiles were seen throughout the site. Topsoil was being stored around the perimeter of the disturbed area. Slopes were graded at a 3H:1V or greater.

Stock Material

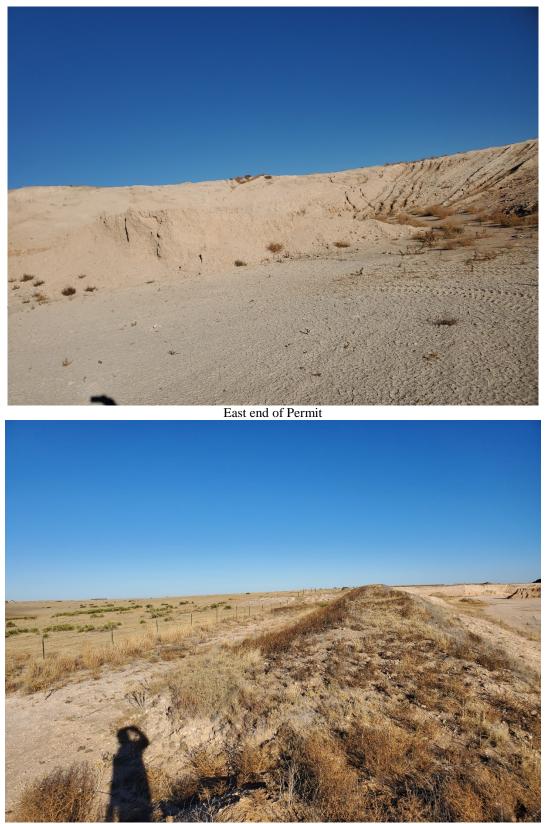
Topsoil
