**MINERALS PROGRAM INSPECTION REPORT**  
**PHONE: (303) 866-3567**

<b>MINE NAME:</b> Shannon Pit	<b>MINE/PROSPECTING ID#:</b> M-1979-163	<b>MINERAL:</b> Sand and gravel	<b>COUNTY:</b> Las Animas
<b>INSPECTION TYPE:</b> Monitoring	<b>INSPECTOR(S):</b> Daniel Cunningham	<b>INSP. DATE:</b> November 3, 2020	<b>INSP. TIME:</b> 09:00
<b>OPERATOR:</b> Las Animas County	<b>OPERATOR REPRESENTATIVE:</b> Clell Goode	<b>TYPE OF OPERATION:</b> 112c - Construction Regular Operation	
<b>REASON FOR INSPECTION:</b> Normal I&E Program	<b>BOND CALCULATION TYPE:</b> None	<b>BOND AMOUNT:</b> \$0.00	
<b>DATE OF COMPLAINT:</b> NA	<b>POST INSP. CONTACTS:</b> None	<b>JOINT INSP. AGENCY:</b> None	
<b>WEATHER:</b> Clear	<b>INSPECTOR'S SIGNATURE:</b>

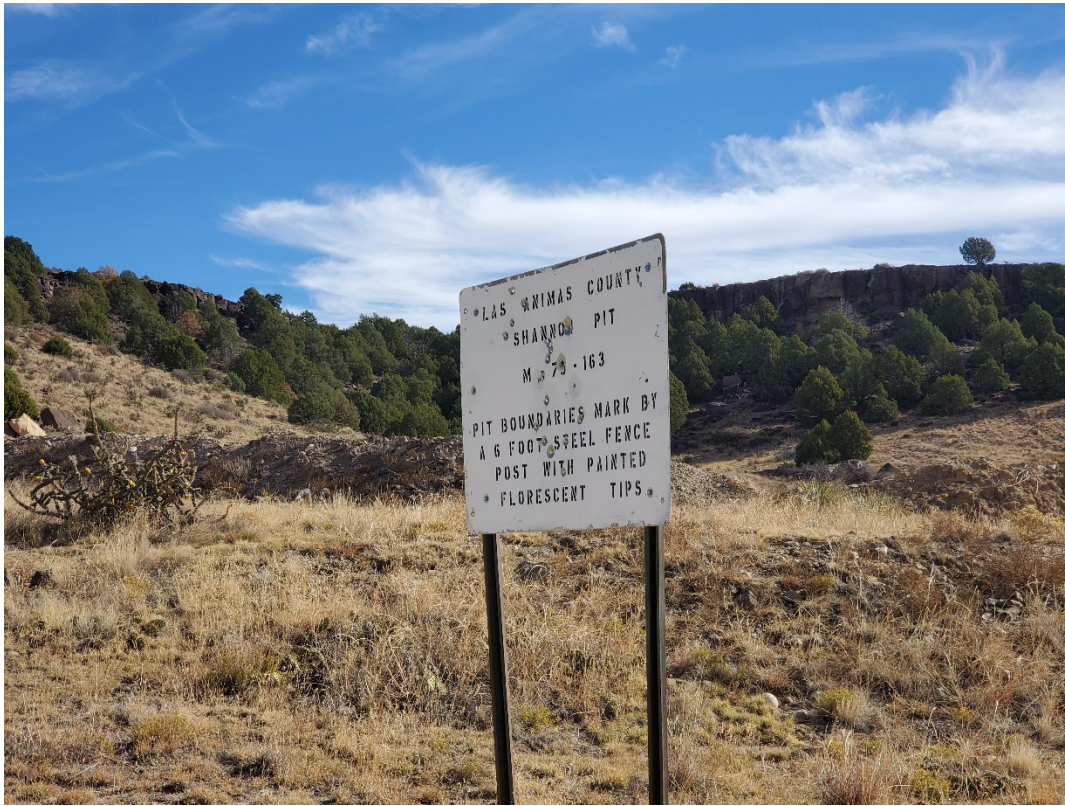
Mine Entrance

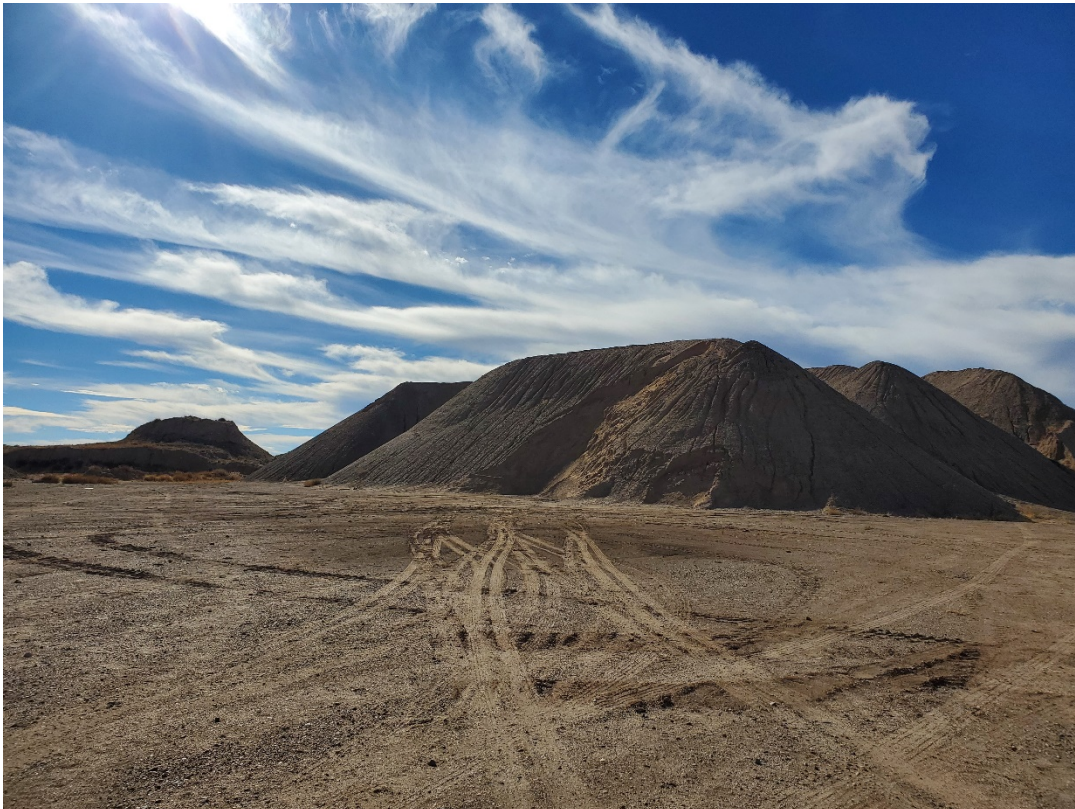
Stock Material

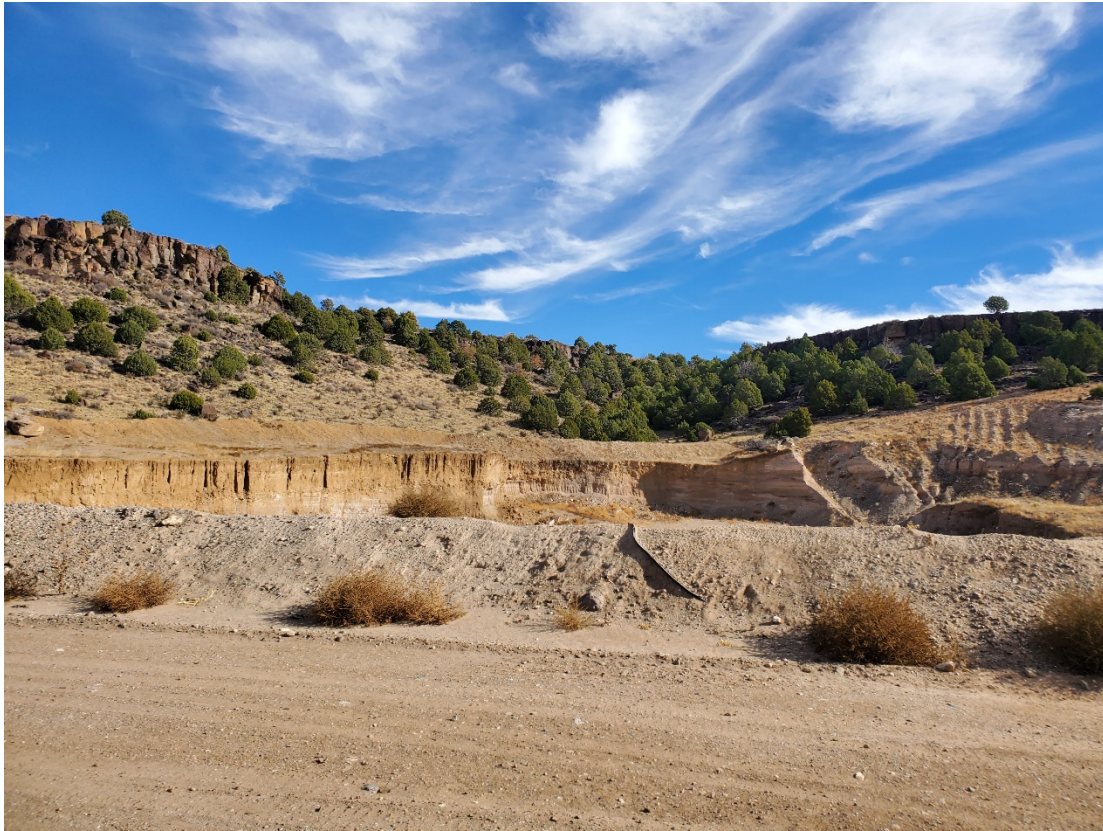
Highwall

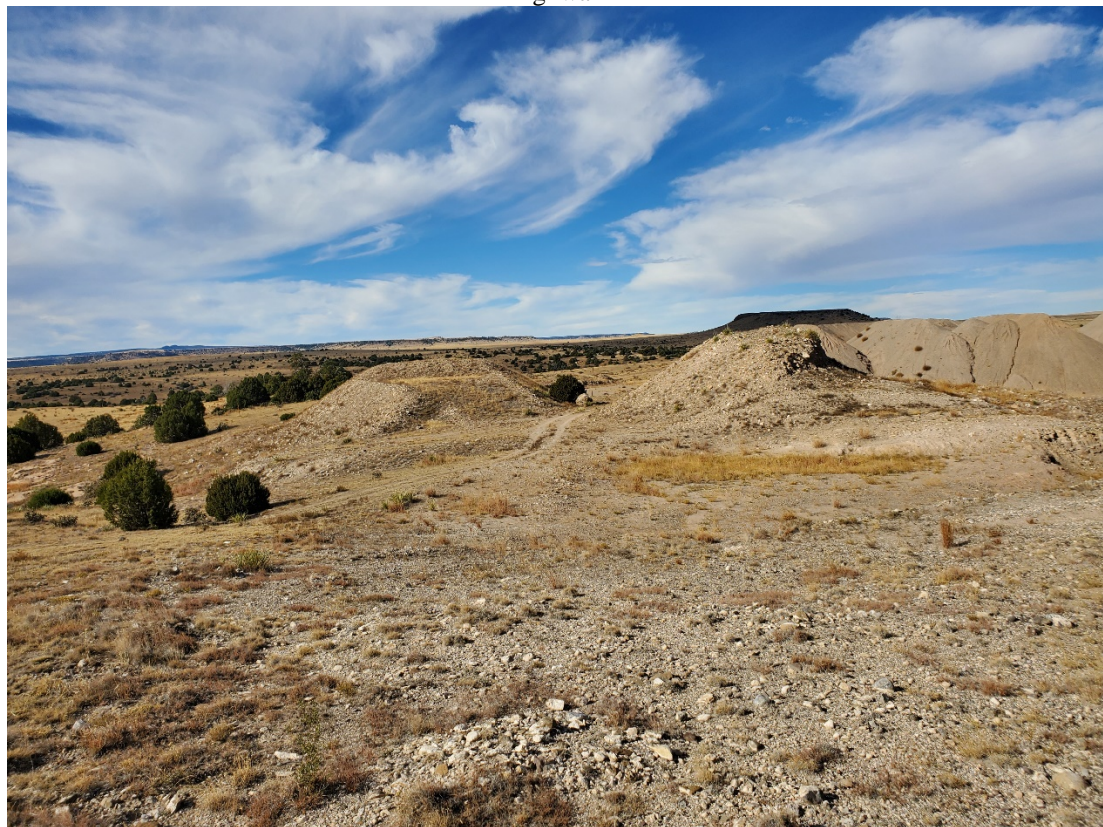
Topsoil Pile
