MINERALS PROGRAM INSPECTION REPORT
PHONE: (303) 866-3567

MINE NAME: Goodrich Pit	MINE/PROSPECTING ID#: M-2019-005	MINERAL: Aggregate and grave	COUNTY: Las Animas
INSPECTION TYPE: Monitoring	INSPECTOR(S): Daniel Cunningham	INSP. DATE: November 3, 2020	INSP. TIME: 12:00
OPERATOR: Fremont Paving & Redi-Mix, Inc.	OPERATOR REPRESENTATIVE: None	TYPE OF OPERATION: 112c - Construction Regular Operation	
REASON FOR INSPECTION: Normal I&E Program	BOND CALCULATION TYPE: Complete Bond	BOND AMOUNT: \$283,190.00	
DATE OF COMPLAINT: NA	POST INSP. CONTACTS: None	JOINT INSP. AGENCY: None	
WEATHER: Clear	INSPECTOR'S SIGNATURE:

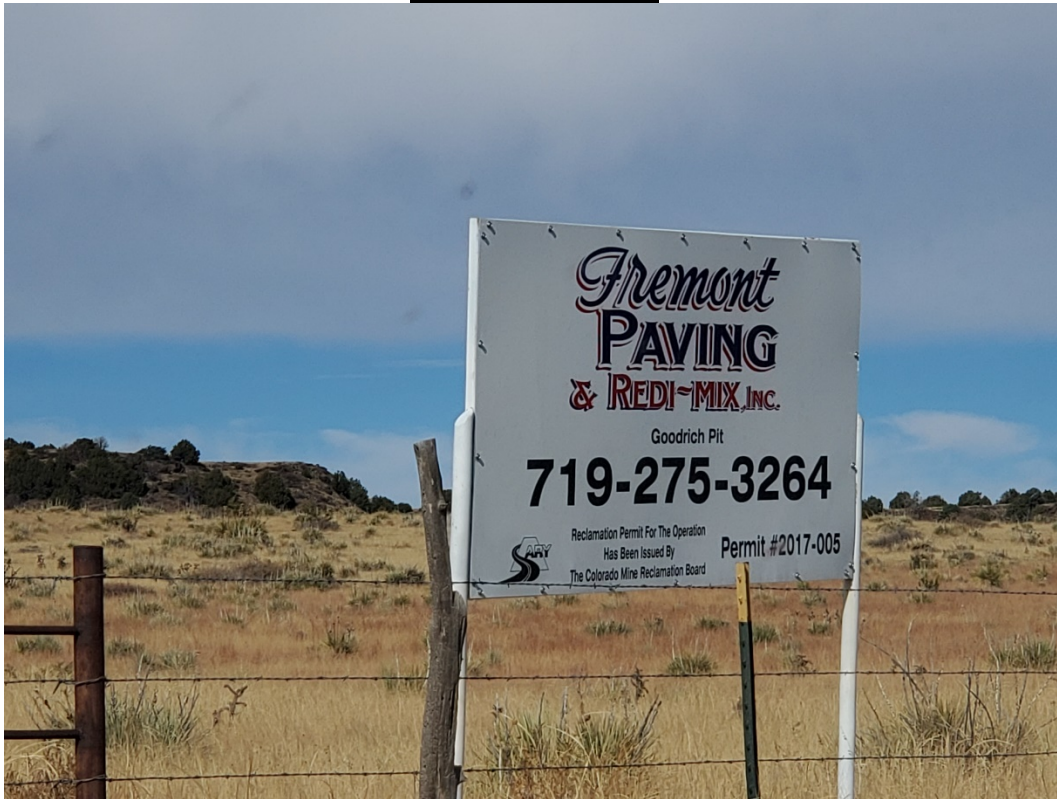
Mine site Entrance

The site identification sign was posted at the mine entrance and the boundary was marked. The mine site entrance sign needs to be updated with the corrected permit number since M2017-005 and M2019005 are combined into one permit. This is not being cited as a problem at this time

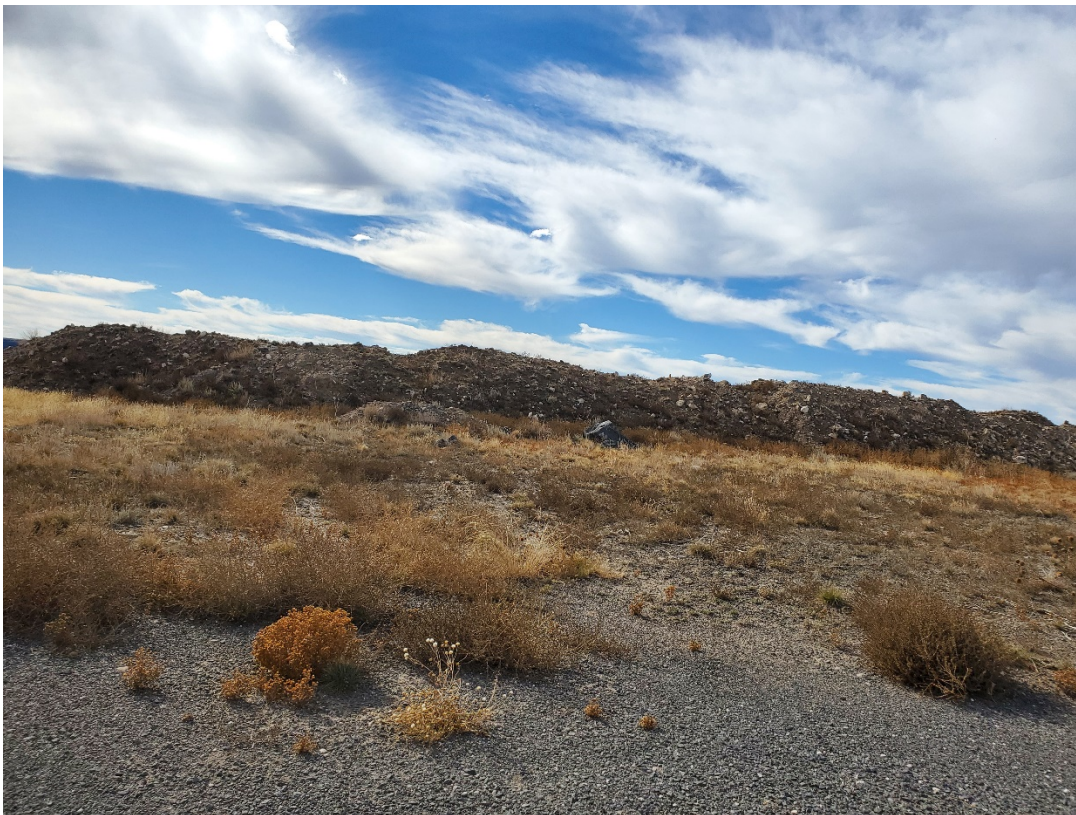
A 200 ft. long by 15 ft. high highwall was located on the eastern end of the disturbed area. Several large stockpiles, of varying sizes of material, were located throughout the permitted area. Topsoil was being stored around the edges of the mesa, it was stable and well vegetated. A large amount of used waddles was located at the northern end of the pit floor.
