**COLORADO**Division of Reclamation,
Mining and Safety

PERMIT INFORMATION

| Permit Number: C-1981-018 Mine Name: Deserado Mine Operator: Blue Mountain Energy, Inc. Operator Address: Mr. Kurtis Blunt 3607 County Road 65 Rangely, CO, 81648 | County: Moffat, Rio Blanco Operation Type: Underground Permit Status: Active Ownership: Private |

INSPECTION INFORMATION

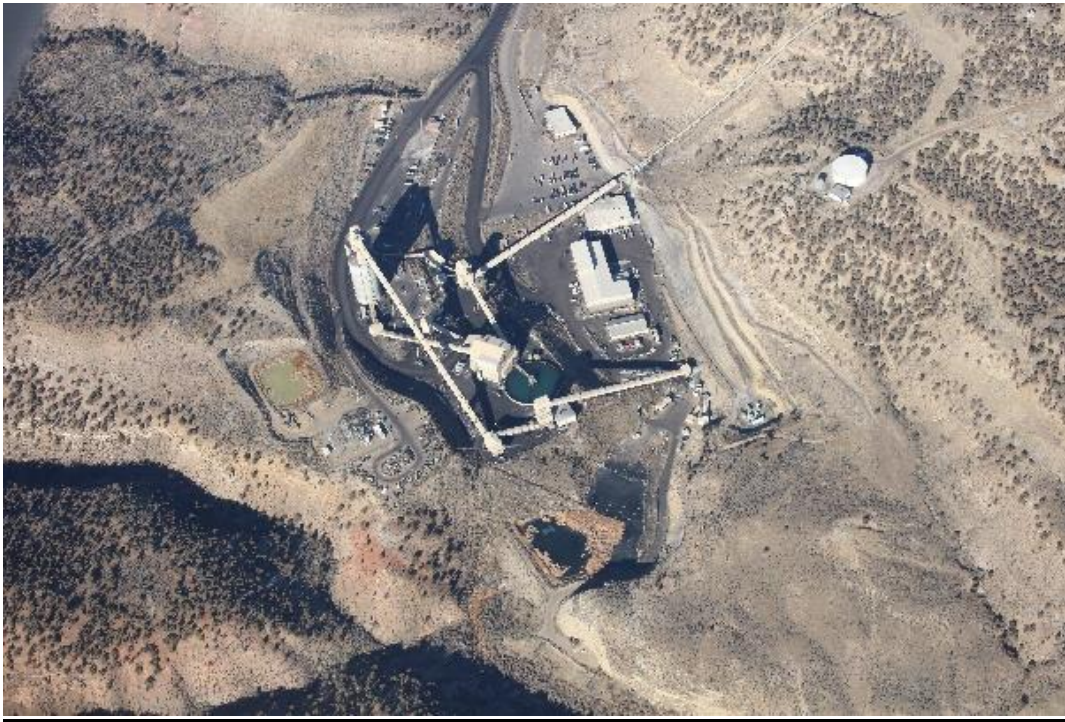
There are three ponds located at the main facilities area; the DP-1 Pond, the PP-1 Pond and the PP-2 Pond (Photo 1). During the inspection the DP-1 Pond was impounding water. The embankment for the pond was vegetated and stable. There were no observed erosional features. The primary and emergency spillways were clear of debris. The PP-2 Pond was holding water. The embankment was stable with vegetation. There were no indications of erosional features. The PP-1 Pond is located in the center of the middle facilities bench. The photos showed the pond in the shade of the processing plant structures. The pond appeared to be holding water. The pond was stable and there were no erosional concerns identified.

Photo 1: The DP-1 Pond, PP-1 Pond, PP-2 Pond and main facilities area.

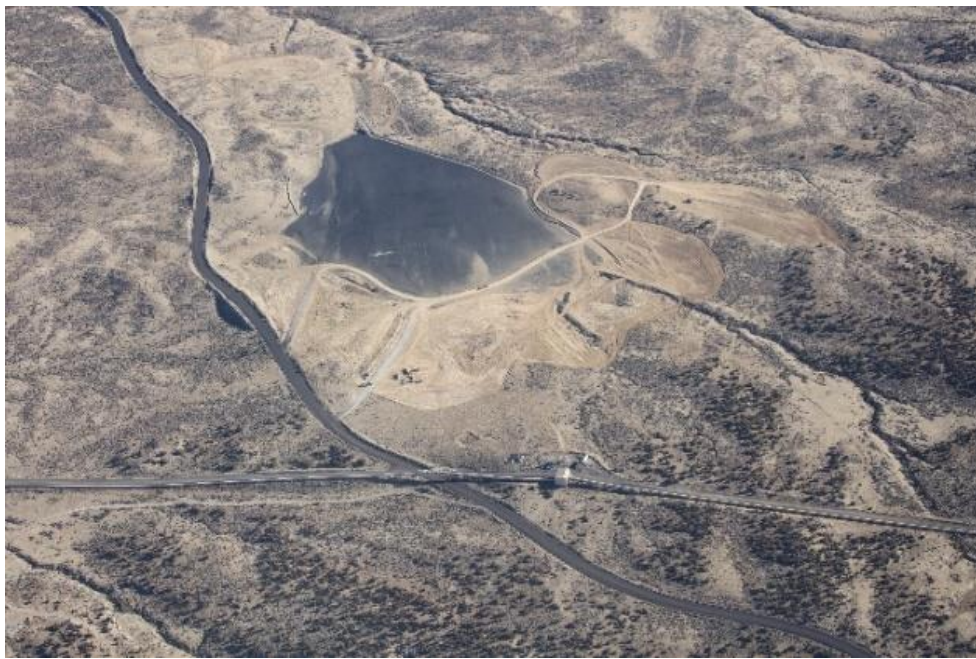
The RP-A Pond located at the eastern base of the RP-A Refuse Pile was dry at the time of the inspection (Photo 2). The embankment was stable and vegetation has begun to grow in. There were no observed erosional features.

The RP-A refuse pile is the newest refuse pile at the mine site. The pile has had refuse placed on the footprint and the base is being created (Photo 2). Refuse appeared to have been spread and compacted on the pile. The site was stable and no off site impacts were observed. No indications of erosion were seen.

Photo 2: The RP-A refuse pile and RP-A Pond.

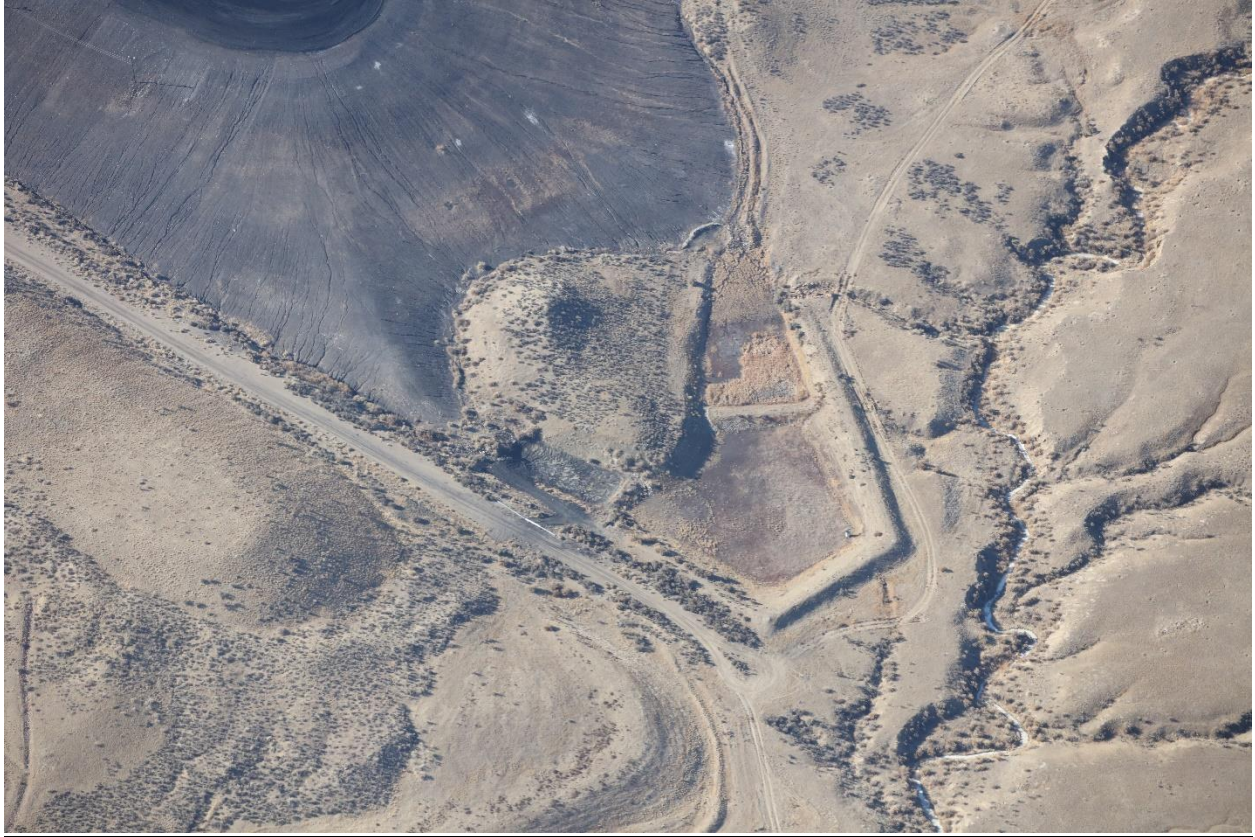
There are three ponds located at the northern bases of the main refuse disposal area. The RP-2/3 Pond consists of three cells (Photo 3). All three cells of the pond were dry at the time of the inspection. The embankments for the cells were stable with vegetation. There were no observed erosional features. The RP-4 Pond was dry. The embankment was vegetated and stable. No erosional concerns were seen. The RP-5a pond was observed to be dry. The embankment was stable with vegetative cover. There were no erosional features.

Photo 3: The RP-2/3 Pond.

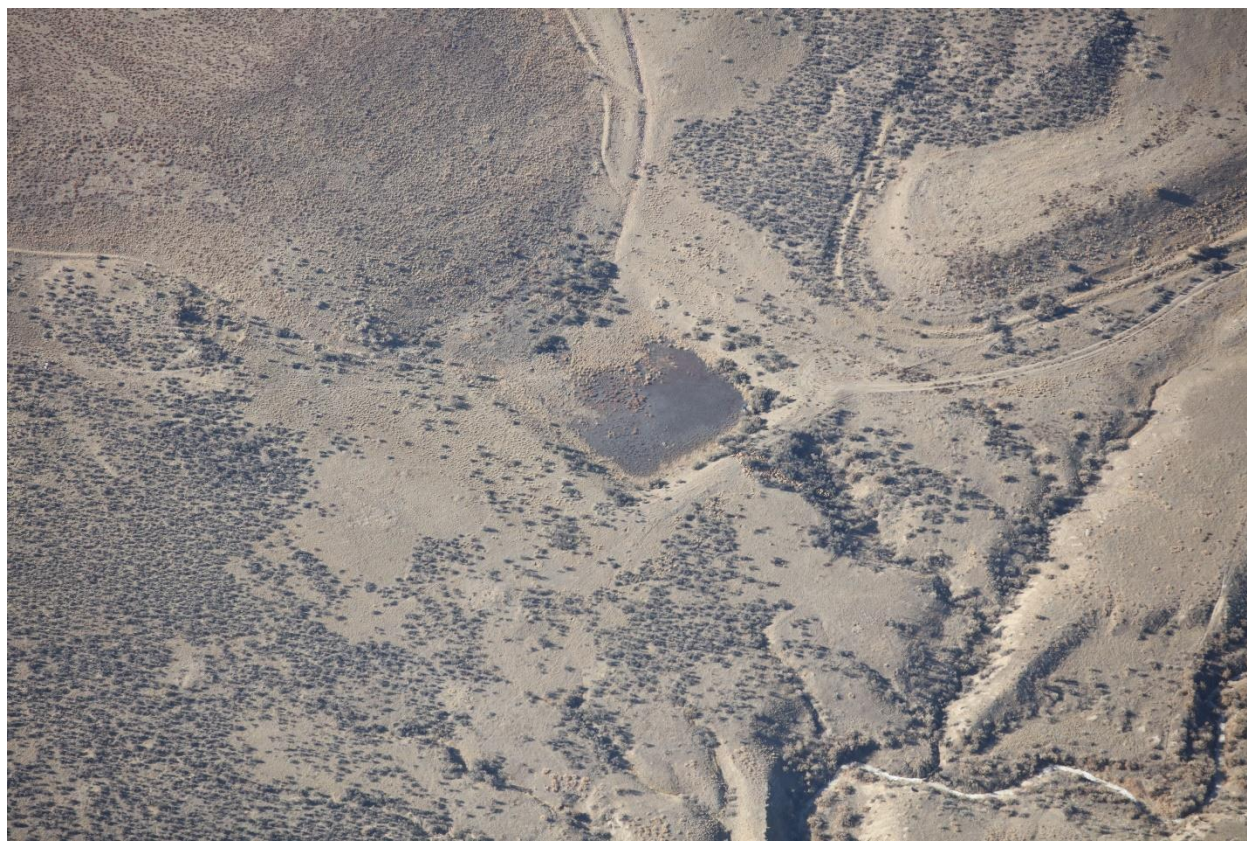
The RP-1 Pond is located at the northern base of the reclaimed RP-1 Refuse Pile (Photo 4). The pond was dry during the inspection. The embankment was stable with vegetative cover. There were no erosional concerns identified.

Photo 4: The RP-1 Pond

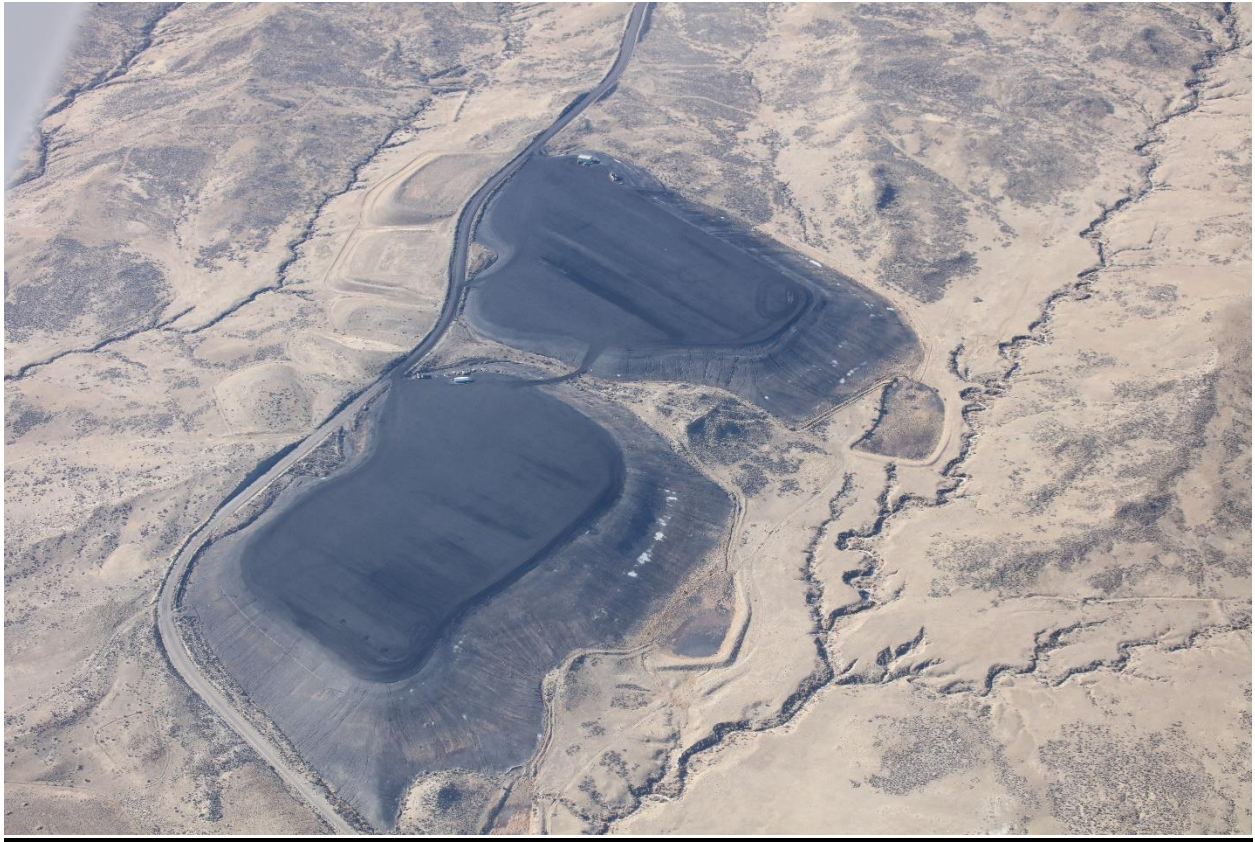
The RP-2/3/4 refuse pile was stable (Photo 5). Refuse material had been spread and compacted. Localized erosion on the slopes in the form of rills and gullies was observed. These features have been identified in previous Division Inspections and are set for maintenance in the spring of 2021. The perimeter ditches were clear of obstructions and stable.

The RP-5a refuse pile was stable during the inspection (Photo 5). The refuse had been spread and compacted on top of the pile. Minor erosion in the form of rills and gullies were observed on the slopes of the pile. These features have been noted in previous Division inspections. The erosional features are included for maintenance in the spring of 2021. The perimeter ditches were stable and clear of blockages.

Photo 5: The RP-2/3/4 and RP-5a refuse piles.
