TRAPPER MINING INC.  
CRAIG, COLORADO

HORSE GULCH FILL  
QUARTERLY FILL CERTIFICATION

# **Horse Gulch Fill Quarterly Inspection Report**

**Fourth Quarter 2020**

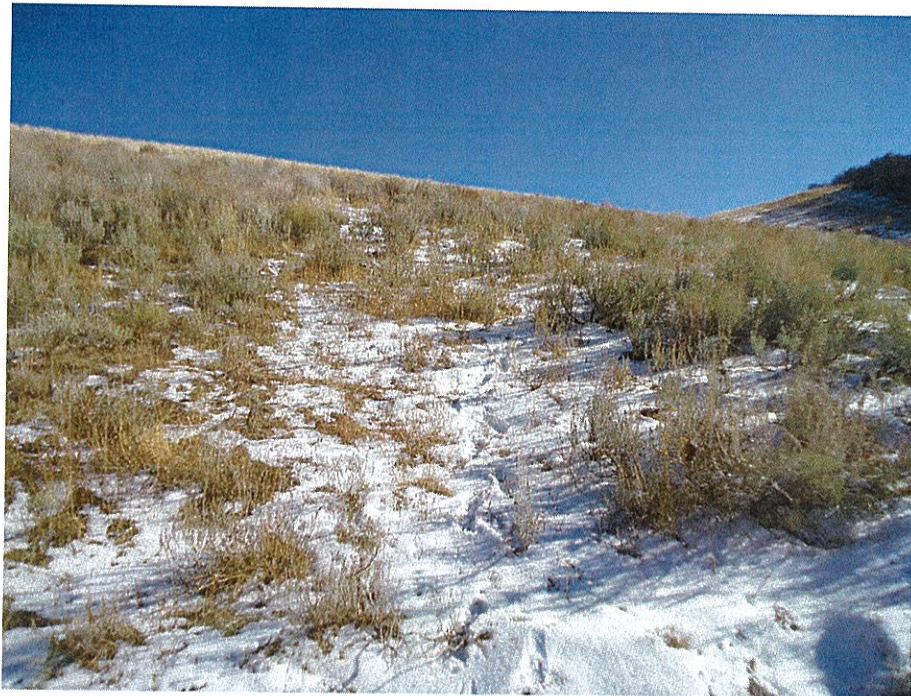
The two spots above the 7350' elevation on the south side of the dump that showed some differential settling in the second quarter of 2013 were inspected and there was no additional settling (Photographs 1 and 2).

Photograph 1: South Site above the 7350 Bench Elevation (12/3/2020)

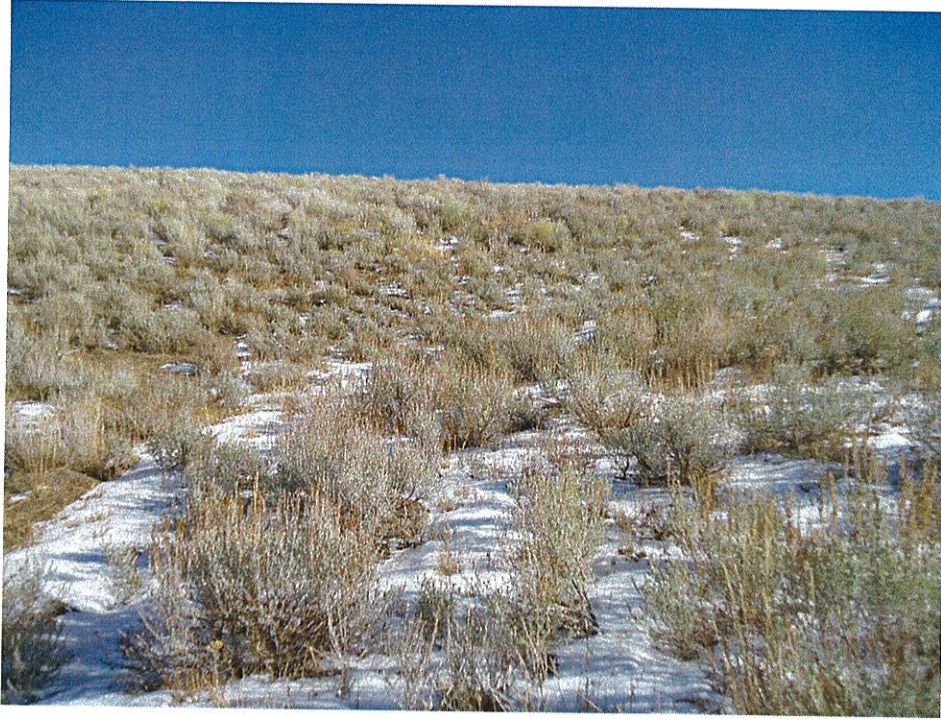
*Photograph 2: North Site above the 7350 Bench Elevation (12/3/2020)*

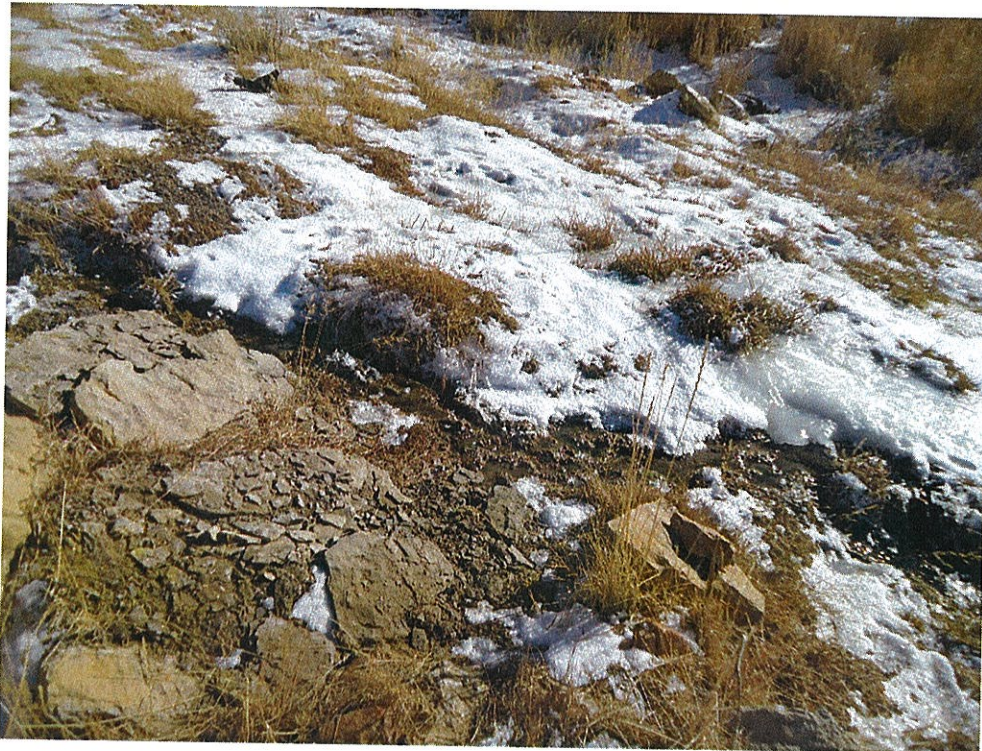
The underdrainage system was completed in the first quarter of 2010; additional work on this system is not anticipated. During the time of the inspection, there was approximately a 0.5 gallons per minute of water flow. (Photograph 3).

*Photograph 3: Water from the Underdrainage System (12/3/2020)*

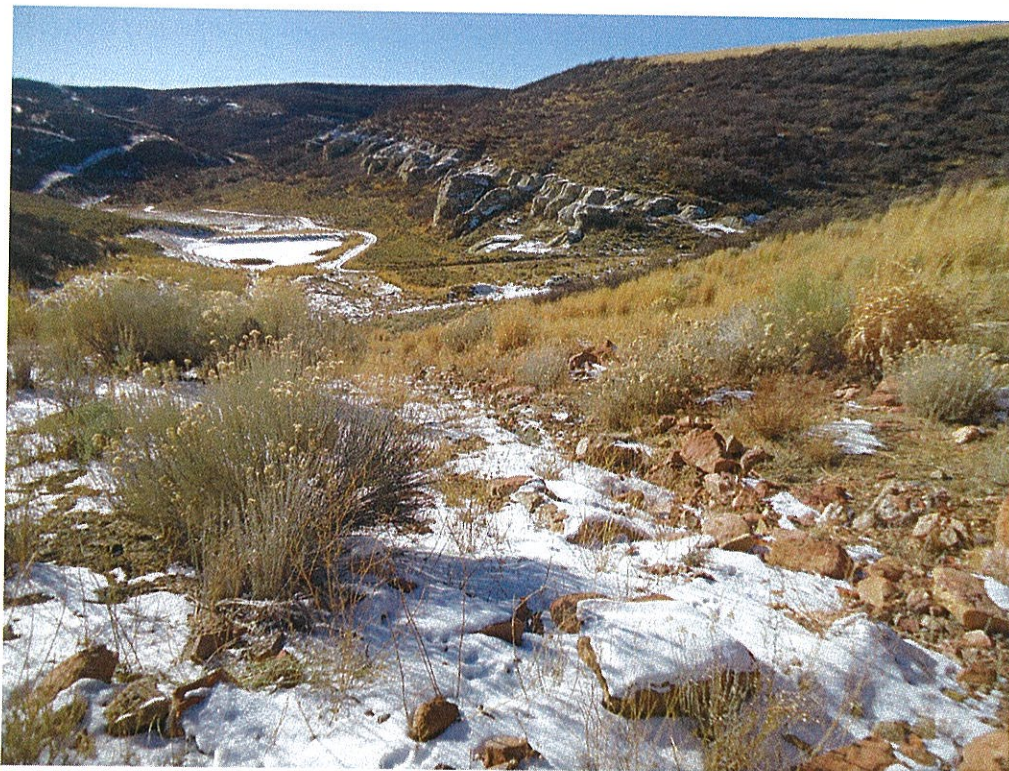
Both the north and south surface drains were inspected (Photographs 4 and 5). At the time of the inspection there was no water flow.

*Photograph 4: North Surface Drain Looking West (10/3/2020)*

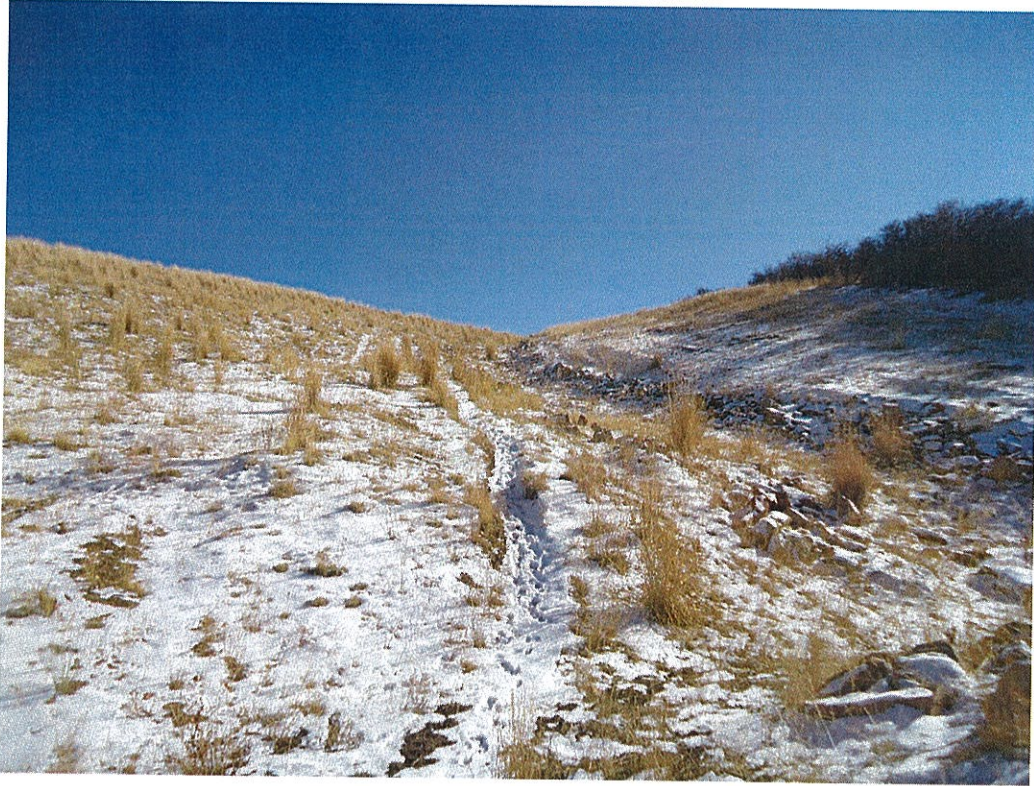
*Photograph 5: South Surface Drain Looking East (12/3/2020)*

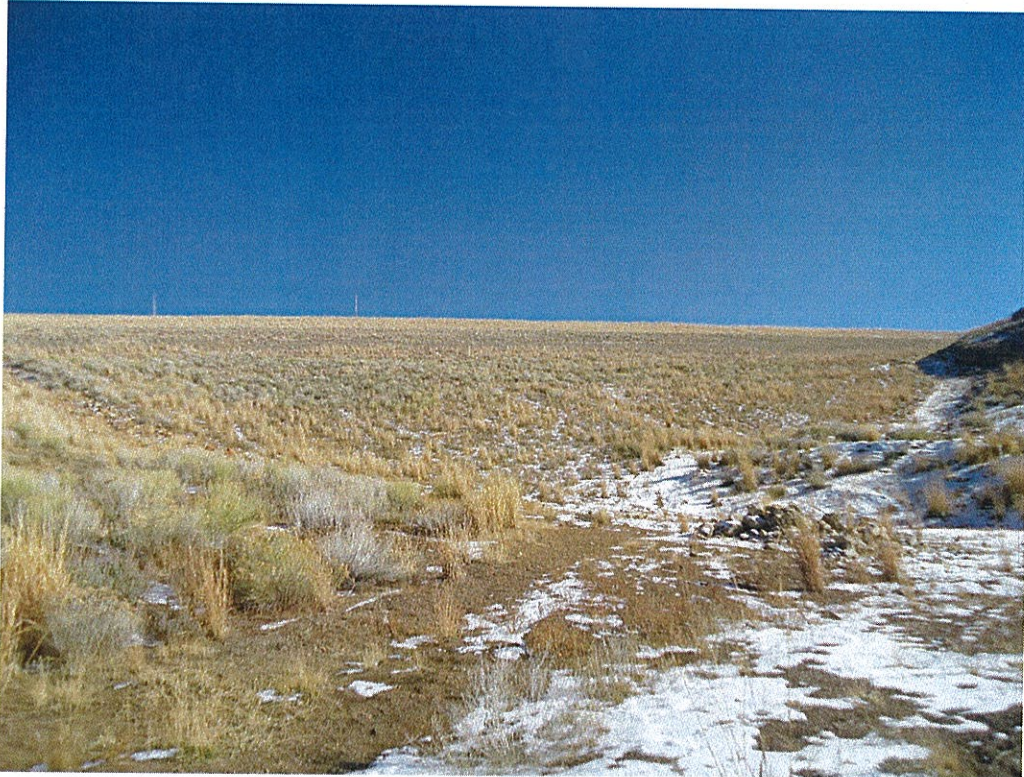
Photograph 6 depicts the west facing slope of the fill in the area where the slope of the fill is at 3H: 1V.

*Photograph 6: West Side Fill 3H: 1V Face Looking East (12/3/2020)*
