QUARTERLY SEDIMENTATION POND INSPECTION REPORT

Mine: New Elk

Inspection Period: Fourth Quarter 2020

Inspection Date: 11/20/2020

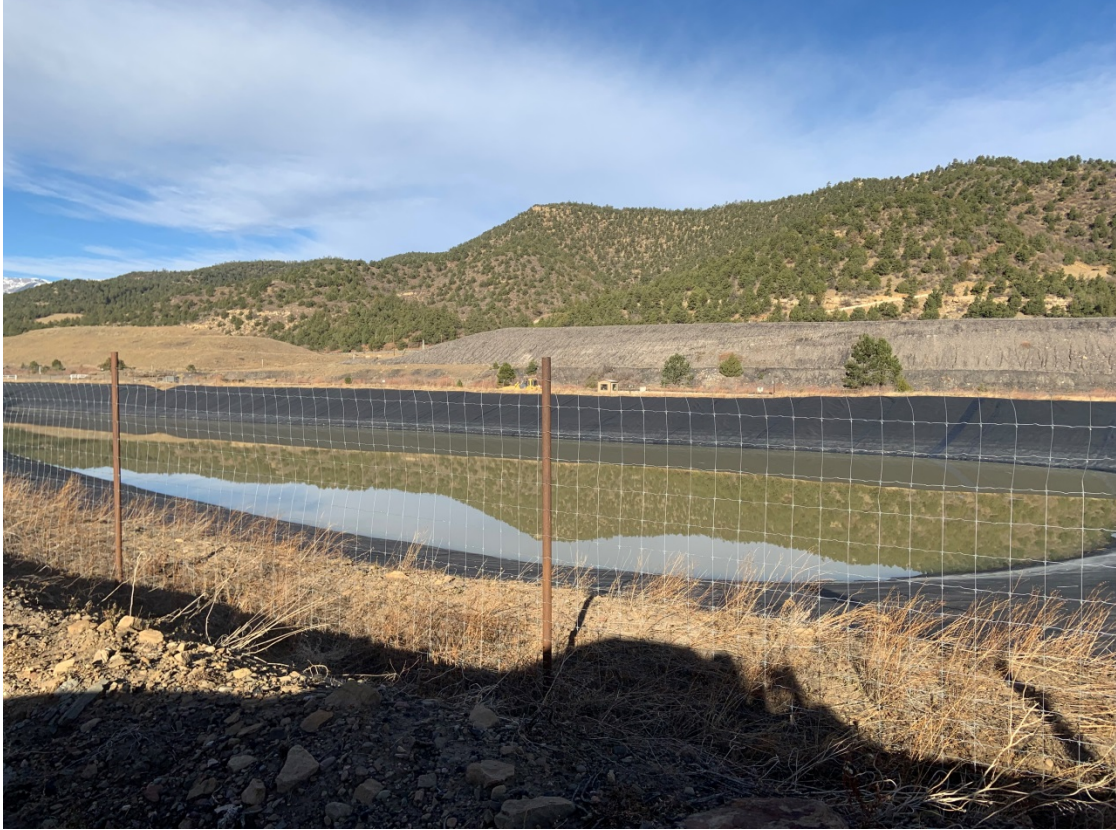
Pond 1

Pond has not discharged since last inspection. Pond was holding water at time of inspection.

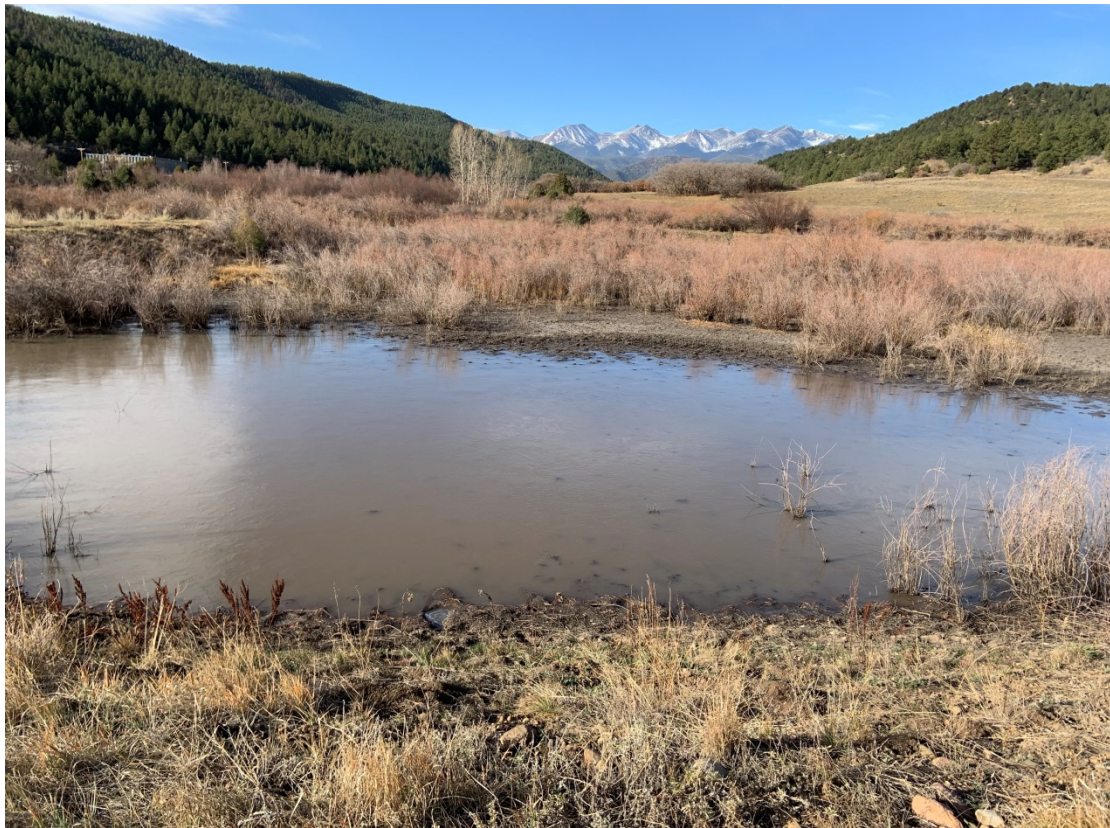
Pond 4

Pond was holding a small amount of water.

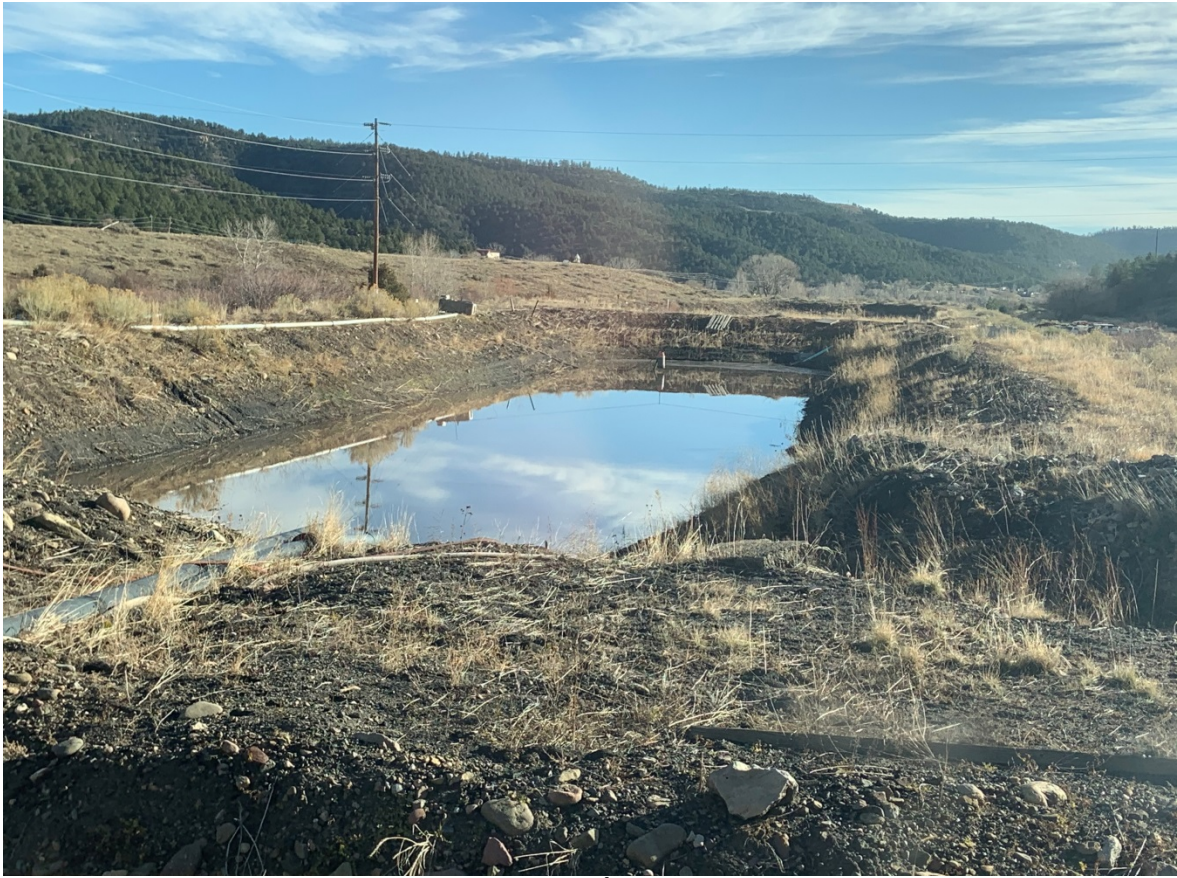
Pond 6

Pond is holding water, not close to full.

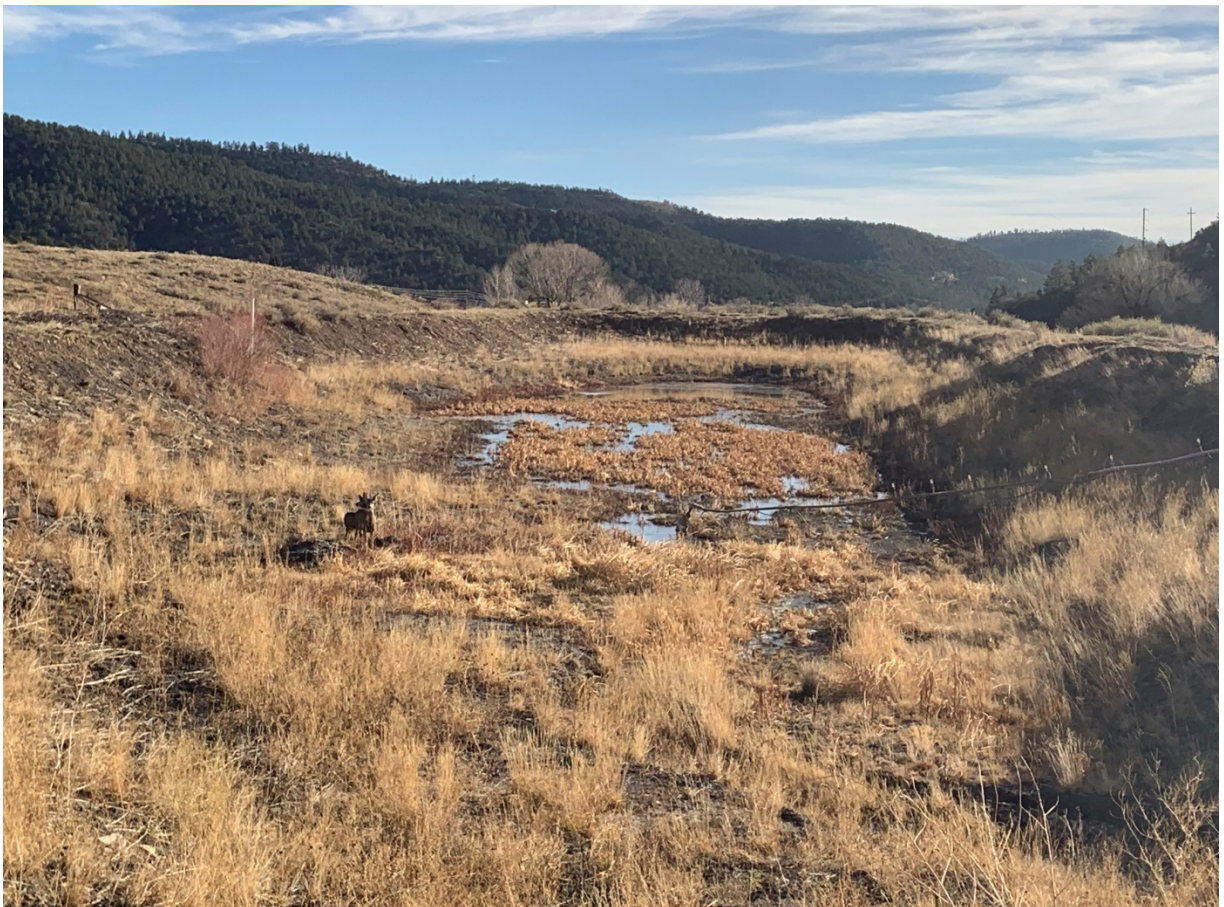
Pond 7

Pond is nearly empty.

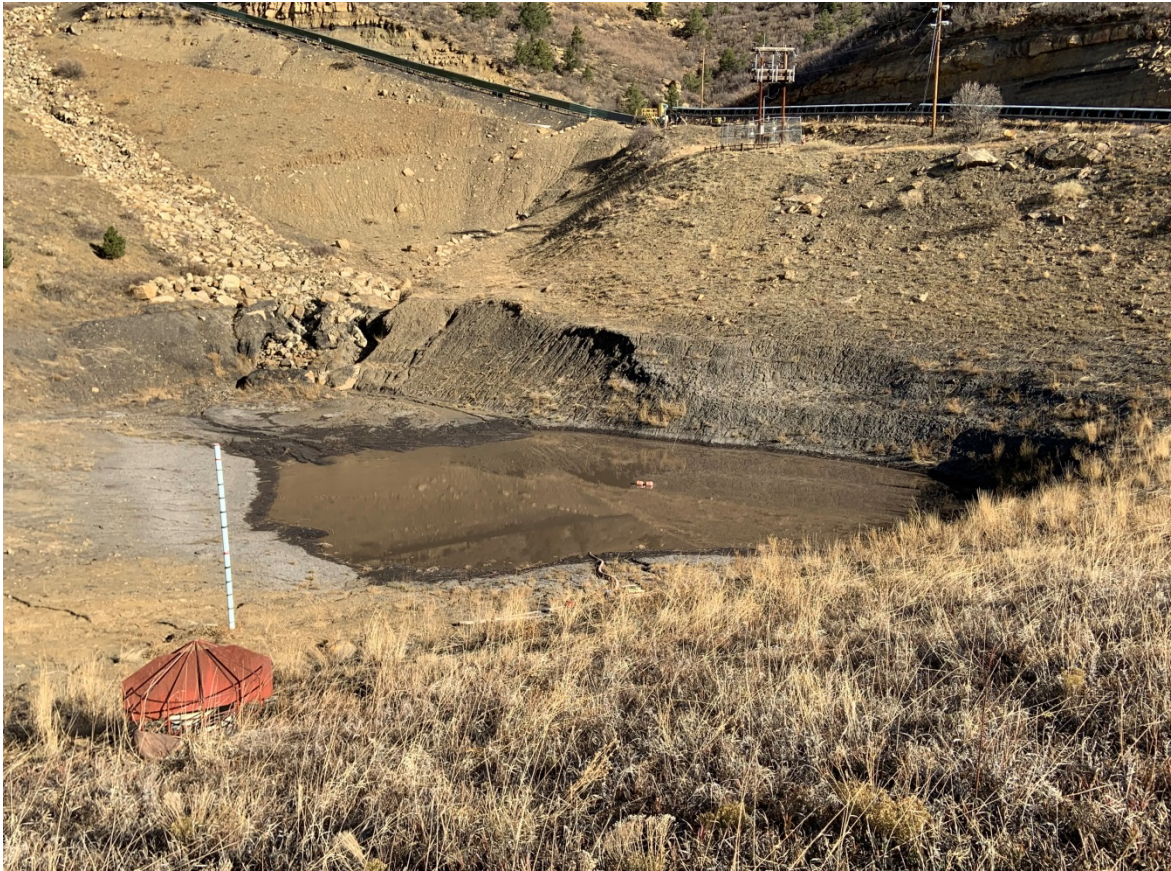
Pond 8

Pond was holding water at the time of inspection. No new sediment has been deposited and there is very little sediment in the pond.

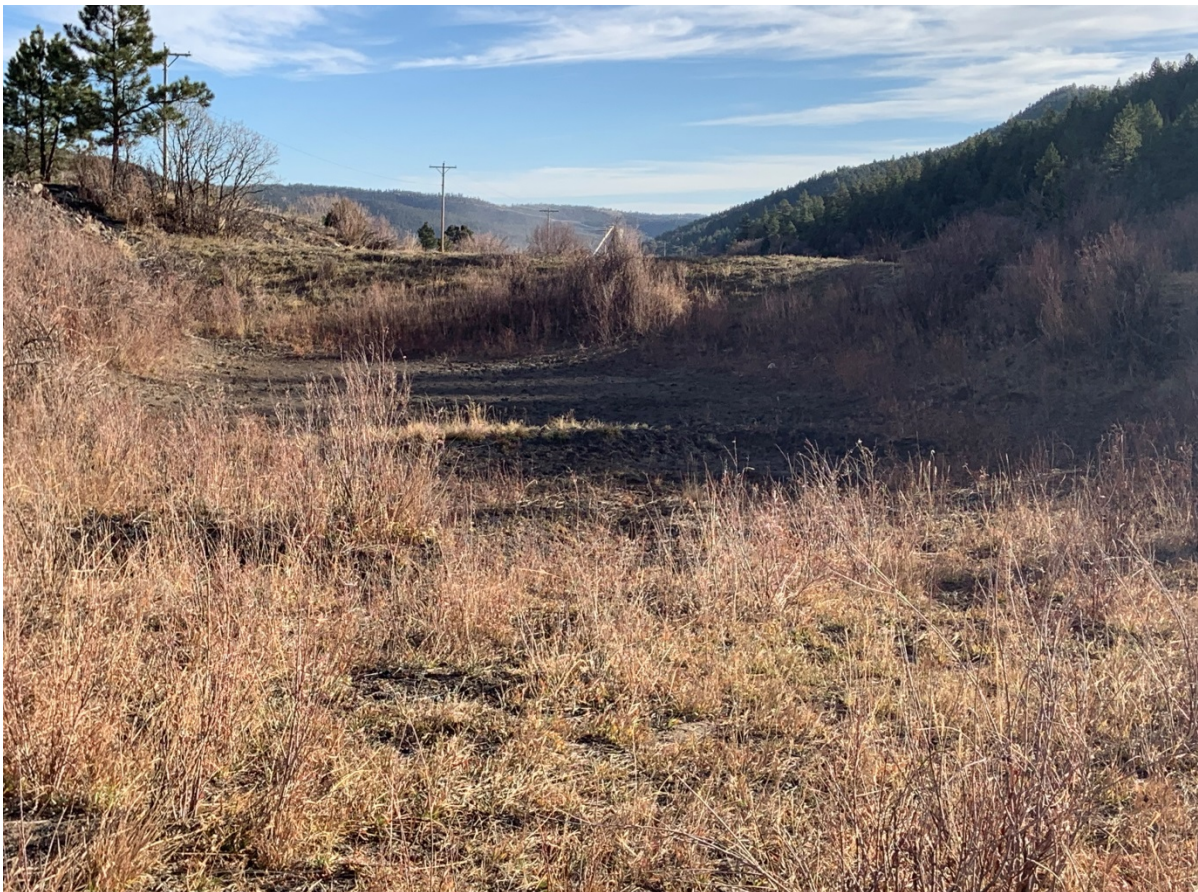
Containment Area #1

Containment area was empty at time of inspection.

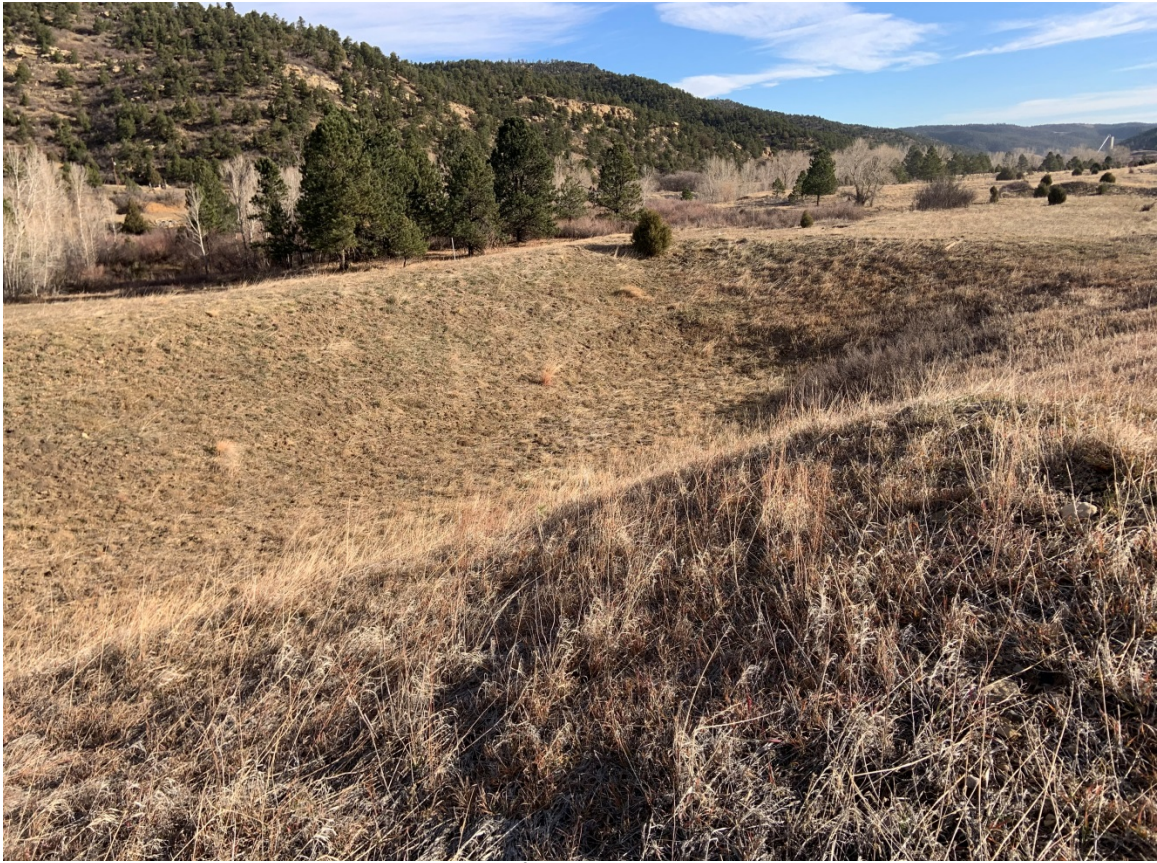
Containment Area #2

Containment is empty.

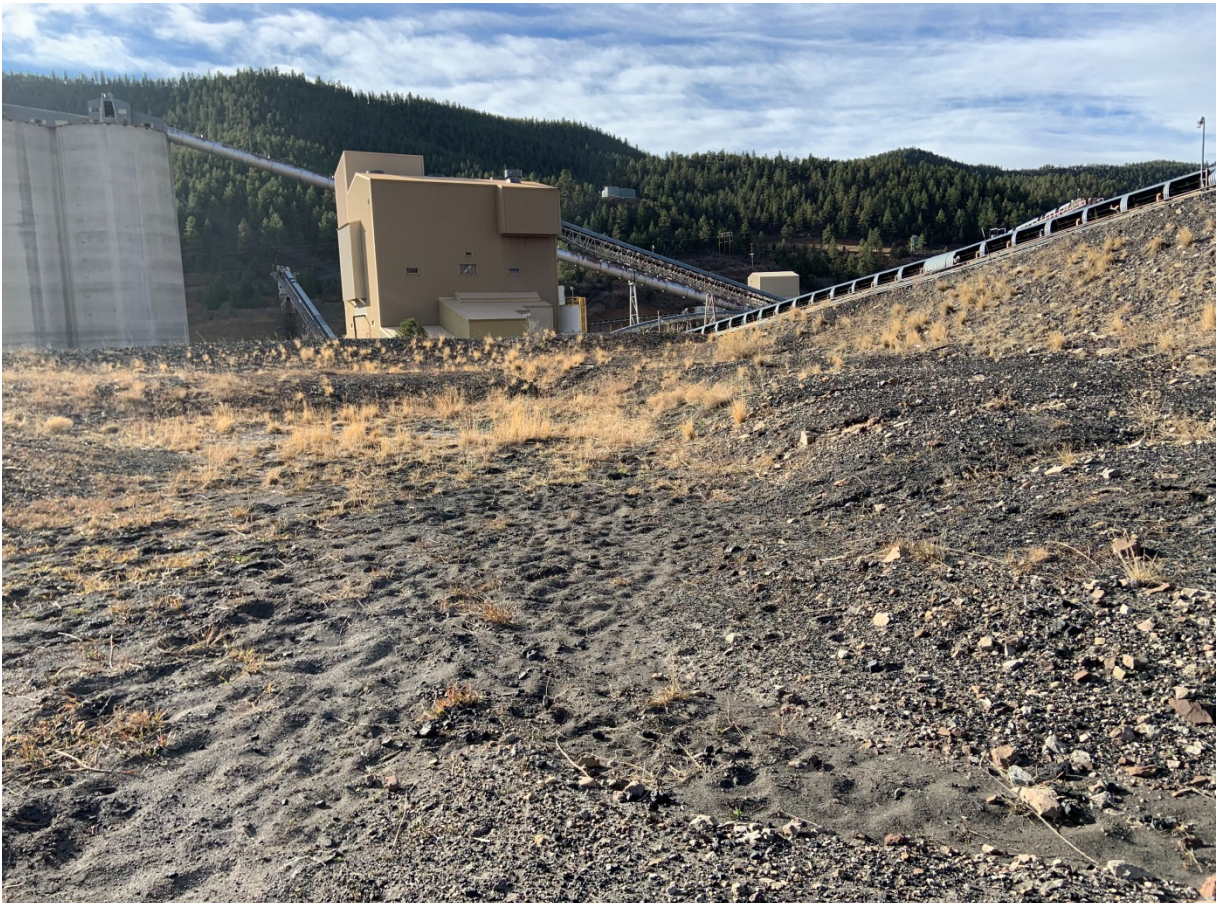
Containment Area #3

Containment Area is dry at time of inspection.

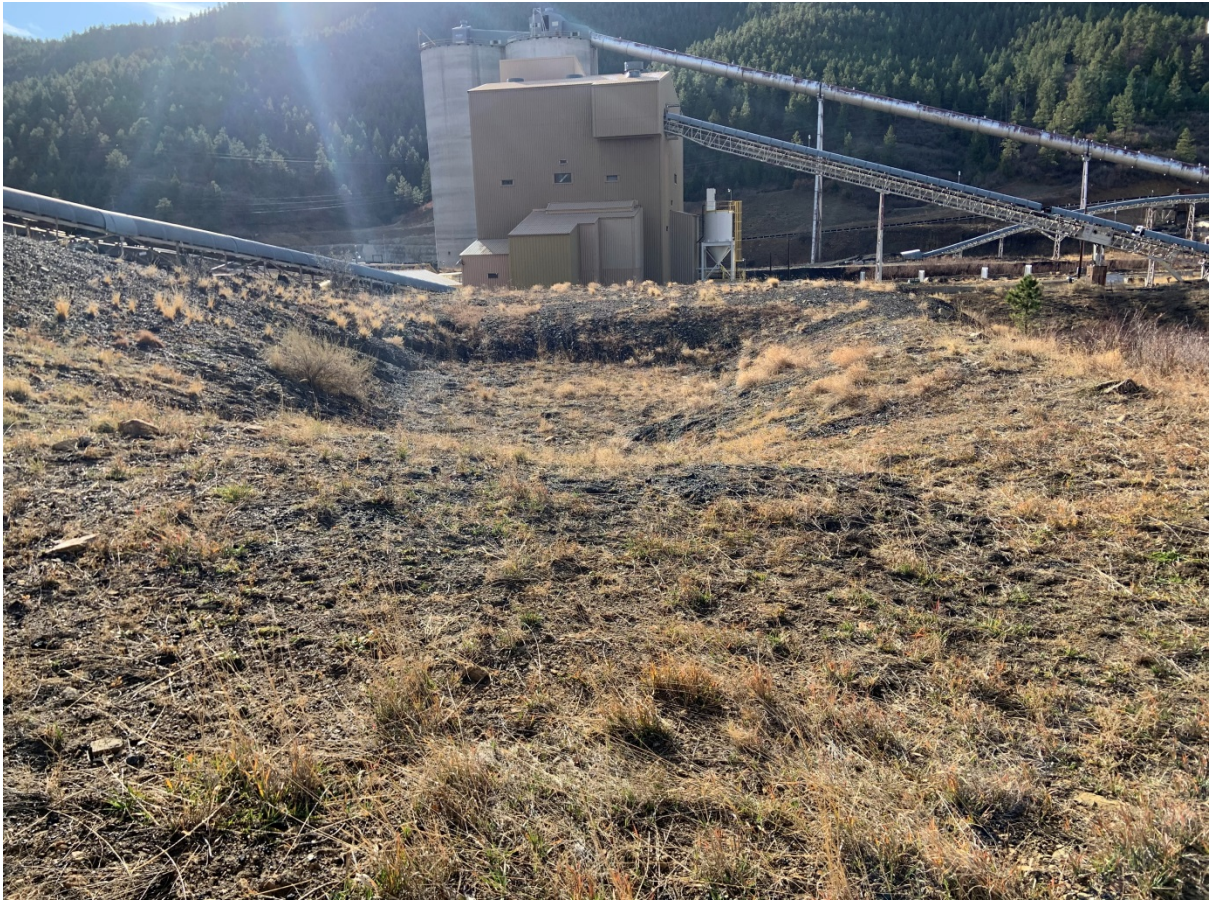
Containment Area #4

Containment Area was dry at time of inspection.

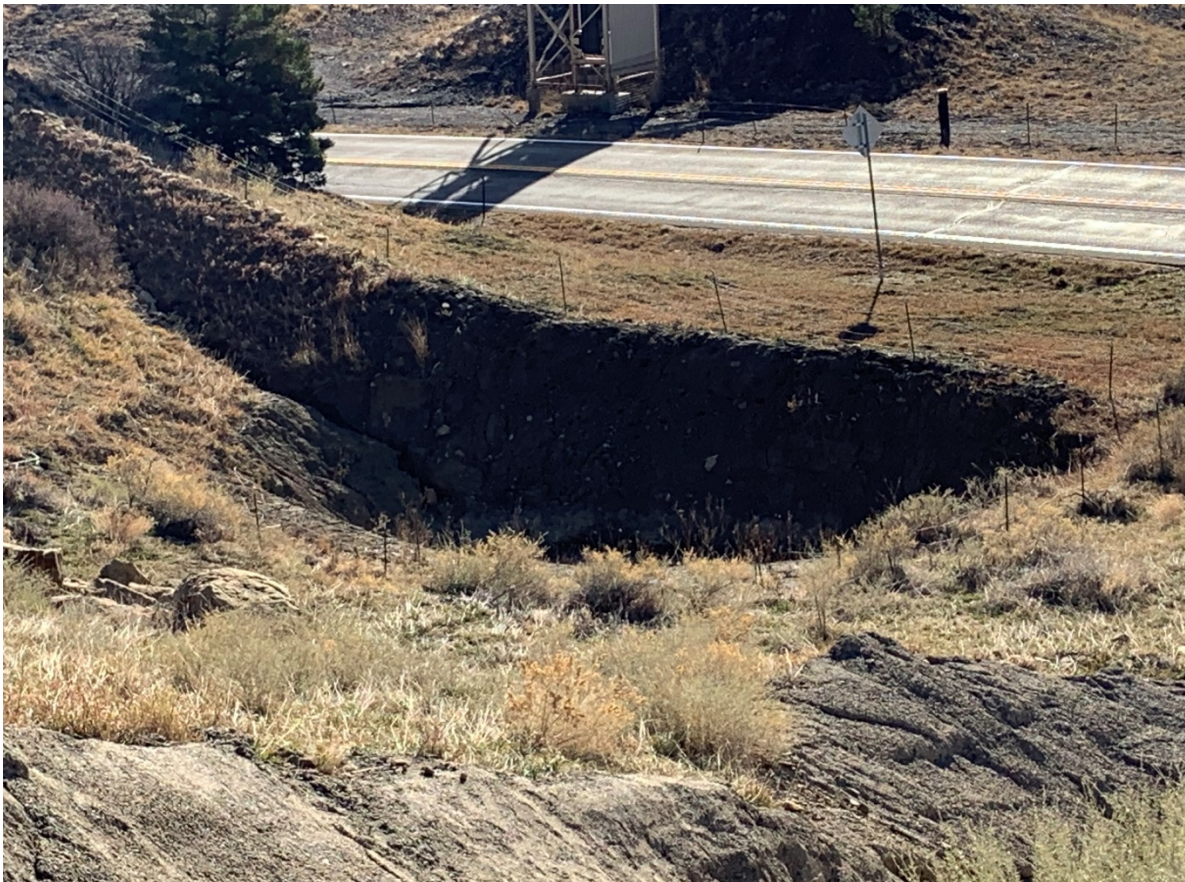
Containment Area #5

Containment Area is empty. Containment Area was cleaned in the first quarter of 2020 and about 70 percent of the sediment in the containment area was removed.
