**NEW ELK MINE**  
**Permit No. C-1981-012**

**QUARTERLY COAL WASTE BANK INSPECTION REPORT**  
**November 20, 2020**

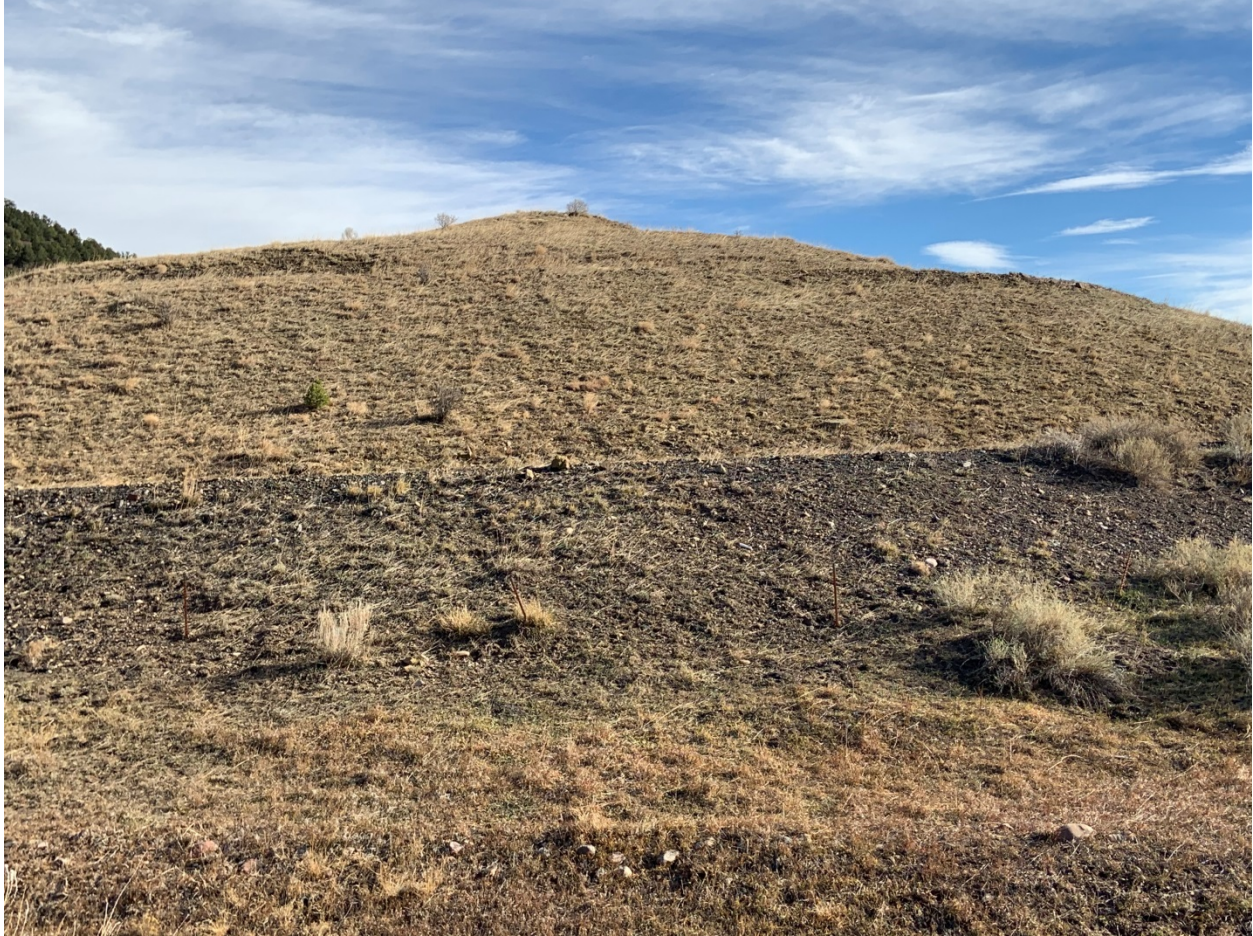
Overall the disposal area is in good condition. Vegetation is overall good for the lack of moisture in recent months.

**DWDA #1 – North Facing Slope**

None at this time.

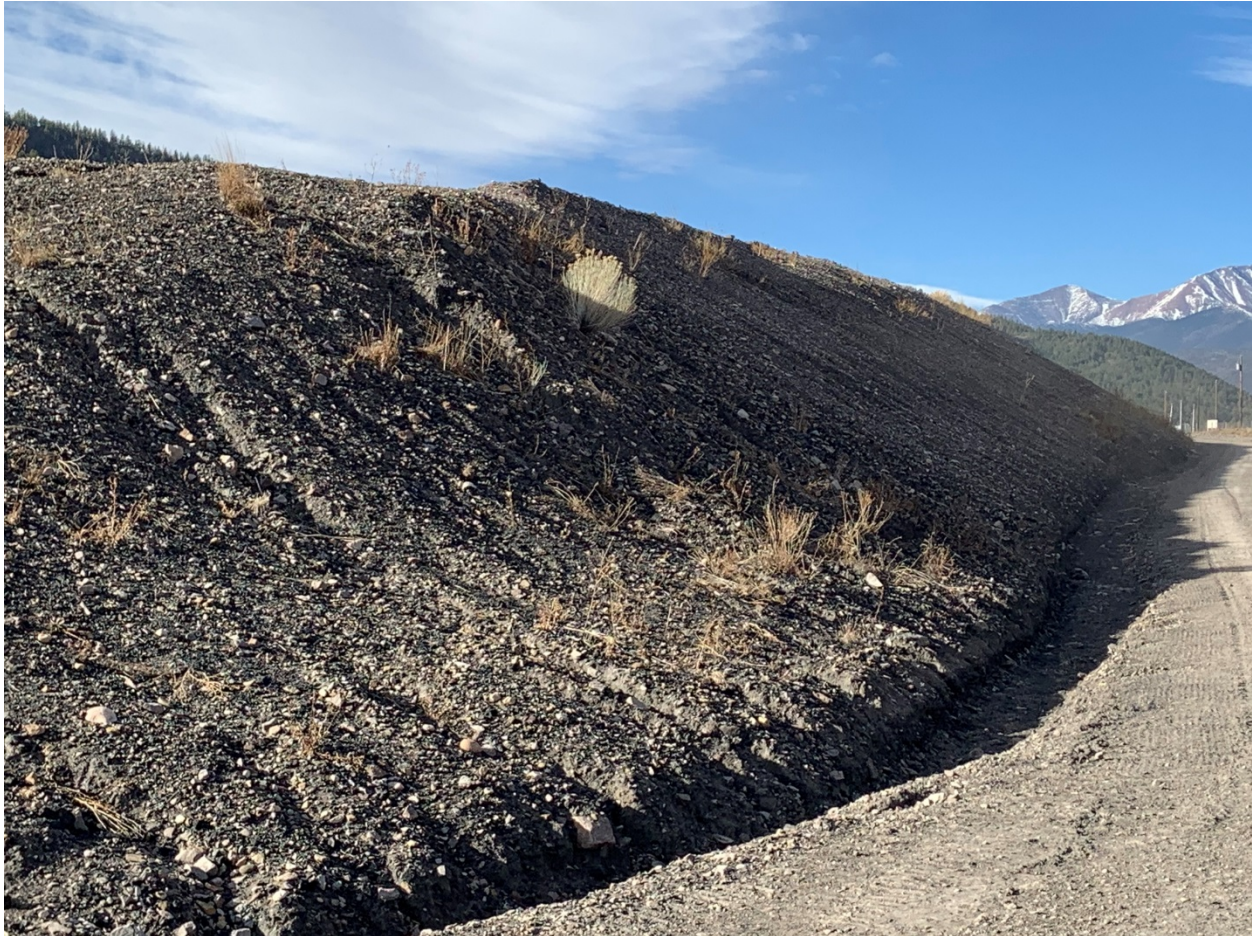
Surface and out slopes of the pile were inspected for visible signs of potential failure or instability. There was some surface erosion but not enough to make the area unstable. In all no signs of failure or instability were observed.

Overall the disposal area is in good condition.

**DWDA #2 – South and West Facing Slopes**

The ditch around the area has been cleaned within the past quarter as part of annual maintenance .The Rills are being monitored and have not gotten any bigger and there is no sediment loading. Operator is evaluating either reclamation of the area or permitting alternative uses of the land north of the Purgatoire River and south of Highway 12.

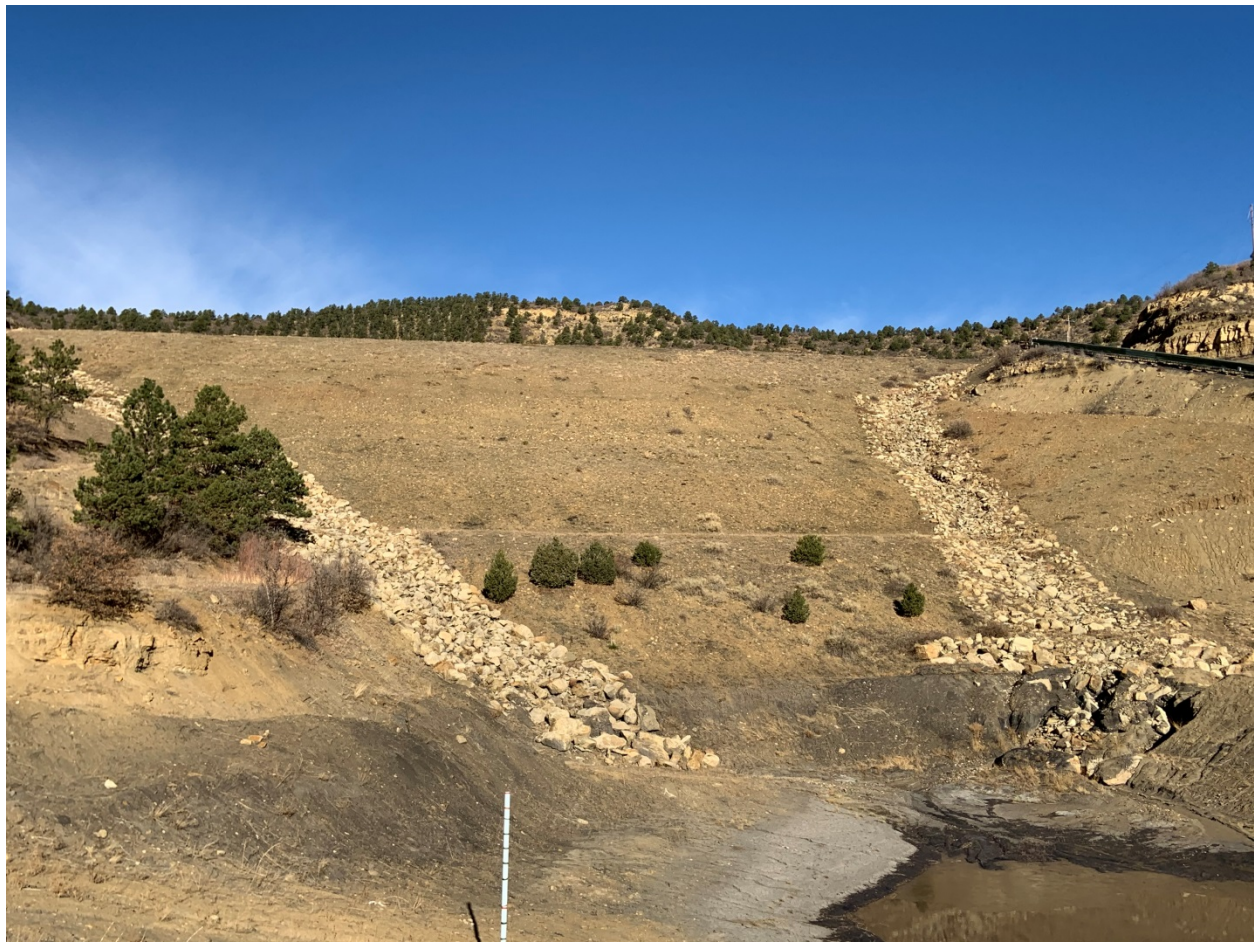
Overall the site is in good condition.

**Refuse Disposal Area – Reclaimed Benches and Armored Drainage**

None required at this time.
