QUARTERLY SEDIMENTATION POND INSPECTION REPORT

Mine: Lorencito

Inspection Period: Fourth Quarter 2020

QUARTERLY SEDIMENTATION POND INSPECTION REPORT
Lorencito Canyon Mine- November 20, 2020

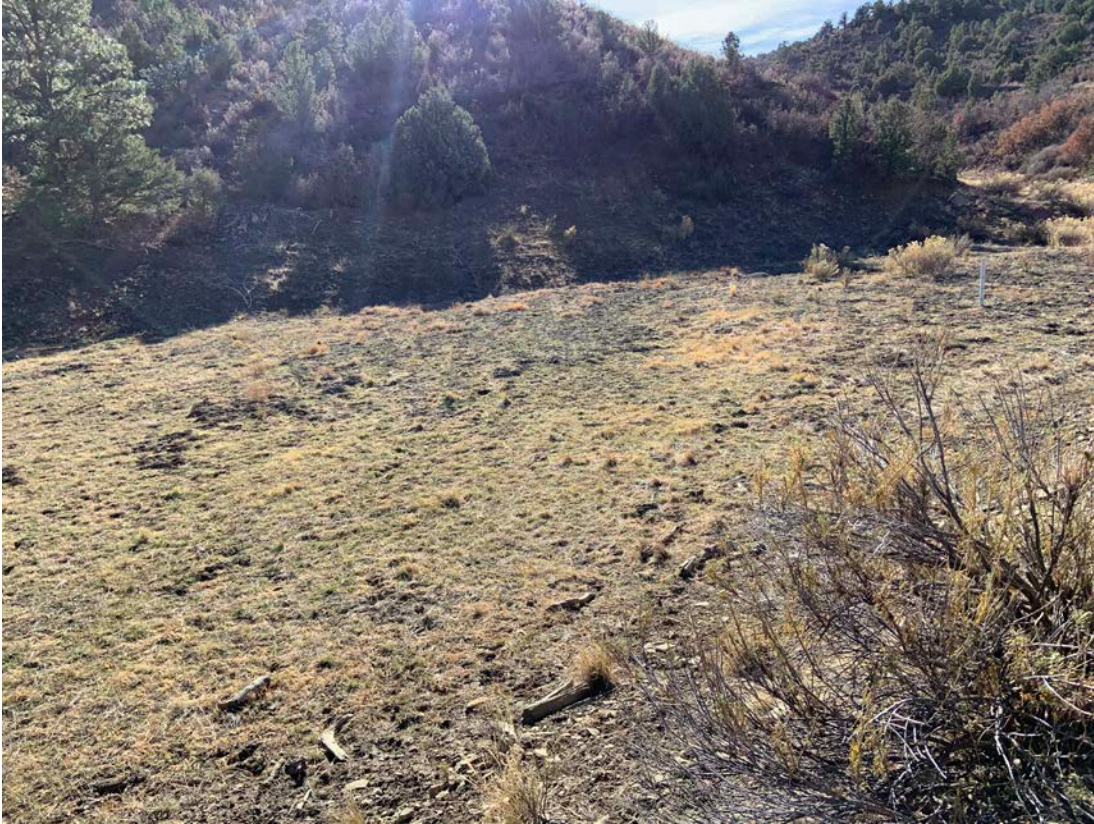
Pond 5

Explain: Sediment in pond does not appear to be over capacity by visual inspection.

Pond empty at time of inspection

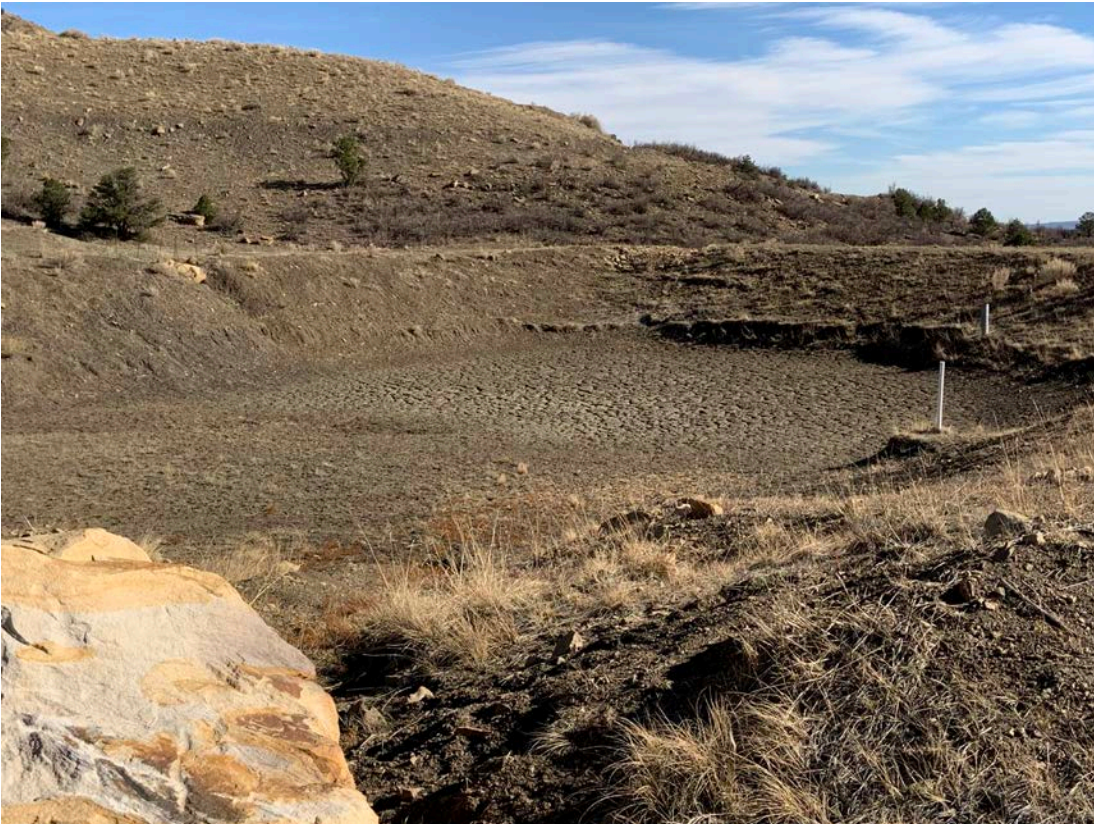
Pond 6

Pond empty at time of inspection.

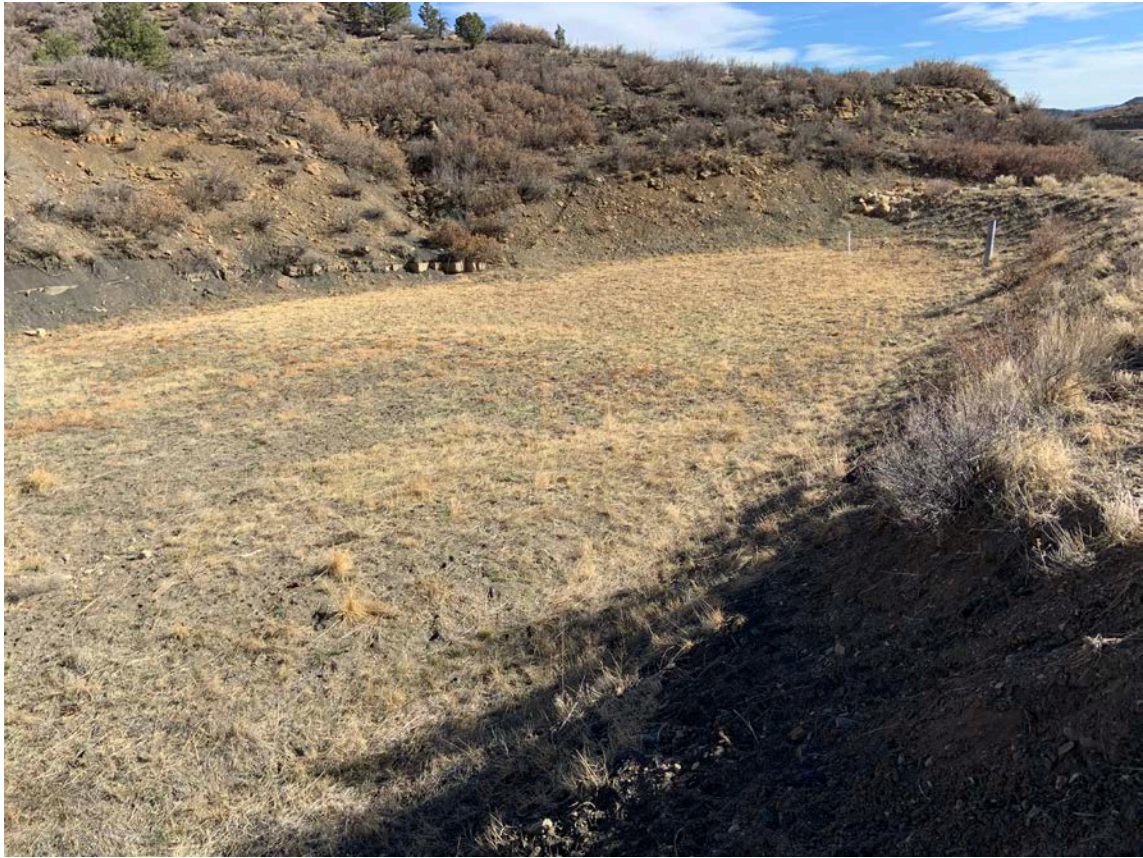
Pond 7

Pond empty at time of inspection.

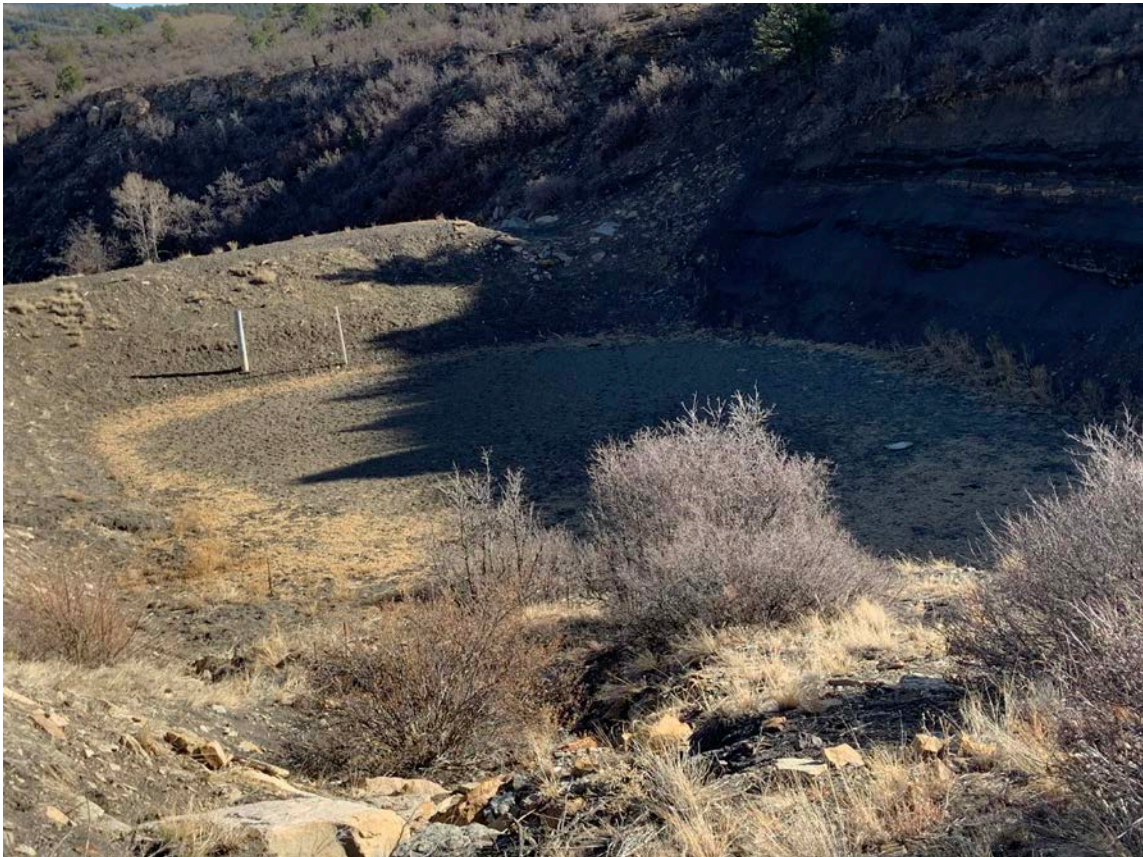
Pond 8

Pond empty at time of inspection.

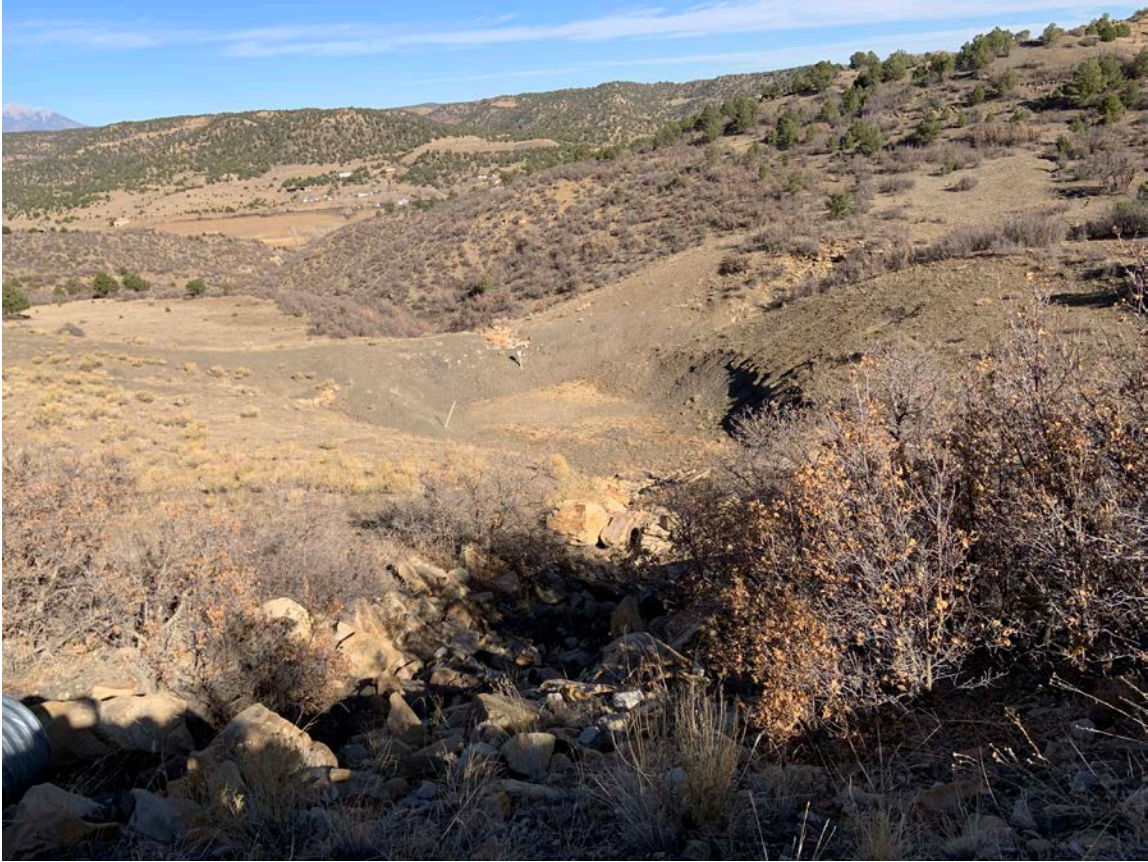
Pond 9

Pond not holding water at time of inspection.

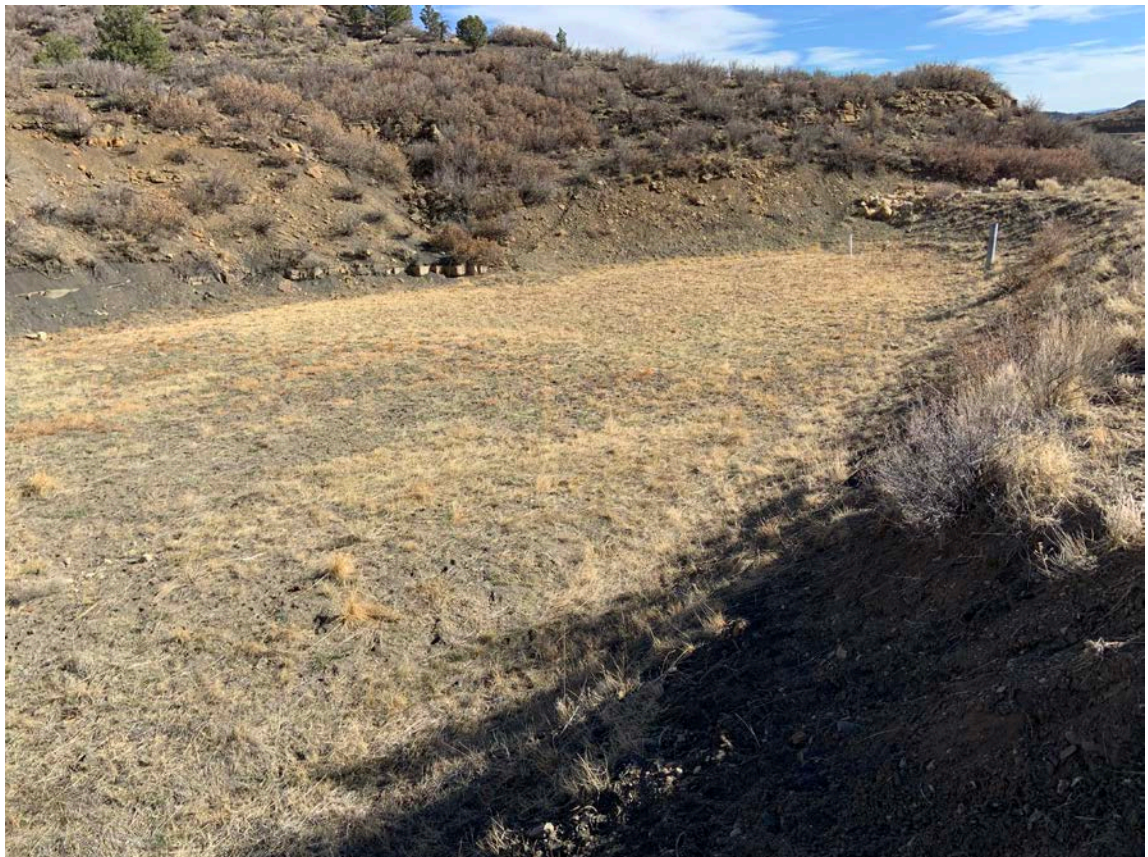
Pond 9a

Pond was empty at time of inspection.
