**MINERALS PROGRAM INSPECTION REPORT**  
**PHONE: (303) 866-3567**

<b>MINE NAME:</b> Schwartzwalder Mine	<b>MINE/PROSPECTING ID#:</b> M-1977-300	<b>MINERAL:</b> Uranium	<b>COUNTY:</b> Jefferson
<b>INSPECTION TYPE:</b> Monitoring	<b>INSPECTOR(S):</b> Amy Eschberger, Tim Cazier	<b>INSP. DATE:</b> November 19, 2020	<b>INSP. TIME:</b> 09:00
<b>OPERATOR:</b> Colorado Legacy Land, LLC	<b>OPERATOR REPRESENTATIVE:</b> Elizabeth Busby, Billy Ray, Sam Lowe	<b>TYPE OF OPERATION:</b> 112d-2 - Designated Mining Operation	
<b>REASON FOR INSPECTION:</b> Normal I&E Program	<b>BOND CALCULATION TYPE:</b> None	<b>BOND AMOUNT:</b> \$8,900,000.00	
<b>DATE OF COMPLAINT:</b> NA	<b>POST INSP. CONTACTS:</b> None	<b>JOINT INSP. AGENCY:</b> None	
<b>WEATHER:</b> Clear	<b>INSPECTOR'S SIGNATURE:</b>

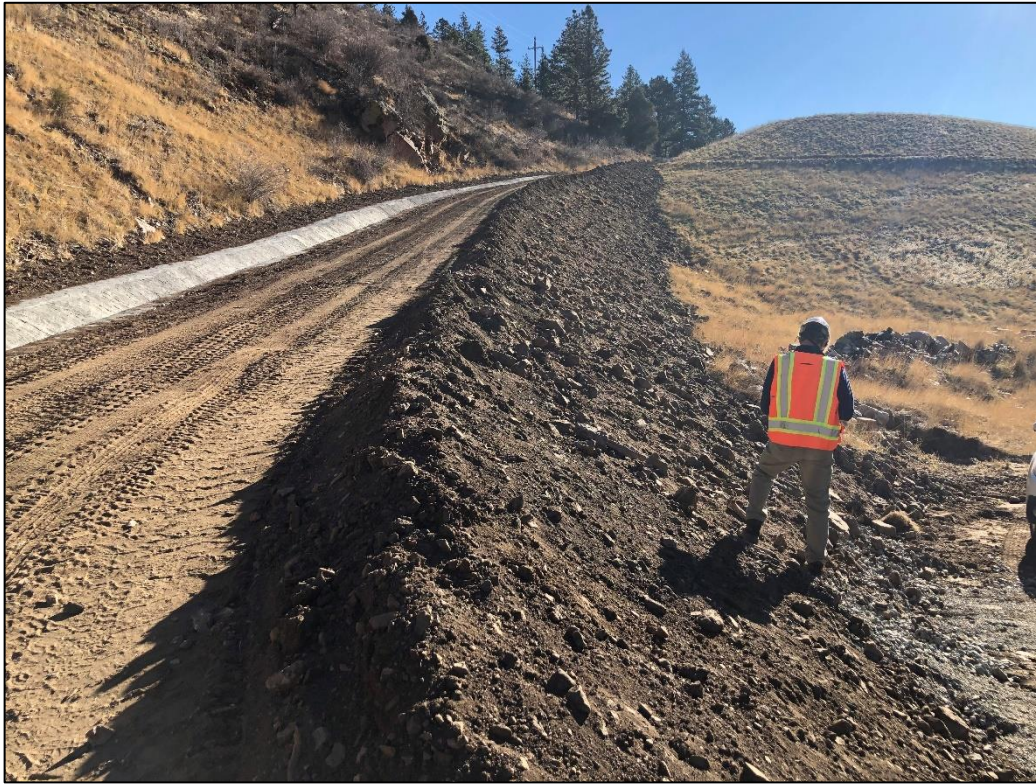
**Photo 1.** View looking east/southeast across side slope of NWRP access road, showing slopes graded to approximately 2H:1V per TR-28. This slope has been seeded for reclamation.

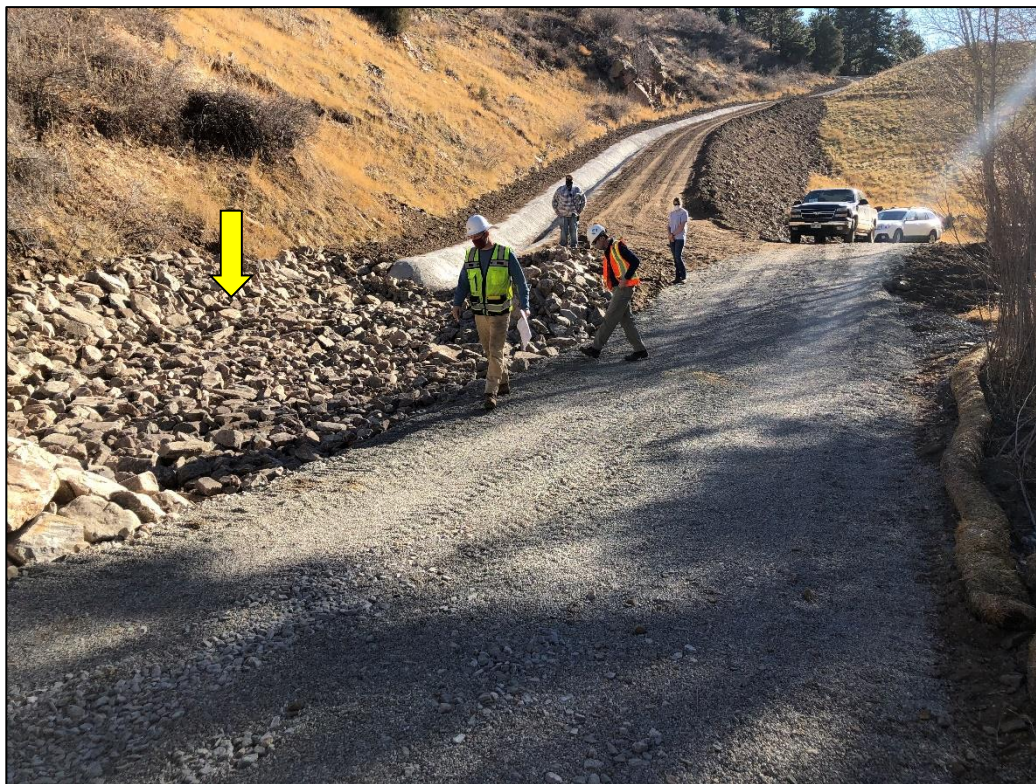
**Photo 2.** View looking east/southeast at riprap-lined energy dissipation basin constructed at downstream end of NWRP diversion channel (indicated with arrow) and road crossing composed of Geoweb system with gravel infill.

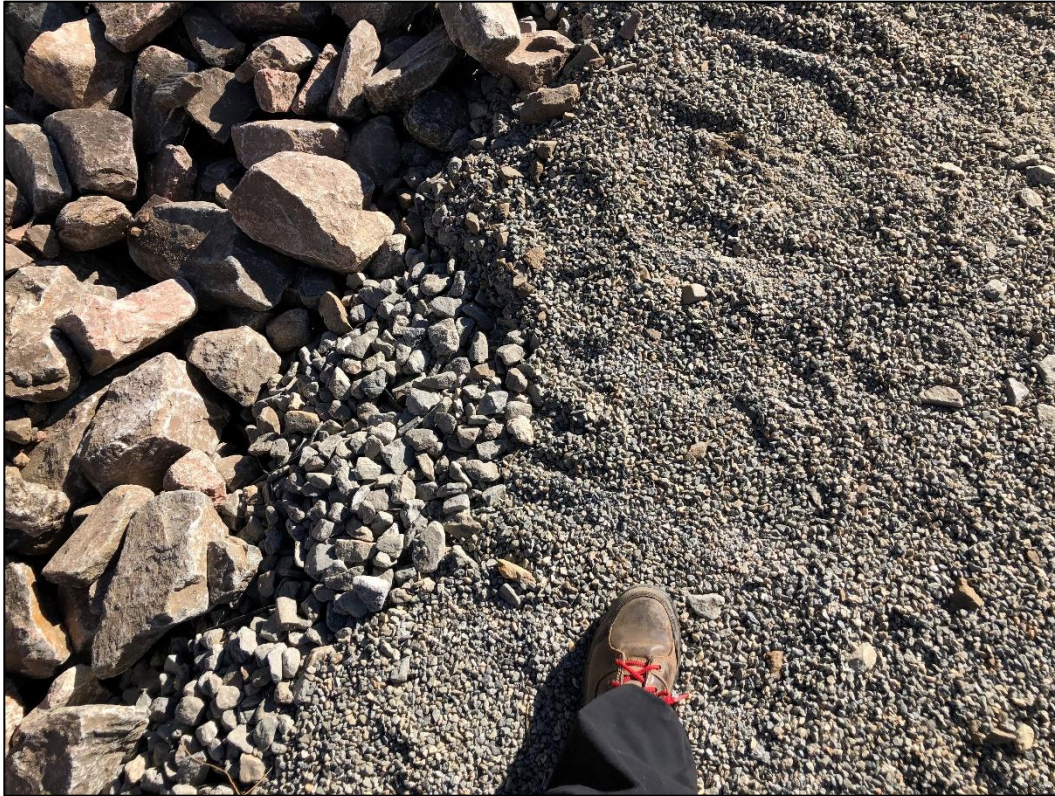
**Photo 3.** Ground view showing interface between riprap-lined energy dissipation basin (at left) and gravel-filled Geoweb system installed for road crossing. Note 1-1/2 inch minus gravel infill (partially exposed at center) and pea gravel plating (at right) on road crossing.

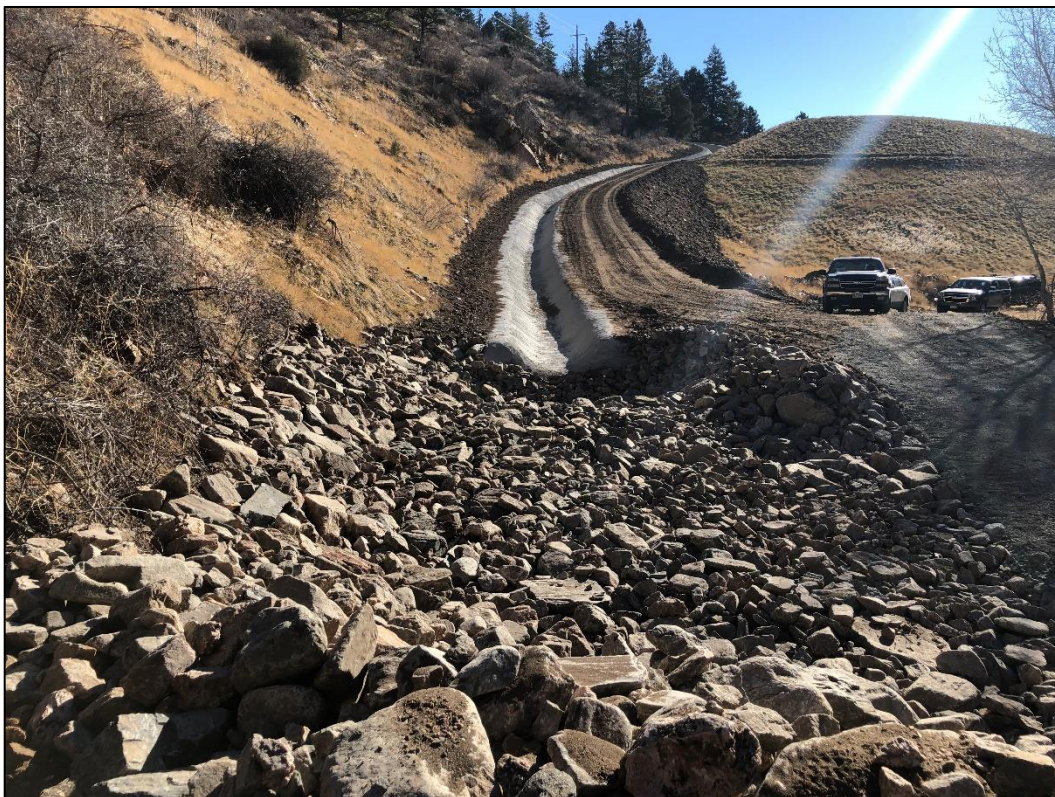
**Photo 4.** View looking east/southeast (upstream) across riprap-lined energy dissipation basin constructed at downstream end of NWRP diversion channel.

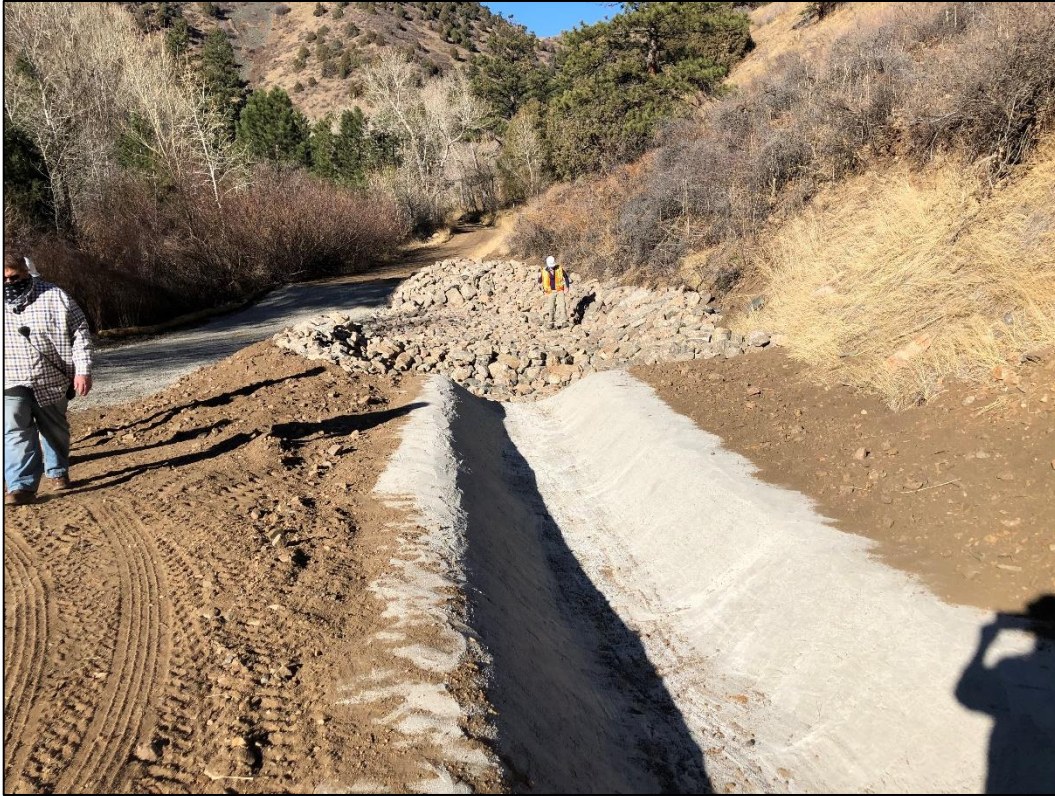
**Photo 5.** View looking west/northwest (downstream) across lower section of NWRP diversion channel. Note riprap-lined energy dissipation basin constructed at downstream end of channel (in background).

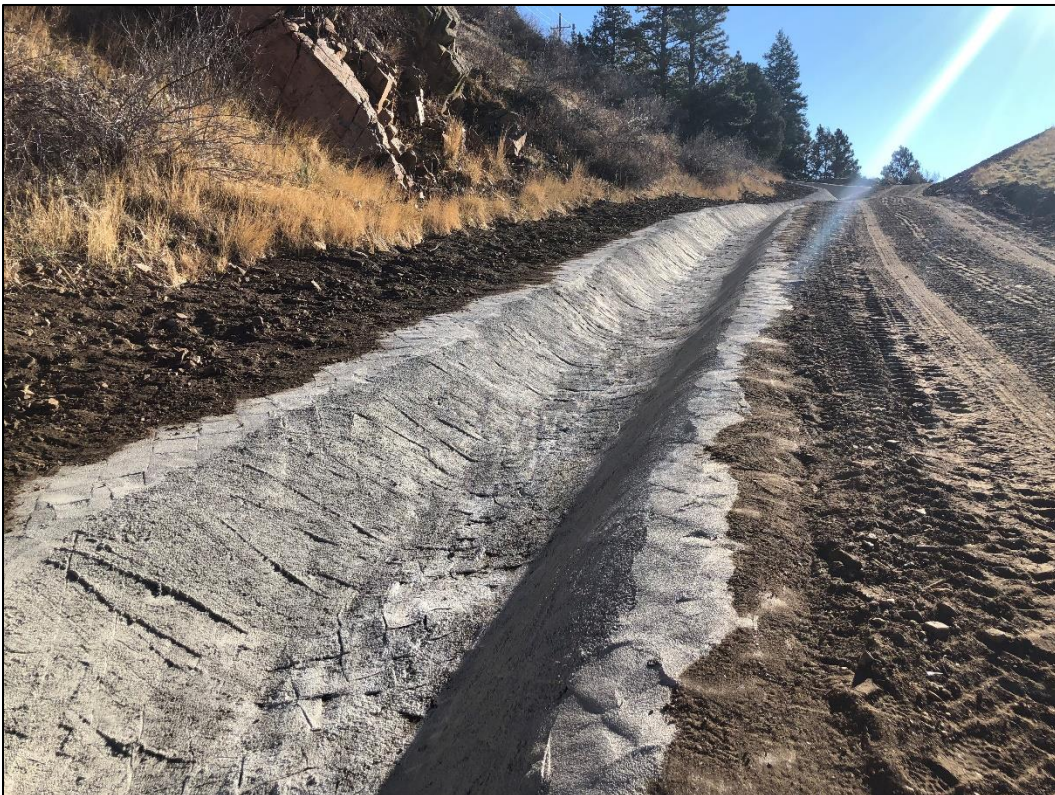
**Photo 6.** View looking east/southeast (upstream) across middle section of NWRP diversion channel. Areas adjacent to channel have been backfilled, graded for positive drainage, and seeded.

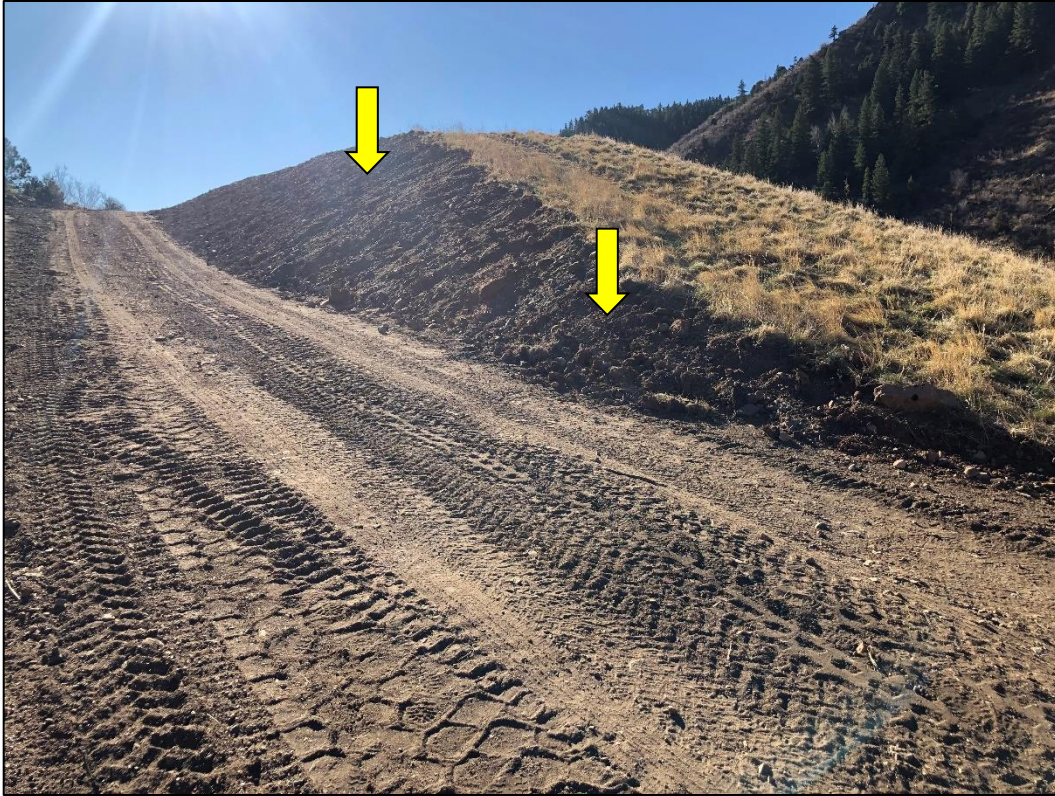
**Photo 7.** View looking southeast at disturbed slope (indicated with arrows) just south of NWRP access road which has been graded to 2H:1V and seeded.

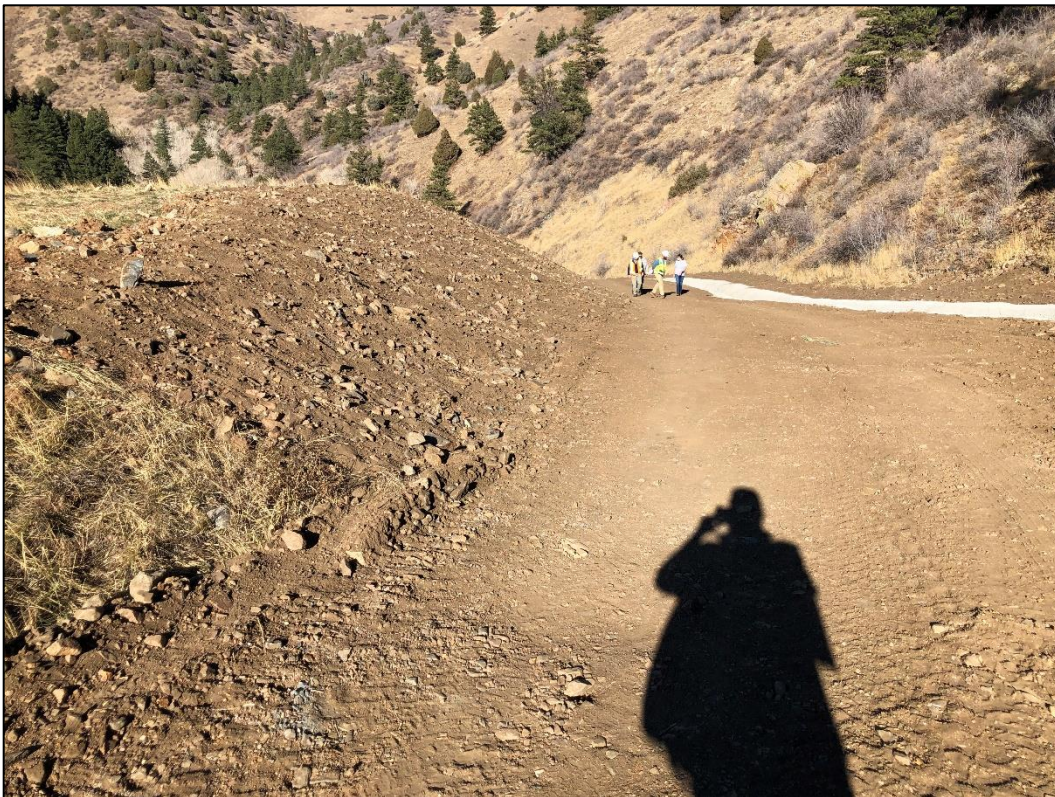
**Photo 8.** View looking northwest across disturbed slope (at left) just south of NWRP access road which has been graded to 2H:1V and seeded.

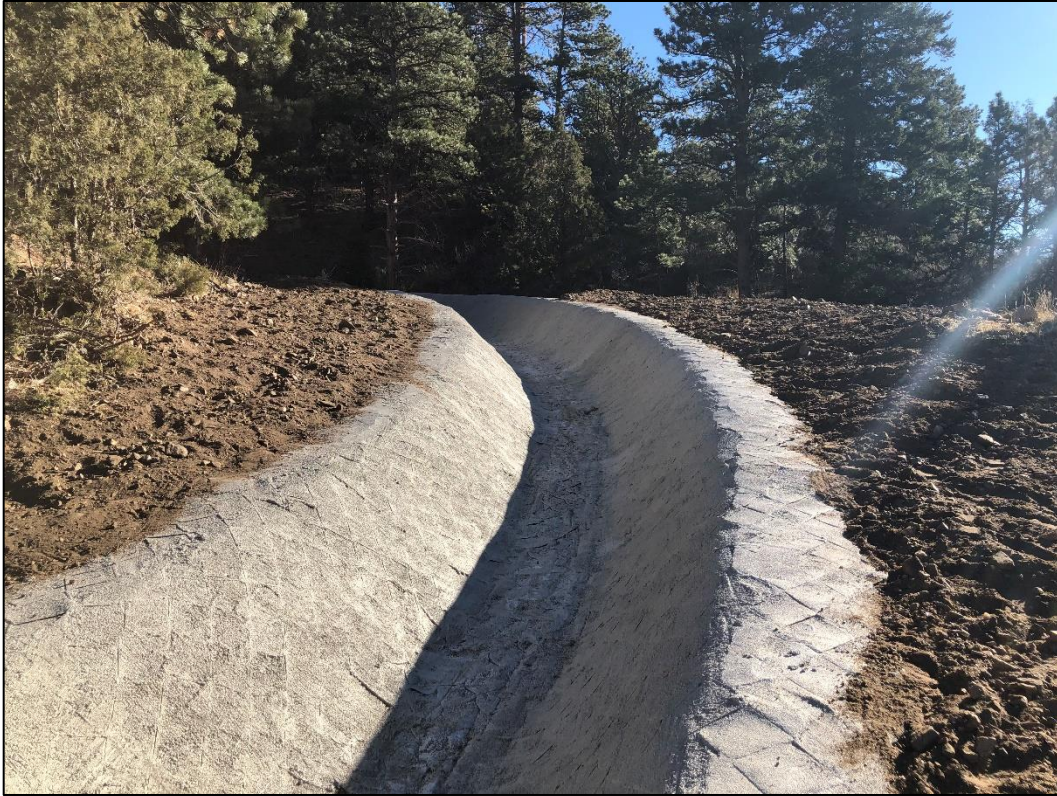
**Photo 9.** View looking east (upstream) across section of NWRP diversion channel which curves around hillside. Areas adjacent to channel have been backfilled, graded for positive drainage, and seeded.

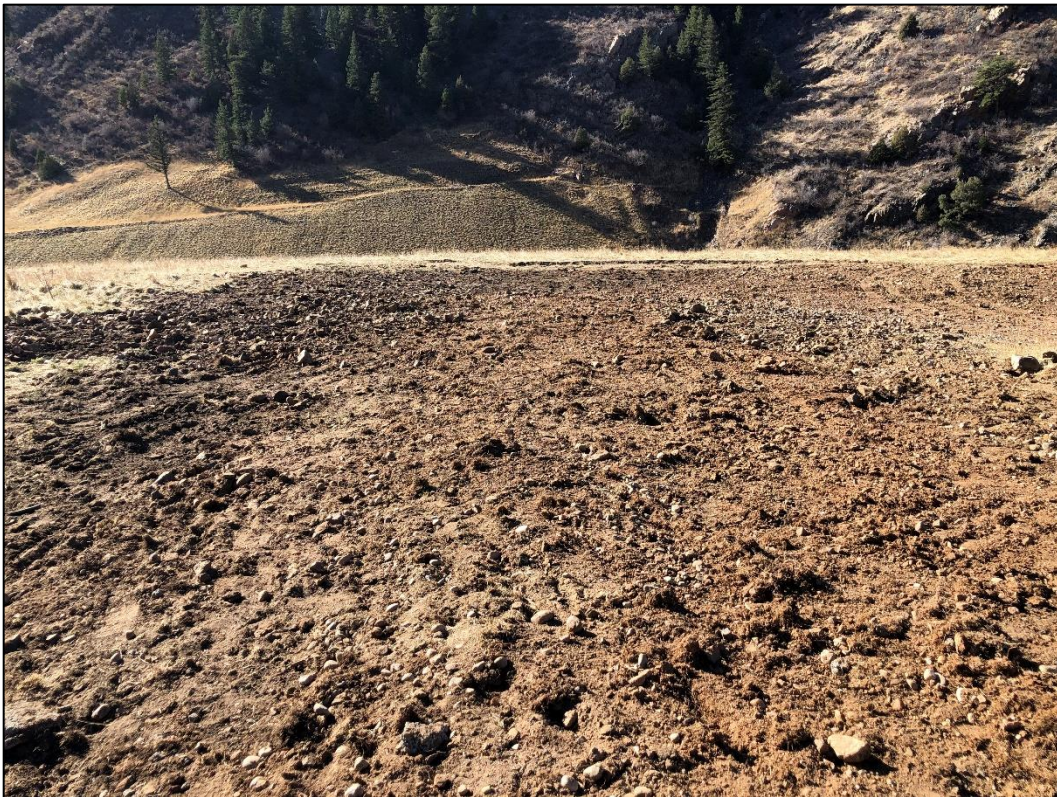
**Photo 10.** View looking south across top of NWRP where disturbed area has been scarified and seeded for reclamation.

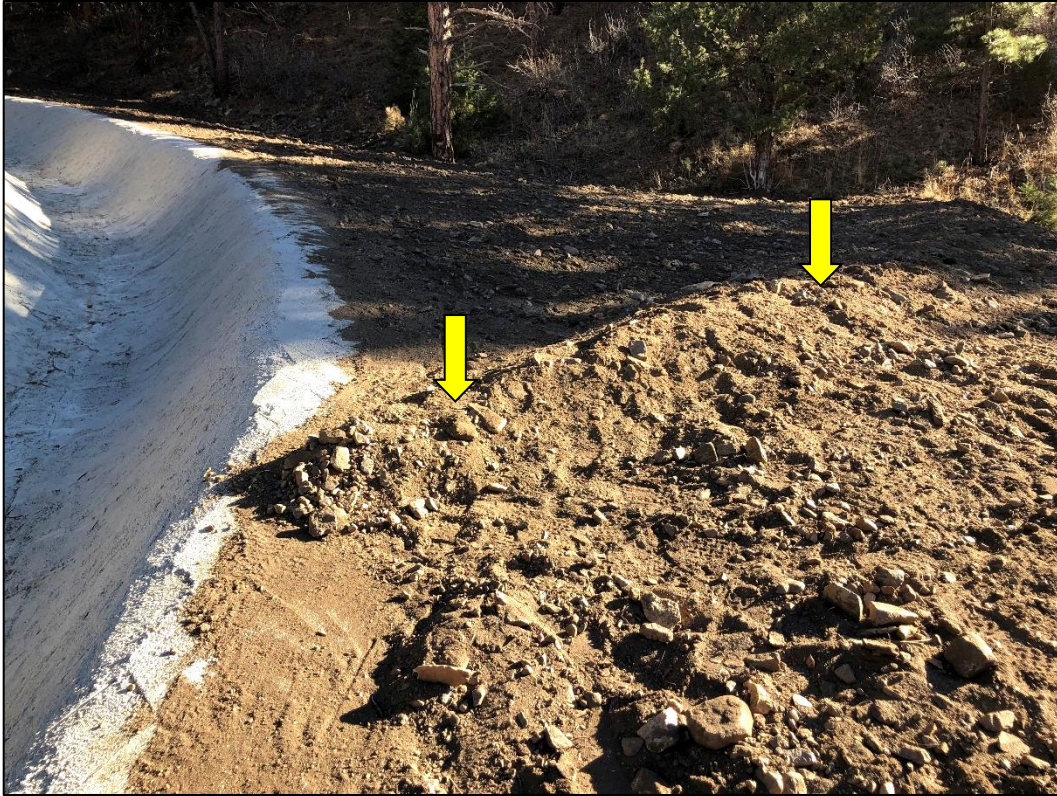
concrete-lined diversion channel appeared to have been constructed in accordance with the proposed design. The areas adjacent to the channel have been backfilled and graded to create positive drainage into the channel. It should be noted, the low-lying diversion berm constructed south of the channel (where the channel curves around the hillside) may need maintenance or additional material added, as discussed during the inspection. The disturbed slope south of the access road and channel and the side slope of the access road were graded to 2H:1V. The riprap-lined energy dissipation basin appeared to be constructed per the approved design. The road crossing installation had some slight deviations from the approved design to include 6 inch thick Geoweb panels instead of 4 inch thick panels, and a gravel infill rather than a concrete infill. The Geoweb panels were filled with 1-1/2 inch minus gravel and surfaced with an approximate one inch thick layer of pea gravel. Any deviations from the design approved in TR-28 will be incorporated into the as-built drawings to be submitted with the final construction report. Areas disturbed by the NWRP diversion channel project, including the top of the NWRP, the disturbed slope located south of the access road and channel (near the top of the NWRP), the side slope of the access road, and areas immediately adjacent to the channel, have been seeded in accordance with TR-28. The operator will continue to monitor revegetation success in the seeded areas and reseed next year as needed.

**Photo 11.** View looking northeast at low-lying diversion berm (indicated with arrows) constructed at top of NWRP, east/southeast of diversion channel, to divert surface flows from eastern hillside into channel. This berm may need maintenance and/or additional material added.

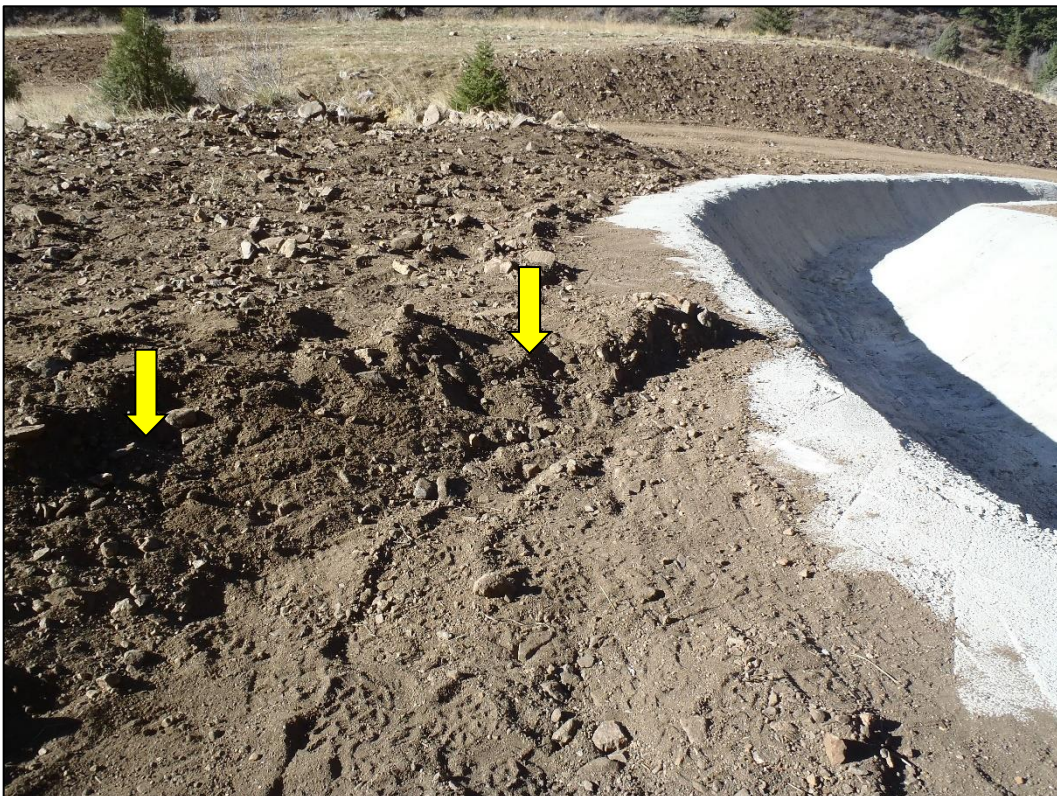
**Photo 12.** View looking southwest at low-lying diversion berm (indicated with arrows) constructed at top of NWRP, east/southeast of diversion channel, to divert surface flows from eastern hillside into channel. This berm may need maintenance and/or additional material added.

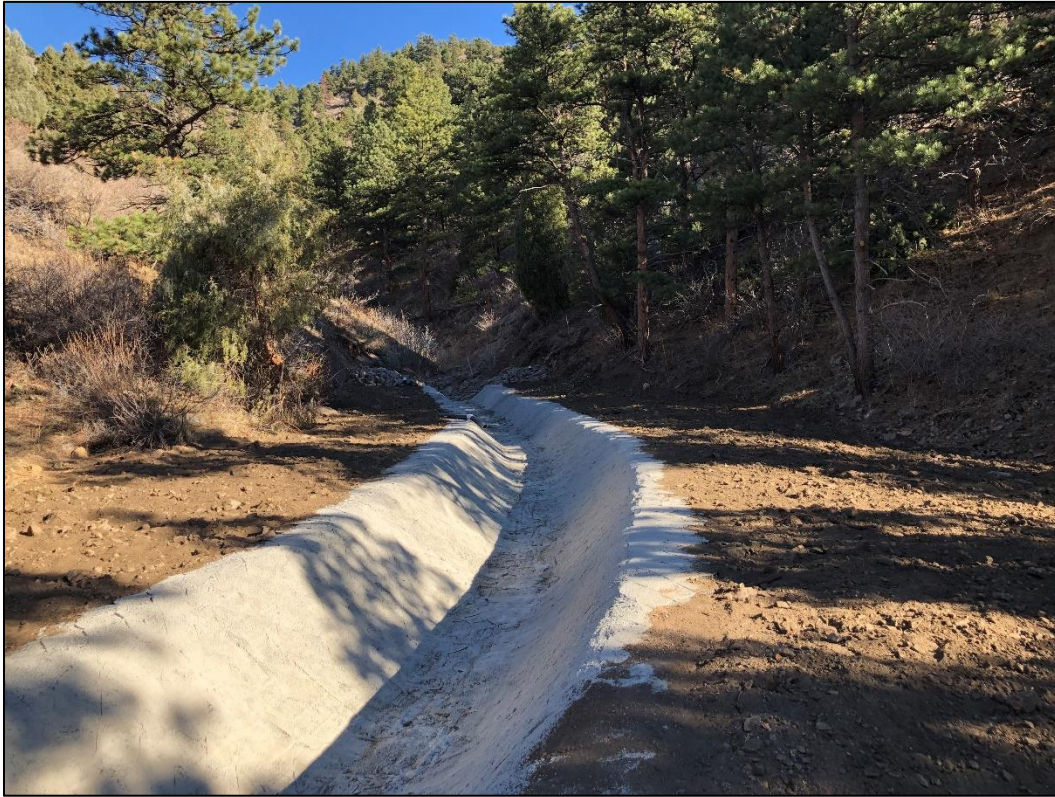
**Photo 13.** View looking north/northeast (upstream) at upper section of NWRP diversion channel. Areas adjacent to channel have been backfilled, graded for positive drainage, and seeded.

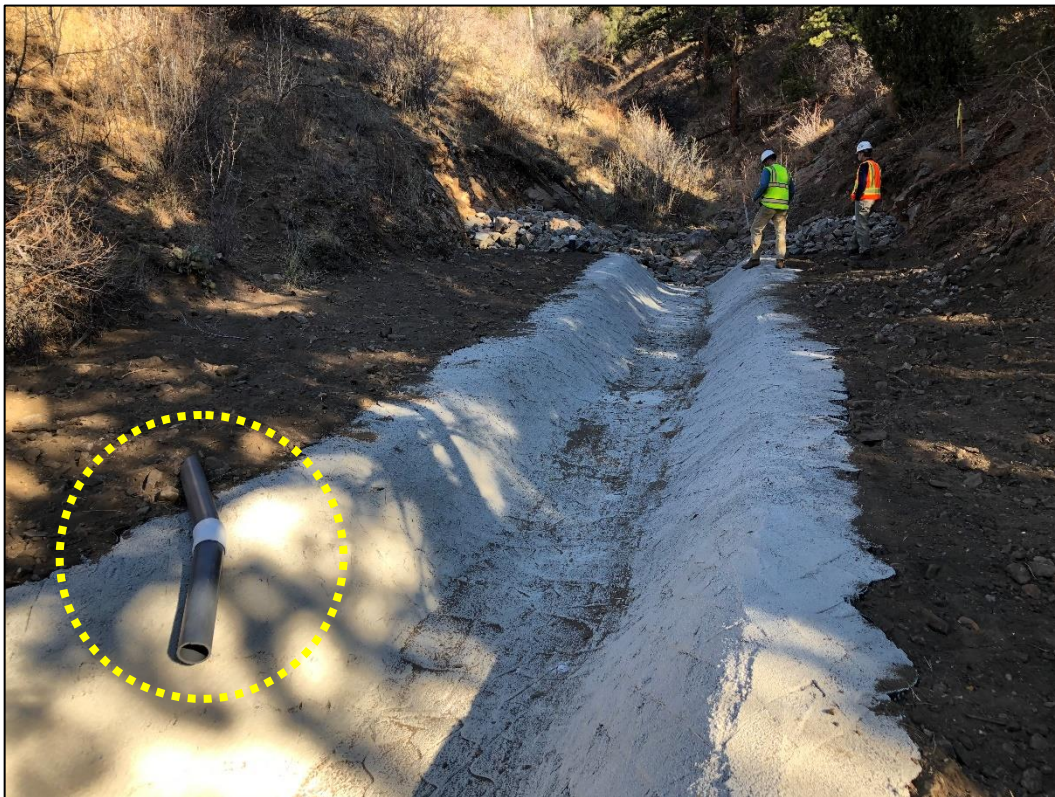
**Photo 14.** View looking north/northeast (upstream) at upper section of NWRP diversion channel, showing pipeline from water intake structure (circled) which daylights to discharge into channel approximately 50 feet from seal wall. Areas adjacent to channel have been backfilled, graded for positive drainage, and seeded.

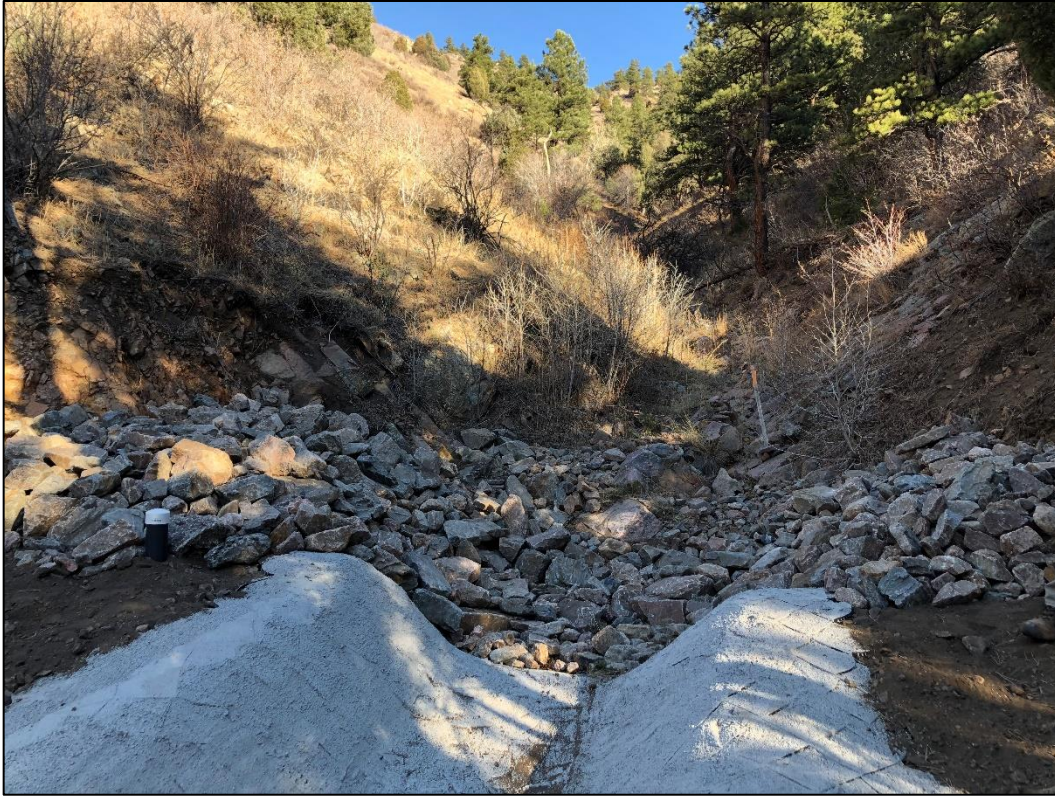
**Photo 15.** View looking north/northeast at riprap-lined water intake structure constructed at upstream end of NWRP diversion channel in ephemeral drainage above the pile.

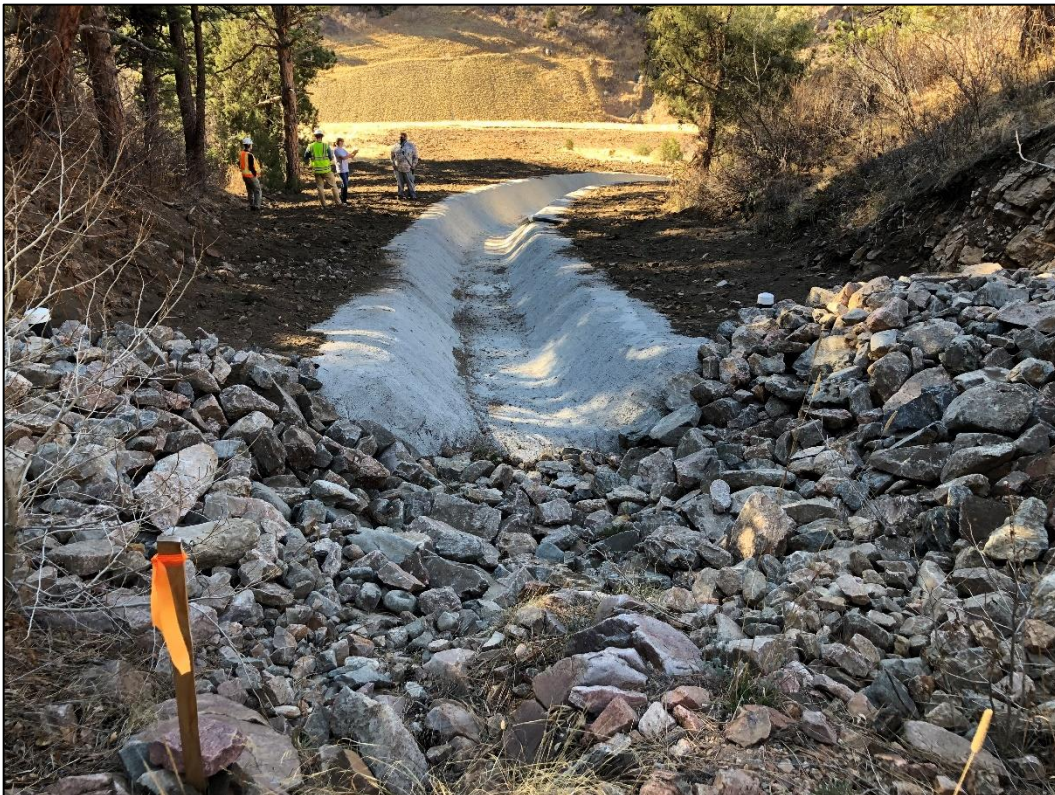
**Photo 16.** View looking south/southwest from ephemeral drainage above NWRP at riprap-lined water intake structure constructed at upstream end of NWRP diversion channel.

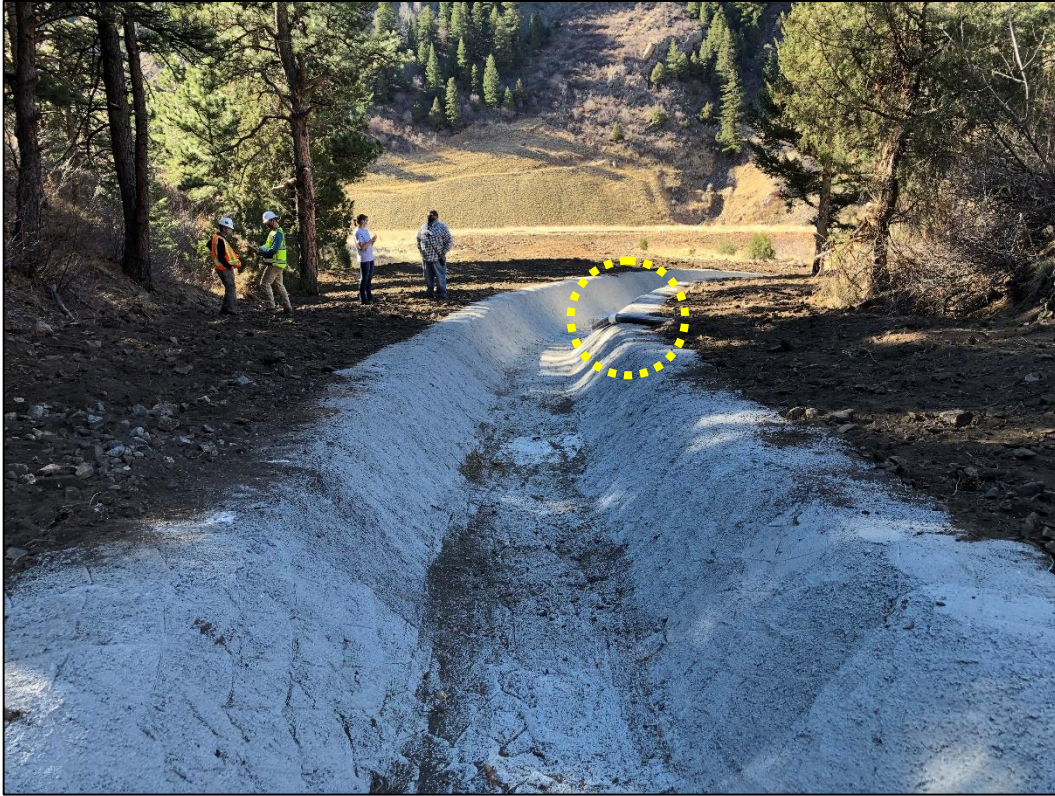
**Photo 17.** View looking south/southwest (downstream) across upper section of NWRP diversion channel, between water intake structure and outlet pipe (circled) which daylights to discharge into channel. Areas adjacent to channel have been backfilled, graded for positive drainage, and seeded.

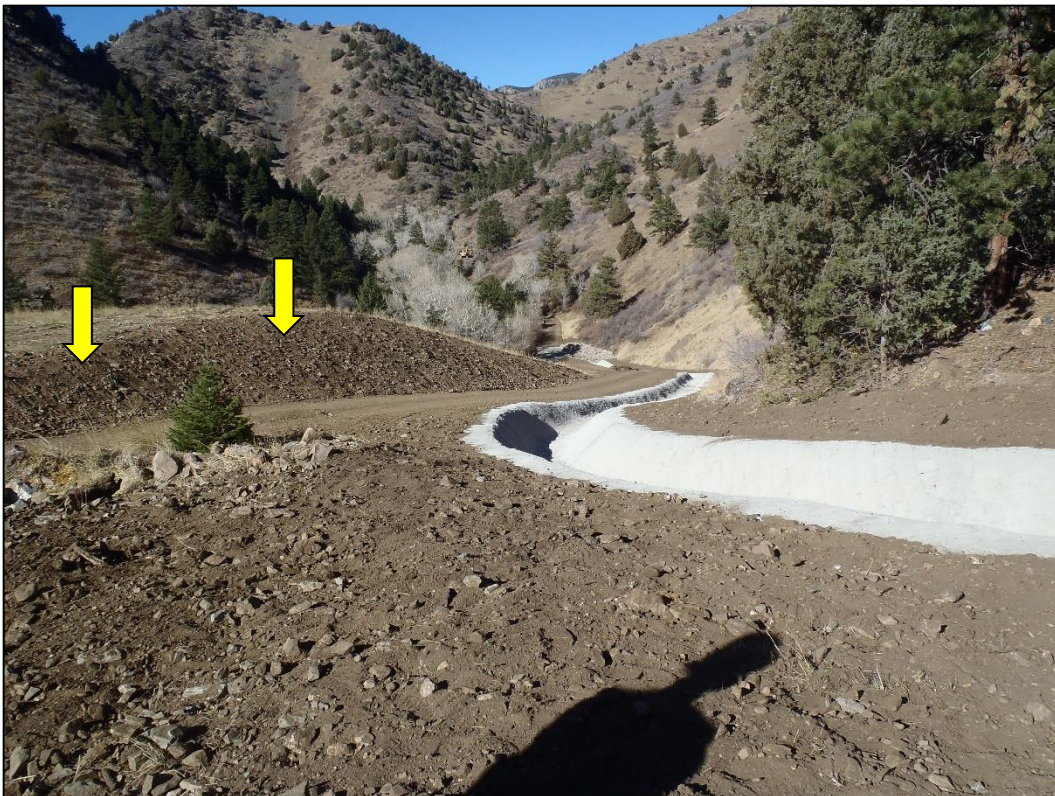
**Photo 18.** View looking southwest (downstream) at section of NWRP diversion channel which curves around hillside. Areas adjacent to channel have been backfilled, graded for positive drainage, and seeded. Note disturbed slope south of NWRP access road (indicated) which was graded to 2H:1V and seeded.

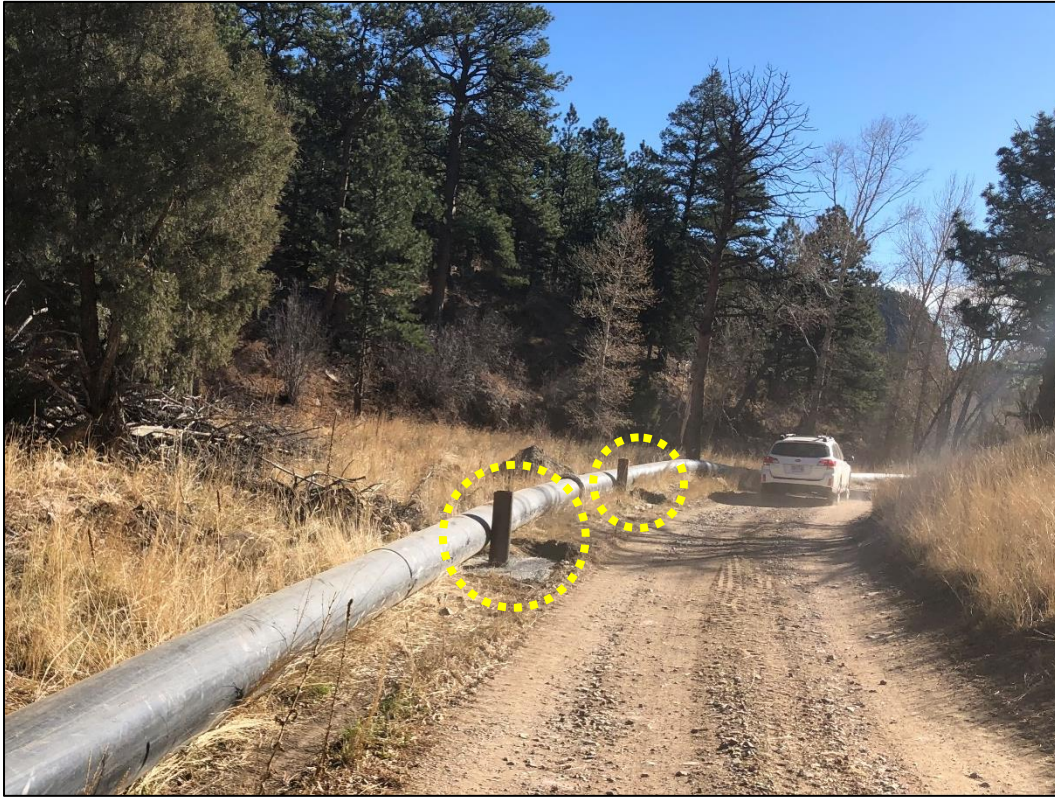
**Photo 19.** View looking east/southeast at above-ground bypass pipeline which diverts surface flows in Ralston Creek above cutoff wall around mine site, showing two ballards (circled) recently installed to keep pipeline from migrating toward access road.

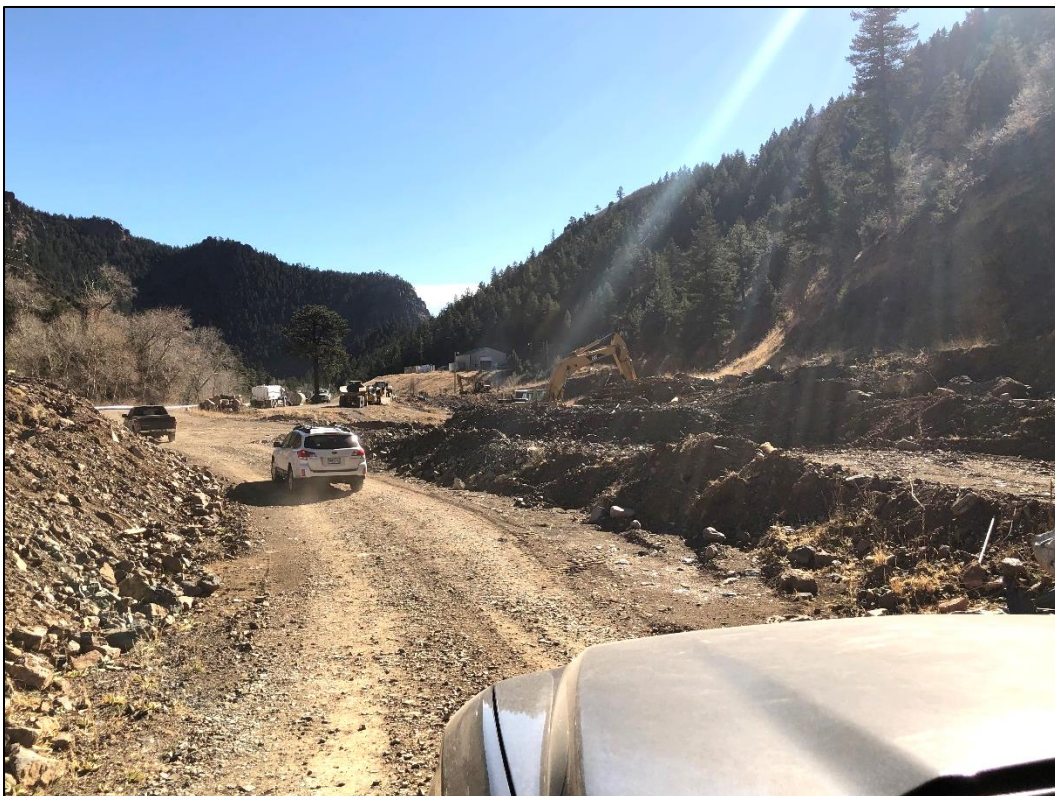
The alluvial excavation project was active during the inspection, with excavated material being hauled up to the CV Glory Hole inside the Minnesota Mine for disposal, per the approved permit. This project was put on hold while the NWRP diversion channel project was completed this fall. At the time of the inspection, the operator estimated there to be approximately 3 weeks of hauling left before they reach capacity in the CV Glory Hole. The Division is currently reviewing an Amendment application (AM-5) submitted by the operator to include disposal of the radio-nuclide impacted alluvial valley soils into the Black Forest Mine, which has an estimated capacity of 15,000 cy. The decision date for AM-5 is currently set for January 15, 2020.

**Photo 20.** View looking southeast across valley excavation project area. This project was active during the inspection, with excavated material being hauled up to the CV Glory Hole inside the Minnesota Mine for disposal.
