## Pikeview monitoring report

To: Jerald Schnabel From: Paul Kos  
Continental Materials Corp. Denver, CO 80222  
File: October 2020 Monitoring Summary Date: November 30, 2020

**Reference: October 2020 Geotechnical Monitoring Summary Pikeview Quarry**

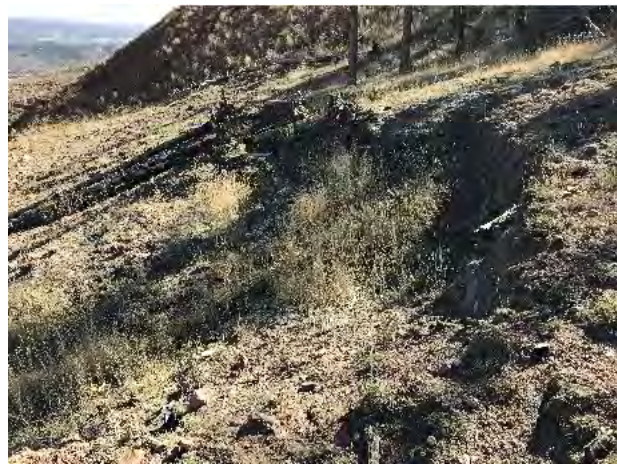
- Healed Cracks: A crack was found on the slope adjacent to the slide where cracking had previously been observed. The crack appeared to be “healed” and did not indicate any recent movement. (Note 6)

6. HEALED CRACKING ABOVE THE SLIDE AREA

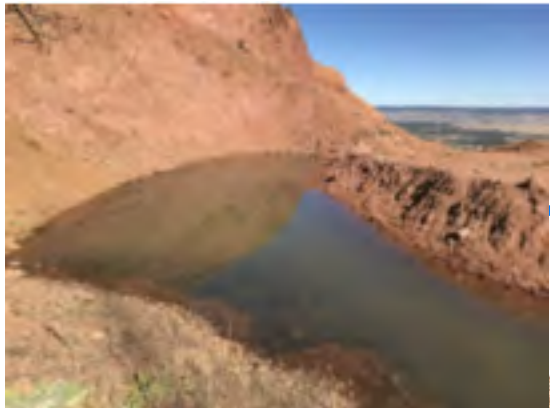
- Gullies: Gullies have formed on the slopes above the slide area as well as in the burn areas above the quarry. (Note 4)
- Pooled water: The grading at the top of the first ridge causes a small amount (0.03ac) of water to pool. While this promotes wildlife habitat, it has been advised that the pond should be drained. (Note 5)

5. POND AREA ON RIDGE

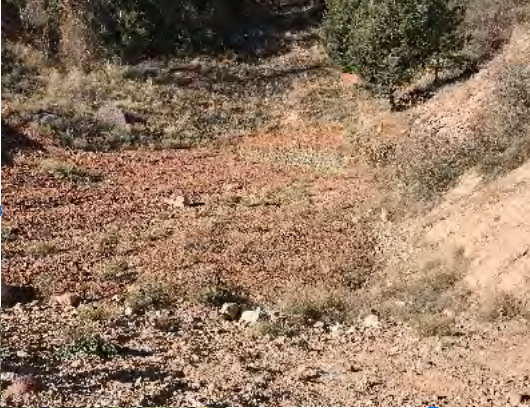
- Culverts: A 6-ft culvert was observed to be blocked on the upstream end. There is evidence that water is collecting at the inlet during rain events and likely seeping through the loose material and through the culvert. During the November visit plans were made for the clearing of the culver inlet. (Note 1).

1. AREA UPSTREAM OF BLOCKED CULVERT

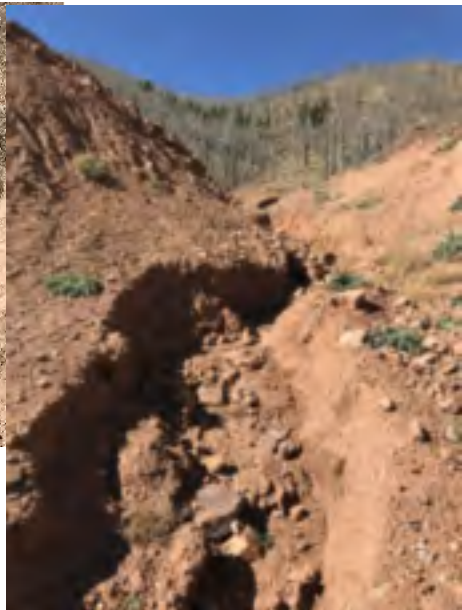
2. EROSION GULLEY

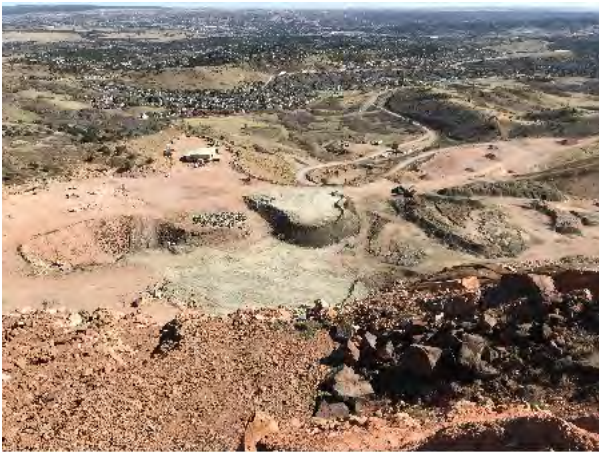
- Fill: Fill is being imported and temporarily placed on the “production floor”. During the visit, different types of material including mulch and general fill were being deposited here for future placement. Based on the drone survey, approximately 1,530 cubic yards of fill were imported during the month of October. (Note 2)

3. DEBRIS AND RUBBLE FILL AREA

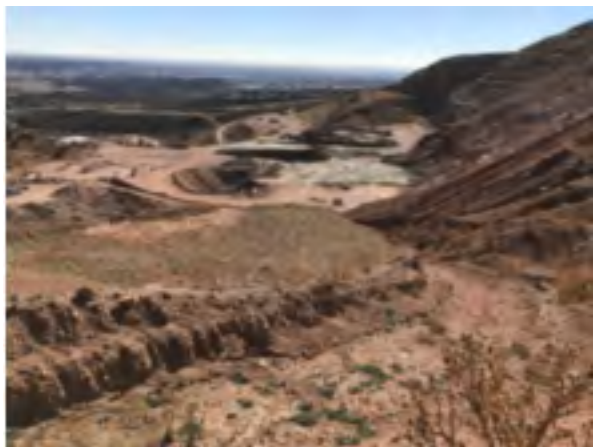
4. VIEW FROM NW TOWARD SURVEY STATION

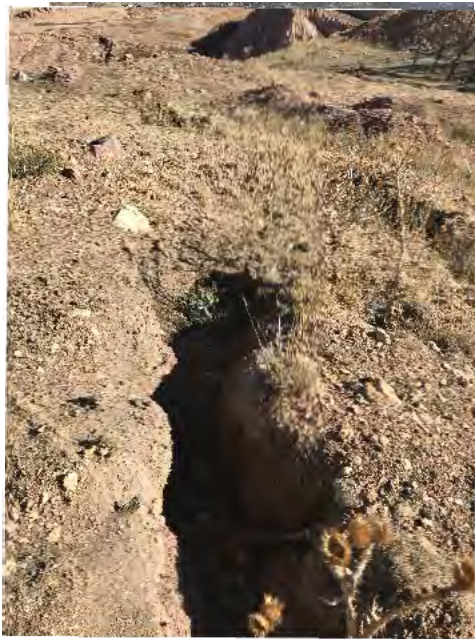
7. GULLY DIVERTS RUNOFF TO SLIDE

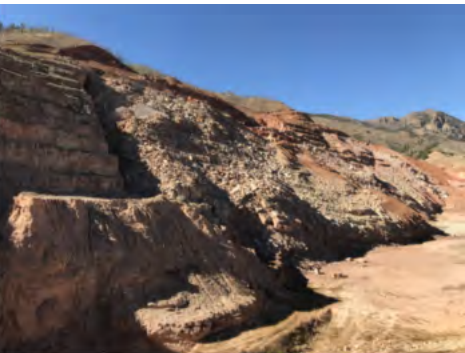
8. VIEW UP SOUTH ESCARPMENT

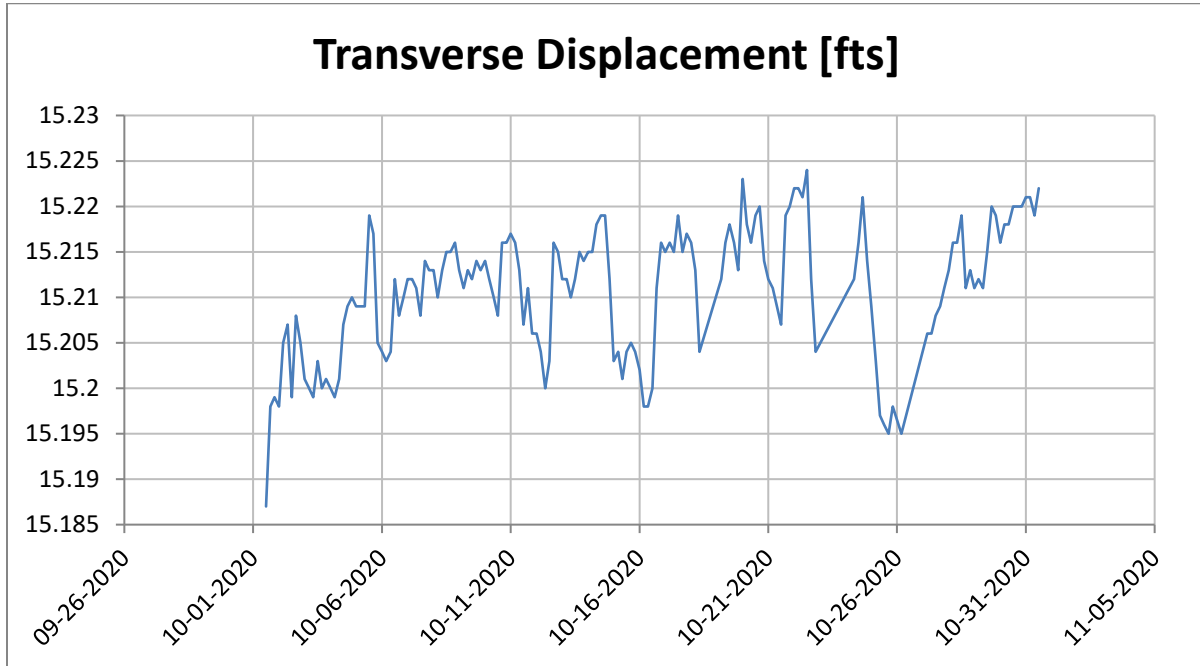
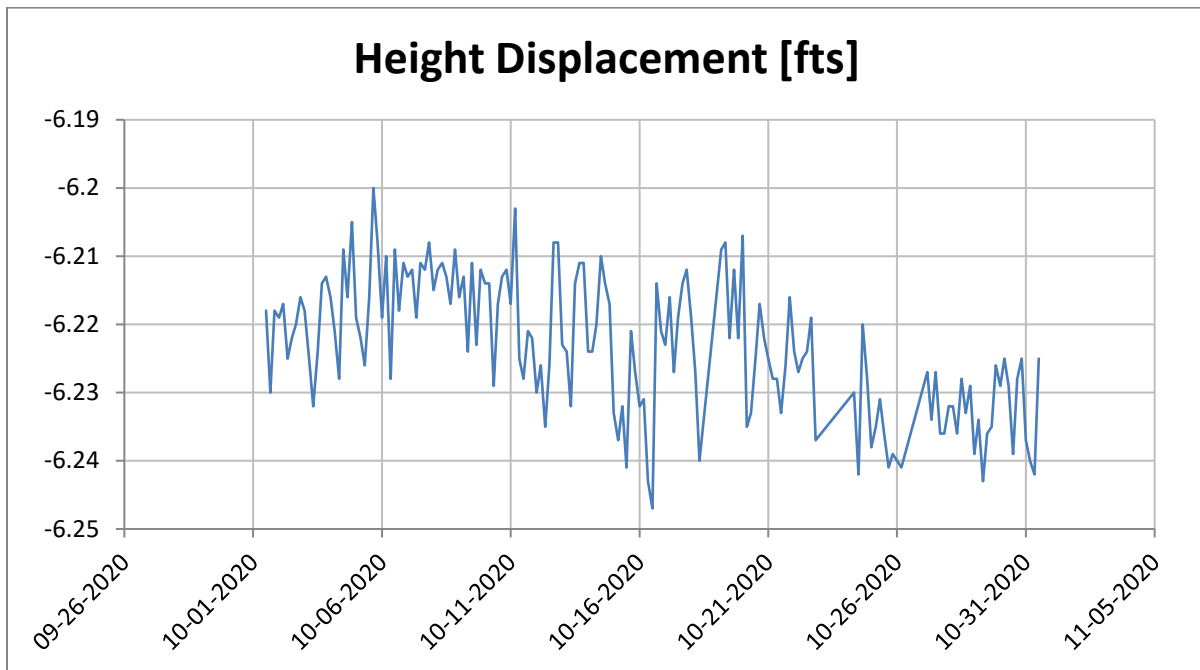
## Prism P63

actual movements. Prism P63 is located at the toe of the landslide, and this location shows slope creep movements at slow velocities (<0.001 ft per day). Plots of the transverse and height displacements for each prism are included in Appendix B.

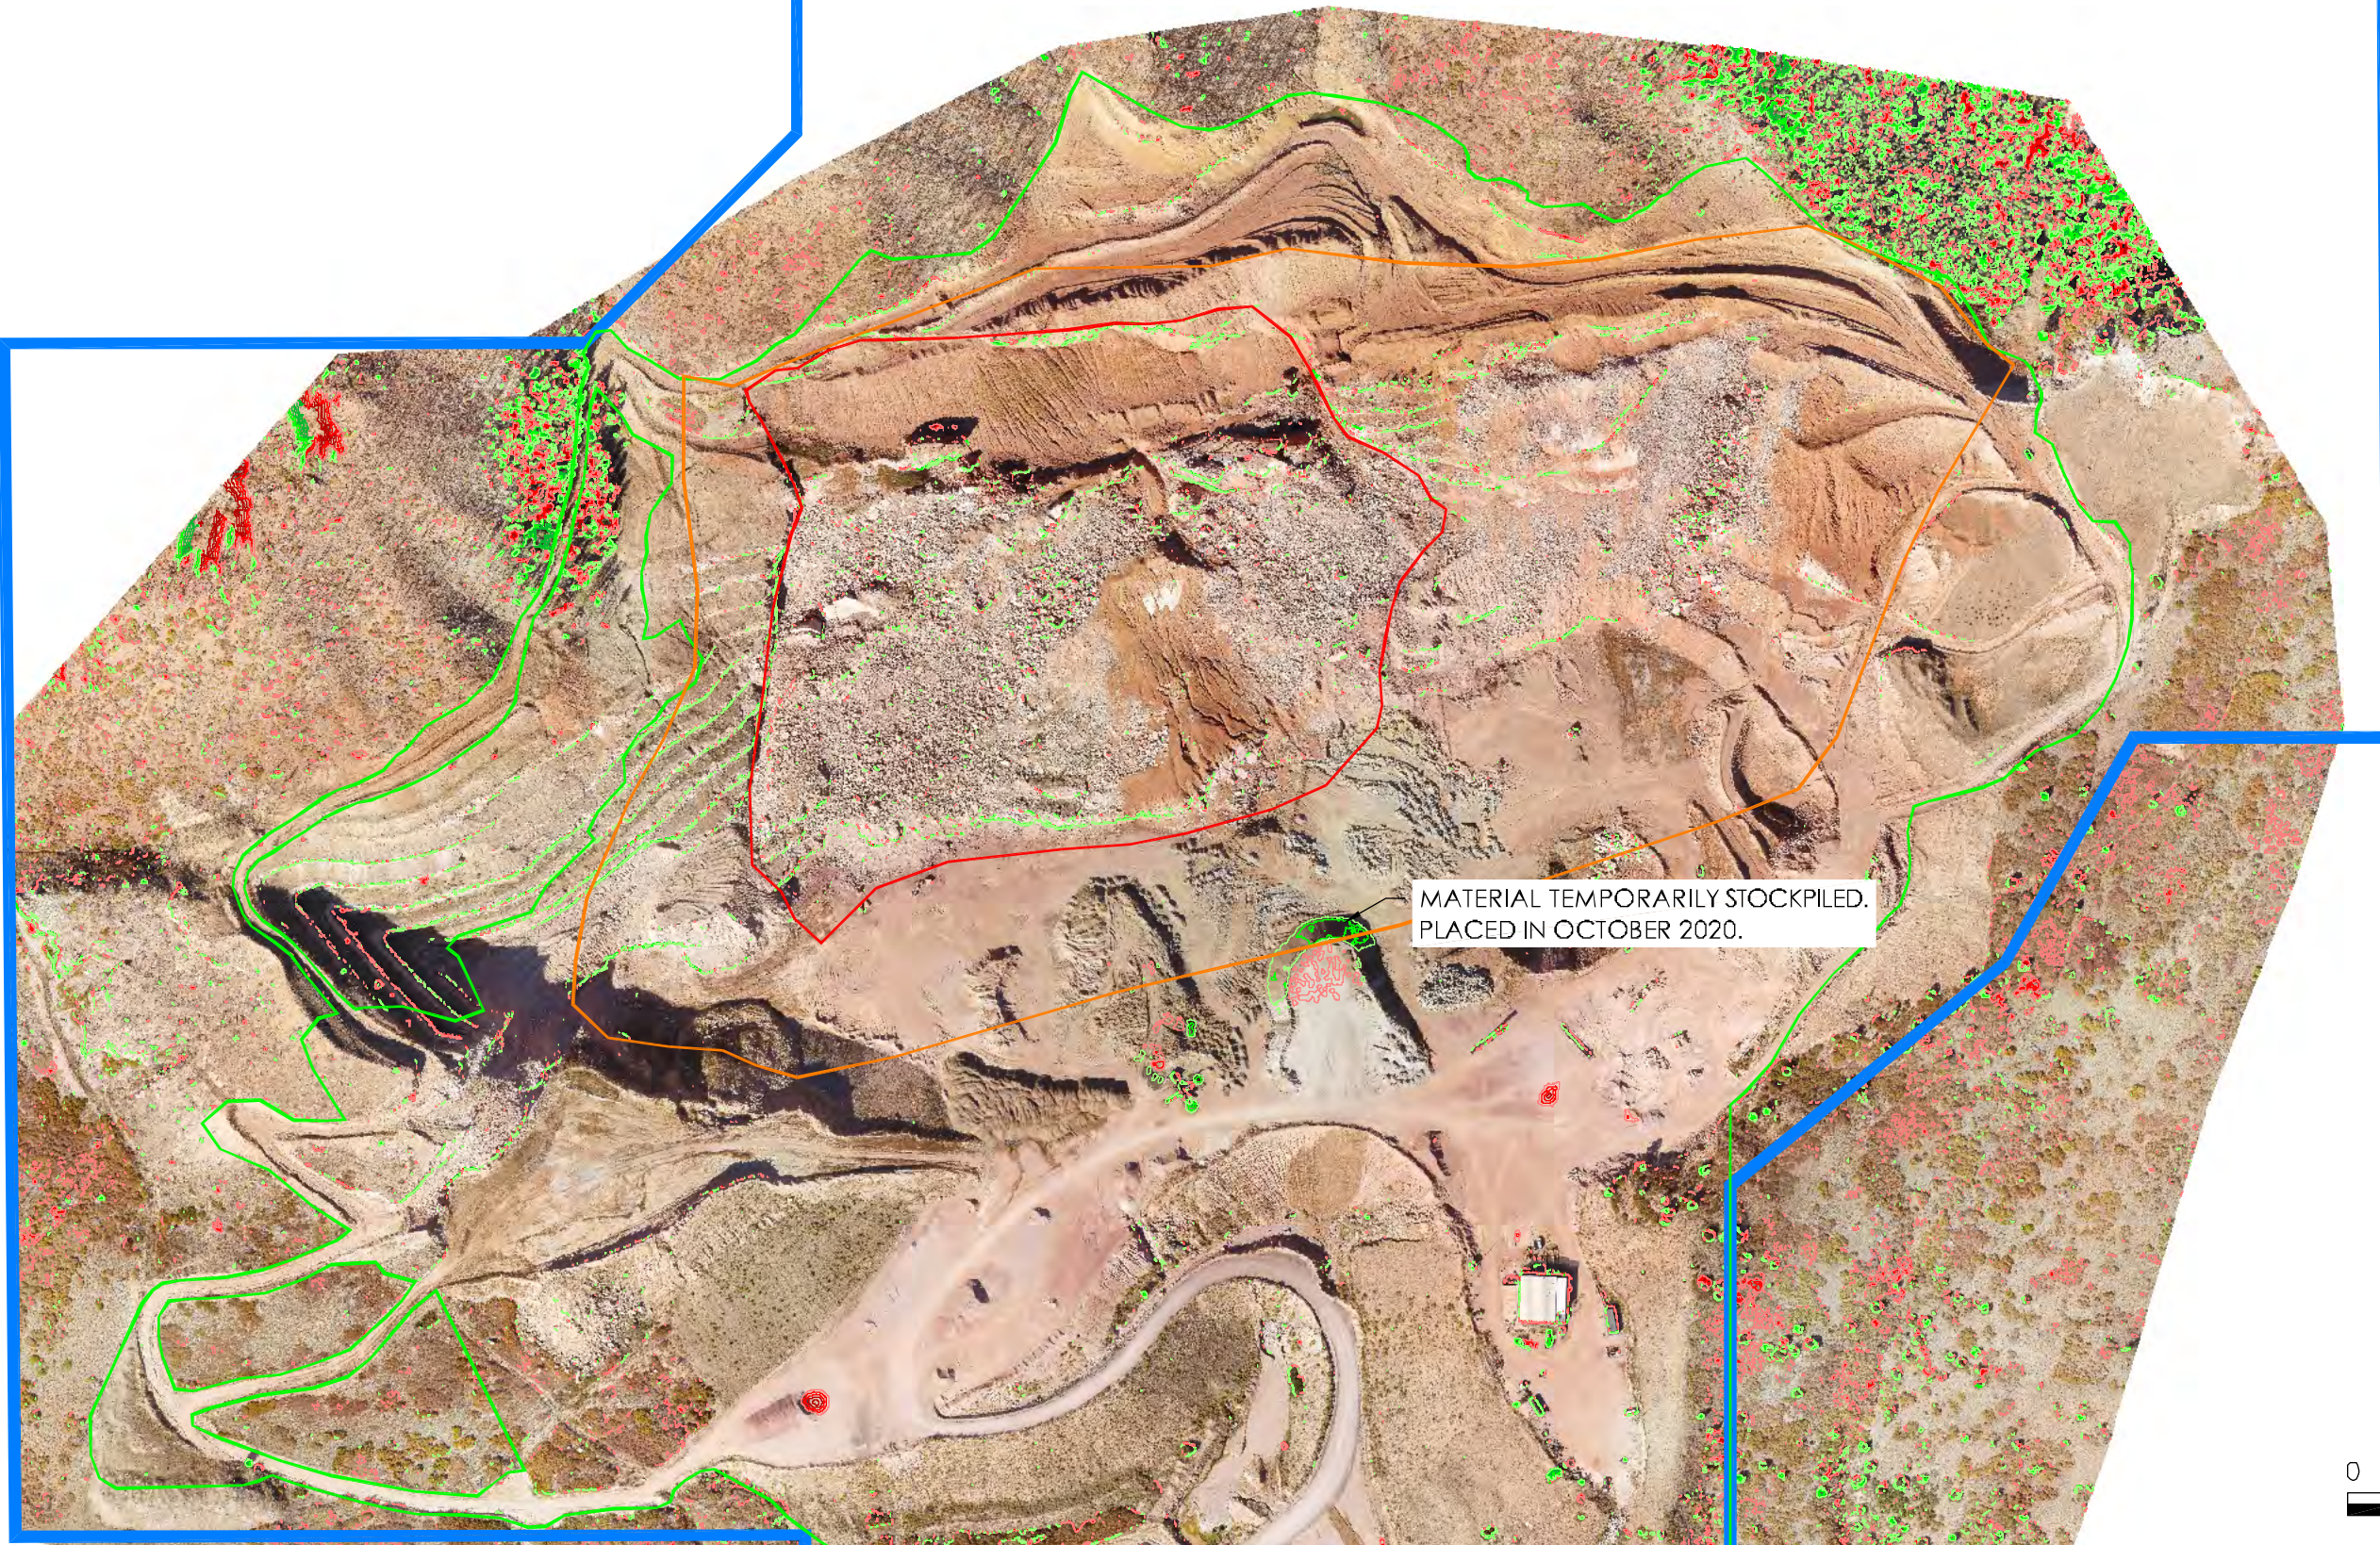
The September topography was also compared to the October topography to identify changes in the site topography. Comparison of the two surveys showed that approximately 1,530 cubic yards of fill had been imported and temporarily placed. No slope movements or other changes in topography were identified. The current imagery and topography are included in Figure 1, and the comparison surface is included as Figure 5 in Appendix C.

As previously reported in the September 2020 monitoring report, there are limitations with the method of comparing drone surveys from different months. The drone data indicate changes in the slopes along each of the reclamation benches, buildings, and areas with trees or shrubs. These areas are stable, and the changes are the result of survey limitations on or near vertical slopes.
