Aerial inspection of Bowie #2

PERMIT INFORMATION

Permit Number: C-1996-083 Mine Name: Bowie No. 2 Mine Operator: Bowie Resources, LLC Operator Address: Mr. Basil Bear P.O. Box 1488 Paonia, CO 81428	County: Delta Operation Type: Underground Permit Status: Active Ownership: Private
	Operator Representative Present: None
Operator Representative Signature: (Field Issuance Only)

Inspection Start Date: December 9, 2020 Inspection Start Time: 12:50 Inspection End Date: December 9, 2020 Inspection End Time: 12:55		Inspection Type: Aerial Inspection Inspection Reason: Normal I&E Program Weather: Clear	
Joint Inspection Agency: None		Joint Inspection Contacts:	
Post Inspection Agency: None		Post Inspection Contacts:	
Inspector(s): Robert Zuber, P.E. Brock Bowles	Inspector's Signature:

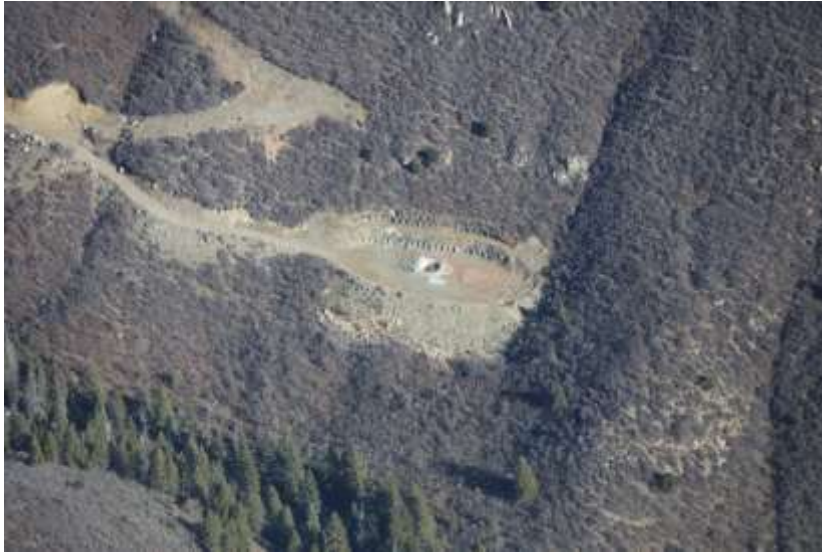
Pad for Terror Creek Vent Shaft

The pad for the Terror Creek Vent Shaft and pads for Gob Vent Boreholes B17A-D were inspected. No problems were identified.

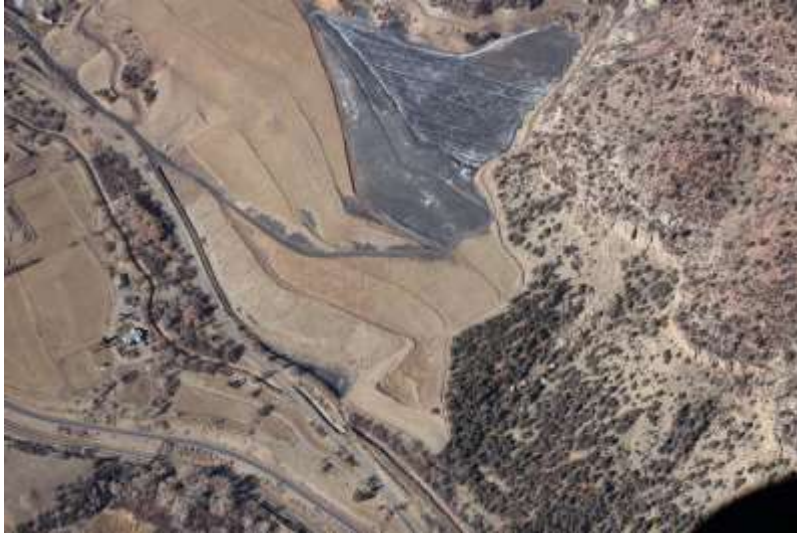
Gob Pile #1, Gob Pile #4, and the reclaimed portion of Gob Pile #2 all appear to be in adequate shape with minimal areas that are bare. No signs of significant erosion can be seen in the photographs.

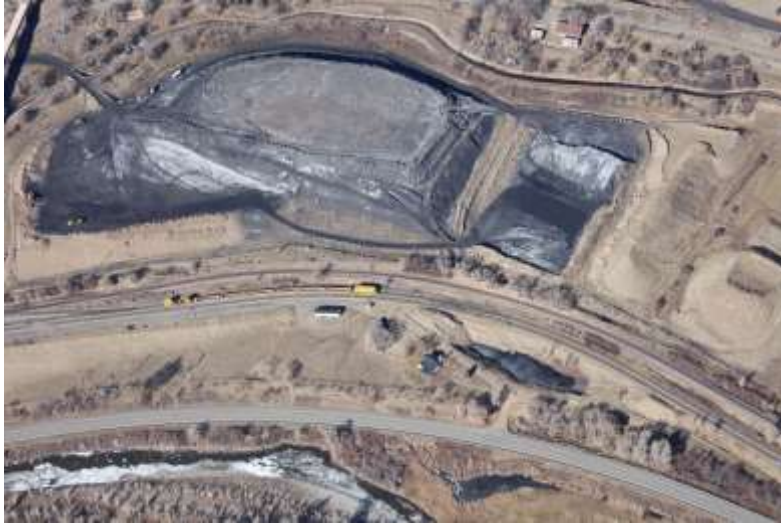
The erosion on Gob Pile #3 does not appear to be getting worse, and there is no sign of coal waste in the ditch below the pile (Ditch J3).

Newly placed coverfill material could be seen on Gob Pile #3, at the southwest corner. The piles of material should be spread in the near future to avoid ponding. Alternatively, the piles could be re-shaped into rows (perpendicular to contour lines on the piles) to allow for positive drainage.

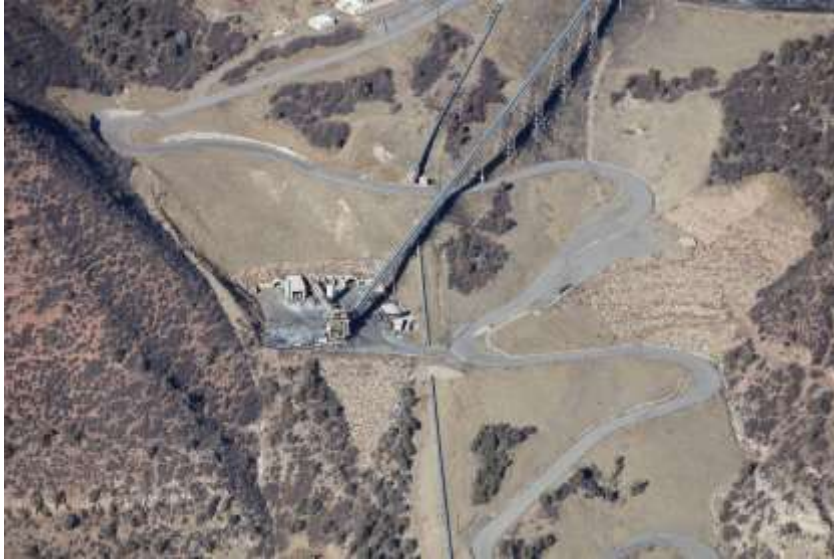
B Portal area

It appears that slumps have not moved significantly in the recent past. These include slumps by the B Portal and by Curve Number 11 along the Haul Road.
