## Bowie #1 Inspection

<b>Permit Number:</b> C-1981-038 <b>Mine Name:</b> Bowie No. 1 Mine <b>Operator:</b> Bowie Resources, LLC <b>Operator Address:</b> Mr Basil R Bear P.O. Box 1488 Paonia, CO 81428	<b>County:</b> Delta <b>Operation Type:</b> Underground <b>Permit Status:</b> Active <b>Ownership:</b> Private
	<b>Operator Representative Present:</b>  None
<b>Operator Representative Signature:</b> (Field Issuance Only)

<b>Inspection Start Date:</b> December 9, 2020 <b>Inspection Start Time:</b> 12:45 <b>Inspection End Date:</b> December 9, 2020 <b>Inspection End Time:</b> 12:49		<b>Inspection Type:</b> Aerial Inspection <b>Inspection Reason:</b> Normal I&E Program <b>Weather:</b> Clear	
<b>Joint Inspection Agency:</b>  None		<b>Joint Inspection Contacts:</b>  	
<b>Post Inspection Agency:</b>  None		<b>Post Inspection Contacts:</b>  	
<b>Inspector(s):</b>  Robert Zuber, P.E.  Brock Bowles	<b>Inspector's Signature:</b>

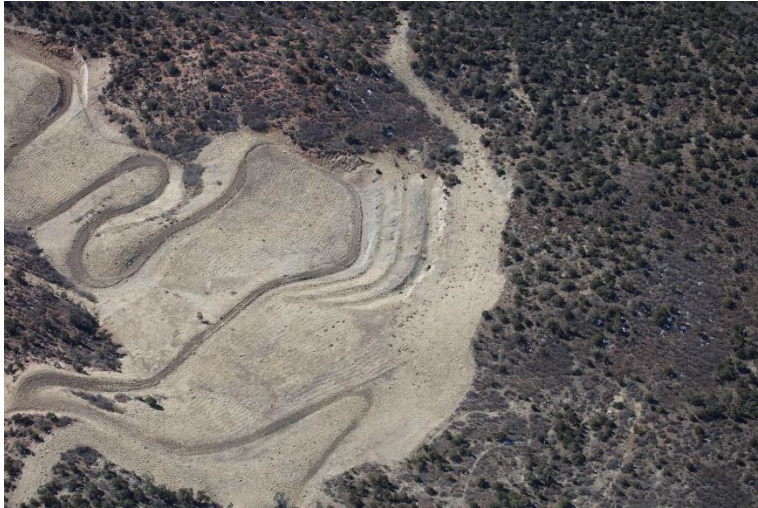
**East Mine – upper portion**

Channels at the East Mine were stable.

No erosion or other problems were identified with the road at the East Mine.

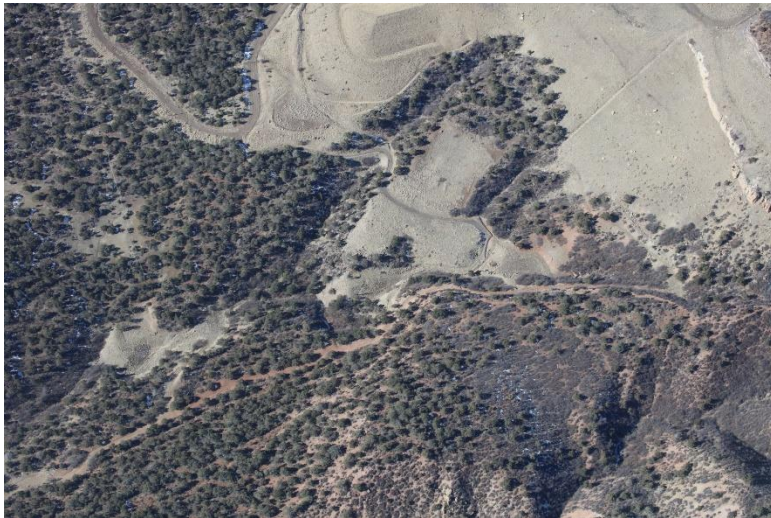
**East Mine – Reclaimed ponds, Old Waste Disposal Area, and RDA**

No erosion problems were identified.

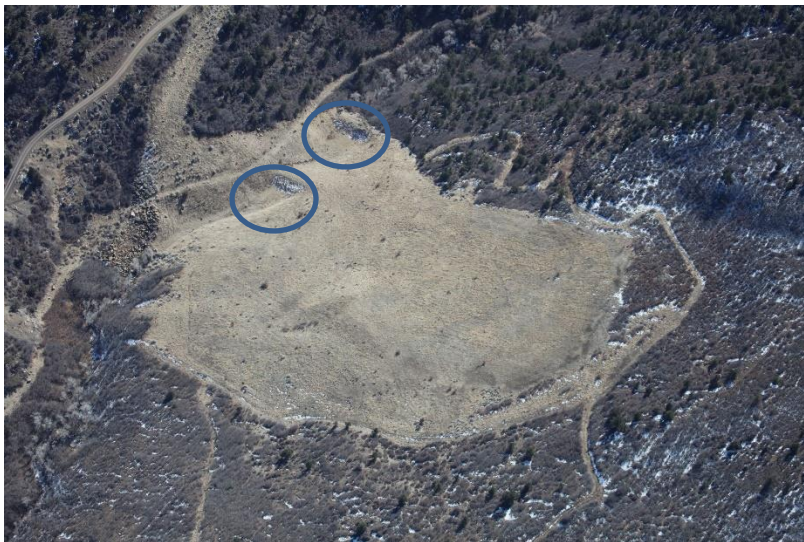
**West Mine (ponds are circled)**

The ponds at the West Mine, the pond at the former coal storage area by Black Bridge Road, and the pond at the loadout were dry. No problems were seen with the embankments or other portions of these ponds.

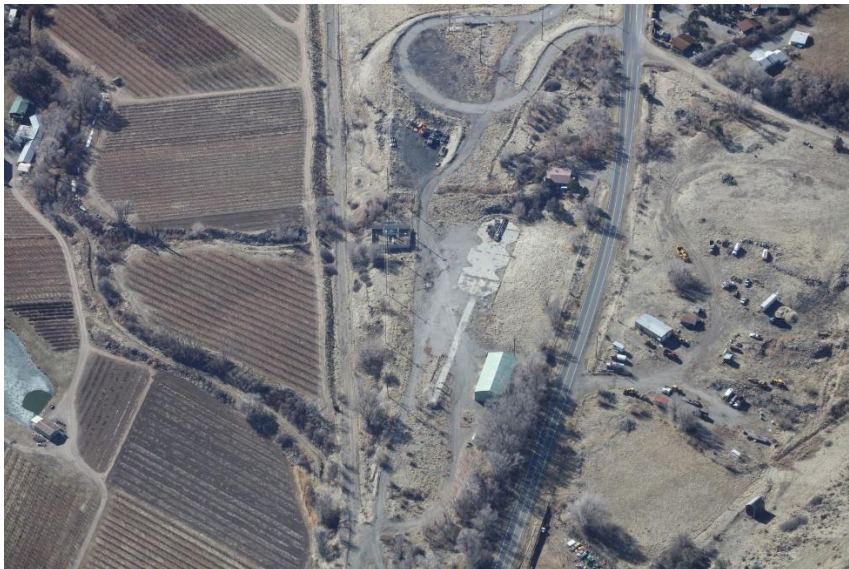
**Loadout**

No erosion or other problems were identified at the loadout. This includes the eastern portion, along the UPRR tracks and adjacent to Grange Road and Black Bridge Road.
