COLORADO
Division of Reclamation,
Mining and Safety
Department of Natural Resources

Permit Number: C-1981-018 Mine Name: Deserado Mine Operator: Blue Mountain Energy, Inc. Operator Address: Mr. Kurtis Blunt 3607 County Road 65 Rangely, CO, 81648	County: Moffat, Rio Blanco Operation Type: Underground Permit Status: Active Ownership: Private
	Operator Representative Present: NA
Operator Representative Signature: (Field Issuance Only)

Inspection Start Date: December 9, 2020 Inspection Start Time: 10:00 Inspection End Date: December 9, 2020 Inspection End Time: 10:05		Inspection Type: Aerial Inspection Inspection Reason: Normal I&E Program Weather: Clear	
Joint Inspection Agency: None		Joint Inspection Contacts: None	
Post Inspection Agency: None		Post Inspection Contacts: None	
Inspector(s): Clayton Wein Brock Bowles	Inspector's Signature: <i>Clayton Wein</i>		Signature Date: 12/10/2020

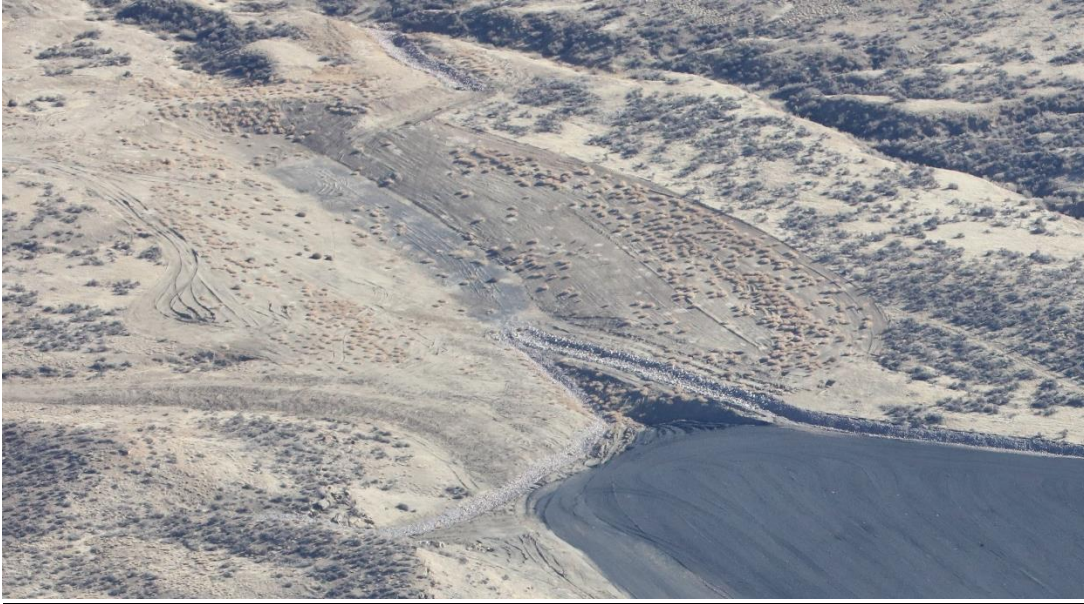
The RP-A pond is located on the eastern base of the RP-A refuse pile (Photo 1). The pond was dry during the inspection. The embankment had vegetative cover and the embankment was stable. There were no indications of erosion.

Photo 1: The RP-A refuse pile pond.

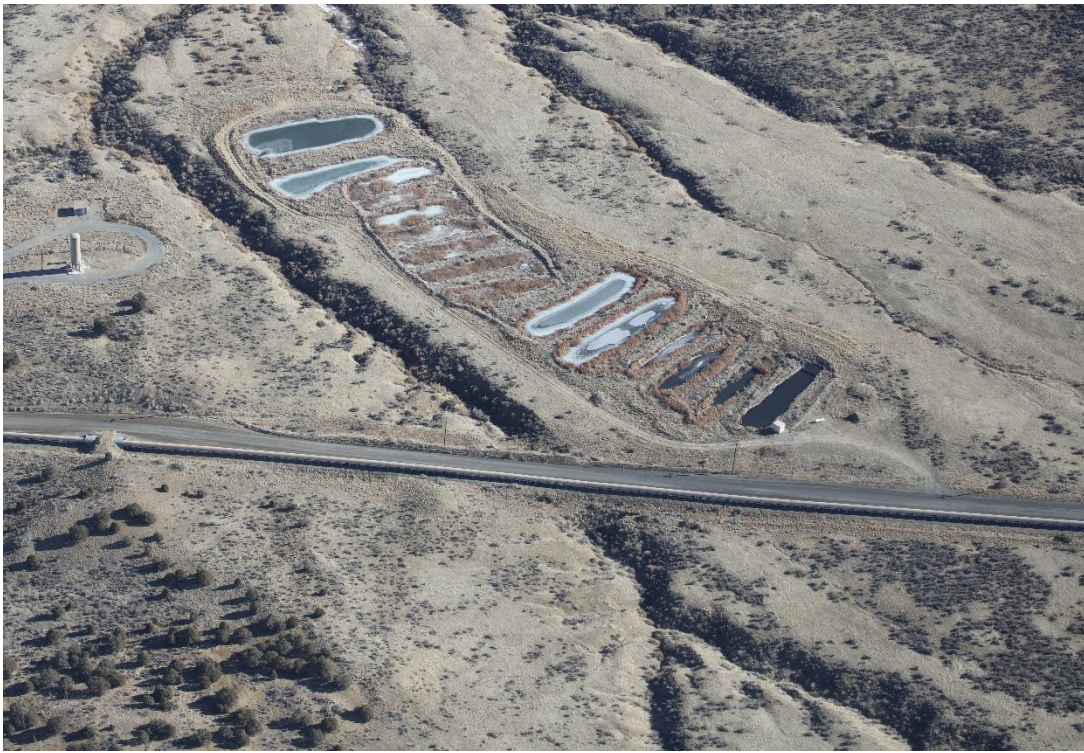
All cells of the B Seam Dewatering System No. 1 were holding water (Photo 2). The water was frozen in all of the cells. The level of water impounded in the Last Chance Pond appeared to be below the level of the primary spillway. The embankments for the cells were stable and vegetated. There were no erosional features identified.

Photo 2: The B Seam Dewatering System No. 1

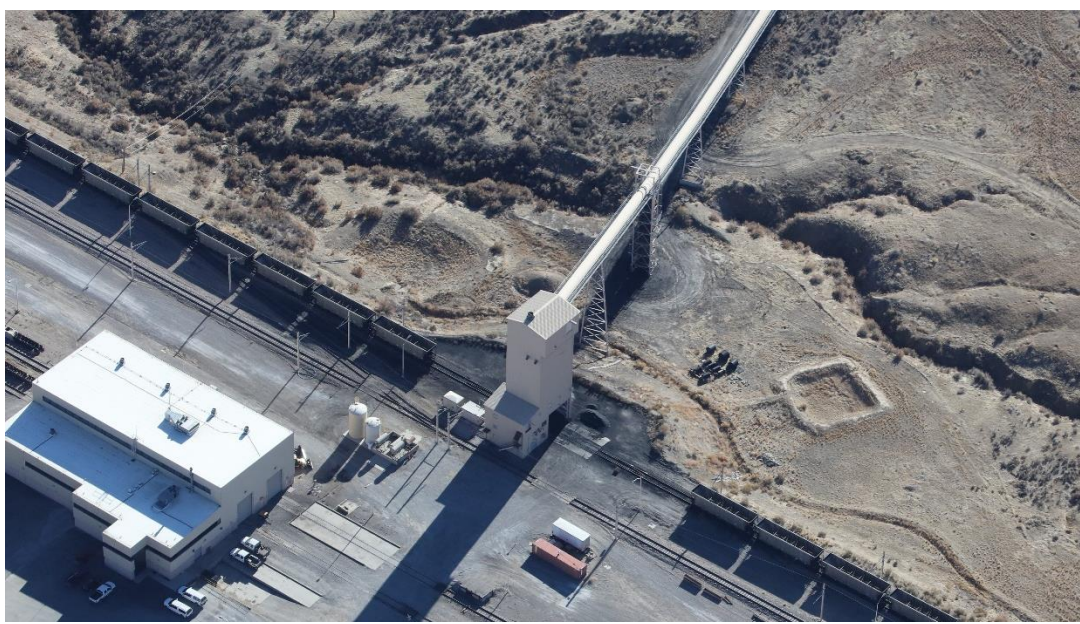
One sump, RS-1, and one pond, RR-1, are located on the south side of the rail loadout (Photo 3). RS-1 was dry. The embankments were vegetated and stable. No indications of erosion were observed. RR-1 was also observed to be dry. The embankment was stable with vegetation. No erosional features were observed.

Photo 3: the rail loadout sump and pond.

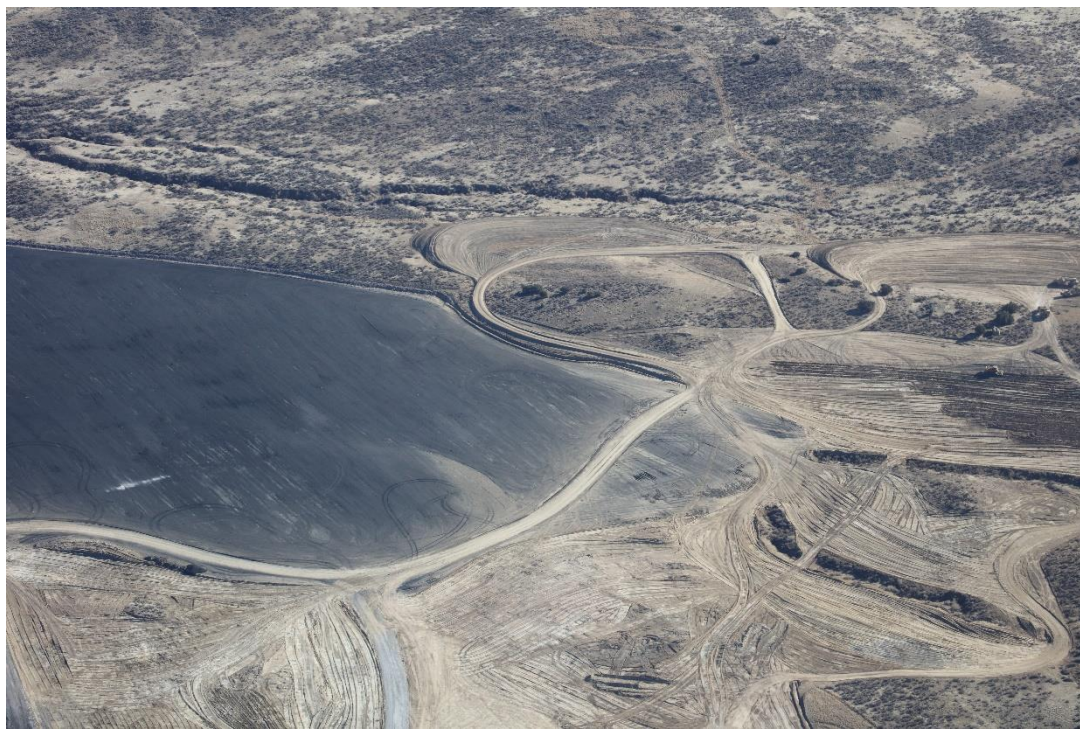
During the inspection earth moving work was being conducted at the RP-A refuse site (Photo 4). The western footprint of the pile was being prepared for the extension of the base. Equipment was also observed working on placing material on the subsoil stockpiles. The refuse material on the RP-A pile was spread and compacted. There were no indications of instability or erosion. The perimeter ditches were clear of debris and stable.

Photo 4: The RP-A refuse disposal site.

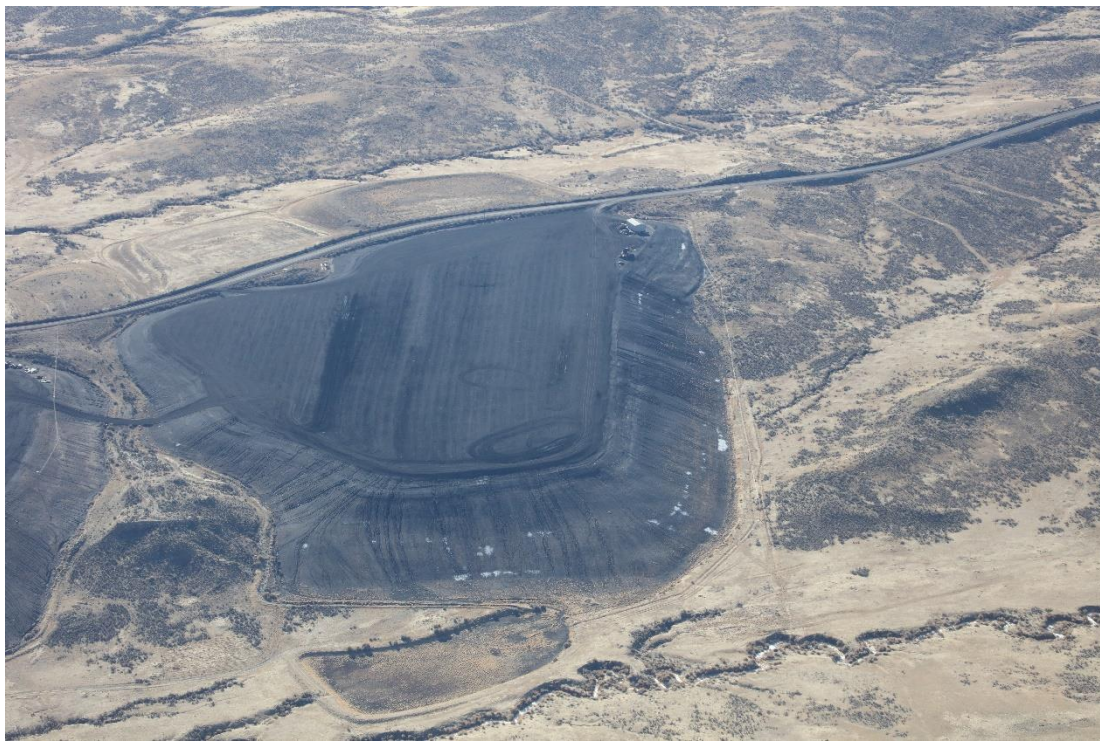
The RP-5a refuse pile was stable (Photo 5). The refuse on the pile was observed to be spread and compacted. There was no material drying on the top. The slopes were stable, but had localized erosion. There are rills and gullies on the slopes of the pile. These features have been noted in previous Division inspections. The slopes of RP-5a are included on the spring maintenance list for 2021. The rills and gullies do not appear to have enlarged since the previous inspection.

Photo 5: The RP-5a refuse disposal site.

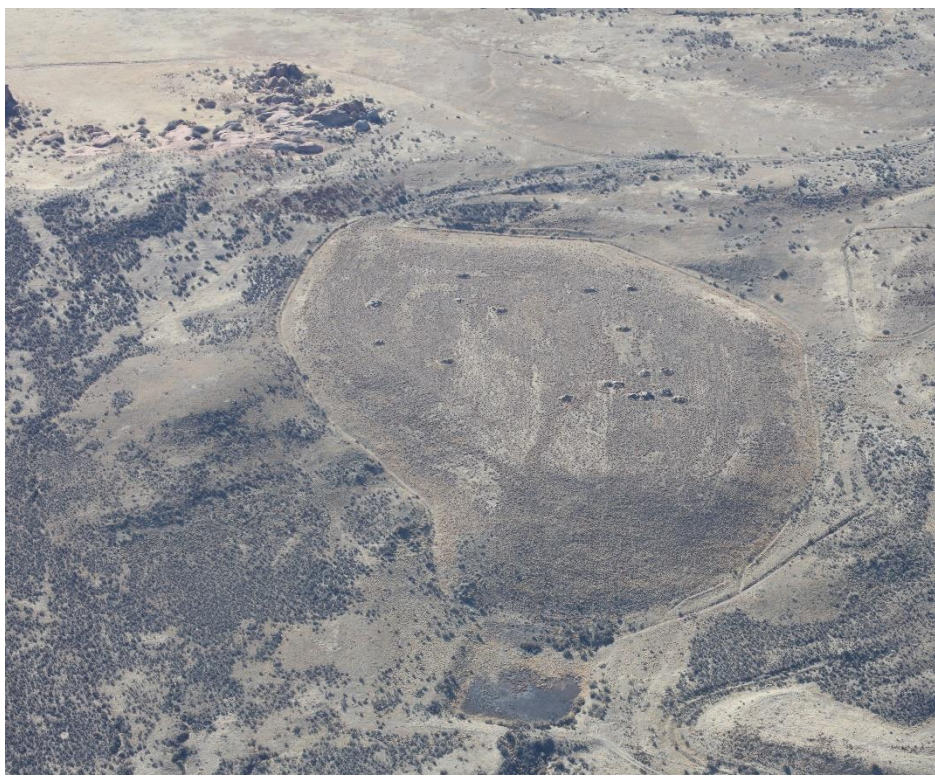
The RP-1 refuse pile is the only reclaimed refuse pile at the mine site. The pile was observed to be stable with vegetative cover (Photo 6). There were no concerns of erosional features. The perimeter ditches were dry and clear from blockages. The large rocks placed on top of the pile are there to promote habitat for wildlife.

Photo 6: The reclaimed RP-1 refuse pile.
