COLORADO
Division of Reclamation,
Mining and Safety
Department of Natural Resources

Permit Number: C-1981-041 Mine Name: Roadside Portals Operator: Snowcap Coal Company, Inc. Operator Address: MS Tonya Hammond P.O. Box 1430 Palisade, CO 81526	County: Mesa Operation Type: Underground Permit Status: Active Ownership: Private
	Operator Representative Present: NA
Operator Representative Signature: (Field Issuance Only)

Inspection Start Date: December 9, 2020 Inspection Start Time: 12:00 Inspection End Date: December 9, 2020 Inspection End Time: 12:05		Inspection Type: Aerial Inspection Inspection Reason: Normal I&E Program Weather: Clear	
Joint Inspection Agency: None		Joint Inspection Contacts: None	
Post Inspection Agency: None		Post Inspection Contacts: None	
Inspector(s): Clayton Wein Brock Bowles	Inspector's Signature: <i>Clayton Wein</i>		Signature Date: 12/11/2020

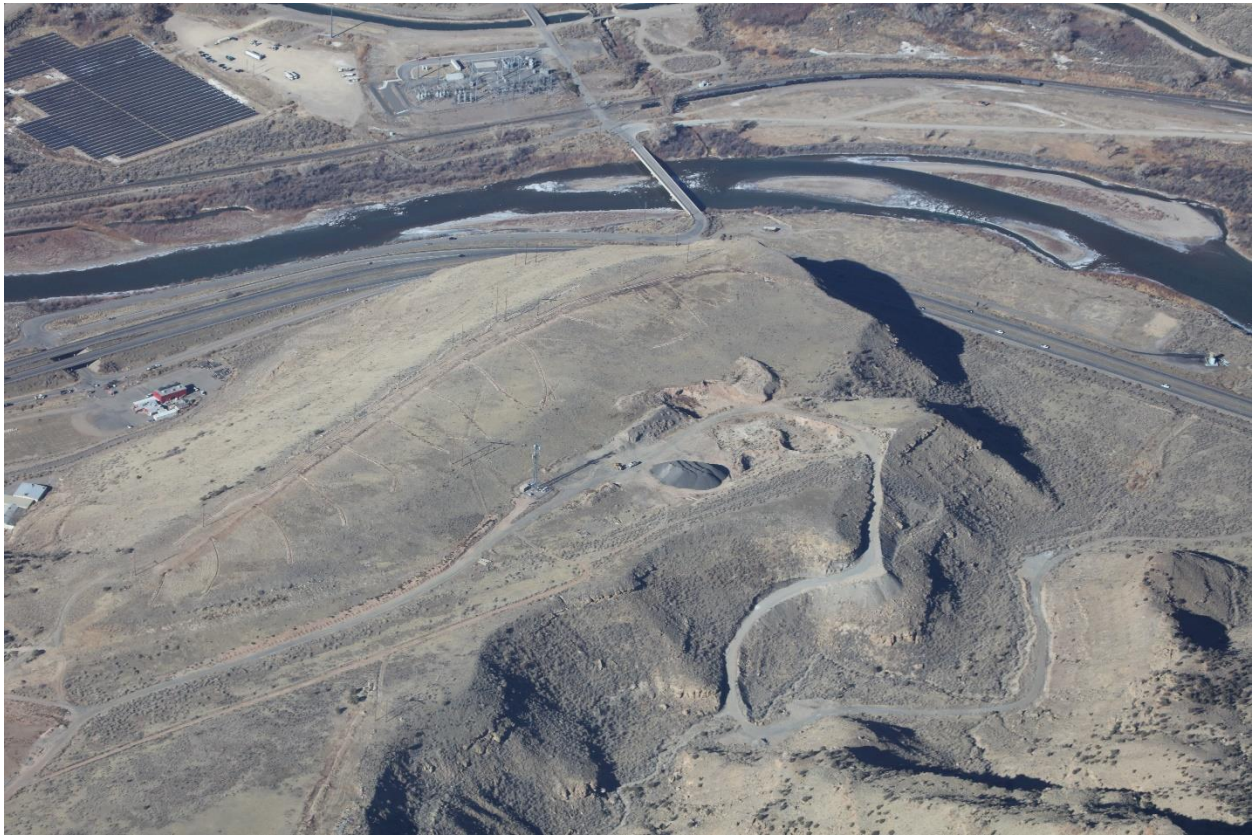
The trenches on top of the tract 70 mesa were observed to be dry (Photo 1). There was no evidence of recent flow. The landowner's field located to the south of the Tract 70 Mesa was also dry (Photo 2). There was no evidence of recent water application to the field. The Carey pit located to the south of the TR-69 repair area, on Tract 71, was dry at the time of the inspection. There were no indications that water had been in the pit recently.

Photo 1: The Tract 70 Mesa. North is approximately toward the upper right corner of the photo.

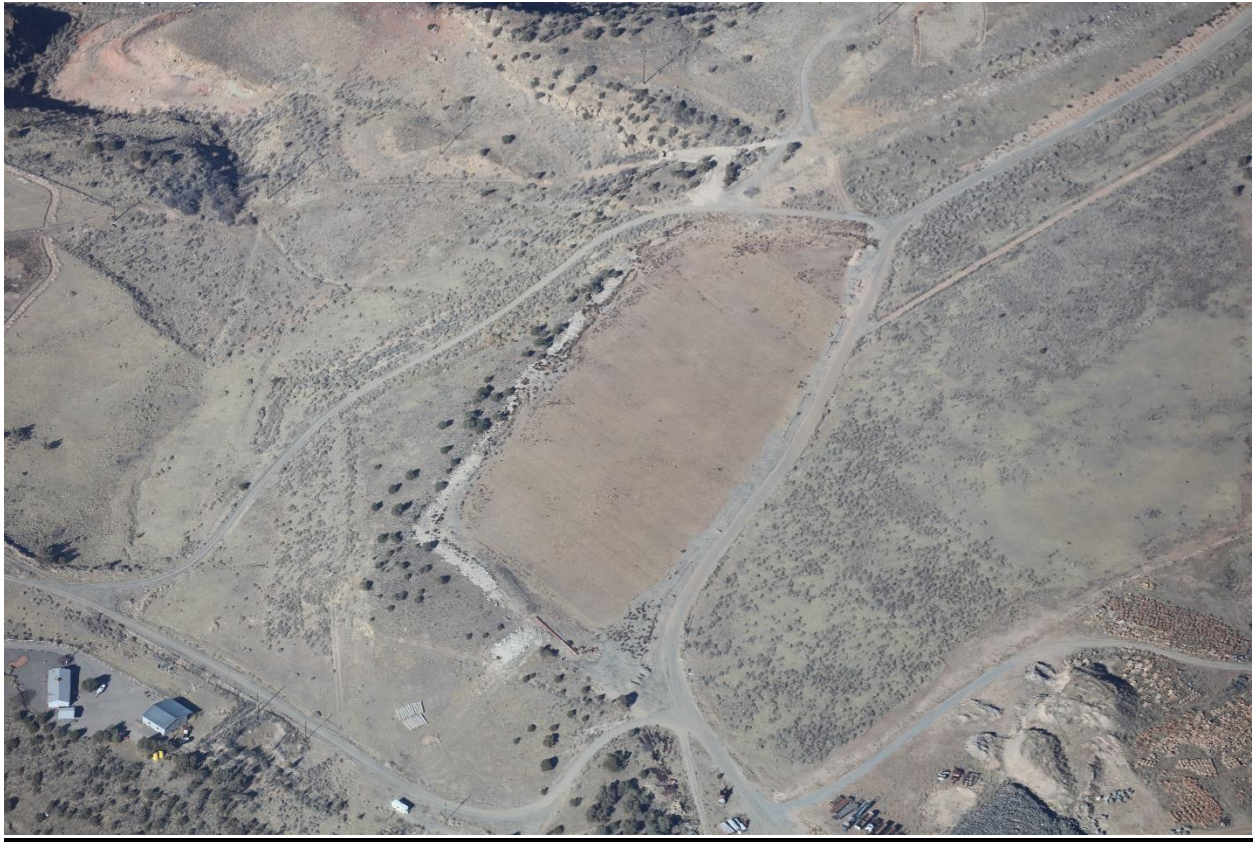
Photo 2: The landowner's field. North is toward the upper right corner of the photo.

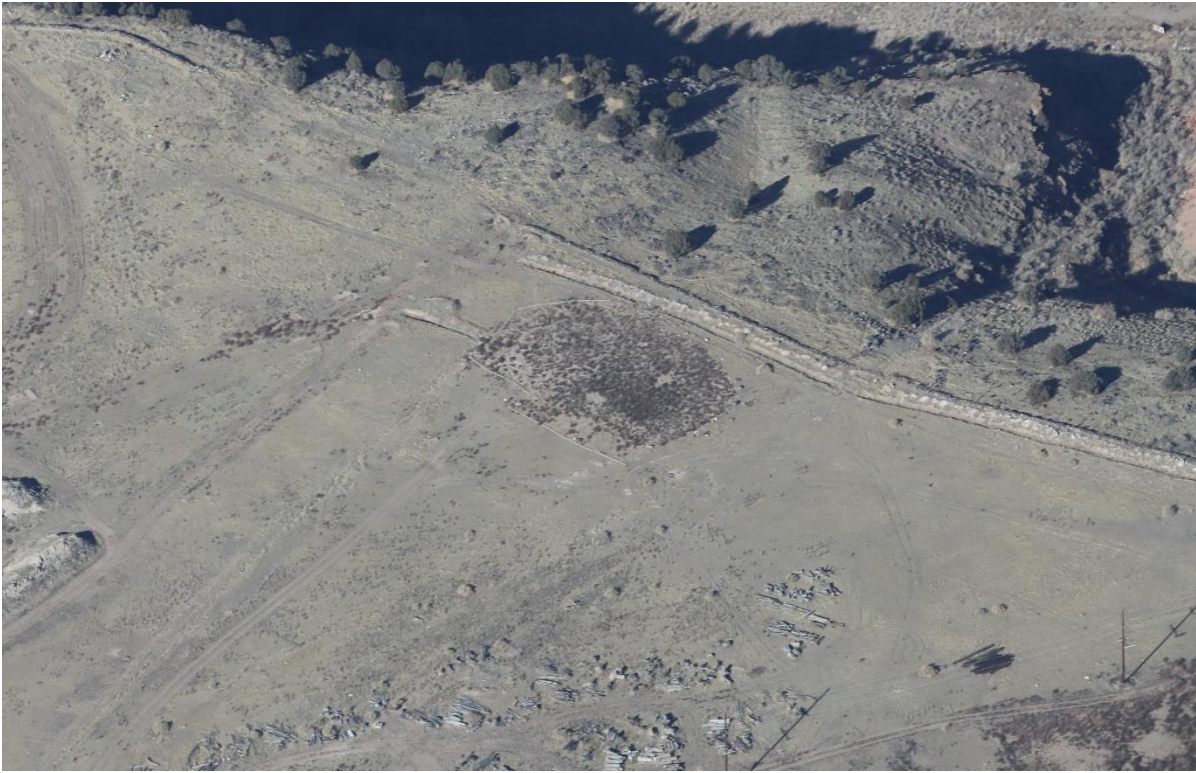
The remaining bonded disturbance at the mine site is 0.4 acres associated with the Technical Revision No. 69 repair area. The site was stable with vegetative cover (Photo 3). There were no erosional features identified. The sediment logs were intact on the down gradient perimeter of the repair area. Disturbance boundary markers were seen encompassing the 0.4 acre disturbed area.

Photo 3: The TR-69 repair area. The disturbed and reclaimed 0.4 acres is in the center of the photo above.
