## MINERALS PROGRAM INSPECTION REPORT

| <b>MINE NAME:</b><br>Pueblo Cement Plant and Limestone Quarry | <b>MINE/PROSPECTING ID#:</b><br>M-2002-004 | <b>MINERAL:</b><br>Limestone (general) | <b>COUNTY:</b><br>Pueblo |
| <b>INSPECTION TYPE:</b><br>Monitoring | <b>INSPECTOR(S):</b><br>Patrick Lennberg | <b>INSP. DATE:</b><br>November 10, 2020 | <b>INSP. TIME:</b><br>09:00 |

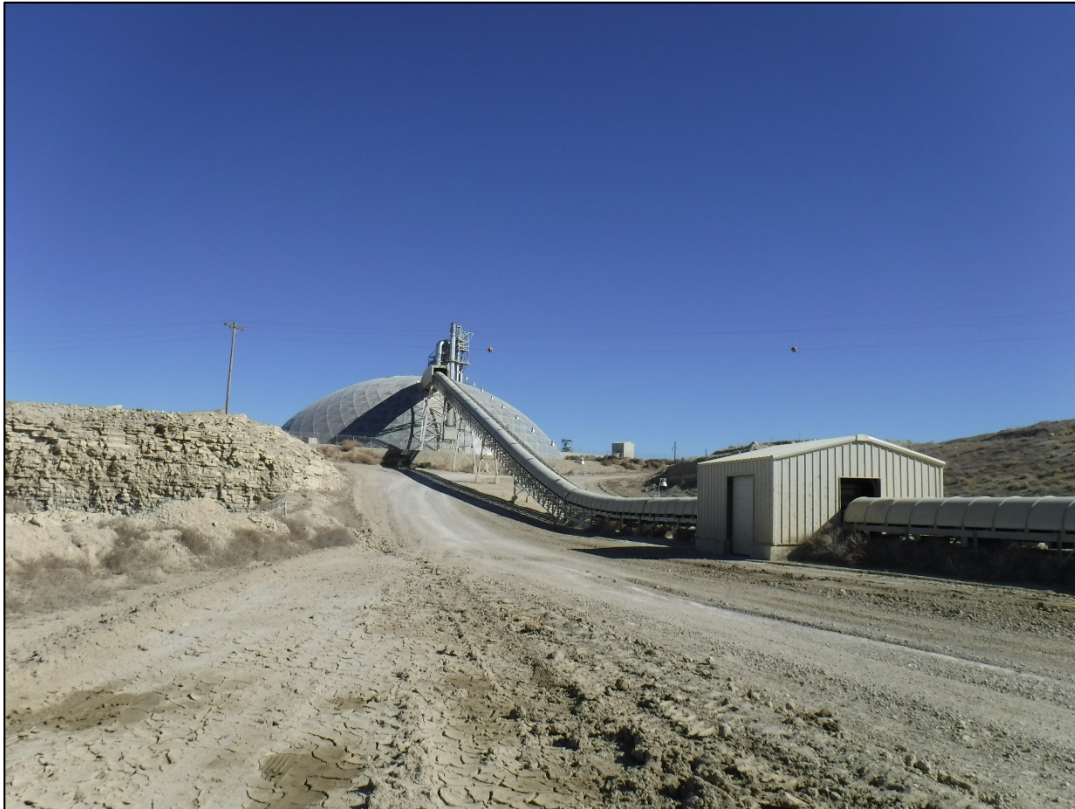
**Photo 1:** Entrance to the quarry, where the conveyor system connects to the storage dome

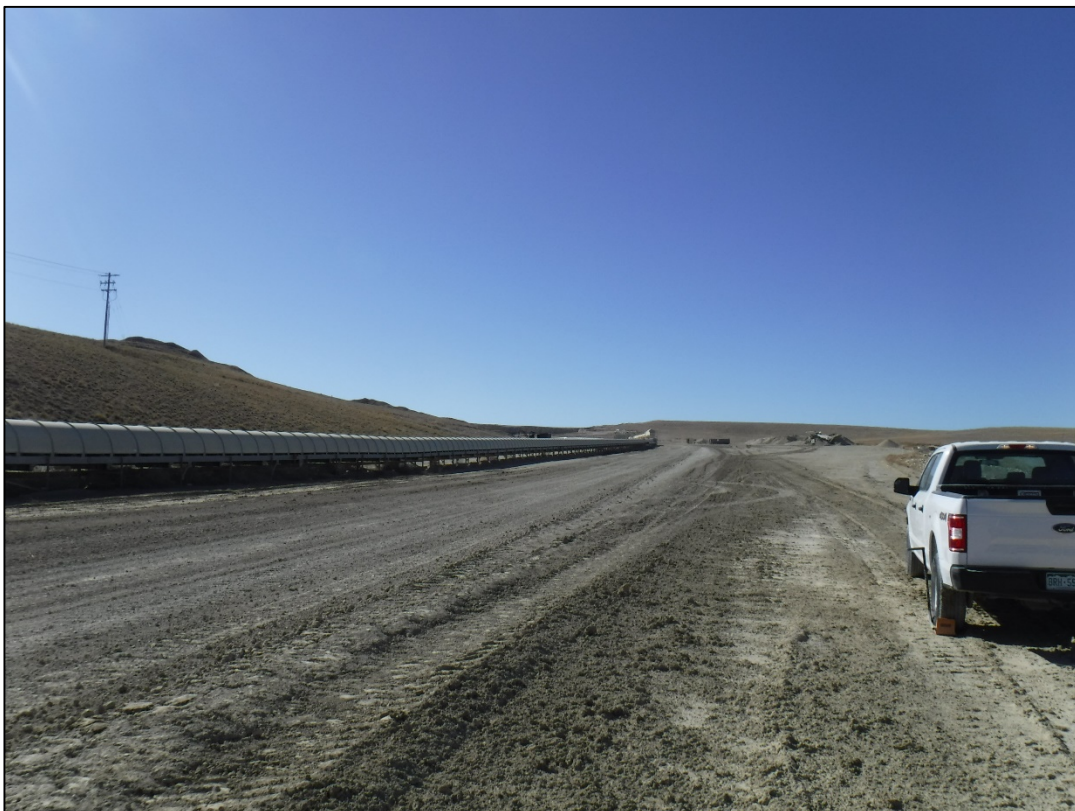
**Photo 2:** Conveyor leading to the active mining area

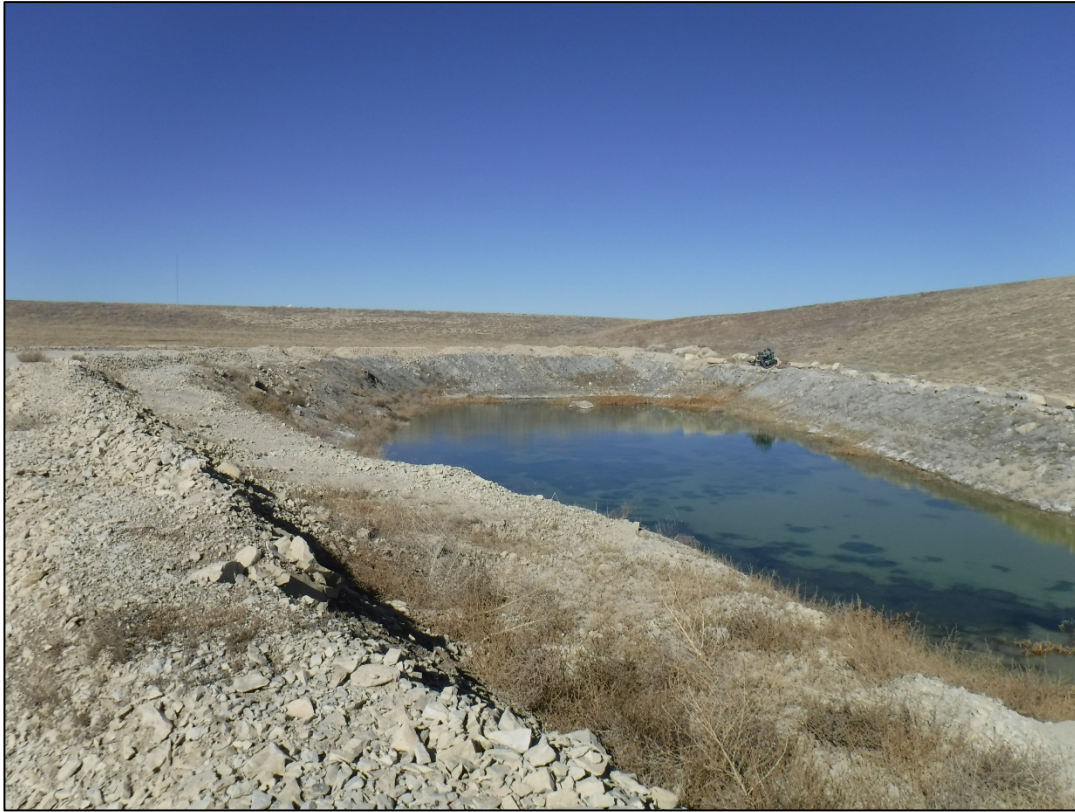
**Photo 3:** Stormwater detention basin, water from recent storm event

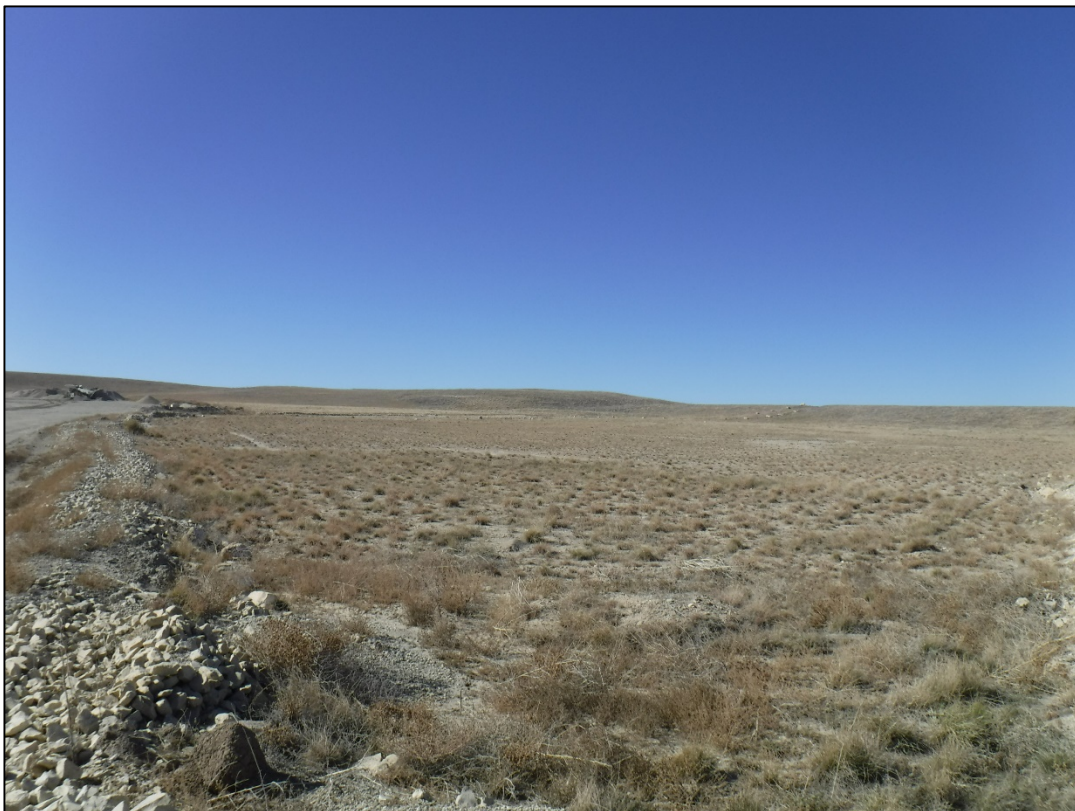
**Photo 4:** Typical conditions of reclaimed areas that have multiple years of growth

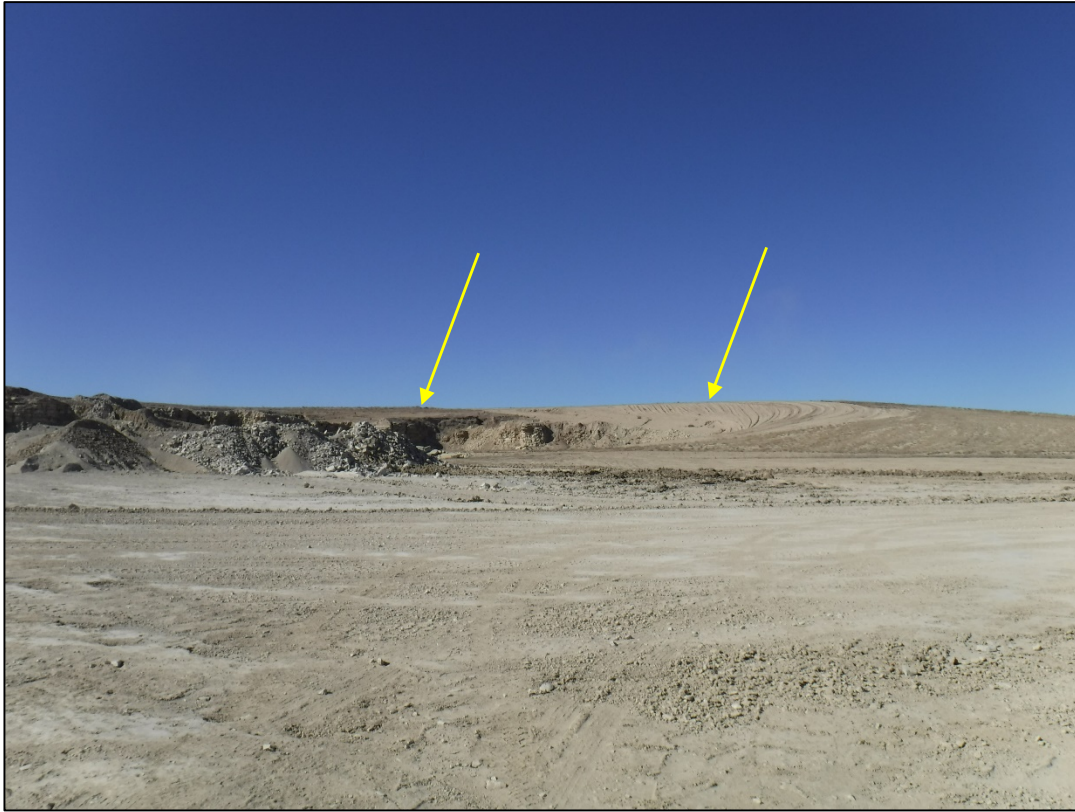
**Photo 5:** Reclaiming activities, yellow arrows indicate mine face and concurrent reclamation

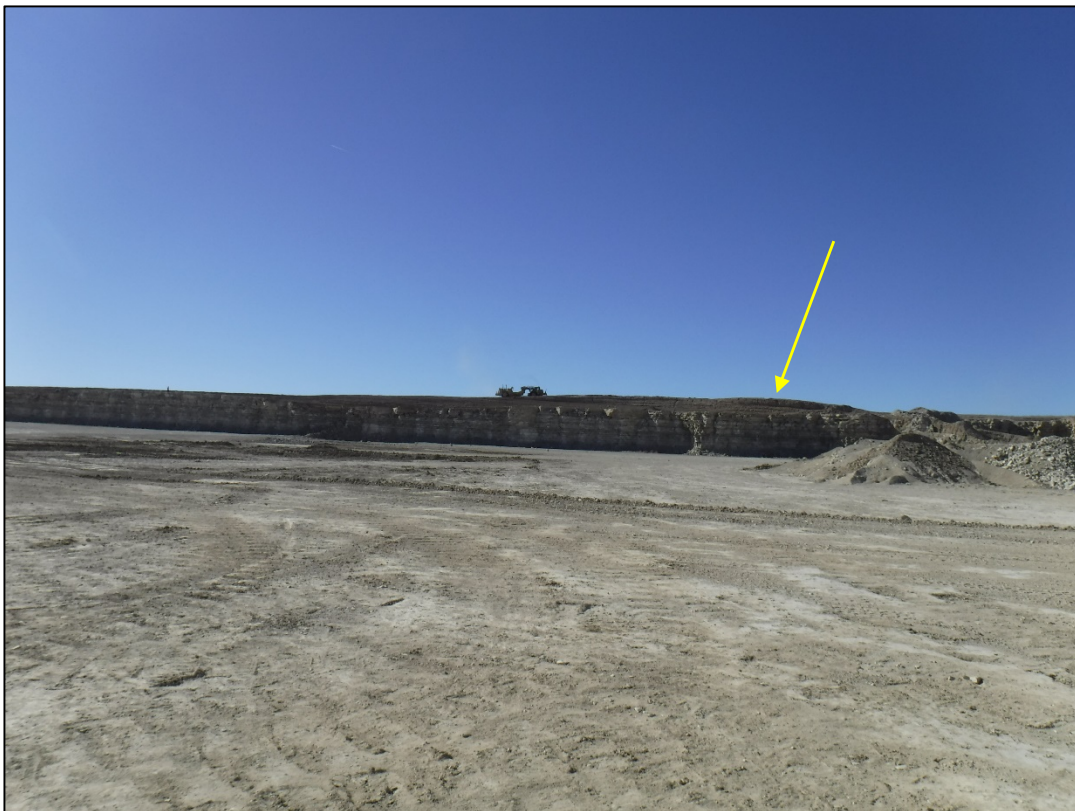
**Photo 6:** Scraper transporting overburden material to be placed, yellow arrow indicate topsoil stockpile, note highwall below scraper

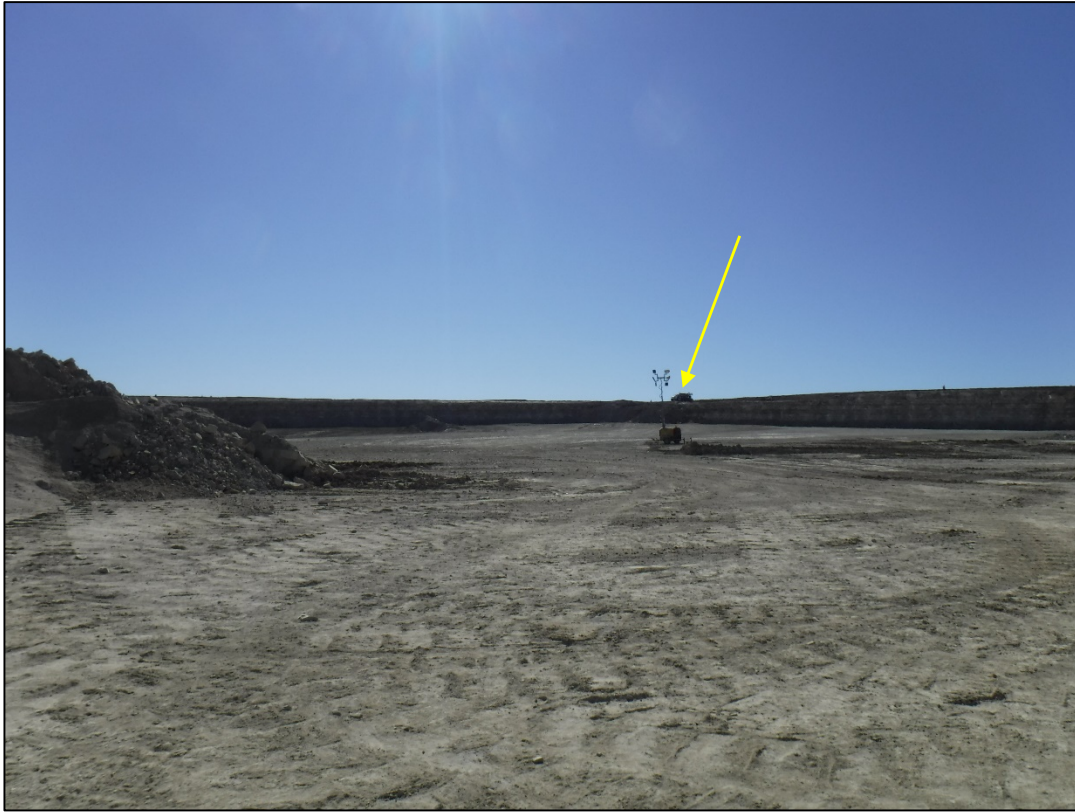
**Photo 7:** Active highwall area, yellow arrow shows ANFO truck loading blast holes

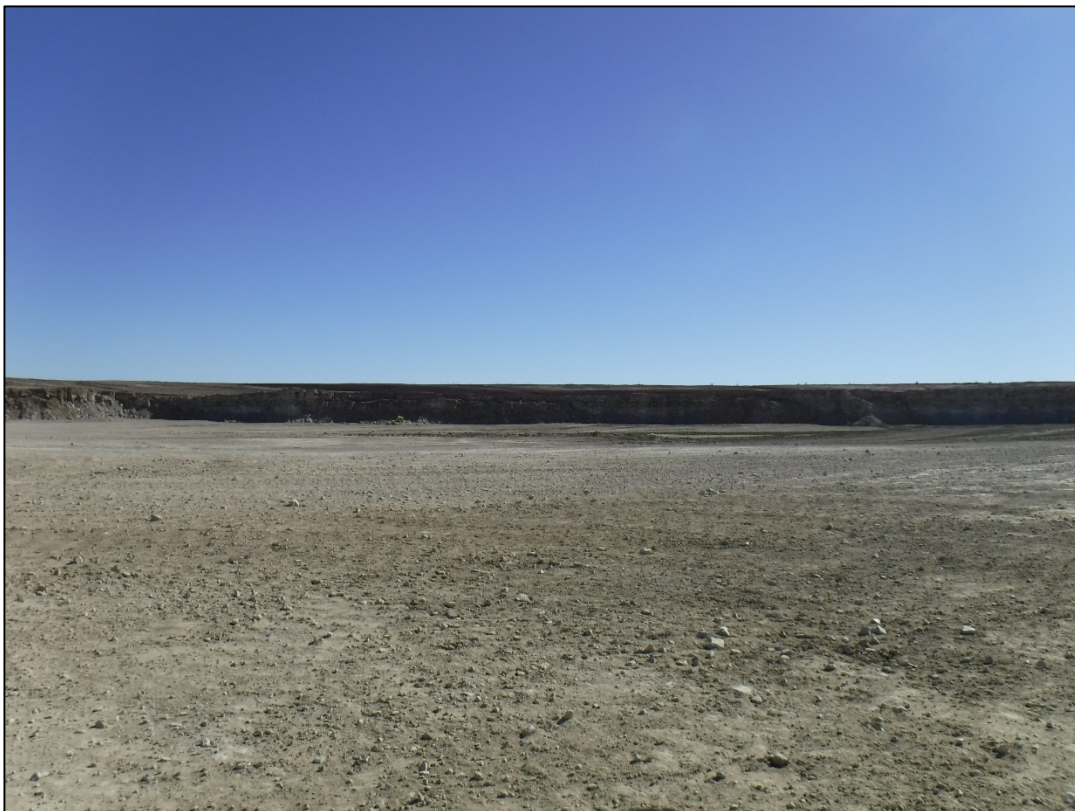
**Photo 8:** Another portion of the active highwall area

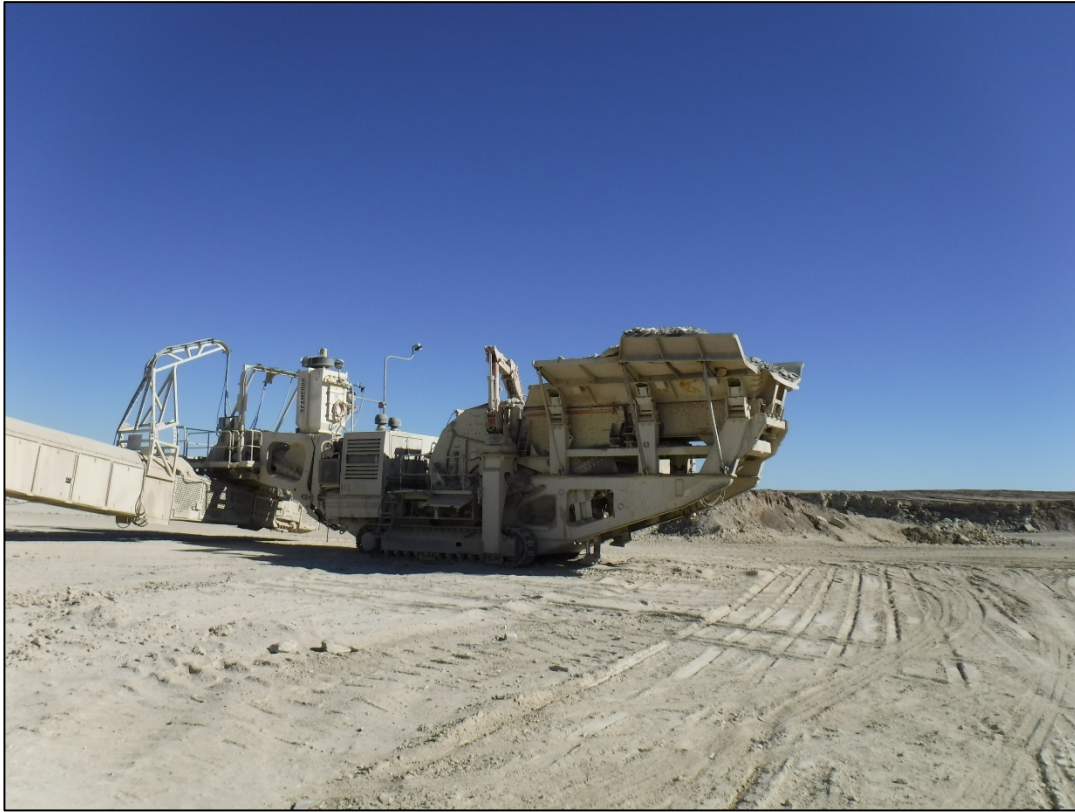
**Photo 9:** Mobile crusher/screener near active mine area

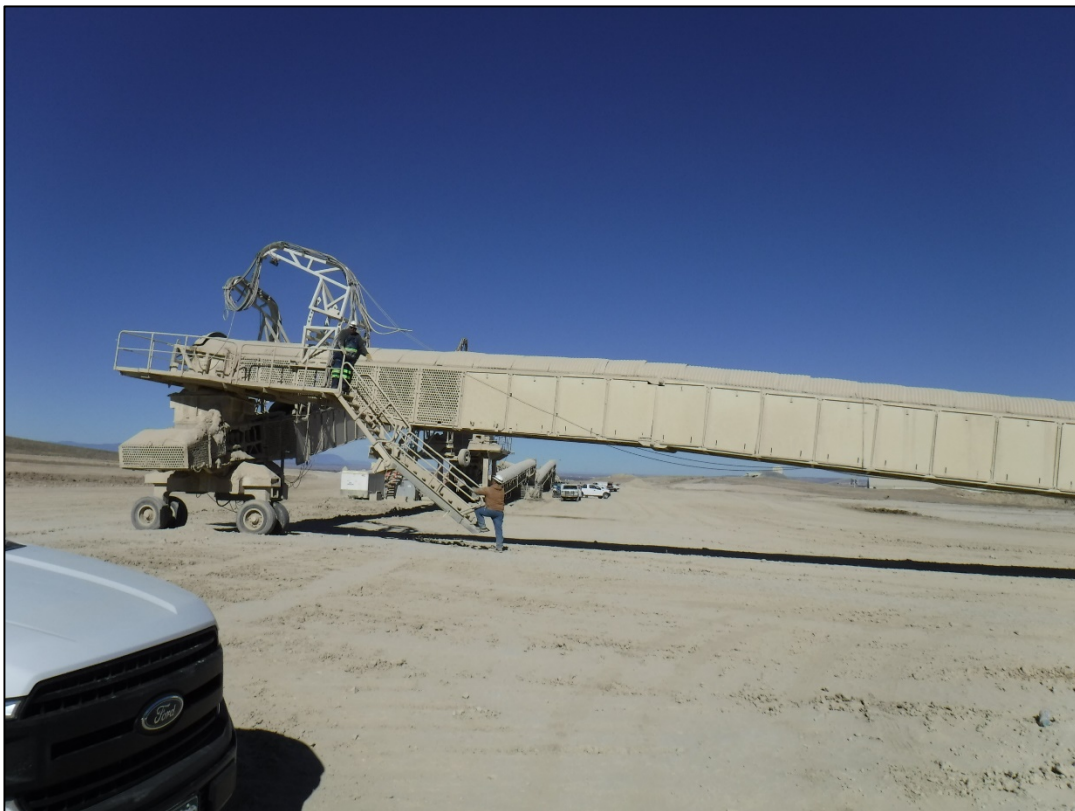
**Photo 10:** Mobile conveyor belt segments

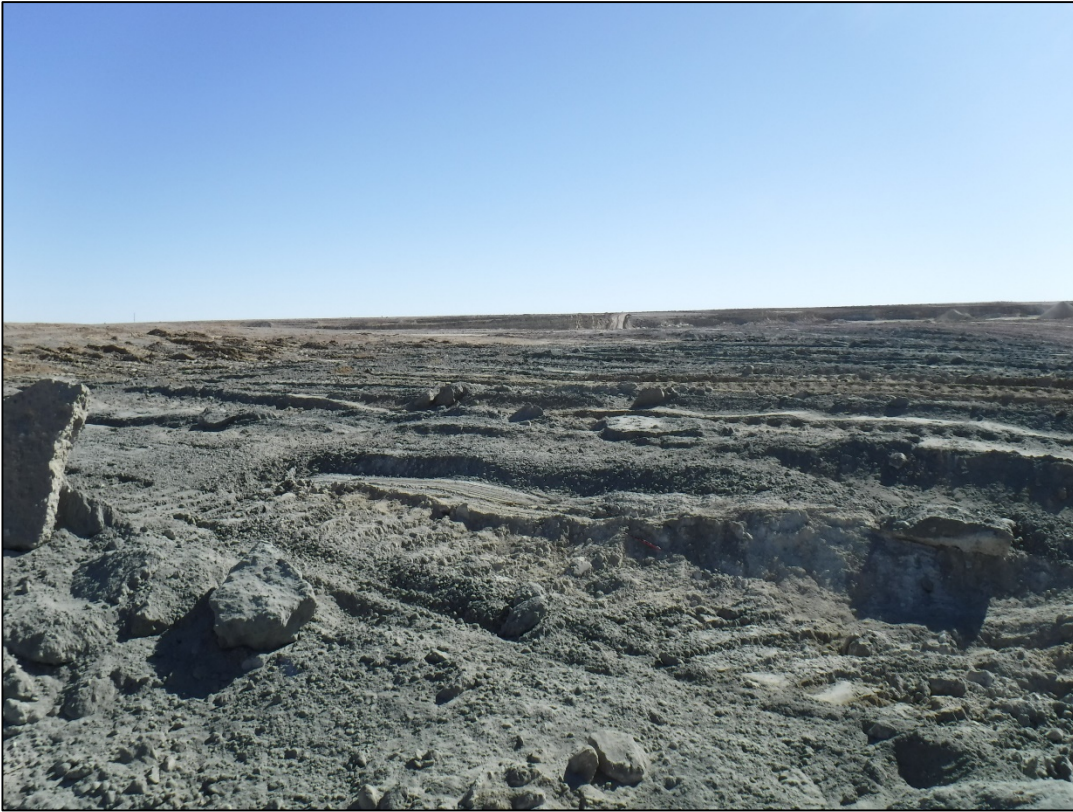
**Photo 11:** Reject raw feed and product used for backfill, will be under three feet of overburden and topsoil

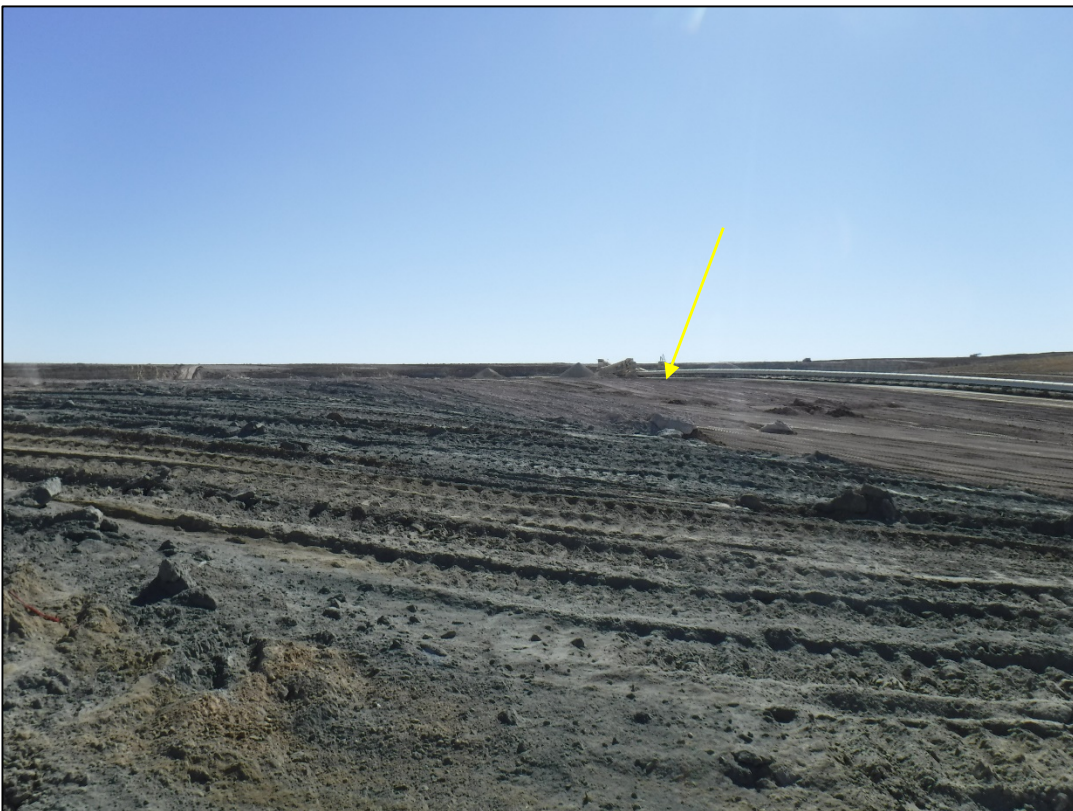
**Photo 12:** Reject material foreground and bag house dust material background (yellow arrow)

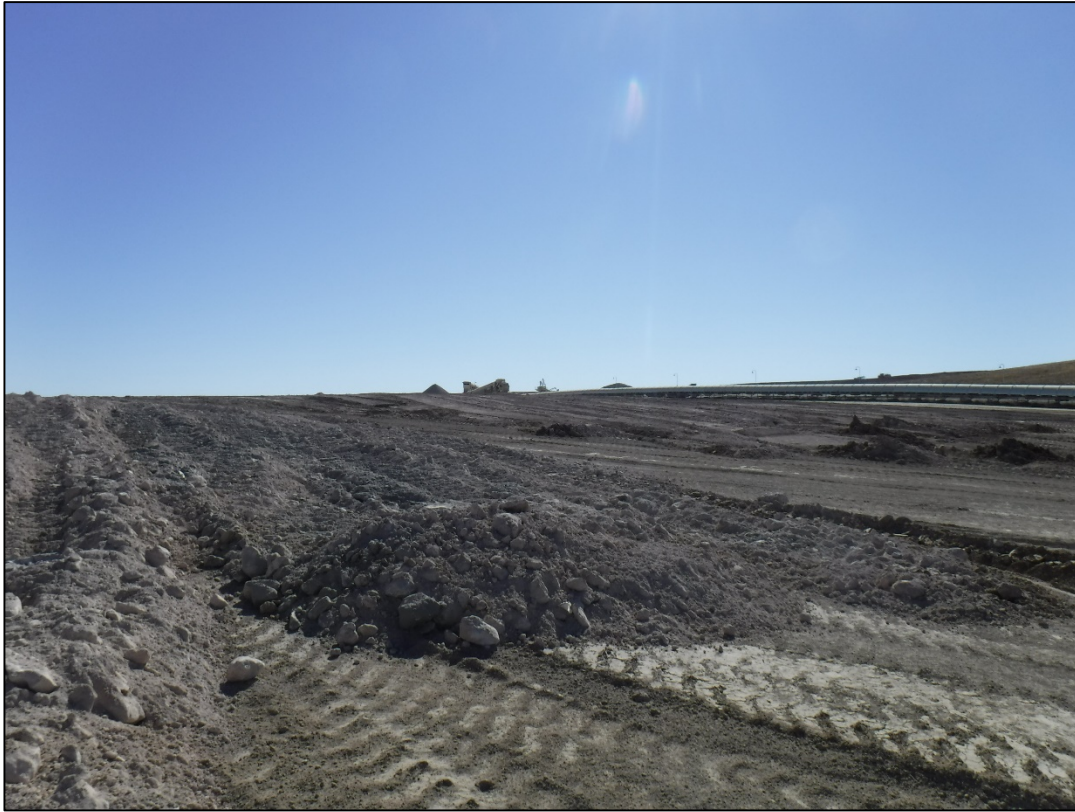
**Photo 13:** Bag house dust material being beneficially reused

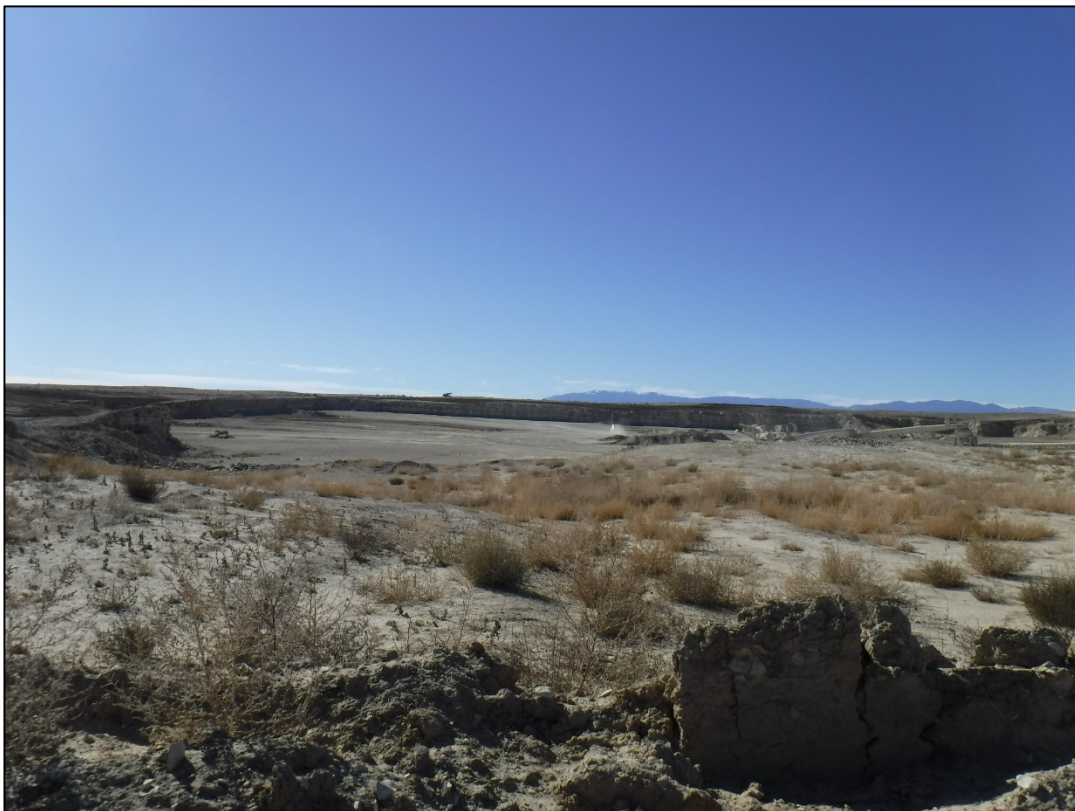
**Photo 14:** Active pit area from a distance

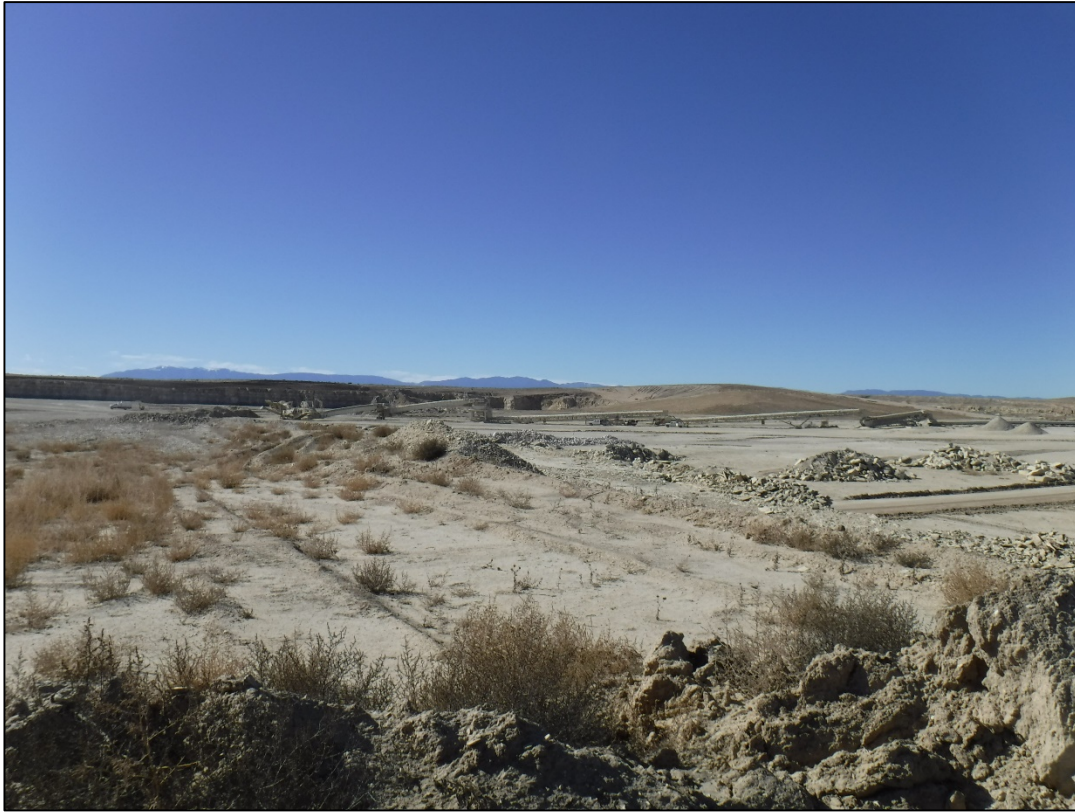
**Photo 15:** Conveyor belt system with crusher/screener (center left of picture)

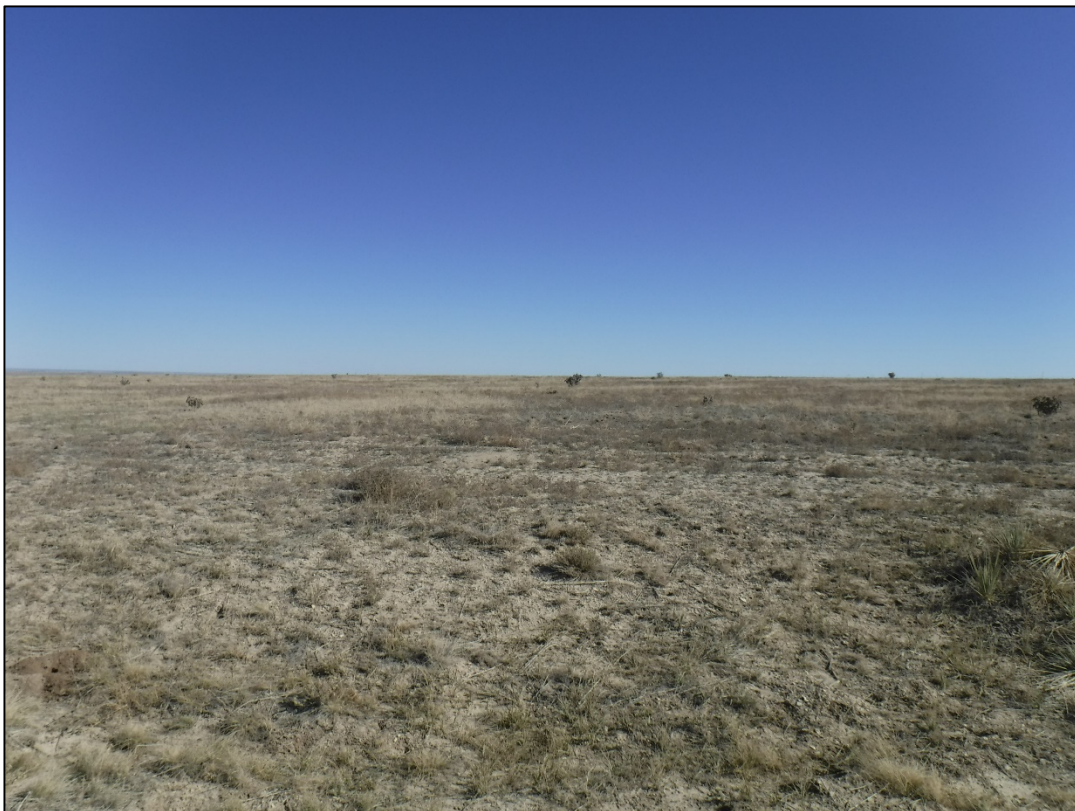
**Photo 16:** Conditions of site unaffected by mining

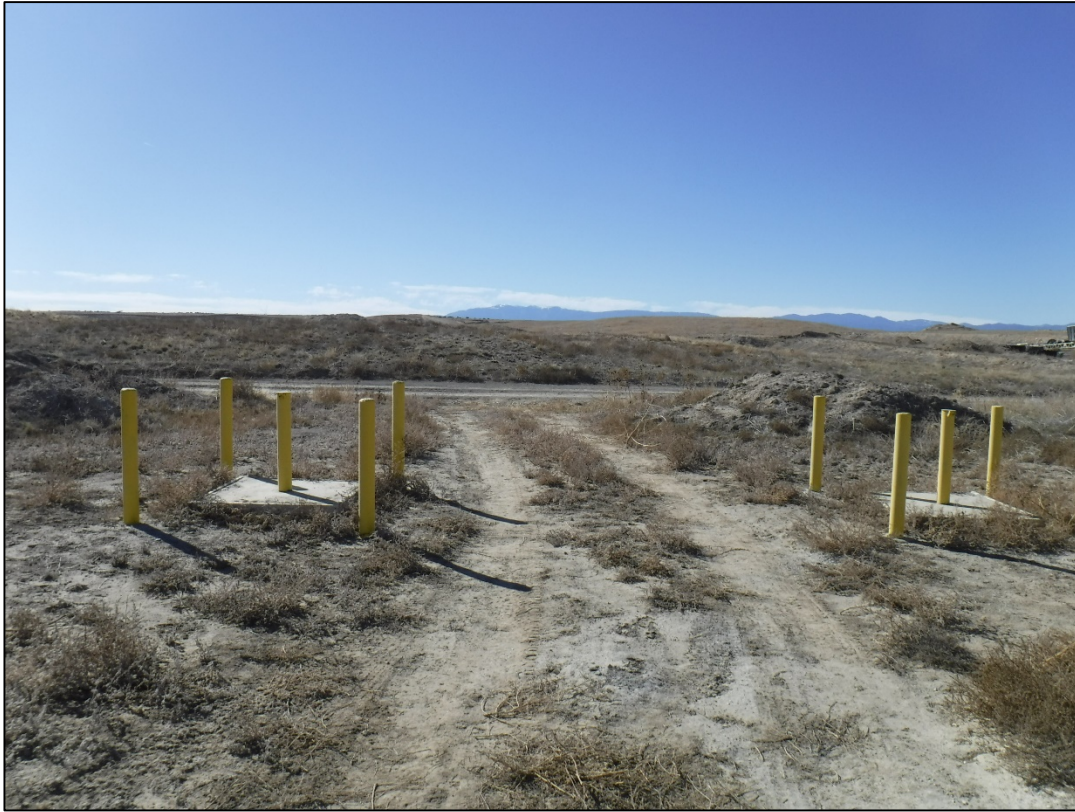
Currently there are three groundwater monitoring wells, MW-6, -7, and -8 that are sampled quarterly. Well MW-8 was installed earlier this year. Sample collection from wells MW-6 and MW-8 have proven to be challenging due to low recharge rates. The operator is currently evaluating protocols and methods to be able to consistently collect samples from the slow recharging wells. As part of TR-7 the operator submits to the Division an annual groundwater sampling report. Any exceedances of groundwater standards are reported in accordance with Rule 3.1.7(9).

**Photo 17:** Monitoring wells 6 and 7

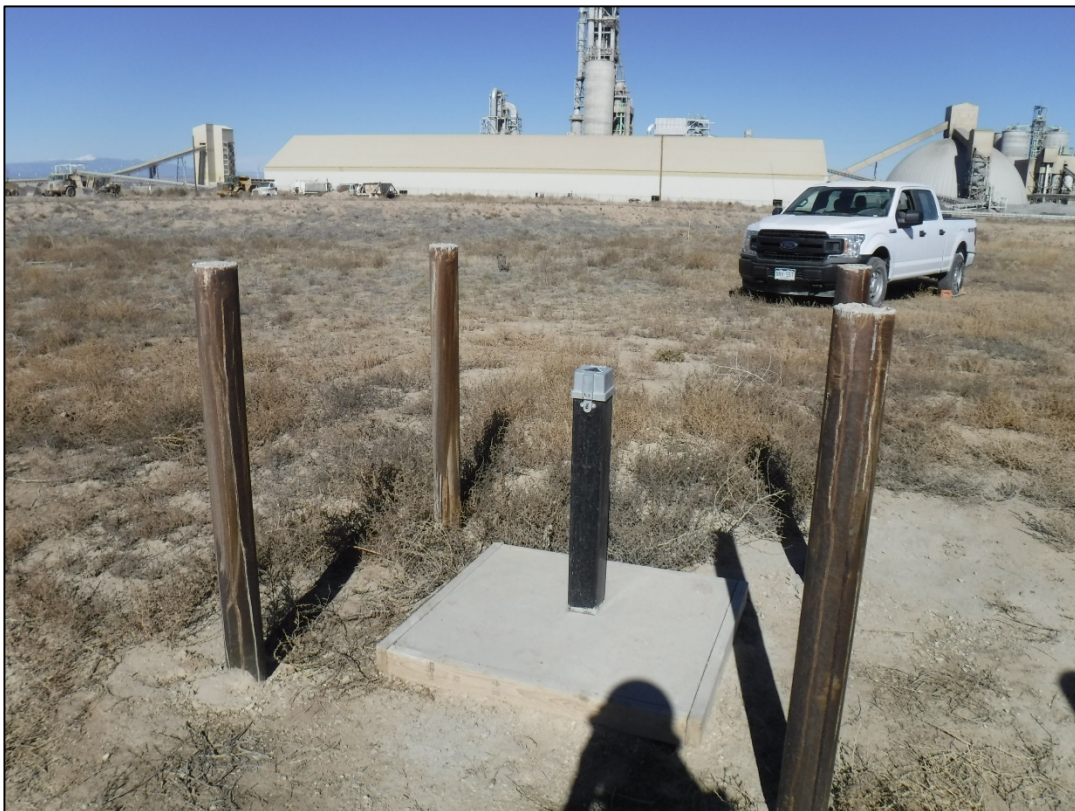
**Photo 18:** Monitoring well 8

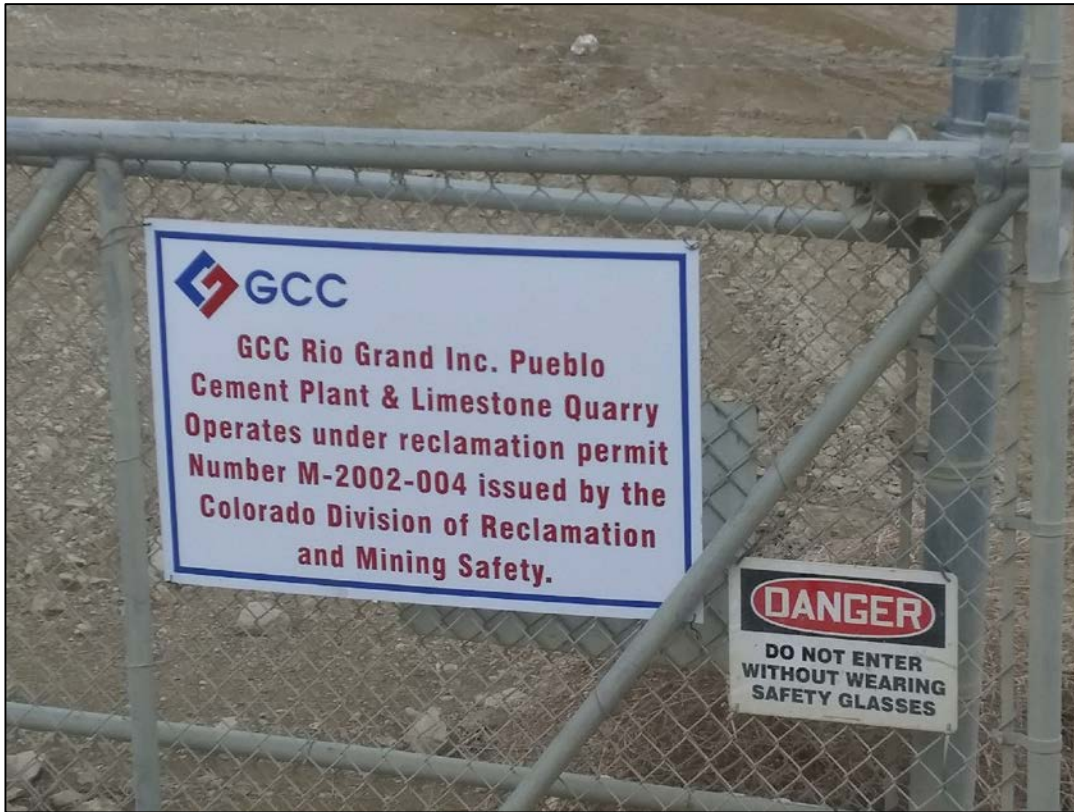
The Pueblo Cement Plant and Limestone Quarry is located in Pueblo County approximately 8 miles south southeast of Pueblo, Colorado. The Pueblo Cement Plant and Limestone Quarry is a 2,500- acre 112c Construction Materials Reclamation Permit. The permit was issued in August 2003. The primary commodity mined at the site is limestone. The approved post-mining land use for the quarry area is rangeland and industrial/commercial for the plant site area. A mine sign was not posted at the mine entrance as required by Rule 3.1.12. However, after the inspection the operator was able to post a new mine sign prior to issuance of this report.

Photo 19: Mine sign posted after inspection

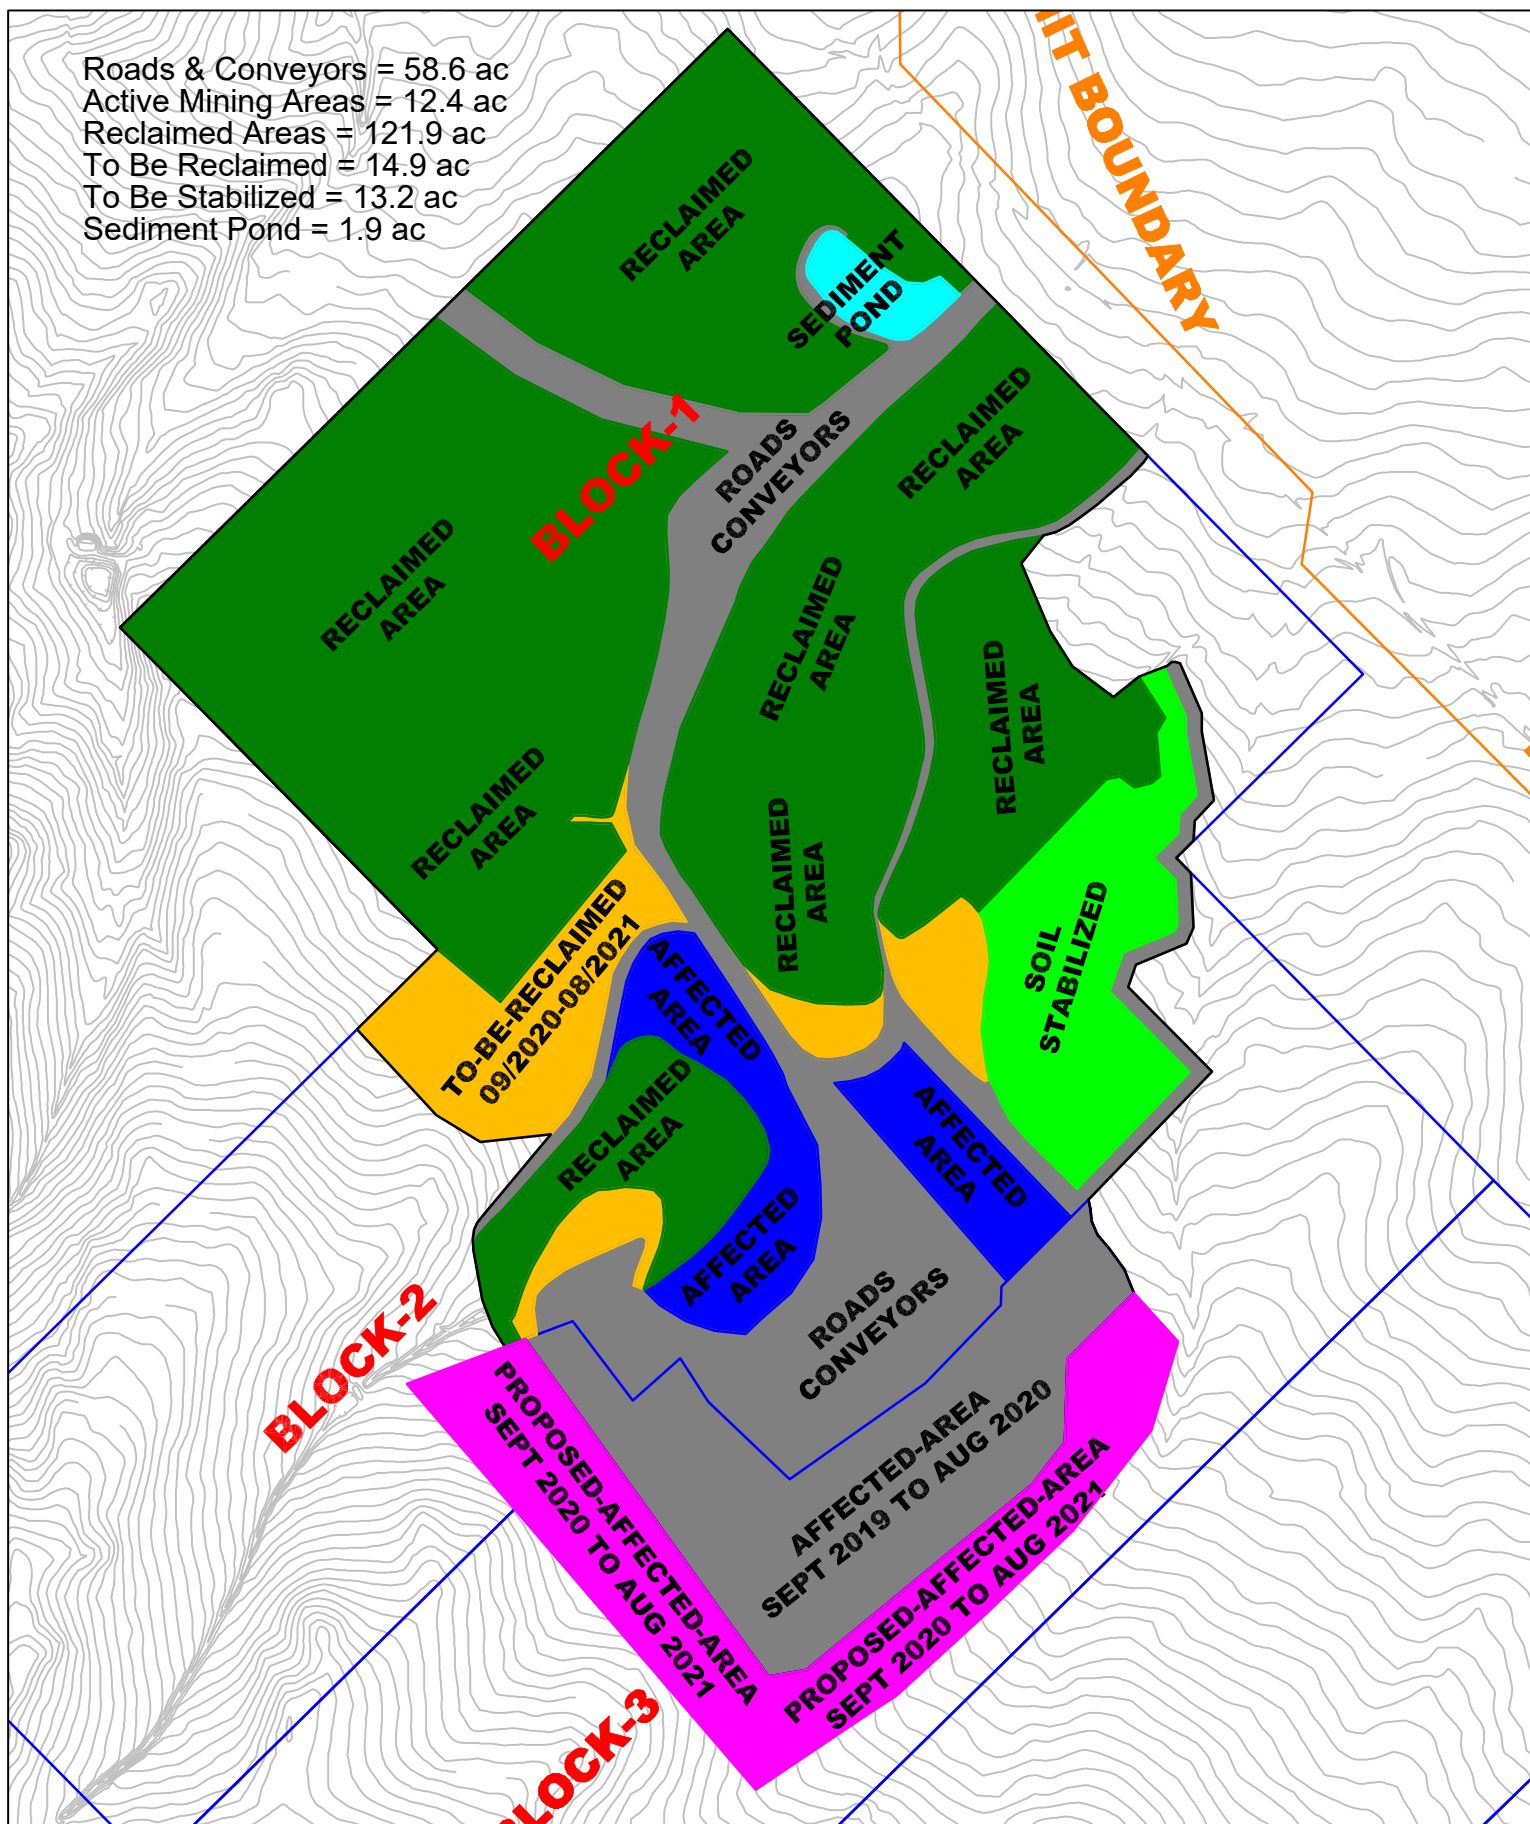
**Project: Reclamation Map**  
**Designed By: Joseph Joshua**  
**Approved By: Joseph Joshua**

Mining activities have affected all of mine block 1 and portions of mine blocks 2 and 3, see attached map. The attached map, provided by the operator, shows the status of the affected area as of 11/19/2020. Approximately 121.9 acres have been backfilled, graded to a 3H:1V slope or shallower, and seeded. There are some areas that have 3+ years of growth and appear very stable and self-regenerating. There are 14.9 acres, to-be-reclaimed, where material is actively being backfilled. There are 13.2 acres, stabilized, that require final grading and seeding. The active mining area is 12.4 acres and includes a highwall that is 14,670 feet long and averages 29 feet in height. Haul roads and conveyors account for 58.6 acres. The conveyor system consists of 4,440 feet of conveyor from a storage dome to a mobile crusher. The conveyor system is cemented in place with the remaining portion is made up of a mobile conveyor segments to the crusher/screener. Stormwater runoff from in the quarry area is directed to a 1.9 acre pond located at the entrance to the quarry area. The pond is pumped out according to their discharge permit.

Roads & Conveyors = 58.6 ac  
 Active Mining Areas = 12.4 ac  
 Reclaimed Areas = 121.9 ac  
 To Be Reclaimed = 14.9 ac  
 To Be Stabilized = 13.2 ac  
 Sediment Pond = 1.9 ac
