Permit Number: C-1992-081 Mine Name: Hayden Gulch Loadout Operator: Hayden Gulch Terminal, LLC Operator Address: Ms Miranda Kawcak County: Routt Operation Type: Loadout Permit Status: Active Ownership: Private

Inspection Start Date: December 8, 2020 Inspection Start Time: 10:00 Inspection End Date: December 8, 2020 Inspection End Time: 10:15			Inspection Type: Aerial Inspection Inspection Reason: Normal I&E Program Weather: Clear		
Joint Inspection Agency:		Joint Inspection Contacts:			
None					
Post Inspection Agency:		Post Inspection Contacts:			
None					
Inspector(s):	Inspector's Signat		0	re Date:	
Tabetha Lynch	Tatha	Ty	12/1	1/20	
Brock Bowles

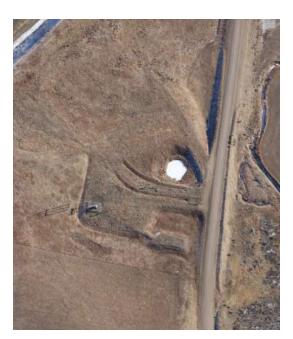
Ponds appear to be holding little to no water and are snow covered. The truck loadout pond and substation are shown in the photo below along with the former haul road. The former haul road is in use and maintained by the County.

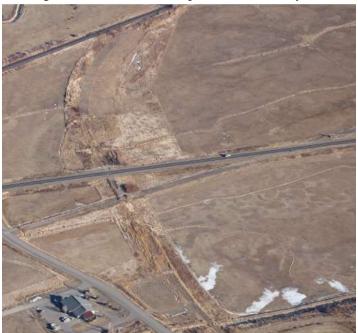
Photo below shows the area to the north of the "trail" parking lot, which is not included in the SL-2 proposed bond release currently under review by the Division to release a portion of the site to recreational use. This area is in process of being reclaimed. Tracks are present across Hwy 40.

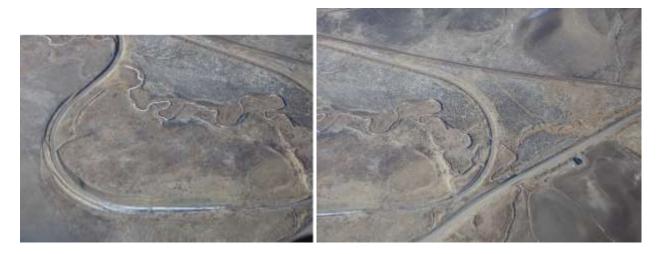
Rail loop shown in 2 photos below, which is proposed to be left to recreational use under PR-2.
