**MINERALS PROGRAM INSPECTION REPORT**  
**PHONE: (303) 866-3567**

<b>MINE NAME:</b> Langston Borrow Pit	<b>MINE/PROSPECTING ID#:</b> M-2020-023	<b>MINERAL:</b> Borrow material for	<b>COUNTY:</b> Fremont
<b>INSPECTION TYPE:</b> Preoperation Inspection	<b>INSPECTOR(S):</b> Brock Bowles	<b>INSP. DATE:</b> December 3, 2020	<b>INSP. TIME:</b> 10:00
<b>OPERATOR:</b> Langston Concrete, Inc.	<b>OPERATOR REPRESENTATIVE:</b> Zac Langston	<b>TYPE OF OPERATION:</b> 112c - Construction Regular Operation	
<b>REASON FOR INSPECTION:</b> Preoperation Inspection	<b>BOND CALCULATION TYPE:</b> None	<b>BOND AMOUNT:</b> No Bond Held	
<b>DATE OF COMPLAINT:</b> NA	<b>POST INSP. CONTACTS:</b> None	<b>JOINT INSP. AGENCY:</b> None	
<b>WEATHER:</b> Clear	<b>INSPECTOR'S SIGNATURE:</b>

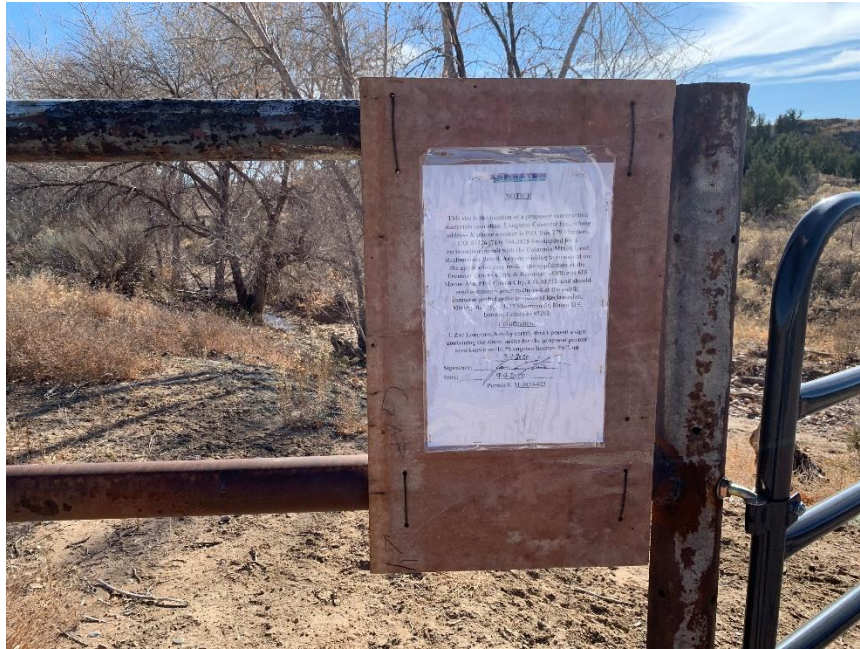
Photo 1 – Public notice facing CR 79

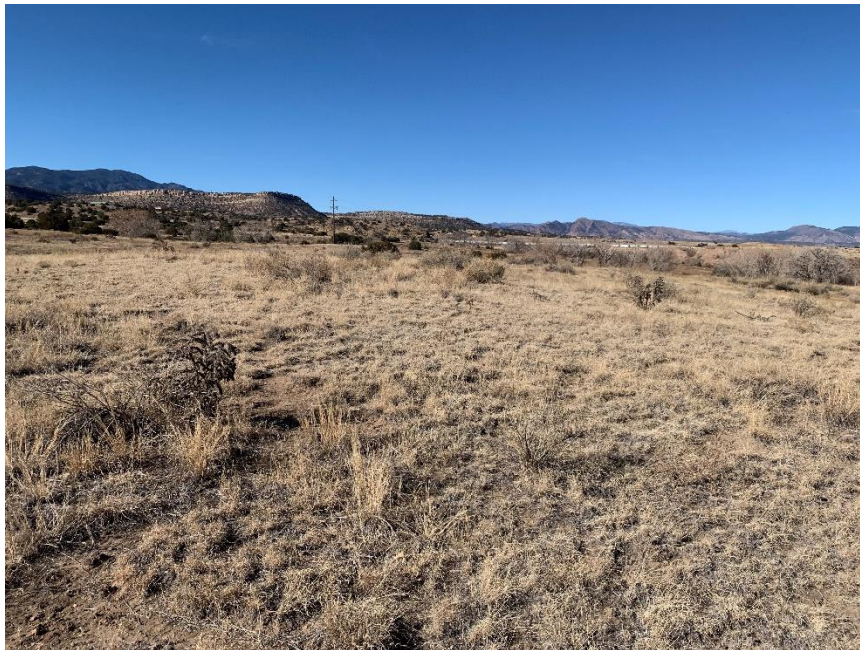
The application proposes to permit 22 acres for the purposes of mining fill dirt, rock and sand. The topography of the proposed mine site mostly flat with a couple of shallow wide drainages (photo 2). The mine site has a gentle slope to the north. Most of the northern boundary is bordered by the Minnequa Canal. A trench is located in the western part of the permit area. The trench is for the Freemont Sanitation District sewer line. The trench is large enough that it is used for vehicles to access the mine site (photo 3). The current entrance road to the mine site crosses Oak Creek which is an ephemeral drainage (photo 4) and was dry during the inspection.

Photo 2 – Proposed mine site topography, looking NW

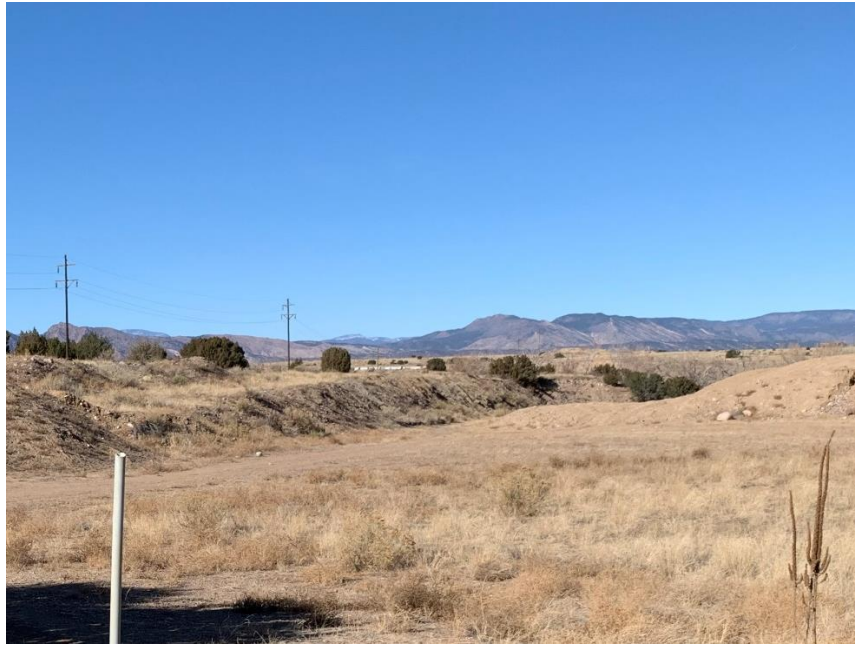
Photo 3 – Top of sewer line trench.

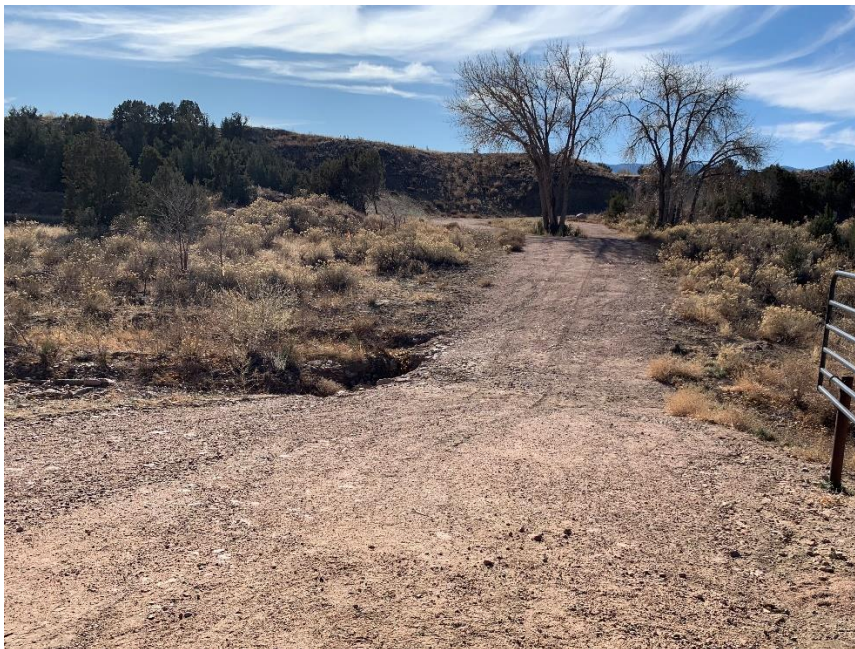
Photo 4- Oak Creek low water crossing

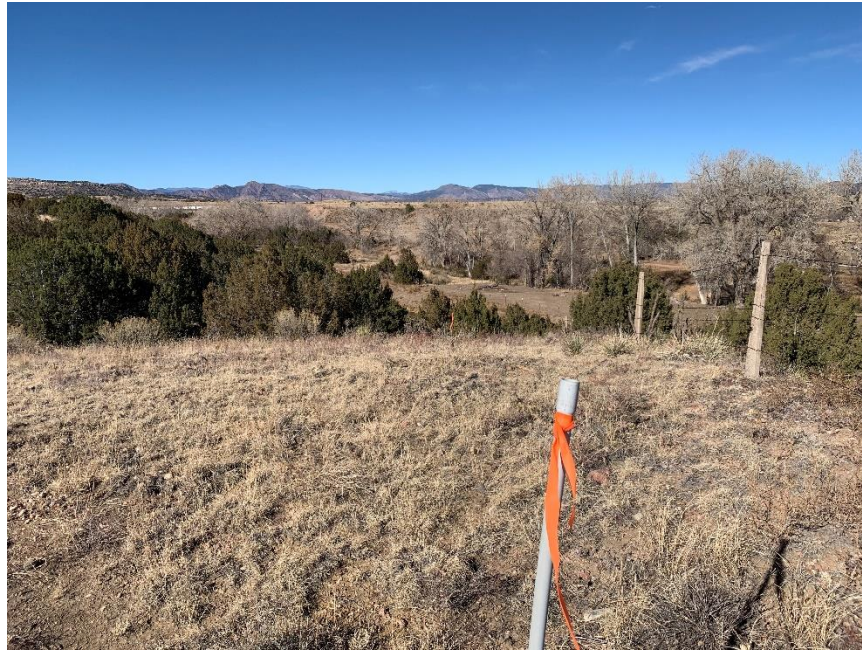
The vegetation on the mine site consisted of dry, upland prairie species. Most of the vegetation was winter dormant and identification was only possible on a few species: blue grama, fourwing saltbush, cholla, rabbitbrush, cedar and yucca. A little bit of cheatgrass, kochia and Russian thistle in the southwestern corner where the land has been disturbed. Overall, most of the site appeared to consist of native species. No erosion features were noted. Permit boundary markers have been installed (photo 5).

Photo 5 – Permit boundary markers along northern boundary
