MINERALS PROGRAM INSPECTION REPORT
PHONE: (303) 866-3567

MINE NAME: Climax Mine	MINE/PROSPECTING ID#: M-1977-493	MINERAL: Molybdenum	COUNTY: Lake, Summit
INSPECTION TYPE: Aerial Inspection	INSPECTOR(S): Dustin Czapla	INSP. DATE: December 1, 2020	INSP. TIME: 12:00
OPERATOR: Climax Molybdenum Company	OPERATOR REPRESENTATIVE: None	TYPE OF OPERATION: 112d-3 - Designated Mining Operation	
REASON FOR INSPECTION: Normal I&E Program	BOND CALCULATION TYPE: None	BOND AMOUNT: \$91,011,850.00	
DATE OF COMPLAINT: NA	POST INSP. CONTACTS: None	JOINT INSP. AGENCY: None	
WEATHER: Clear	INSPECTOR'S SIGNATURE:

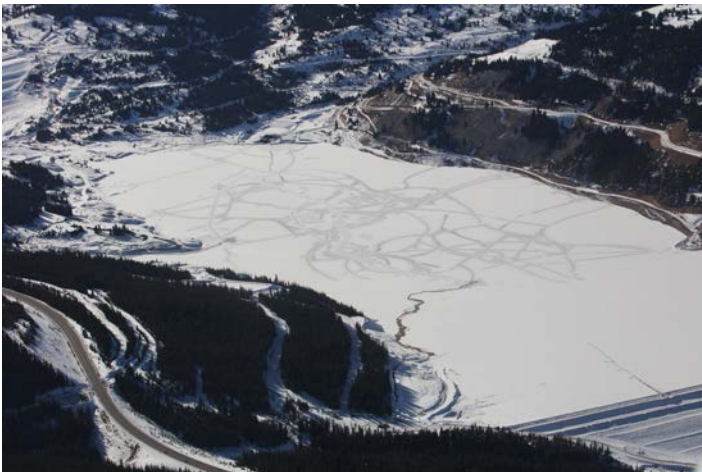
The Mayflower TSF and 5 Dam, Tenmile TSF and 3 Dam, Robinson TSF and 1 and 2 Dams, Robinson Lake, Eagle Park Reservoir and 4 Dam were observed. The area was under snow cover, up to approximately one foot depth. No staining or discoloration were noted at any of the TSF dams. No abnormal conditions were noted. TSF's appear to be functioning within the established design criteria.

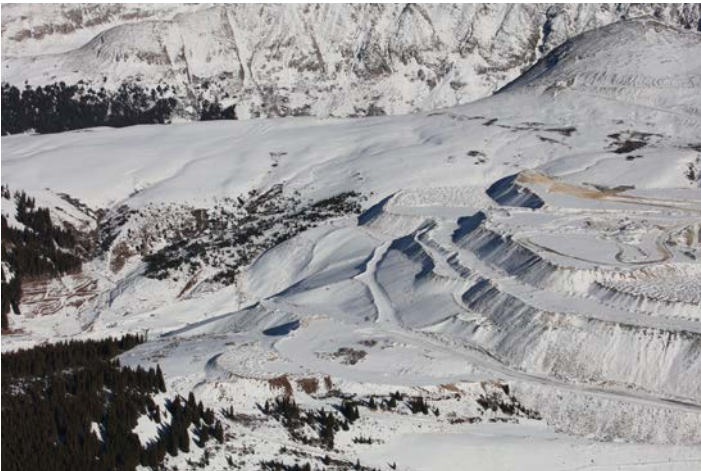
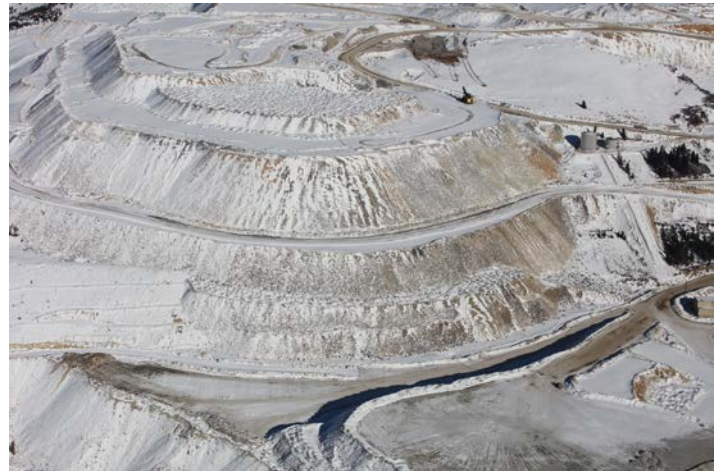
McNulty OSF

The McNulty and North 40 OSF's were observed. Snow cover on the OSF's appeared to range from approximately one foot on north and west facing slopes, to no snow cover on south facing slopes. The current OSF operating plan was drafted by Golder Associates in December 2016. The plan was submitted to the Division as part of TR-25. Climax appears to be in compliance with Golder recommendations for OSF operations. No problems were noted with the OSF's.
