MINERALS PROGRAM INSPECTION REPORT

MINE NAME: Phil Sheridan Lode	MINE/PROSPECTING ID#: M-1988-081	MINERAL: Gold and silver	COUNTY: Boulder
INSPECTION TYPE: Surety-Related Inspection	INSPECTOR(S): Amy Eschberger	INSP. DATE: December 9, 2020	INSP. TIME: 10:00
OPERATOR: Harry Covey	OPERATOR REPRESENTATIVE: Janice Wheeler, Dennis Covey	TYPE OF OPERATION: 110(1) - Hard Rock Limited Impact	
REASON FOR INSPECTION: Surety Related	BOND CALCULATION TYPE: Complete Bond	BOND AMOUNT: \$6,100.00	
DATE OF COMPLAINT: NA	POST INSP. CONTACTS: None	JOINT INSP. AGENCY: None	
WEATHER: Clear	INSPECTOR'S SIGNATURE: 	SIGNATURE DATE: December 22, 2020

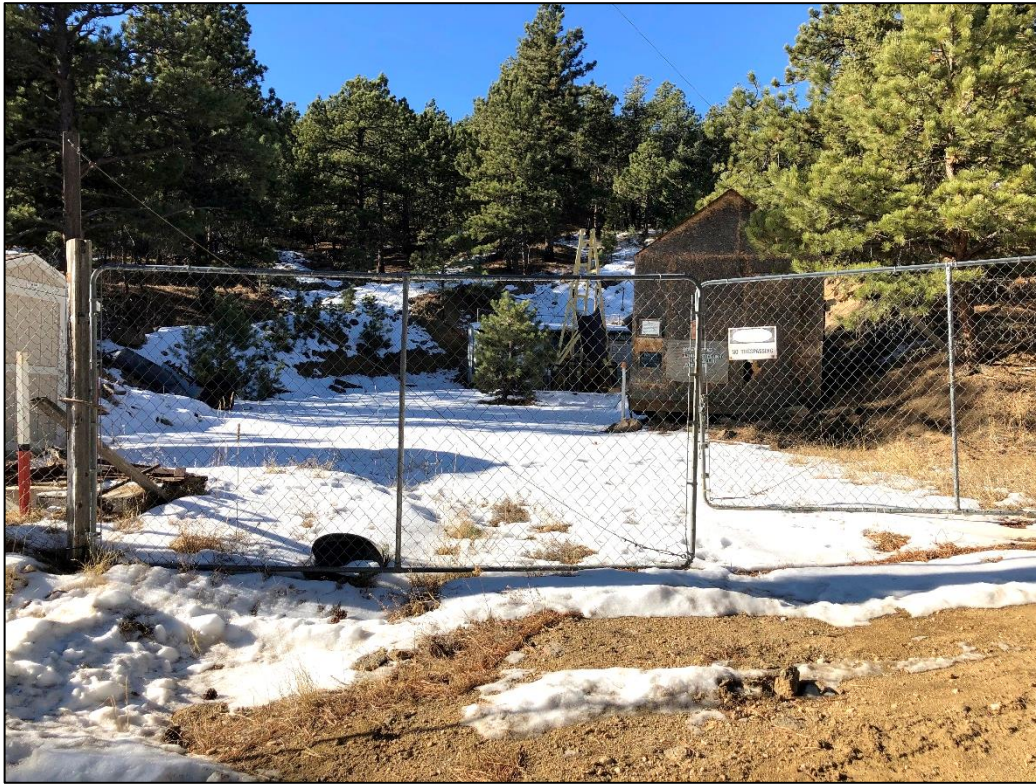
Photo 1. View looking southwest at gated entrance to mining area.

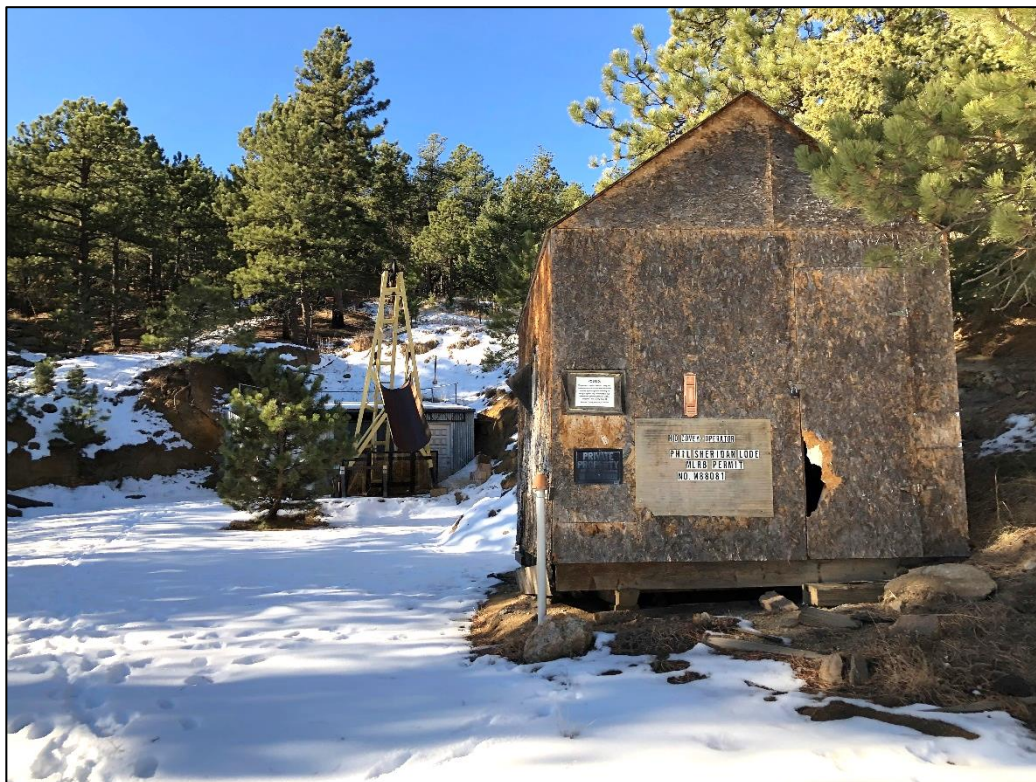
Photo 2. View looking southwest across mining area, showing equipment shed constructed of particle board (in foreground) and mine shaft, headframe, and winch house (in background).

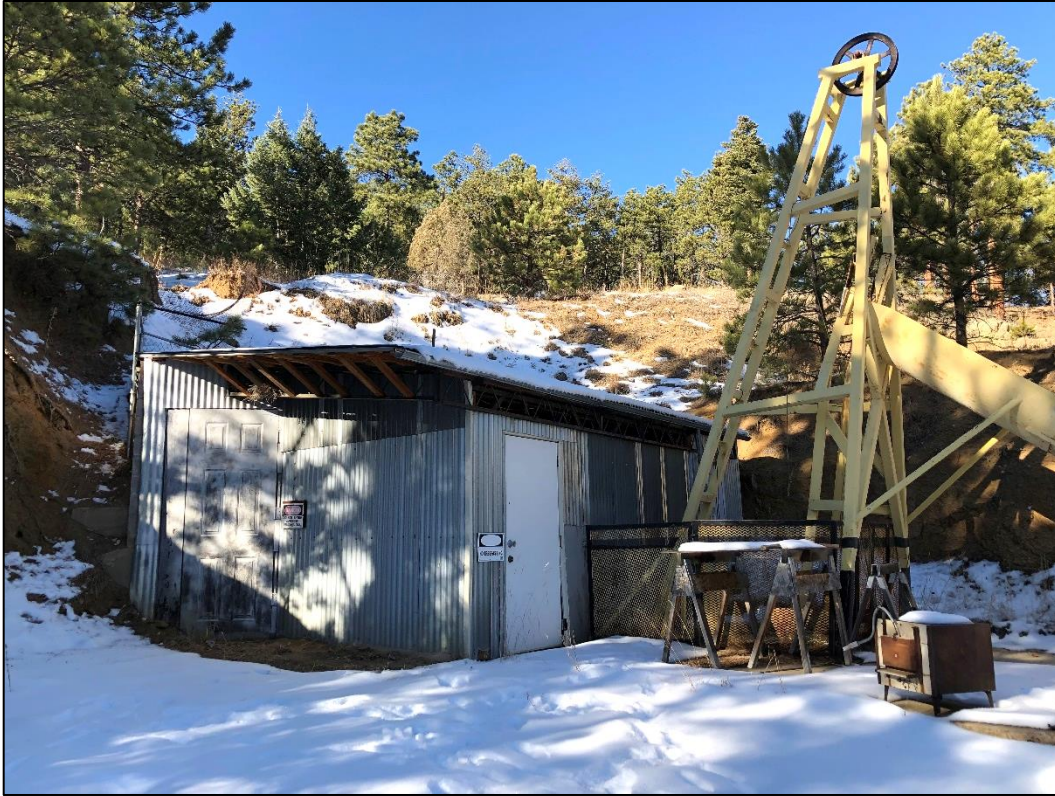
Photo 3. Closer view of fenced mine shaft, steel headframe above shaft, and winch house constructed of corrugated metal, located at southwestern edge of mining area.

After conducting this inspection, the Division determined remaining reclamation at the site includes demolishing and removing the steel headframe and winch house, grading disturbed slopes to 3H:1V, and retopsoiling and revegetating a total of 0.4 acre of disturbance. The currently held financial warranty of \$6,100.00 was found to be adequate for completing this reclamation.

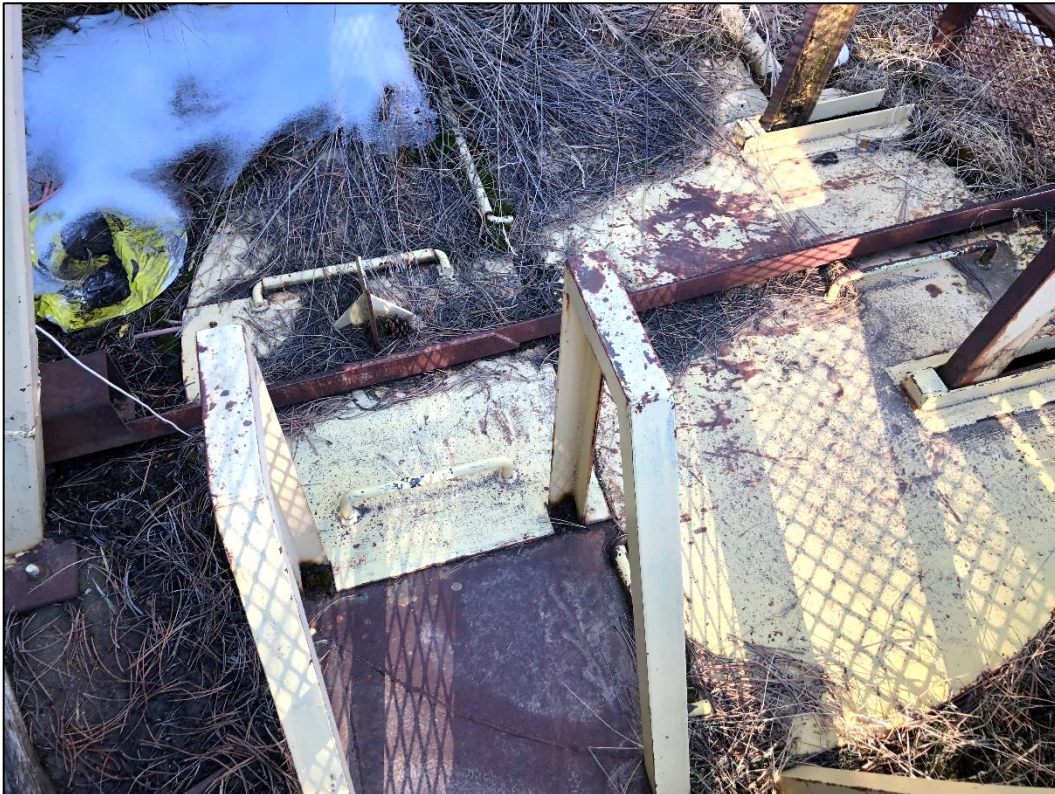
Photo 4. Closer view of mine shaft collared in concrete slab and secured by covered locking device.

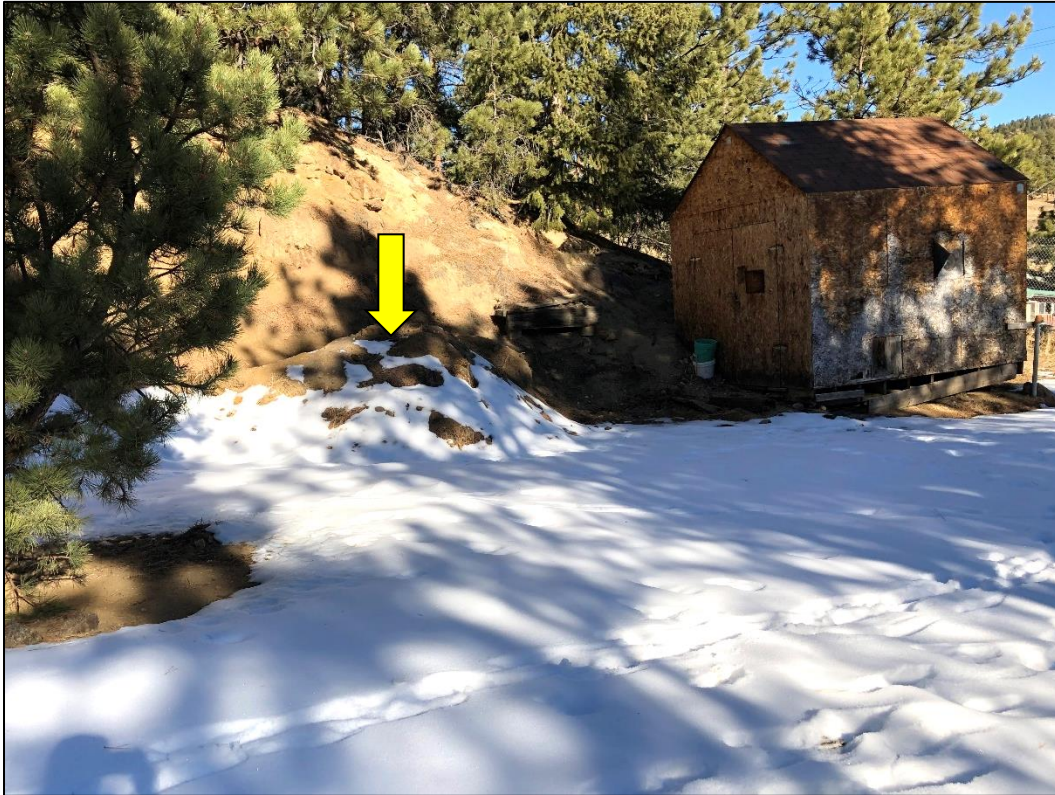
Photo 5. View looking north across mining area, showing small topsoil stockpile (indicated) and equipment shed constructed out of particle board present in this area.

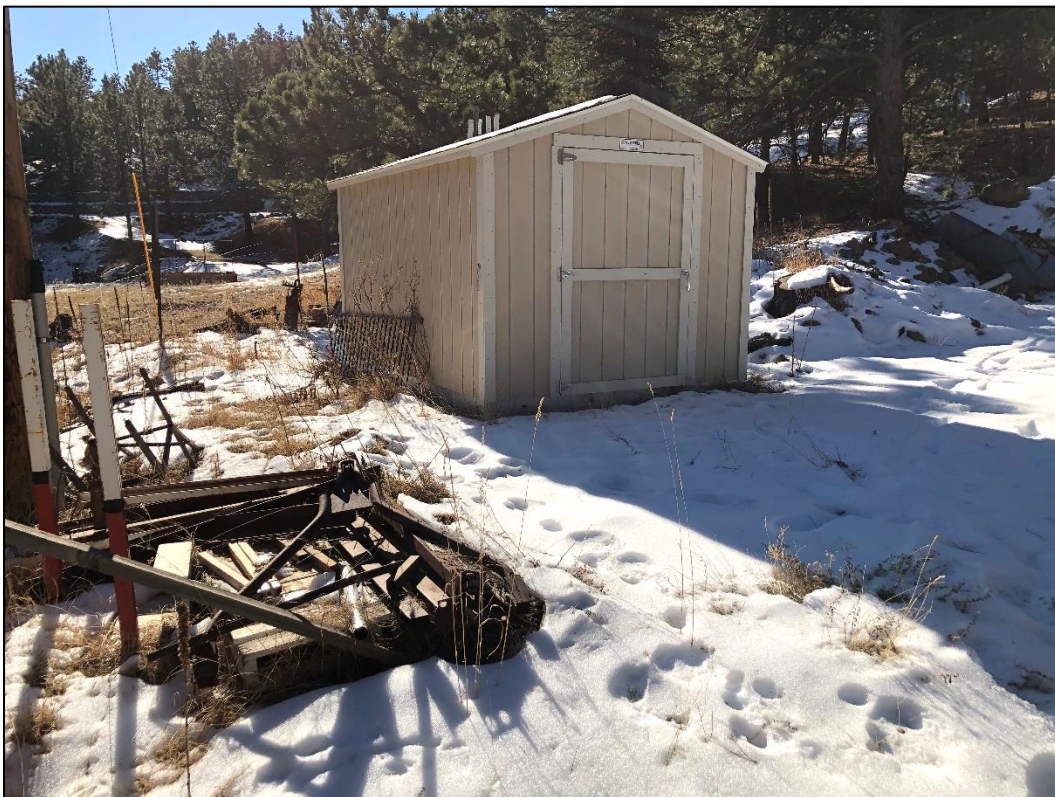
Photo 6. View looking south across mining area showing Tuff shed present in this area.

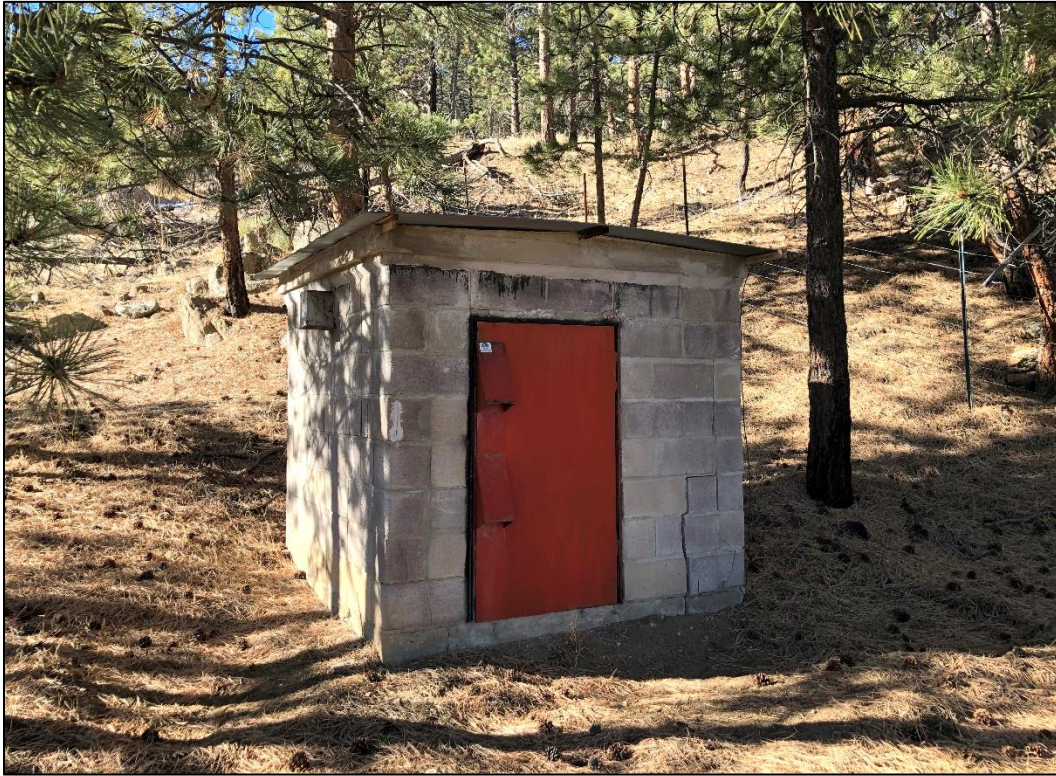
On the hillside west of the mining area, accessed by a separate gated entrance, there are two small cinder-block sheds which were constructed to house the powder and blasting caps (in the larger shed) and the detonators (in the smaller shed). Both sheds were securely locked. However, according to the operator, these sheds have been empty for many years. The operator must maintain explosives permits with the Colorado Division of Oil and Public Safety and with the Bureau of Alcohol, Tobacco, Firearms, and Explosives (ATF) for the transportation, use, and storage of explosives on site. According to the permit file, the operator had the appropriate explosives permits in place during the 1990's when blasting was conducted on site. However, the appropriate explosives permits were not maintained after operations ceased, and the on-site storage of explosives was discontinued.

Photo 7. View looking southwest at cinder-block explosives storage building with locked door present in northwestern portion of permit area. According to operator, this building has been empty for the past few decades.

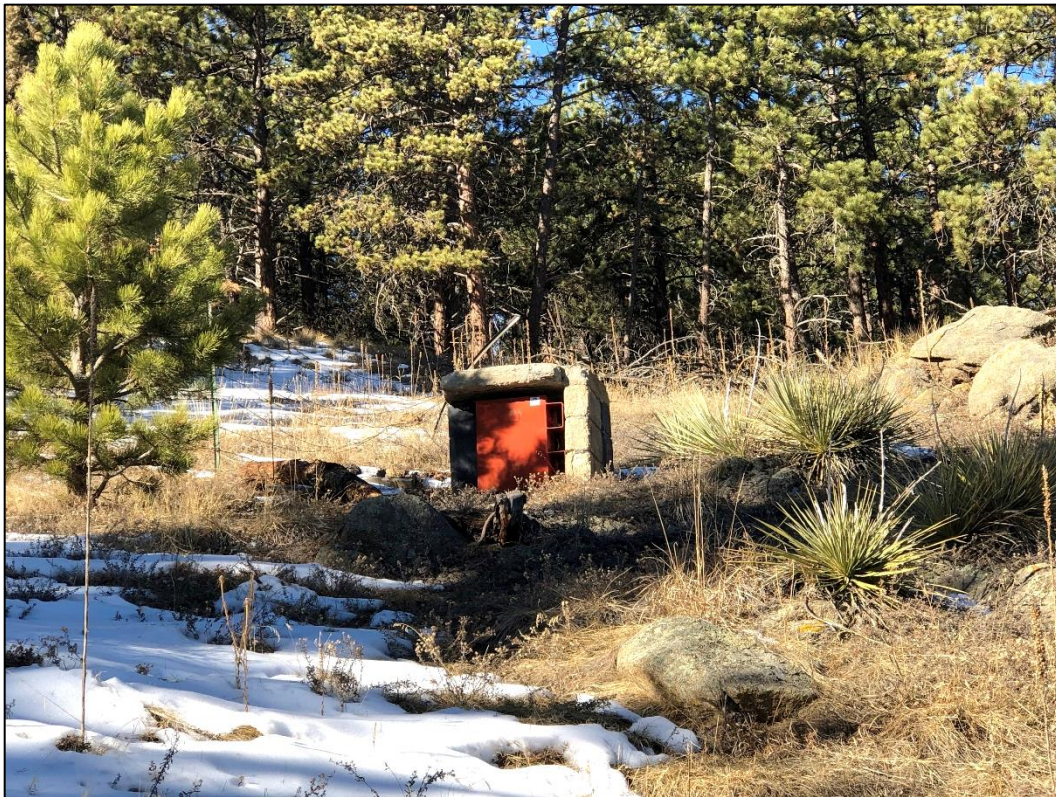
Photo 8. View looking southwest at smaller cinder-block explosives storage building with locked door present in northwestern portion of permit area. According to operator, this building has been empty for the past few decades.

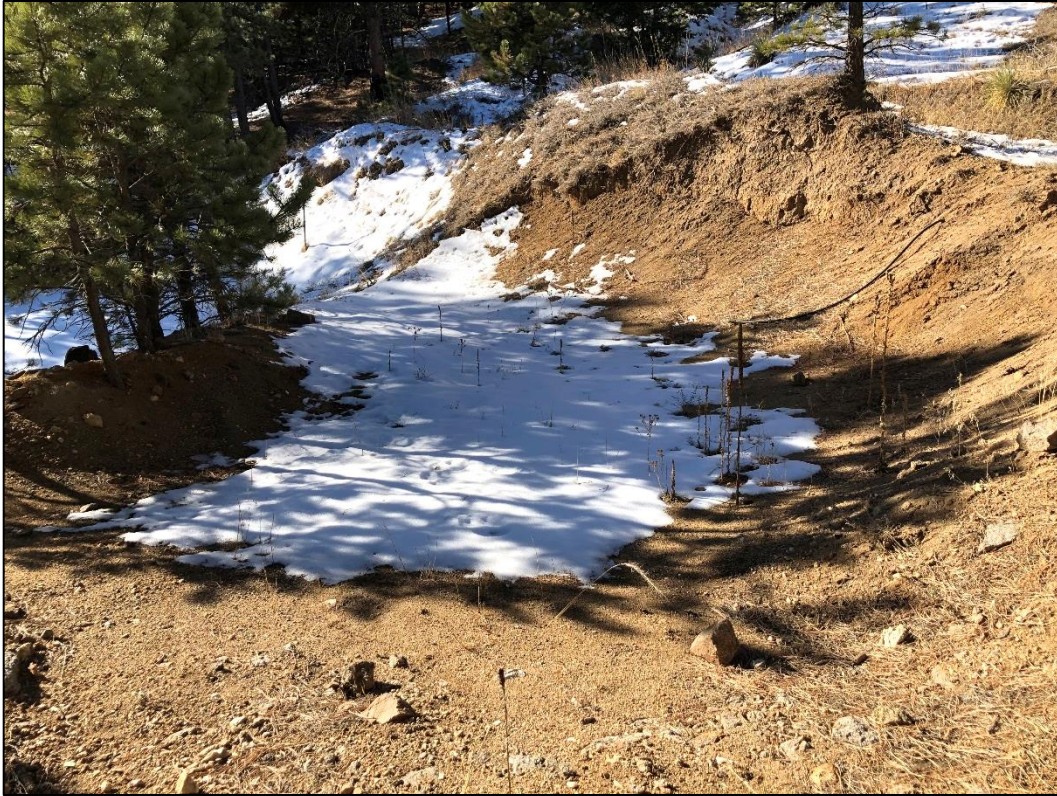
The Division observed a disturbed area approximately 0.1 acre in size located between the explosives storage area and the mining area where, according to the permit file, waste rock and/or development material had been stored at one time. This area will need to be graded, retopsoiled and seeded for reclamation. According to Mr. Covey, the access road to the explosives storage area continues through the site to a historic mine shaft located outside of the permit area. This shaft was sealed some years ago by the Division's Inactive Mine Reclamation Program (IMRP). Mr. Covey inquired about having IMRP reassess the shaft which has collapsed in recent years, creating unsafe conditions. The Division provided Mr. Covey contact information for Erica Crosby with IMRP.

Photo 9. View looking southwest across old waste rock storage area located on slope between mine area and explosives storage area.

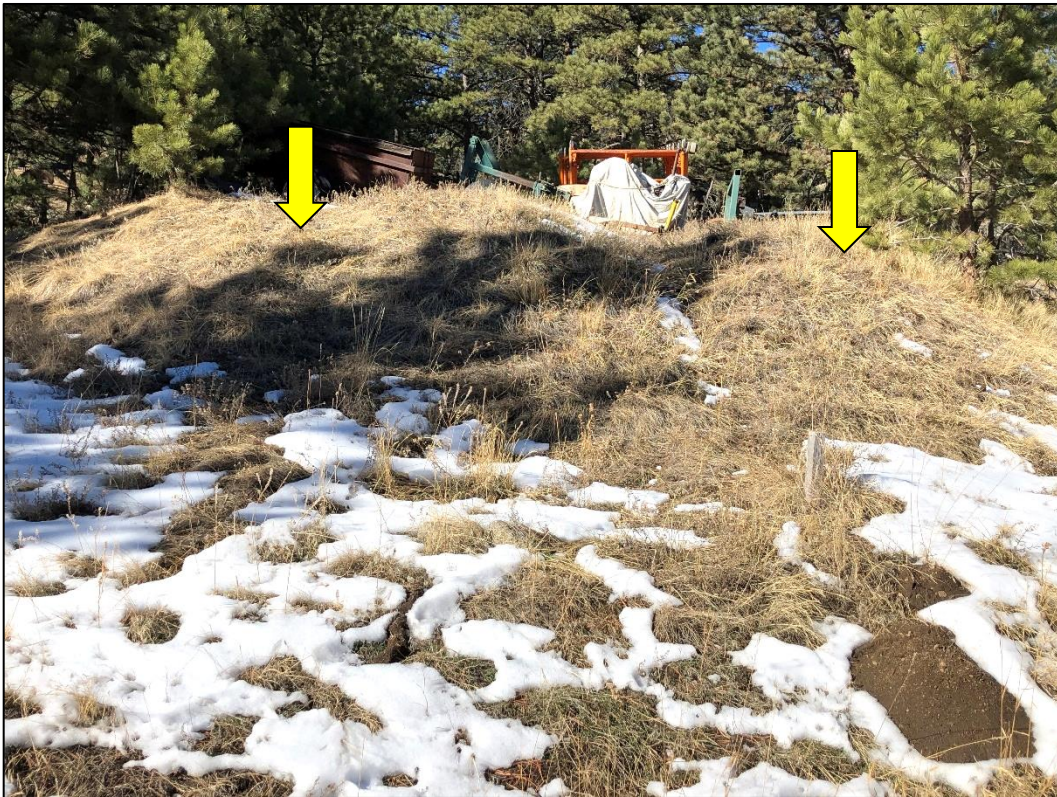
Photo 10. View looking southwest at topsoil stockpile (indicated) stored at northern edge of permit area, outside of fenced enclosure. Note stockpile stable with good grass cover.
