Re: King I Mine, C-1981-035  
Stoner Engineering: Quarterly Inspection: Water Quality Improvements  
4th Quarter 2020

Date: December 17, 2020

Re: King Coal I – Quarterly Water Quality Improvements Inspection

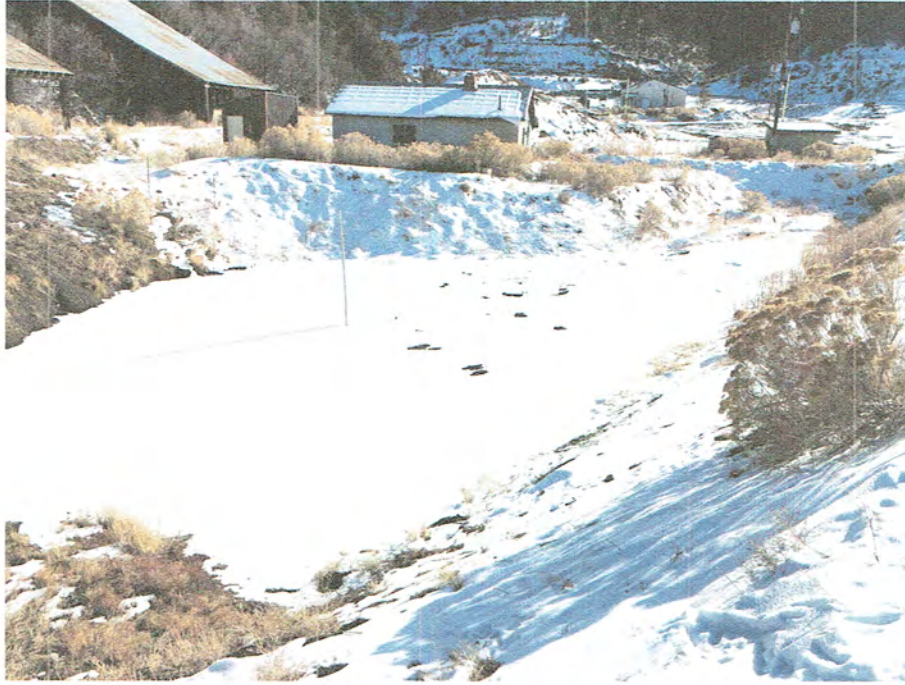
Both ponds were dry but, covered with snow at the time of the inspection and appeared to generally be in good condition (see Pic. 1). The sedimentation gages show the ponds are not yet it need of cleaning (see Pic. 2). The sediment loading in the ponds appeared to be the same since the previous inspection. A large storm event could result in the sediment ponds reaching the level requiring the built-up sediment removed in order to continue to function as originally designed. Preparations/plans for the removal of the excess material during the next significant period with dry conditions (spring/summer 2021) should be considered. The ponds should continue to be monitored after storm events to ensure that excess sediment does not reduce the required storage capacity available for storm water runoff.

Pic. 1 – East pond.

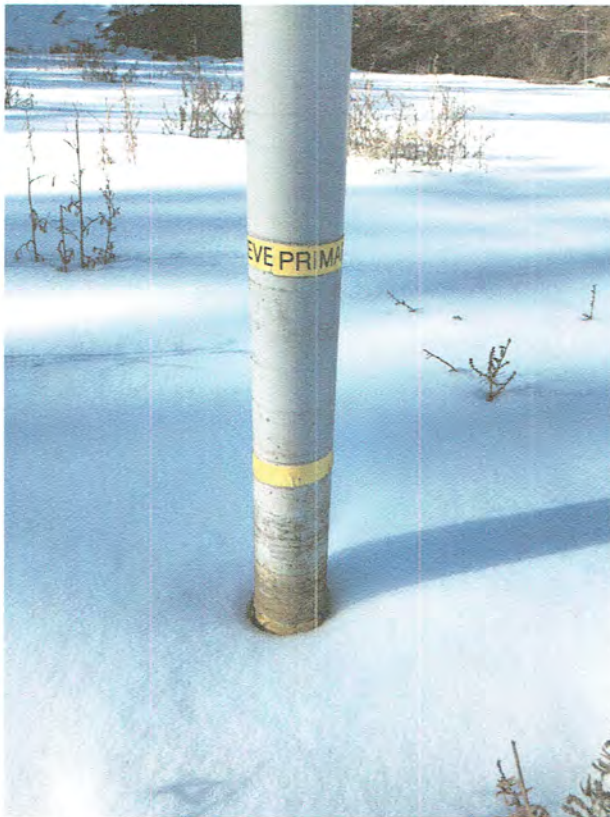
Pic. 2 – West pond sediment gage.

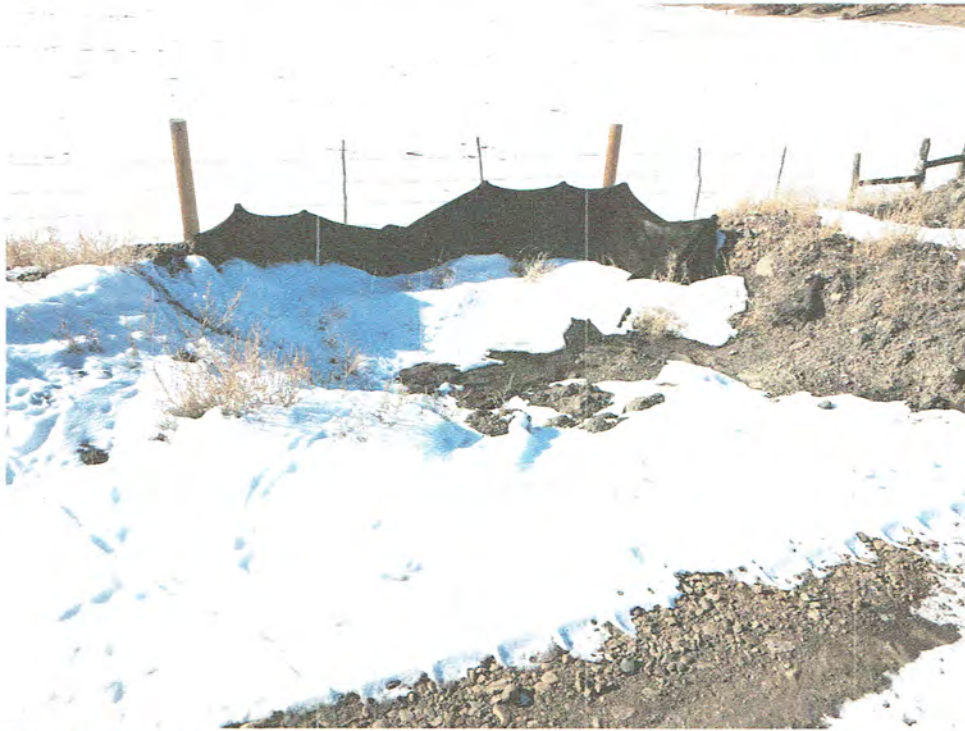
The sedimentation traps at the entrance to the site are generally in good condition (see Pic. 3). The stockpiled waste material has been installed on the lower pile or placed via loader to the top of the main pile. There was no stockpiled material on the site at the time of the inspection (see Pic. 4). The grading of the lower waste embankment pile directs surface runoff generally to the south and west as required in the design documents. The replacement culvert located near the top of the main waste embankment pile under the haul road (at the new switchback) is on-site and being prepped for installation. The new switchback located at the south side of the waste embankment pile has been constructed and additional fill material has been installed at the top pf the pile. A new drainage ditch is being constructed along the new haul road (see Pic. 5).

Pic. 3 – Sediment trap at driveway.

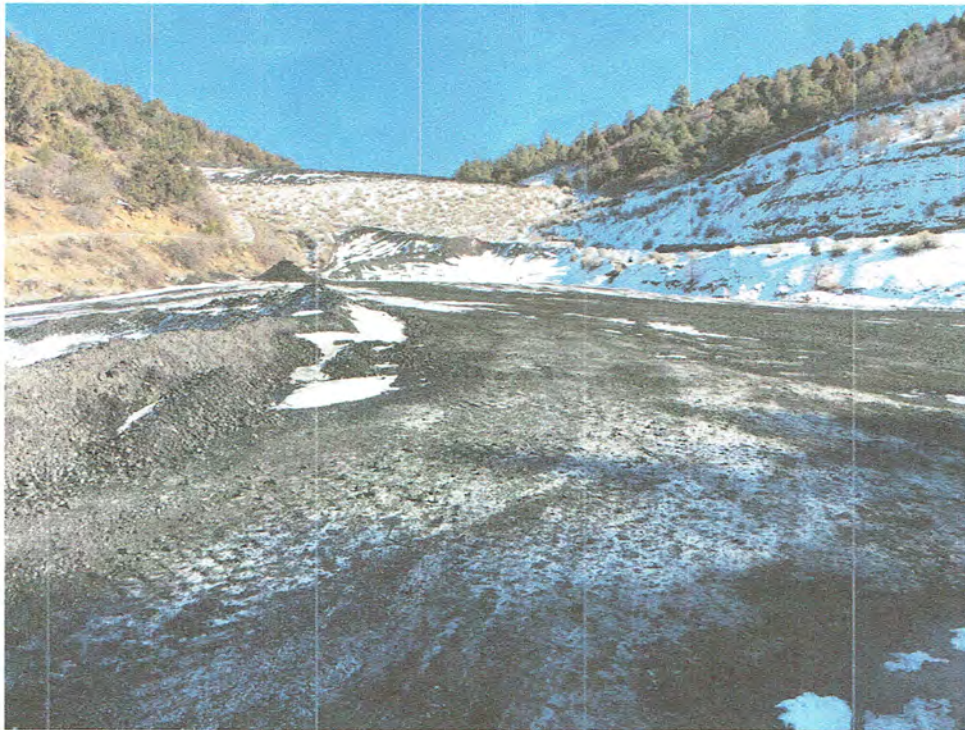
Pic. 4 – Lower waste embankment pile, not stockpiled material.

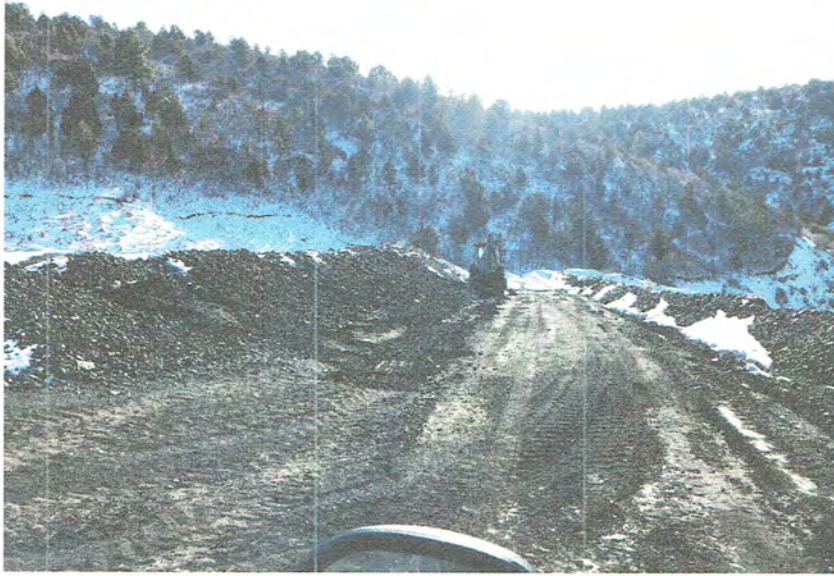
Pic. 5 – Ditch being constructed along haul road above new switchback.

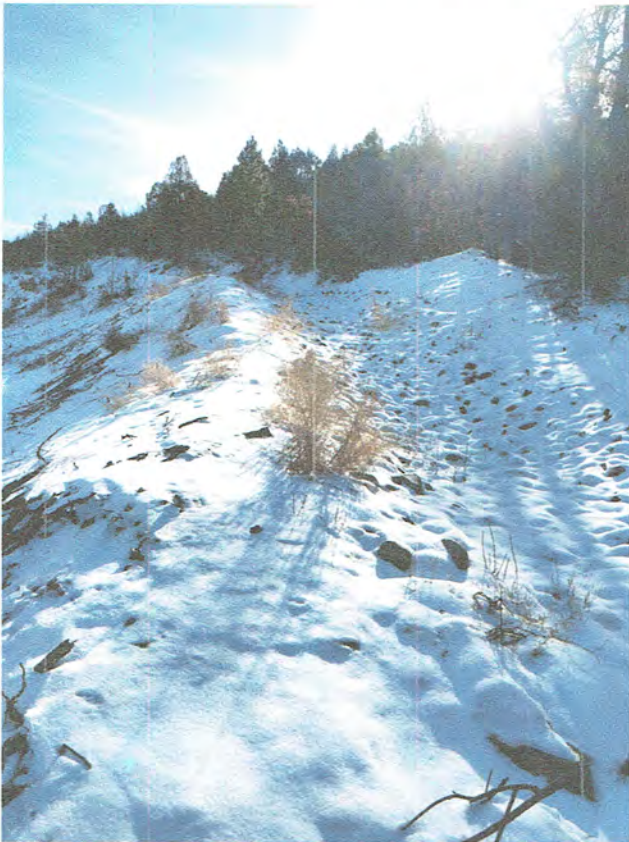
The clear water and the treated water ditches, while covered with some snow accumulation, appeared to be in generally good condition (see Pic. 6). There do not appear to be any issues with any of the ditches or culverts at the time of the inspection, with the exception of the culvert replacement at the new switchback as noted in this report.

Pic. 6 – West clear water ditch.
