Re: King I Mine, C-1981-035  
Stoner Engineering: Quarterly Inspection: Refuse Pile  
3rd Quarter 2020

Date: September 30, 2020

Re: King Coal I – Quarterly Waste Pile/Embankment Inspection

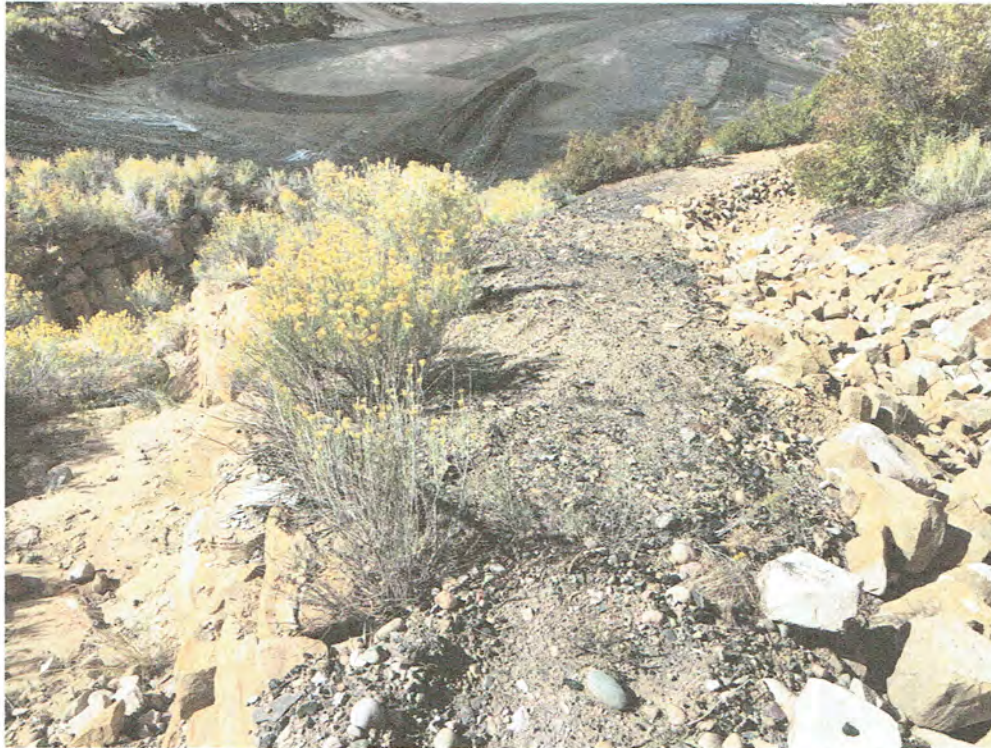
Both the south treated water ditch (Reach 10) and the north clear water ditch (Reach 1) were found to be in generally good condition. A portion of Reach 2 and Reach 13 have been reconstructed higher up the hillside (see Pic. 1). The face of the embankment appeared to be in good condition as there were no signs of excessive erosion, instability or weakness (see Pic. 2).

Pic. 1 –Portion of Reach 2 and Reach 13 reconstructed, old section left side of picture.

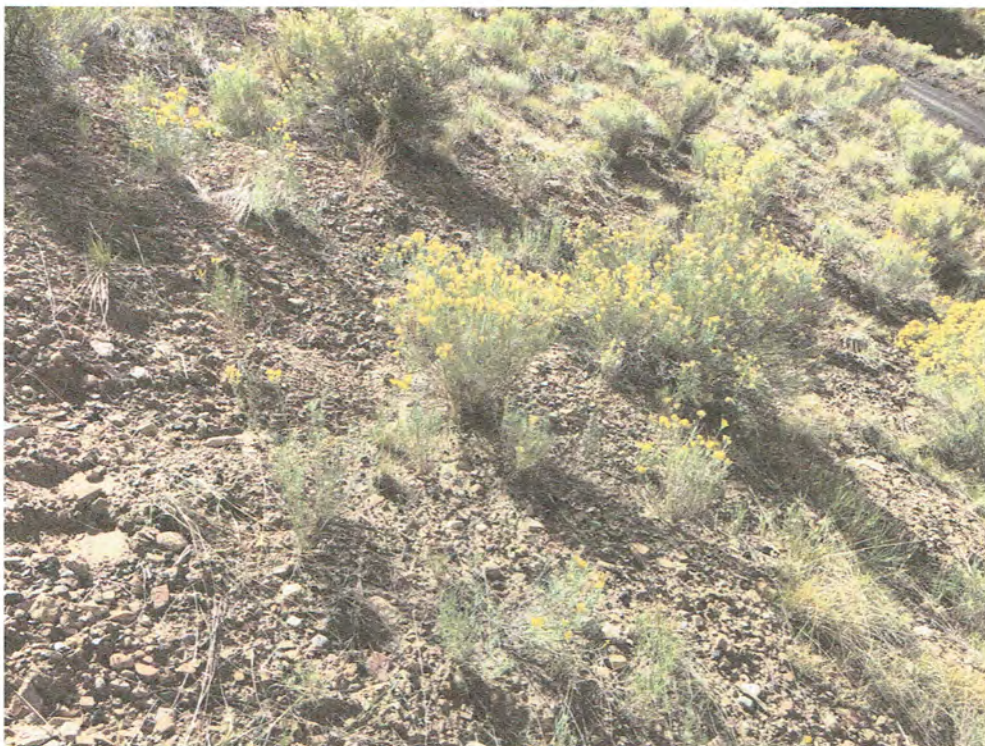
Pic. 2 – Face of waste pile in good condition.

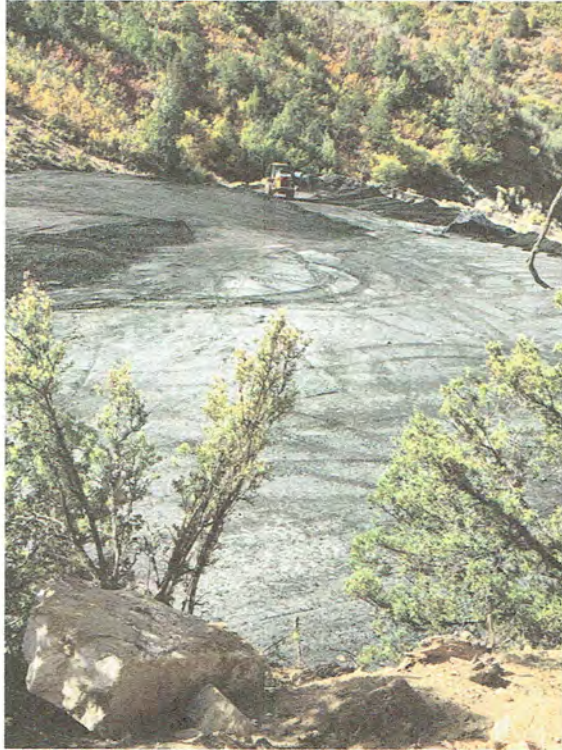
Waste material has been hauled from the base of the waste embankment pile to the top by front end loader (see Pic. 3). The slope of the top of the existing pile is currently in excess of that defined in the Waste Bank Design produced by Don May, 1997. Specifically, the cross slope from north to south across the top of the waste pile embankment. The haul road is in the process of being extended up the slope which will help facilitate the placement of additional fill material at the top of the pile which will reduce the existing slopes (see Pic. 4). The excess slope does not pose any danger to the stability of the existing waste pile though some localized erosion may occur during/after localized storm events.

Pic. 3 – Waste material being installed at top of waste embankment pile.

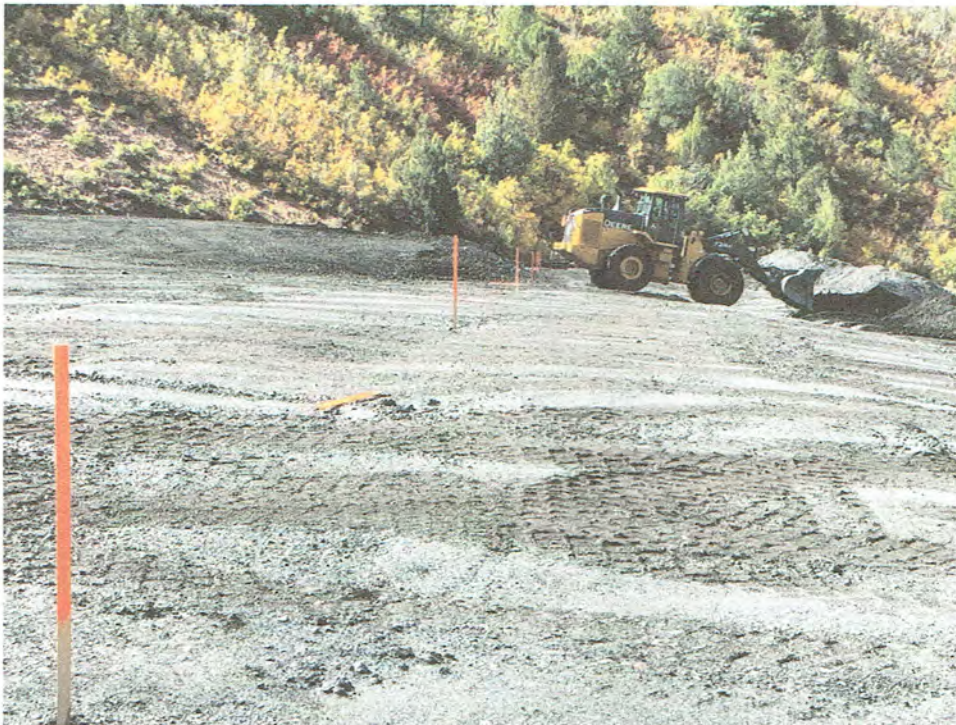
Pic 4 – Staking for the extension of haul road at top of pile.
