Re: King I Mine, C-1981-035
Stoner Engineering: Quarterly Inspection: Water Quality Improvements
3rd Quarter 2020

Date: September 30, 2020

Re: King Coal I – Quarterly Water Quality Improvements Inspection

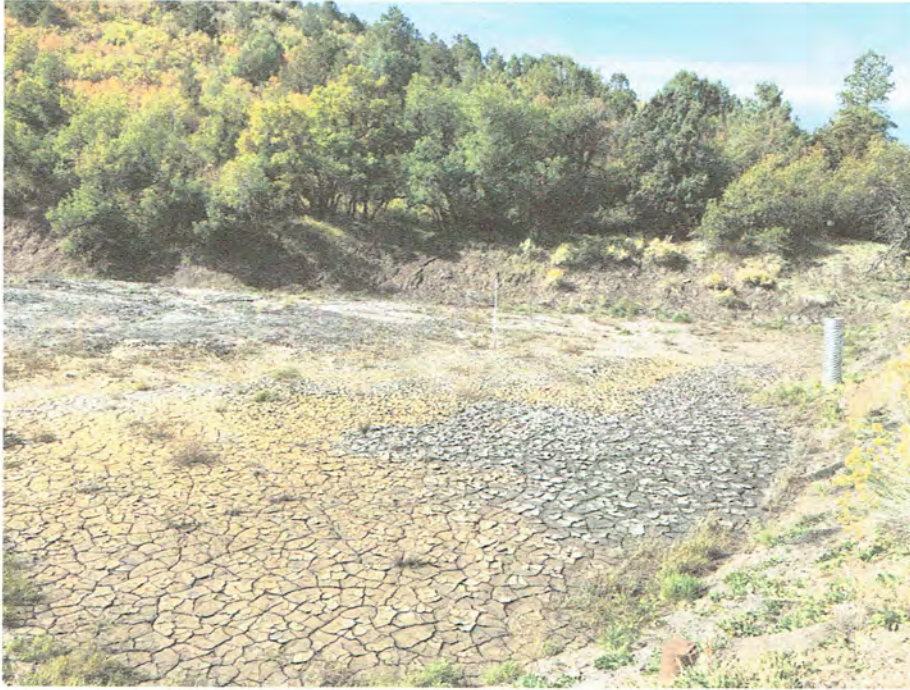
Both ponds were dry at the time of the inspection and appeared to generally be in good condition (see Pic. 1). The sedimentation gages show the ponds are not yet in need of cleaning (see Pic. 2). The western pond saw an increase in the sediment loading during a storm event since the previous inspection. An additional storm event or two of similar intensity will likely require the sediment pond to have the built-up sediment removed in order to continue to function as originally designed. Consideration for removal of the excess material with dry conditions may warrant performing the work this fall rather than the wetter spring or early summer seasons when the site conditions may become much wetter and more difficult to complete. The ponds should continue to be monitored after storm events to ensure that excess sediment does not reduce the required storage capacity available for storm water runoff.

Pic. 1 – West pond.

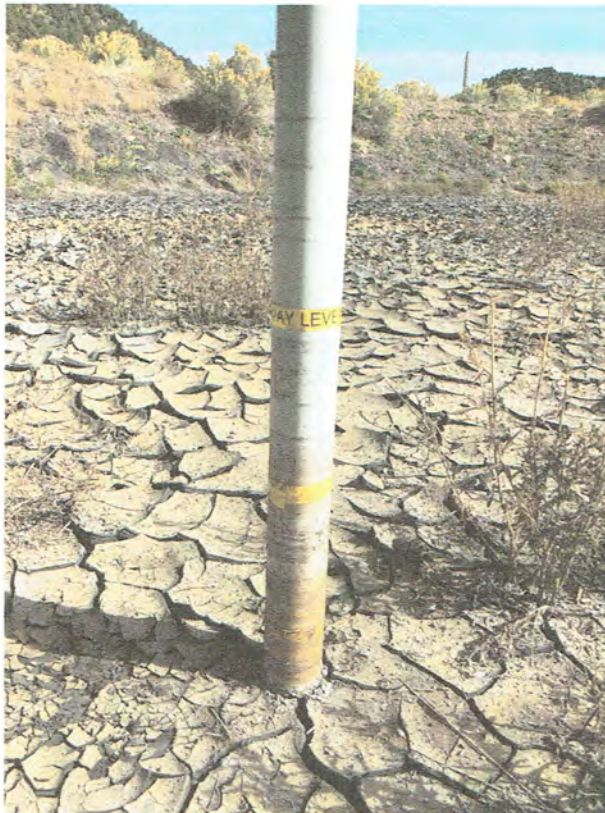
Pic. 2 – West pond sediment gage.

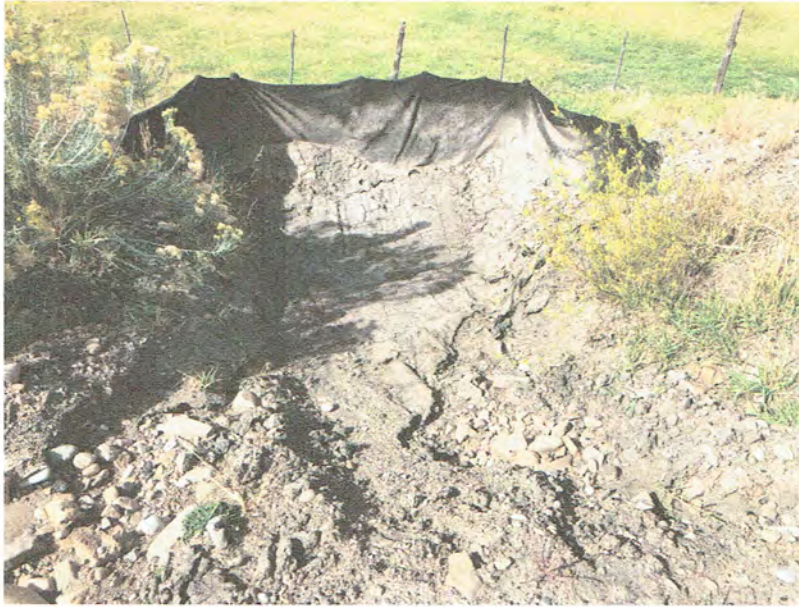
Pic. 3 – Sediment trap at driveway.

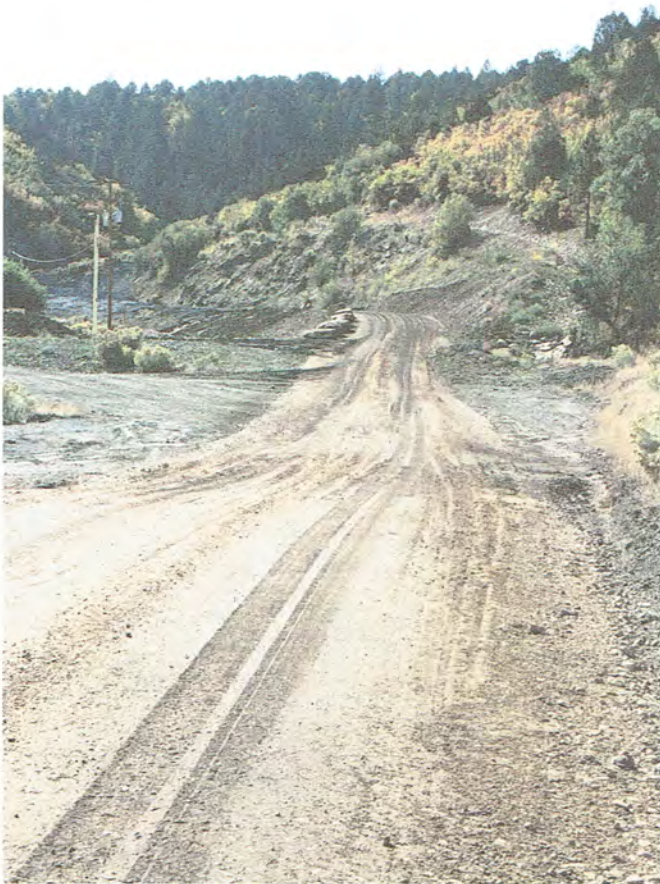
Pic. 4 – Ongoing work for new haul road.

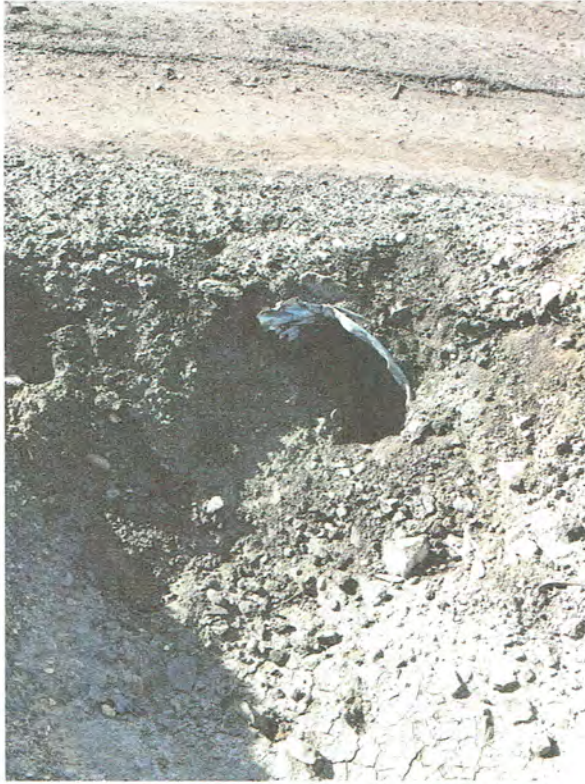
The sedimentation traps at the entrance to the site are generally in good condition but need some cleaning (see Pic. 3). Work is ongoing for the new haul road along the west side of the property (see Pic. 4). Waste material continues to be placed at the base of the embankment and moved via loader to the top of the pile. The culvert located at the top of the waste embankment pile under the haul road has been partially crushed at its upstream end and should be repaired (see Pic. 5).

Pic. 5 – Damaged culvert at top of embankment pile (upstream end).

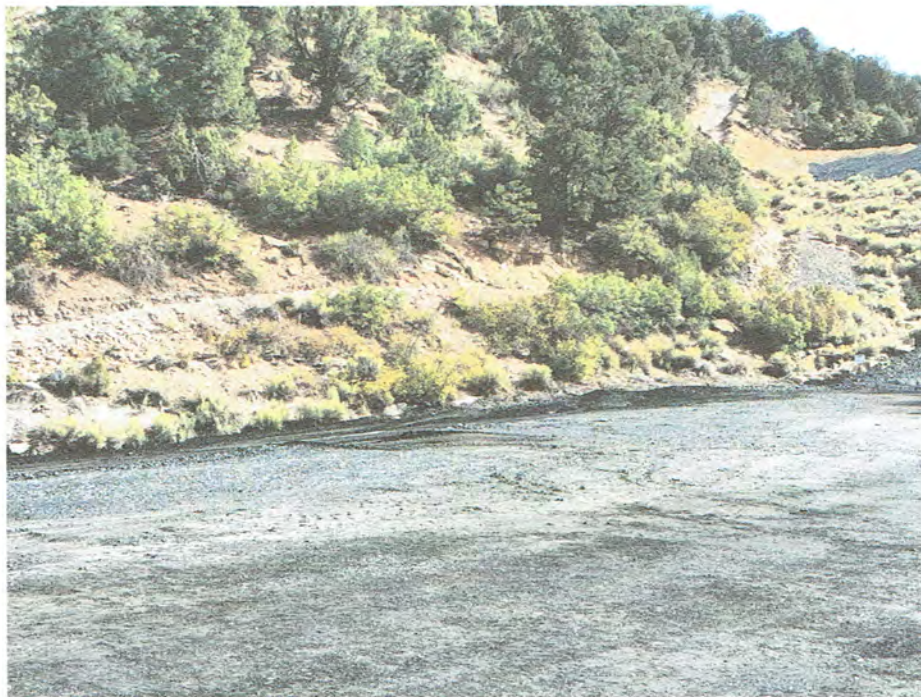
The lower section of the north clear water channel has been reconstructed near the base of the waste embankment pile (below the improvements constructed last year) (see Pic. 6). The relocated channel is now higher on the slope below the disturbance limits. The existing culverts throughout the site were in good condition at the time of the inspection.

Pic. 6 – North clear water ditch relocation (lower section).
