Re: King I Mine, C-1981-035

Stoner Engineering: Quarterly Inspection: Refuse Pile

4th Quarter 2020

King Coal I - Quarterly Waste Pile/Embankment Inspection

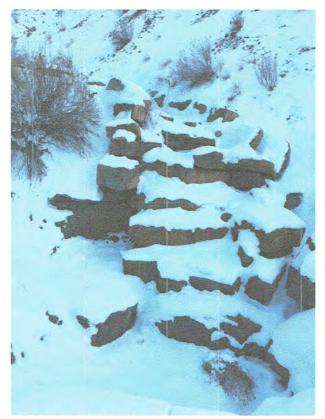
Both the south treated water ditch (Reach 10) and the north clear water ditch (Reach 1) were covered in 3-4" of snow but, appeared to be in generally good condition (see Pic. 1). The face of the embankment was also covered with snow so it was not possible to identify any signs of excessive erosion, instability or weakness (see Pic. 2) though there were no visible signs of sluffing.

Pic. 1 -Reach 10 treated water channel.

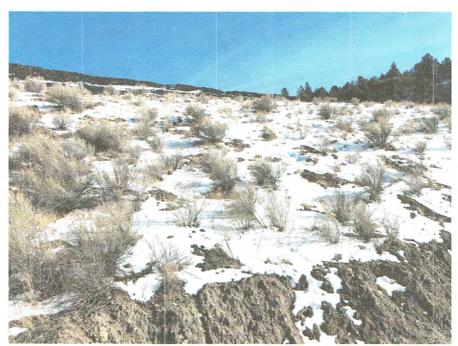
Pic. 2 - Face of waste pile covered with snow.

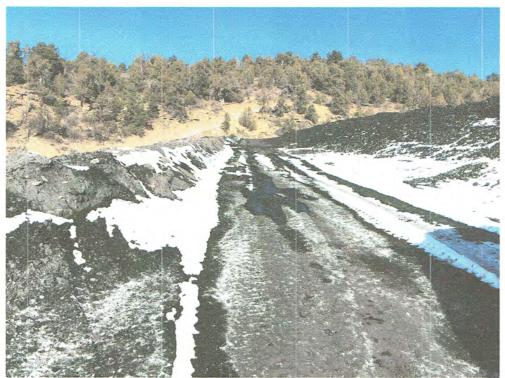
All the waste material has been hauled from the base of the waste embankment pile to the top and installed. The new switchback has been installed near the top of the waste embankment pile (south side) near the south treated water ditch (Reach 10) (see Pic. 3). The slope of the top of the existing pile is now much closer to that defined in the Waste Bank Design produced by Don May, 1997. The construction of the new switchback has allowed the cross slope along the top of the pile, from north to south, to be flattened significantly with the installation of additional waste material from that which was present during the previous inspection (see Pic. 4).

Pic. 3 – New haul road heading generally north from new switchback.

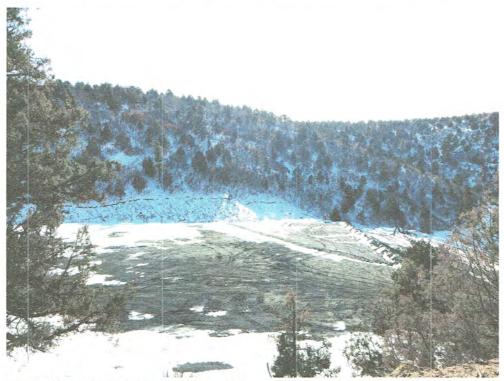
Pic 4 – Top of pile with much less N-S cross slope with new haul road constructed.
