**MINERALS PROGRAM INSPECTION REPORT**  
**PHONE: (303) 866-3567**

<b>MINE NAME:</b> Highway 50 Borrow Area No. 2	<b>MINE/PROSPECTING ID#:</b> M-1999-076	<b>MINERAL:</b> Borrow material	<b>COUNTY:</b> Mesa
<b>INSPECTION TYPE:</b> Monitoring	<b>INSPECTOR(S):</b> Amy Yeldell	<b>INSP. DATE:</b> December 15, 2020	<b>INSP. TIME:</b> 09:00
<b>OPERATOR:</b> Elam Construction, Inc.	<b>OPERATOR REPRESENTATIVE:</b> Jim Doody	<b>TYPE OF OPERATION:</b> 111 - Construction by Government Agency	
<b>REASON FOR INSPECTION:</b> Normal I&E Program	<b>BOND CALCULATION TYPE:</b> None	<b>BOND AMOUNT:</b> \$55,000.00	
<b>DATE OF COMPLAINT:</b> NA	<b>POST INSP. CONTACTS:</b> None	<b>JOINT INSP. AGENCY:</b> None	
<b>WEATHER:</b> Clear	<b>INSPECTOR'S SIGNATURE:</b>

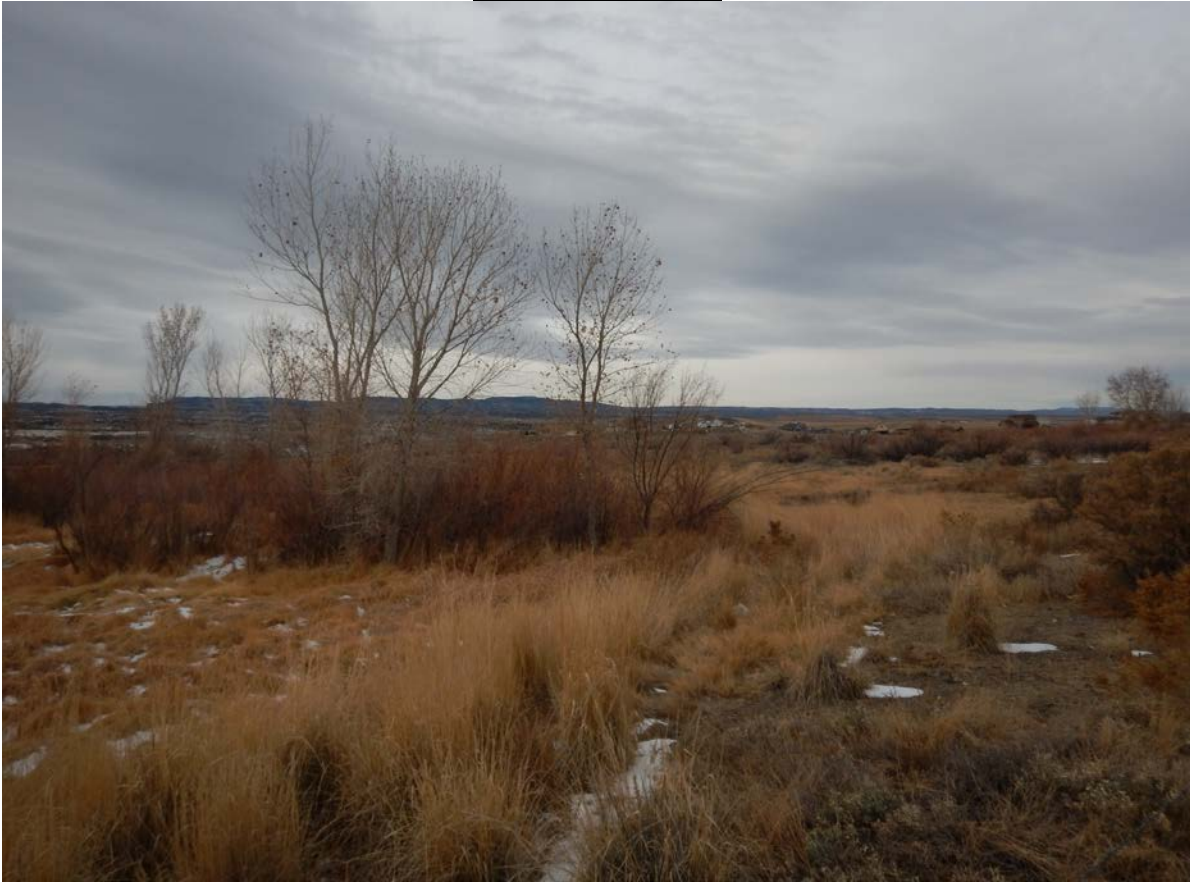
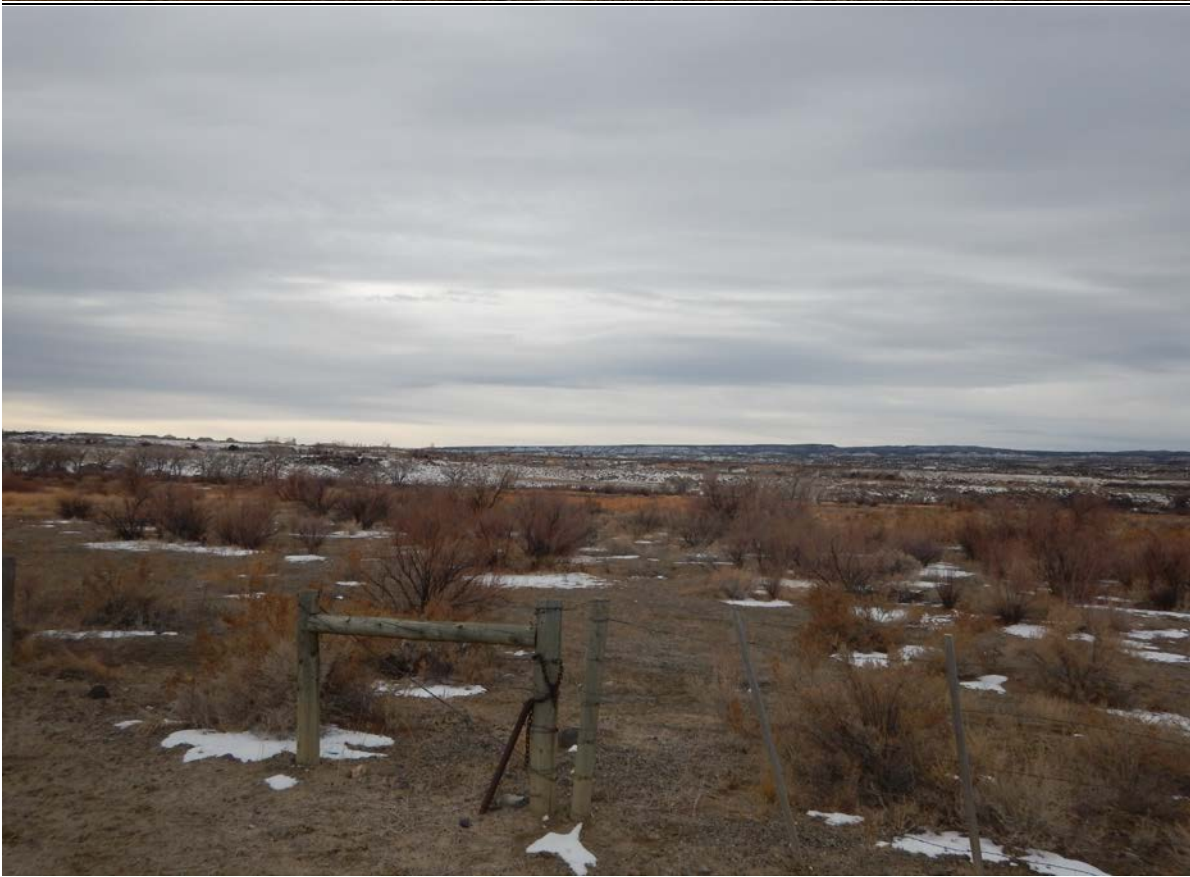
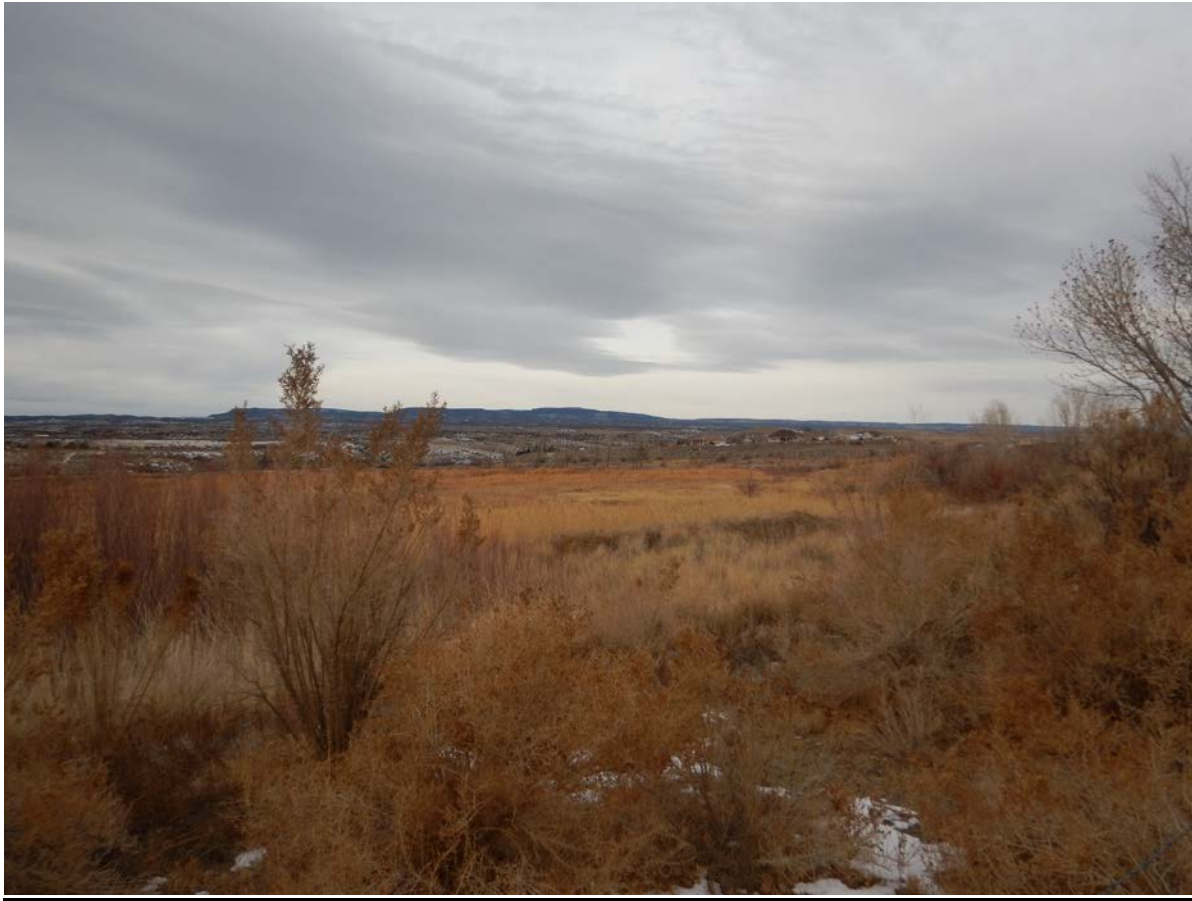
**PHOTOGRAPHS**

This site is in final reclamation. The inspection occurred during the winter when plants were dormant. No excessive signs of erosion or soil stabilization issues were observed. No equipment, fuel or structures are located on site. All stockpiles have been removed and reclaimed.

Mining has resulted in an approximately 1.5 acre pond/wetlands area. This site cannot be released until water rights have been obtained. Mr. Doody indicates that the property is out of probate court and water right acquisition is imminent. The Operator shall provide the Division with the necessary water rights or a formal update within 60 days of this report.
