### MINERALS PROGRAM INSPECTION REPORT

<b>MINE NAME:</b> Mica Lode	<b>MINE/PROSPECTING ID#:</b> M-1977-144	<b>MINERAL:</b> Quartz (quartzite/ quartzose sandstone)	<b>COUNTY:</b> Fremont
<b>INSPECTION TYPE:</b> Monitoring	<b>INSPECTOR(S):</b> Timothy Cazier, P.E.	<b>INSP. DATE:</b> February 13, 2020	<b>INSP. TIME:</b> 13:20
<b>OPERATOR:</b> Colorado Quarries Inc	<b>OPERATOR REPRESENTATIVE:</b> Aaron Tezak	<b>TYPE OF OPERATION:</b> 112c - Construction Regular Operation

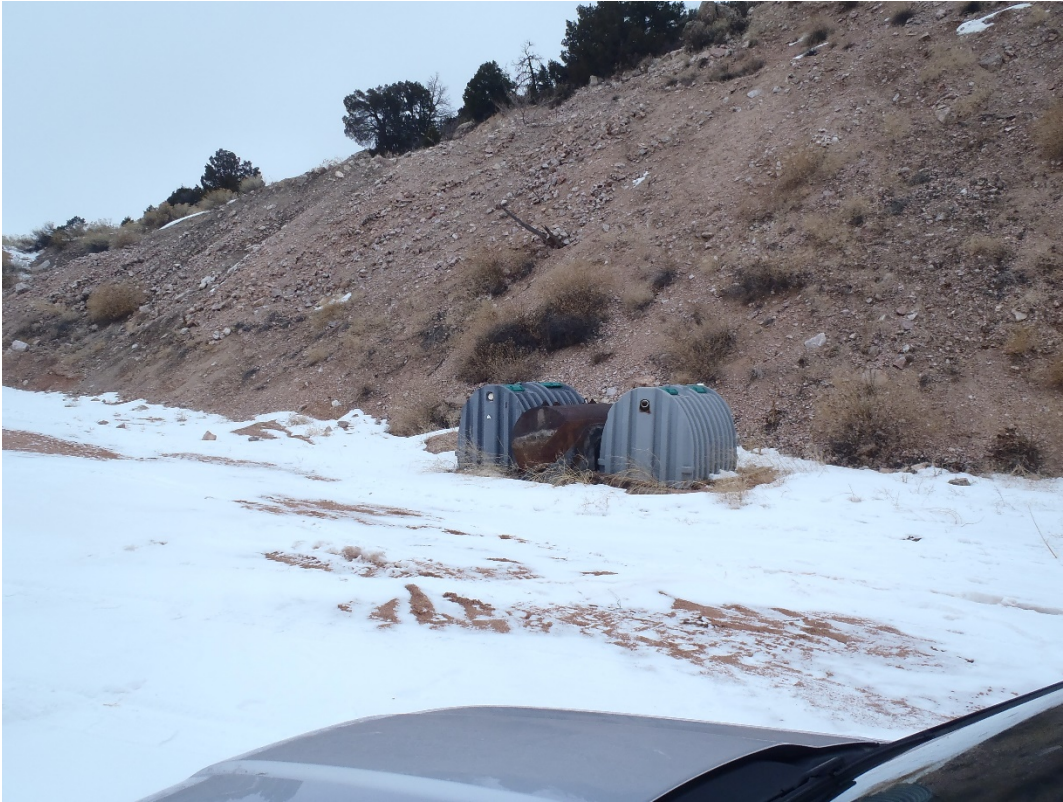
**Acid And Toxic Materials:** The tanks observed on site were empty (see **Photo 1**).

Photo 1. Empty tanks (staging area).

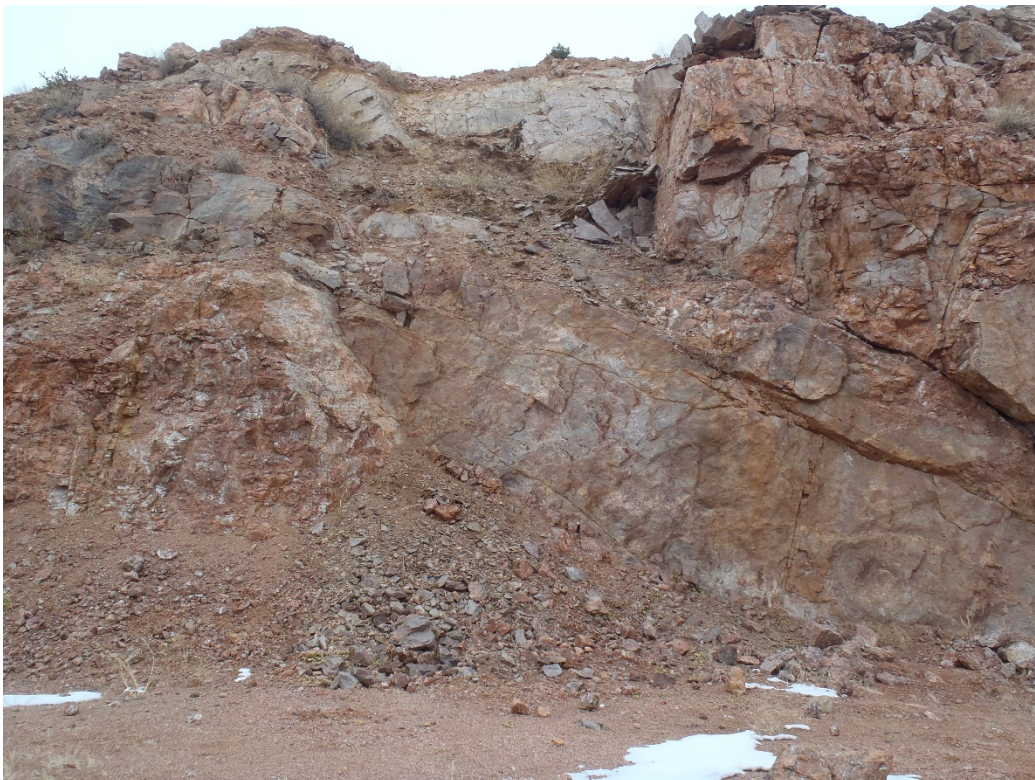
**Gen. Compliance with Mine Plan:** The operation appeared to be in compliance with the discernable portions of the approved mine plan. The maximum allowed disturbed area is 46 acres. Google Earth was used to measure the disturbed area, which was estimated to be approximately 20 acres, based on 2019 imagery. Highwalls in the Ruby pit (see **Photo 2**) were estimated to be between 12 and 20 feet in height and the observed highwall on the south side of the Mica Pit (see **Photo 3**) was estimated to be 20 feet high. All observed highwalls appeared stable.

Photo 2. Ruby Pit highwall (looking north).

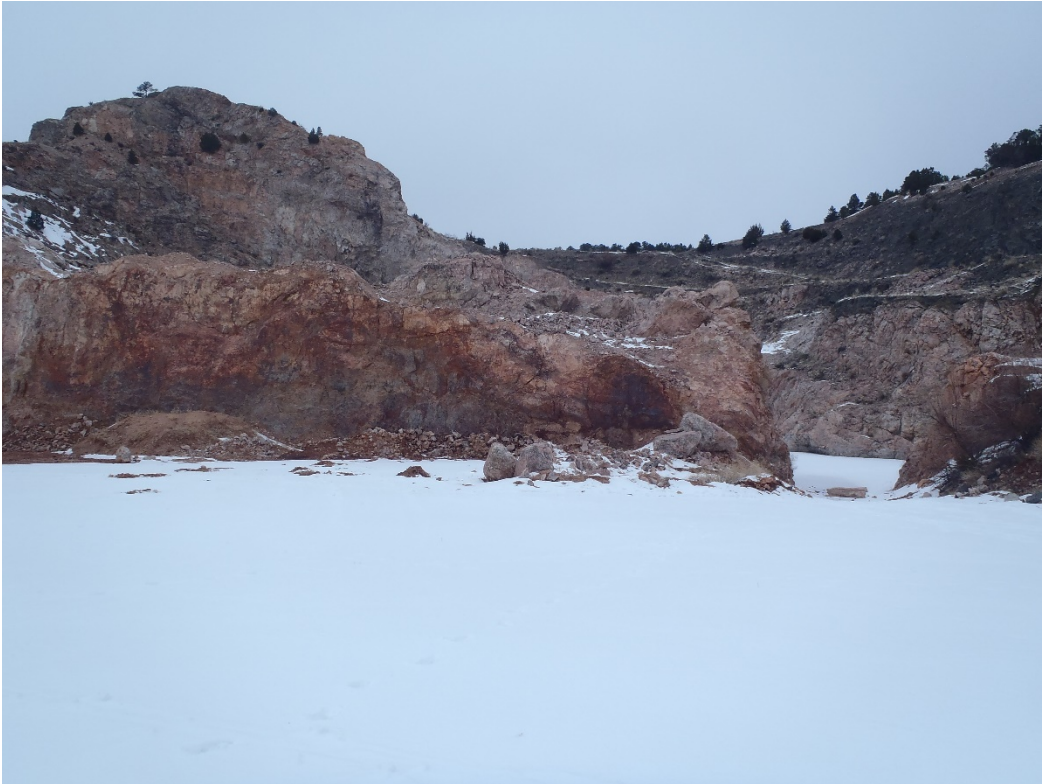
Photo 3. Mica Pit highwalls (south side, looking north).

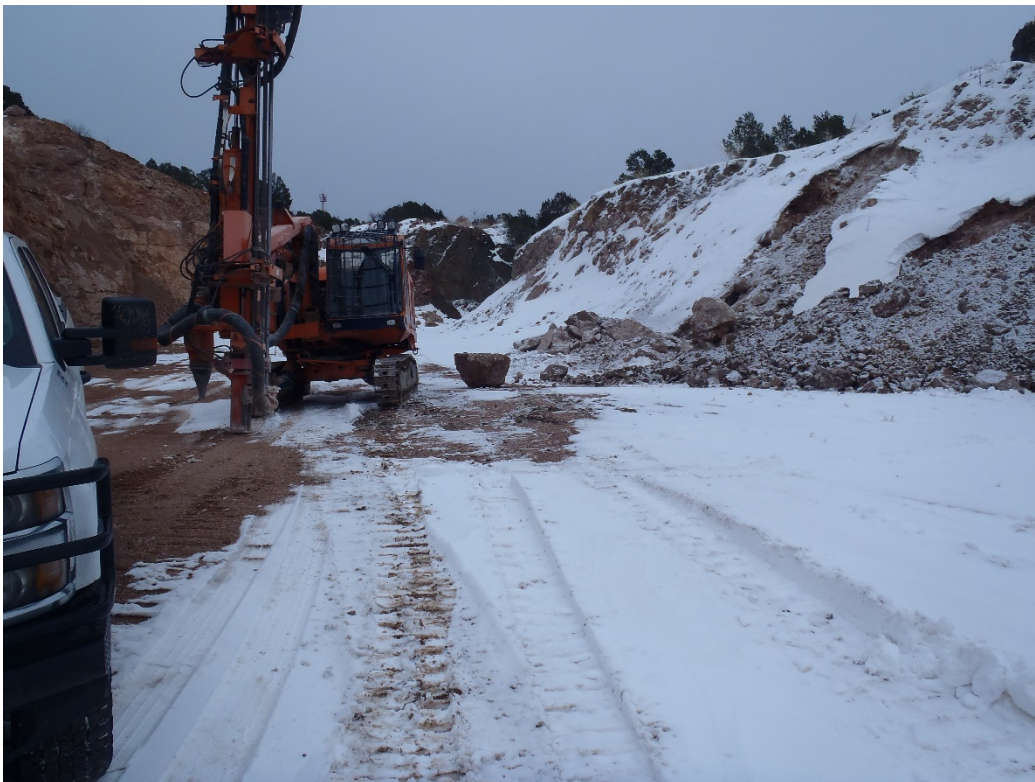
Support Facilities On-site: A drill (see **Photo 4**), trackhoe and loader were observed on site.

Photo 4. Drill in Ruby Pit (looking east).

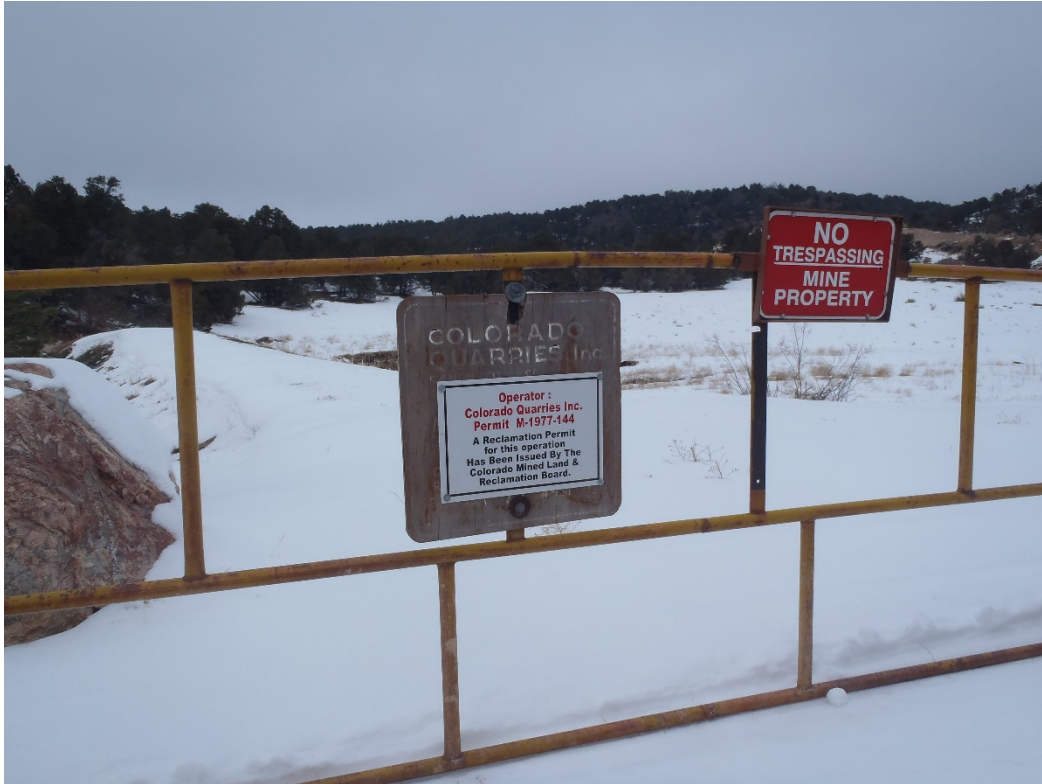
Signs and Markers: A new permit sign was properly posted (see **Photo 5**) as recommended in the 2016 inspection report. Four permit boundary corner markers were located during the 2016 inspection. However, Rule 3.1.12(2) requires boundaries for affected areas be marked. As there is some uncertainty related to map boundaries for the 46 acres of affected areas, the lack of affected area boundary markers is not cited as a problem; but the DRMS will require these boundaries be marked after the required Technical Revision addressing these map boundaries and clarification to the mining and reclamation plans is approved.

Photo 5. Permit sign at site entrance.

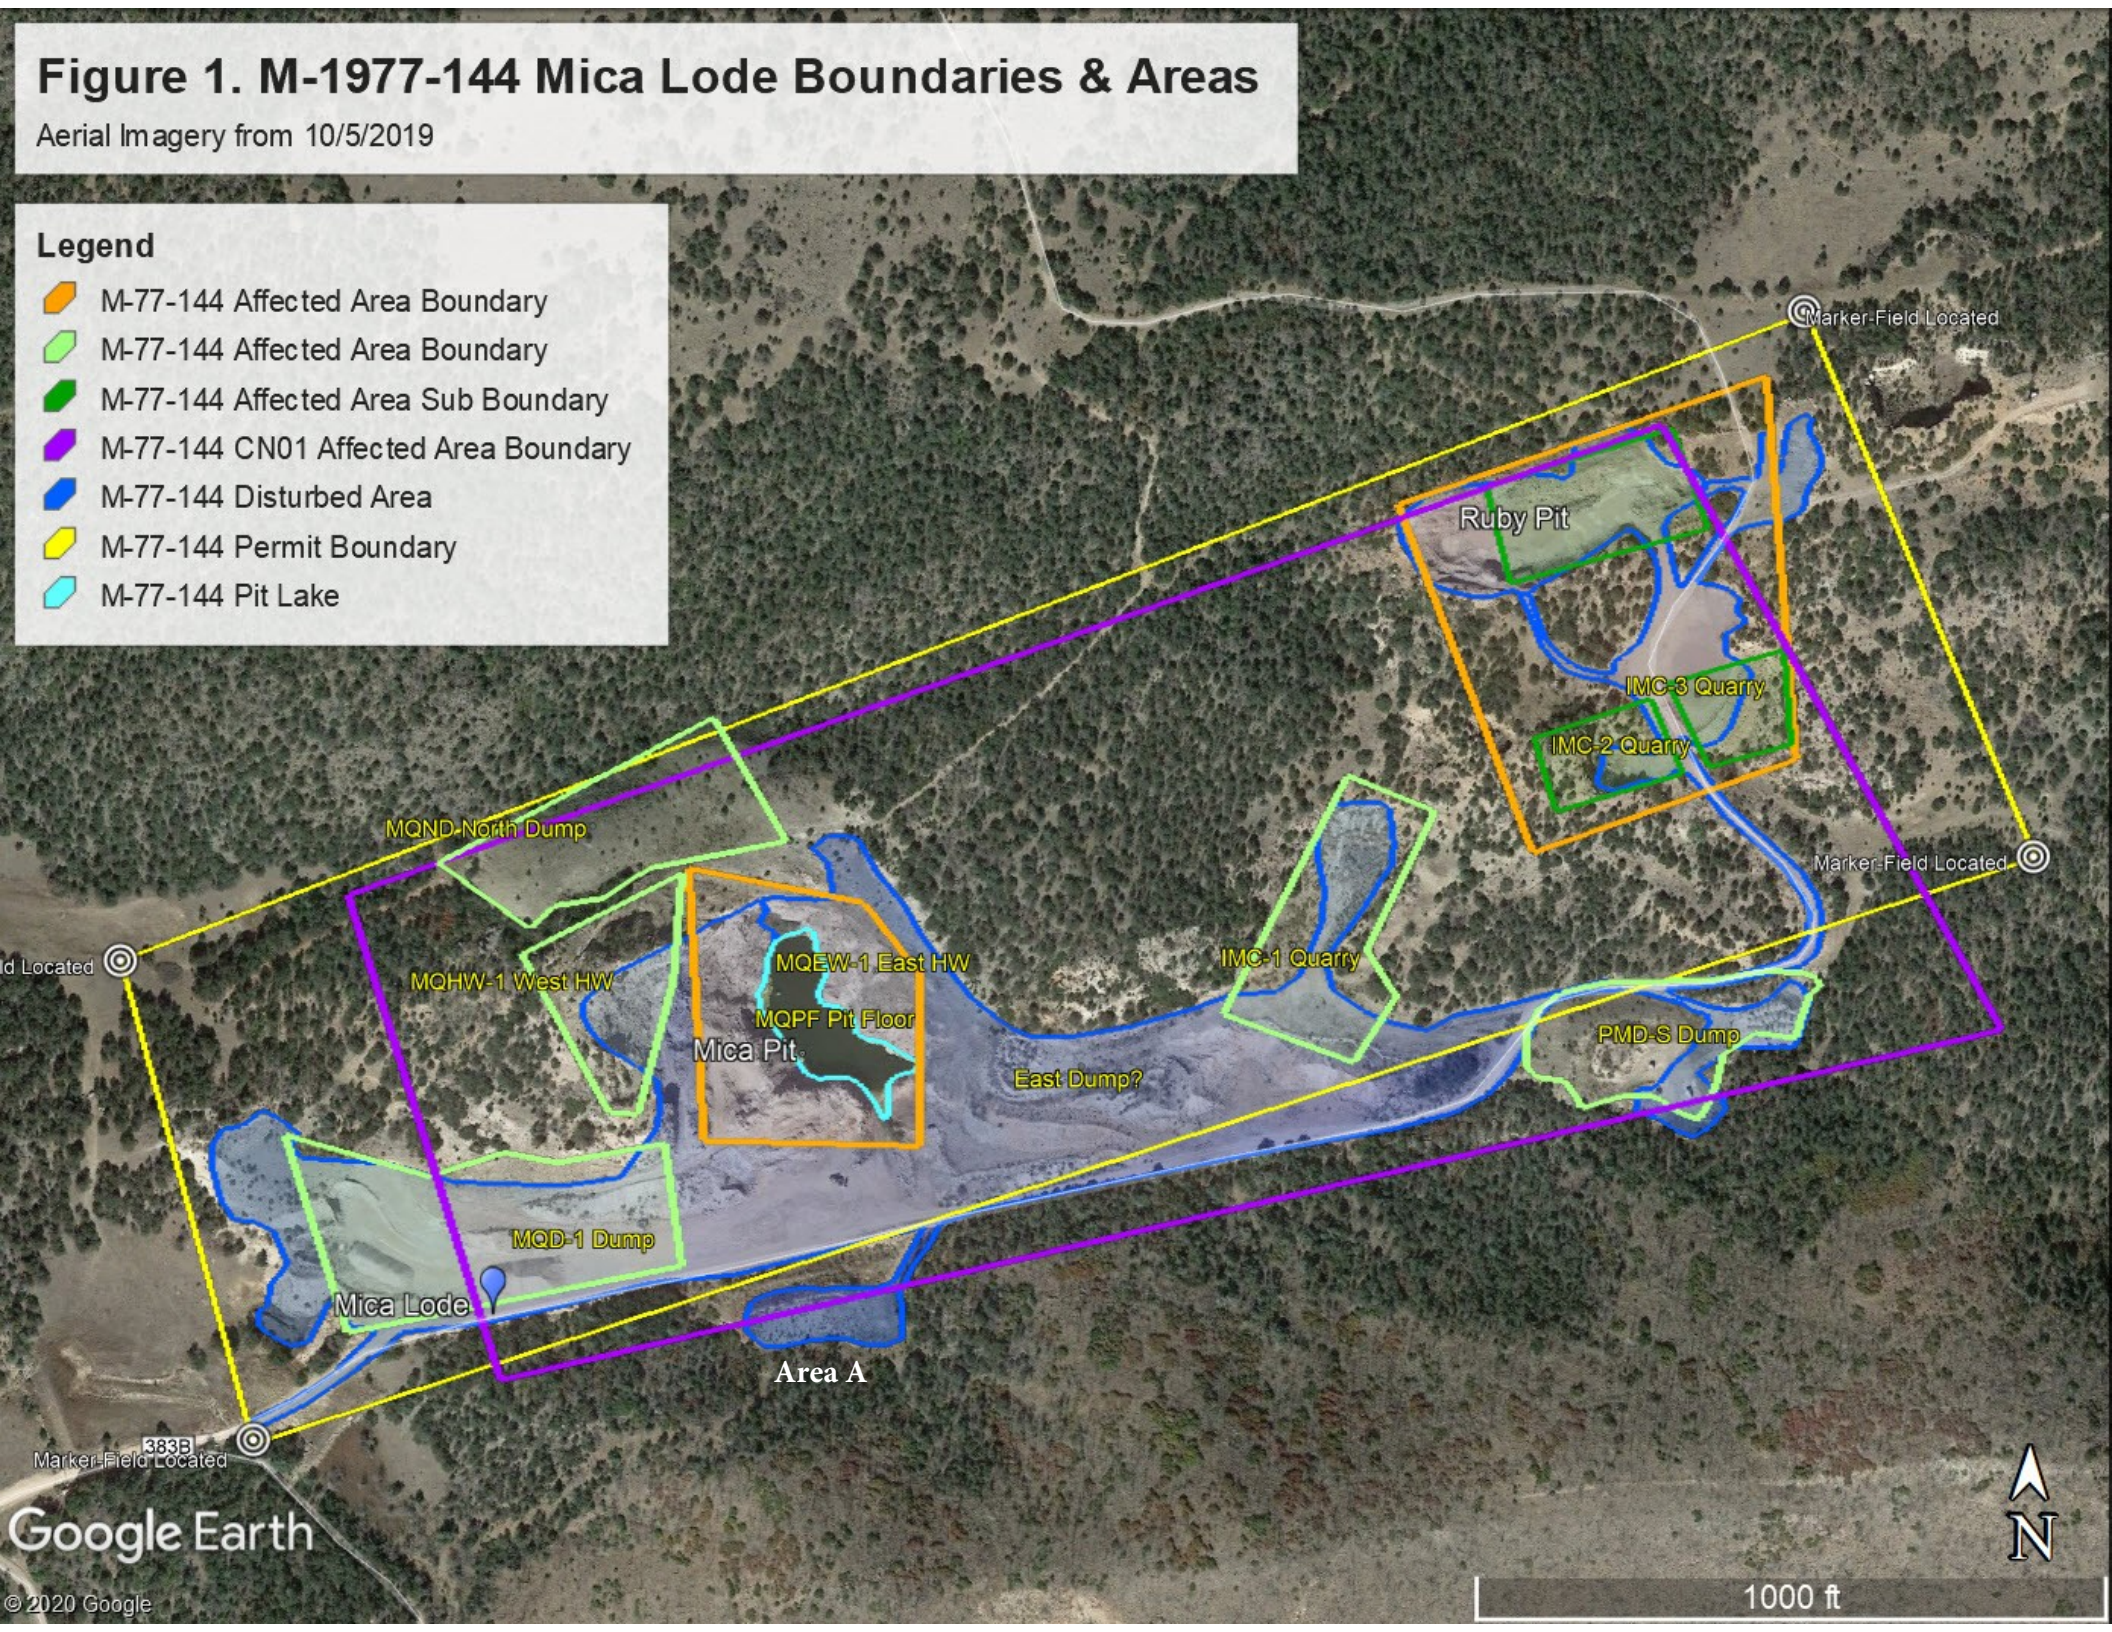
# Figure 1. M-1977-144 Mica Lode Boundaries & Areas

**PROBLEM/POSSIBLE VIOLATION:** Problem: The affected area map, mine and reclamation plans need to be updated and clarified pursuant to C.R.S. 34-32.5-112 (1)(c). The operator must provide updated maps and sufficient information to describe or identify how the operator intends to conduct the mining operation and reclamation.

**Off-site Damage:** The 2016 inspection identified and located four permit boundary corners. Most of the operation appears to be within the permit boundary (yellow boundary on **Figure 1**), with the exception of the PMD-S (or PMD-5) dump and an area south of the Mica Pit ("Area A" on **Figure 1**) that was re-disturbed between 2013 and 2016 (based on Google Earth history review). It is possible the affected area boundaries may include all disturbances, but would require adjustments to the permit boundary, as well as clear delineation of the affected areas. The following is a summary of the various boundaries shown on **Figure 1** and their missing areas:

- **Permit Boundary** (~58 acres, yellow line): Does not include the PMD-5 dump and Area A.
- **CN-01 Affected Area Boundary** (~50 acres, purple line): Does not include the northeast corner of the Ruby Pit area; small portions of Area A, the PMD-5 and MQND dumps, and the western portion of the MQD-1 dump.
- **Affected Area Boundaries** (~20 acres, light green and orange lines): Does not include the majority of the disturbed area (outlined in blue) in the central portion of the permit area, the access road, or the wester

end of the MQD-1 Dump.

**CORRECTIVE ACTIONS:** The operator shall submit a Technical Revision, with the required \$216 revision fee, to update the affected area boundaries and clarify the current approved mining and reclamation plans to reflect existing and proposed activities by the corrective action date.

**The lack of clearly defined affected area boundaries is cited as a Problem on page 1 of this report.** A technical revision is required to clearly delineate the boundaries for the 46 acres of approved affected area. The revised map must include the area outlined in blue on **Figure 1** (~20 acres), as well as the currently delineated affected areas outlined in light green and orange on **Figure 1**. Updated mine and reclamation plans are required to accompany the updated map in order to clarify the missing items in **Attachment A** and provide the DRMS with a basis to update the financial warranty. The updated map should show locations of stockpiled topsoil and backfill material.
