MINERALS PROGRAM INSPECTION REPORT
PHONE: (303) 866-3567

| MINE NAME: Orchard Grove Industrial Pit | MINE/PROSPECTING ID#: M-1990-094 | MINERAL: Gravel | COUNTY: Mesa |
| INSPECTION TYPE: Monitoring | INSPECTOR(S): Amy Yeldell | INSP. DATE: December 17, 2020 | INSP. TIME: 09:50 |

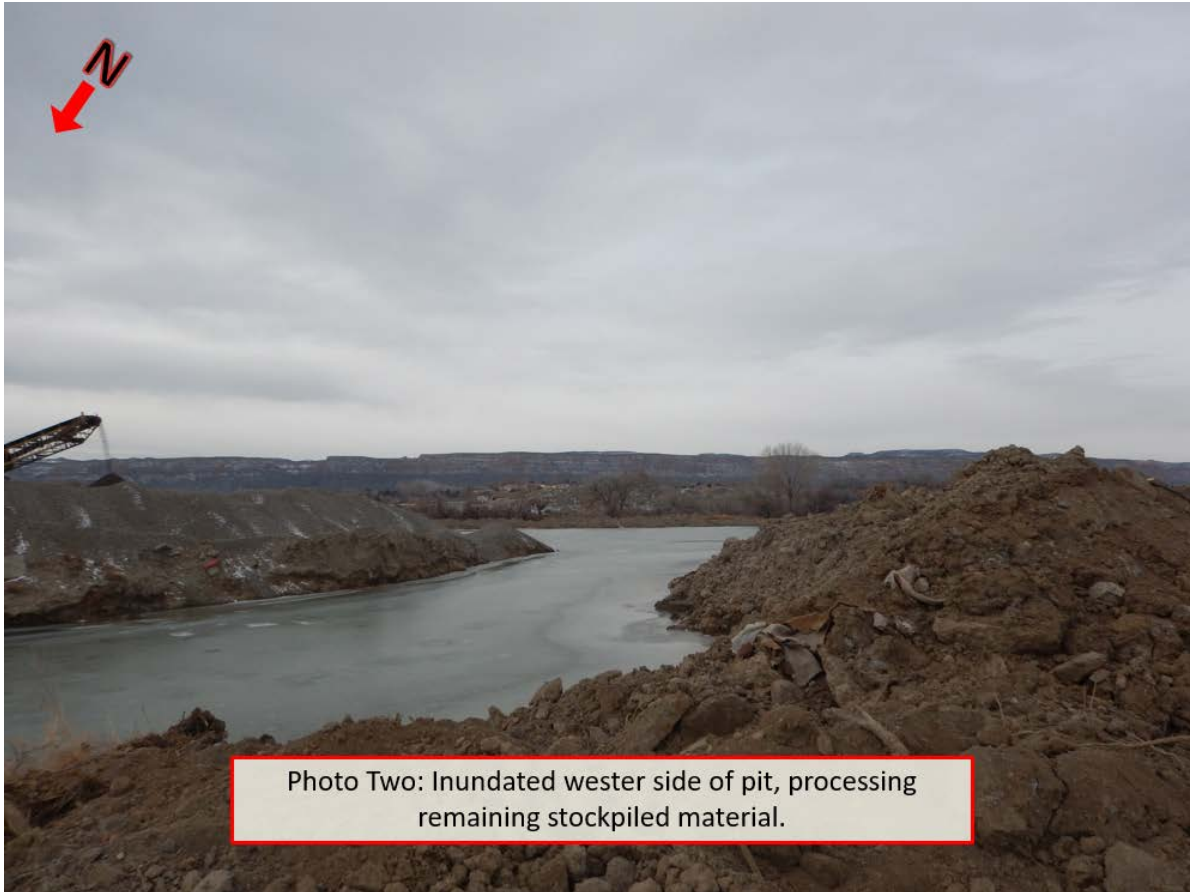
Photo Two: Inundated western side of pit, processing remaining stockpiled material.

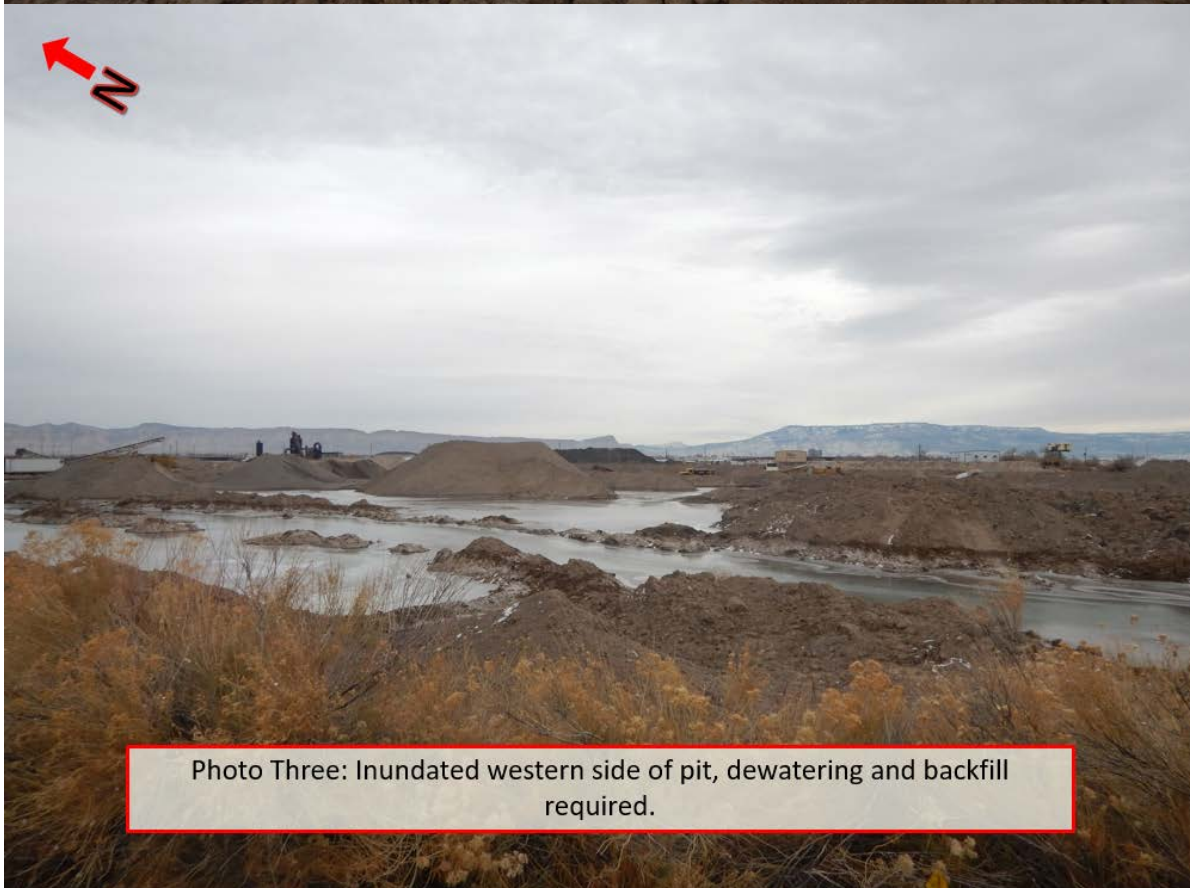
Photo Three: Inundated western side of pit, dewatering and backfill required.

The main focus of this operation is importing backfill material and placement. A significant volume of material will need to be imported to backfill the entire pit to two feet above the water table. The neighboring 23.25 West Pit has recently been approved and mining has commenced in 'Area 2' which is directly north and adjoins the Orchard Grove Industrial Pit. Material was observed being stripped from 23.25 West Pit and being hauled to Orchard Grove Industrial Pit and used as backfill. As a reminder 23.25 West Pit, Area 2, post-mining land use is rangeland so sufficient backfill will also be necessary. Furthermore no dewatering of the 23.25 West Pit shall enter the Orchard Grove Industrial Pit without documentation of approval from CDPHE.

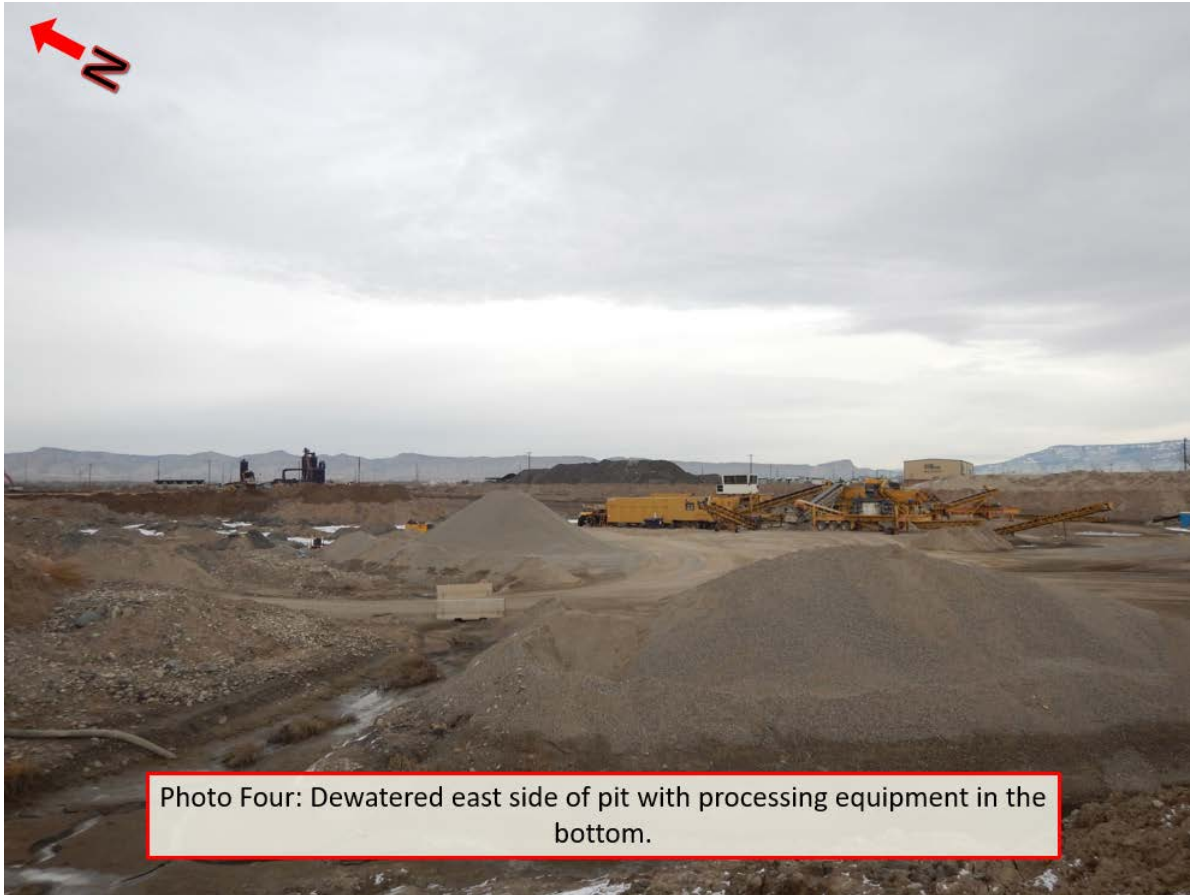
Photo Four: Dewatered east side of pit with processing equipment in the bottom.

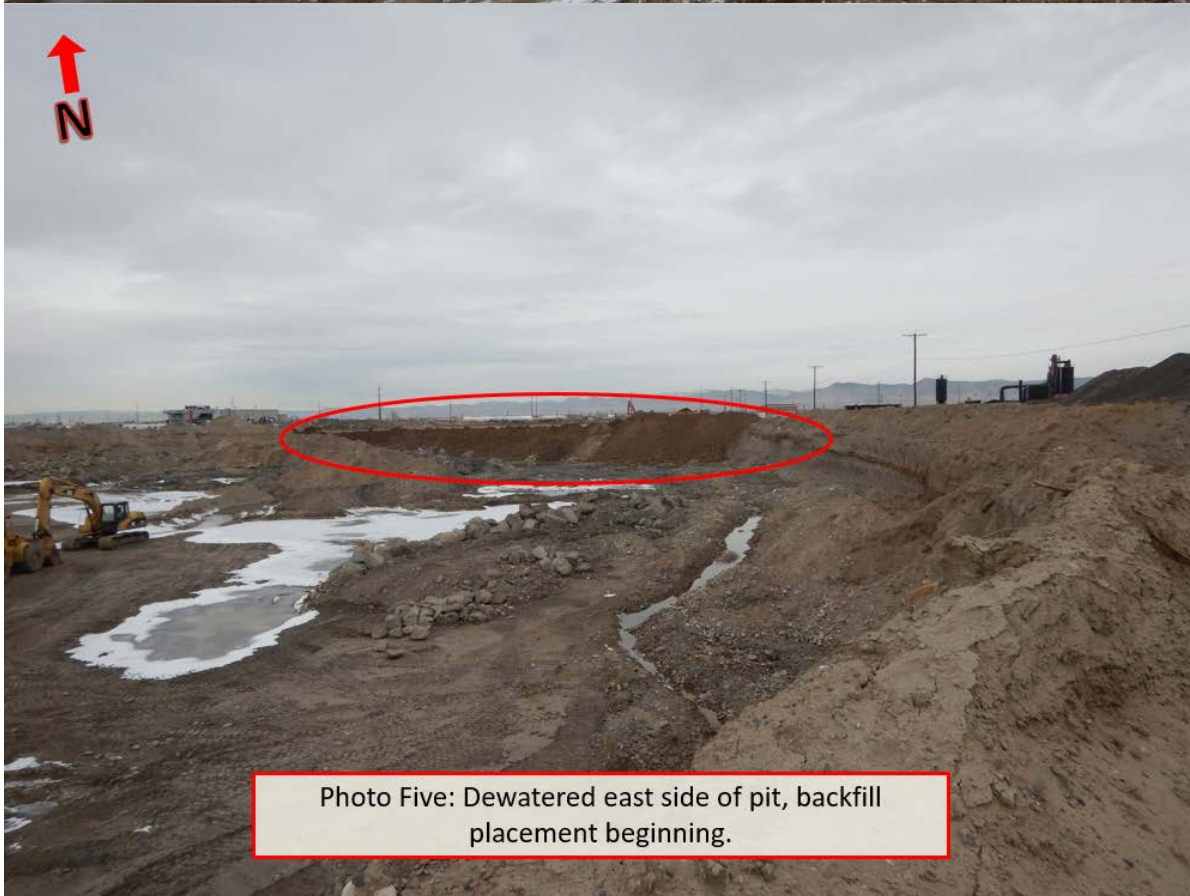
Photo Five: Dewatered east side of pit, backfill placement beginning.
