**MINERALS PROGRAM INSPECTION REPORT**  
**PHONE: (303) 866-3567**

<b>MINE NAME:</b> 23 1/4 West Pit	<b>MINE/PROSPECTING ID#:</b> M-2020-035	<b>MINERAL:</b> Sand and gravel	<b>COUNTY:</b> Mesa
<b>INSPECTION TYPE:</b> Monitoring	<b>INSPECTOR(S):</b> Amy Yeldell	<b>INSP. DATE:</b> December 17, 2020	<b>INSP. TIME:</b> 10:15
<b>OPERATOR:</b> Elam Construction, Inc.	<b>OPERATOR REPRESENTATIVE:</b> Jim Doody	<b>TYPE OF OPERATION:</b> 112c - Construction Regular Operation	
<b>REASON FOR INSPECTION:</b> Normal I&E Program	<b>BOND CALCULATION TYPE:</b> None	<b>BOND AMOUNT:</b> \$288,111.00	
<b>DATE OF COMPLAINT:</b> NA	<b>POST INSP. CONTACTS:</b> DRMS	<b>JOINT INSP. AGENCY:</b> None	
<b>WEATHER:</b> Clear	<b>INSPECTOR'S SIGNATURE:</b>

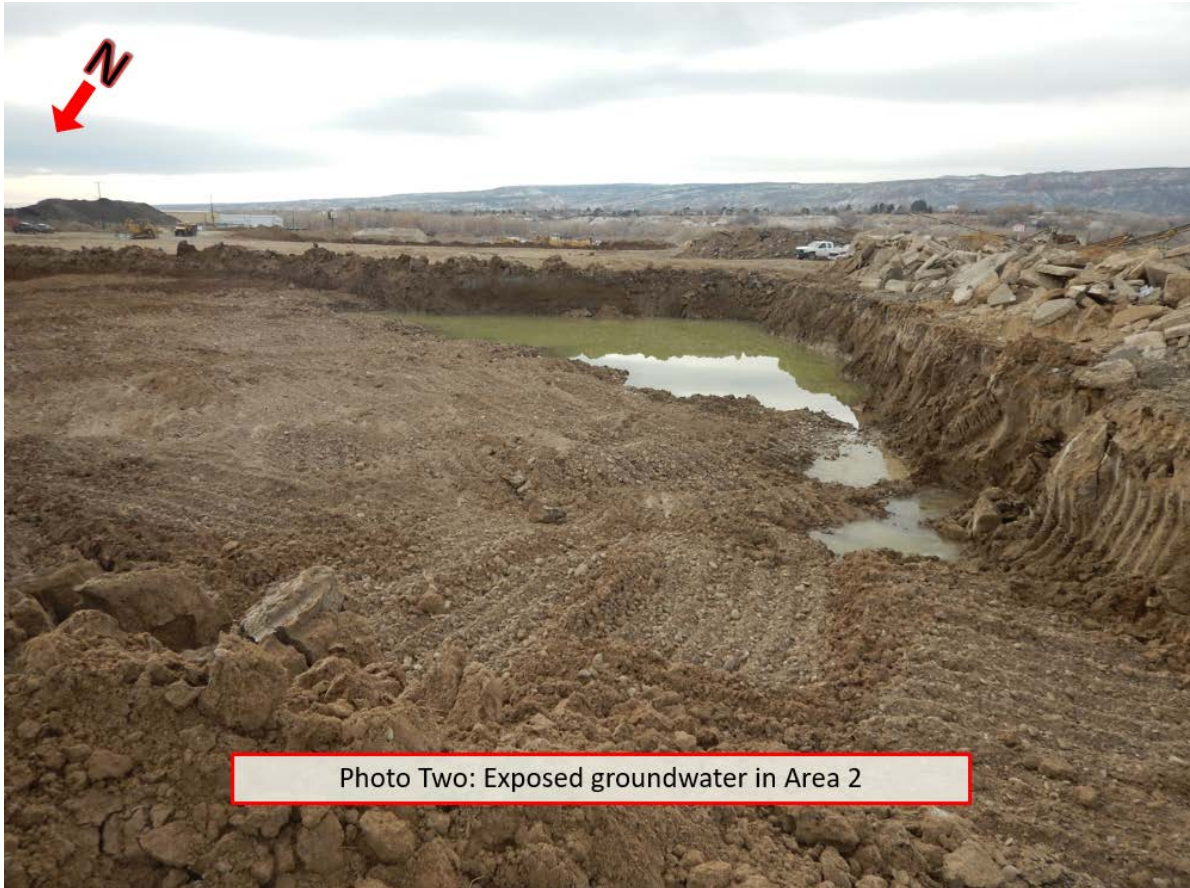
Small amounts of water was observed on the western side of the excavated Area 2 pit. No dewatering of the 23.25 West Pit shall enter the Orchard Grove Industrial Pit without documentation of approval from CDPHE. If dewatering is necessary prior to written approval, a new sediment pond should be built in the northwestern corner of Area 2 as shown in the mining maps.

Photo Two: Exposed groundwater in Area 2

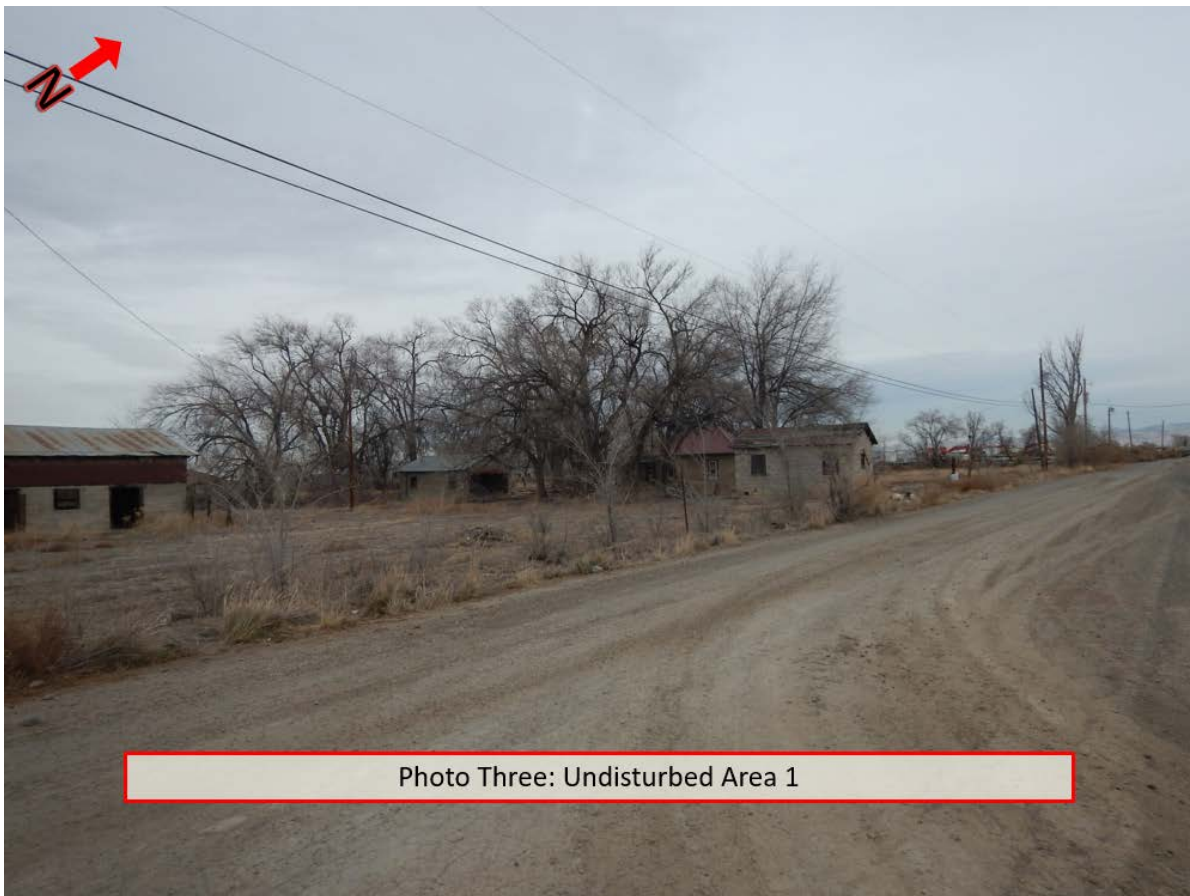
Area 1 remains undisturbed. The structures identified in the permit application remain on site and have yet to be removed. The Division also observed the raptor nest identified by CPW. Given the timing of this inspection no birds were observed during the inspection.

Photo Three: Undisturbed Area 1

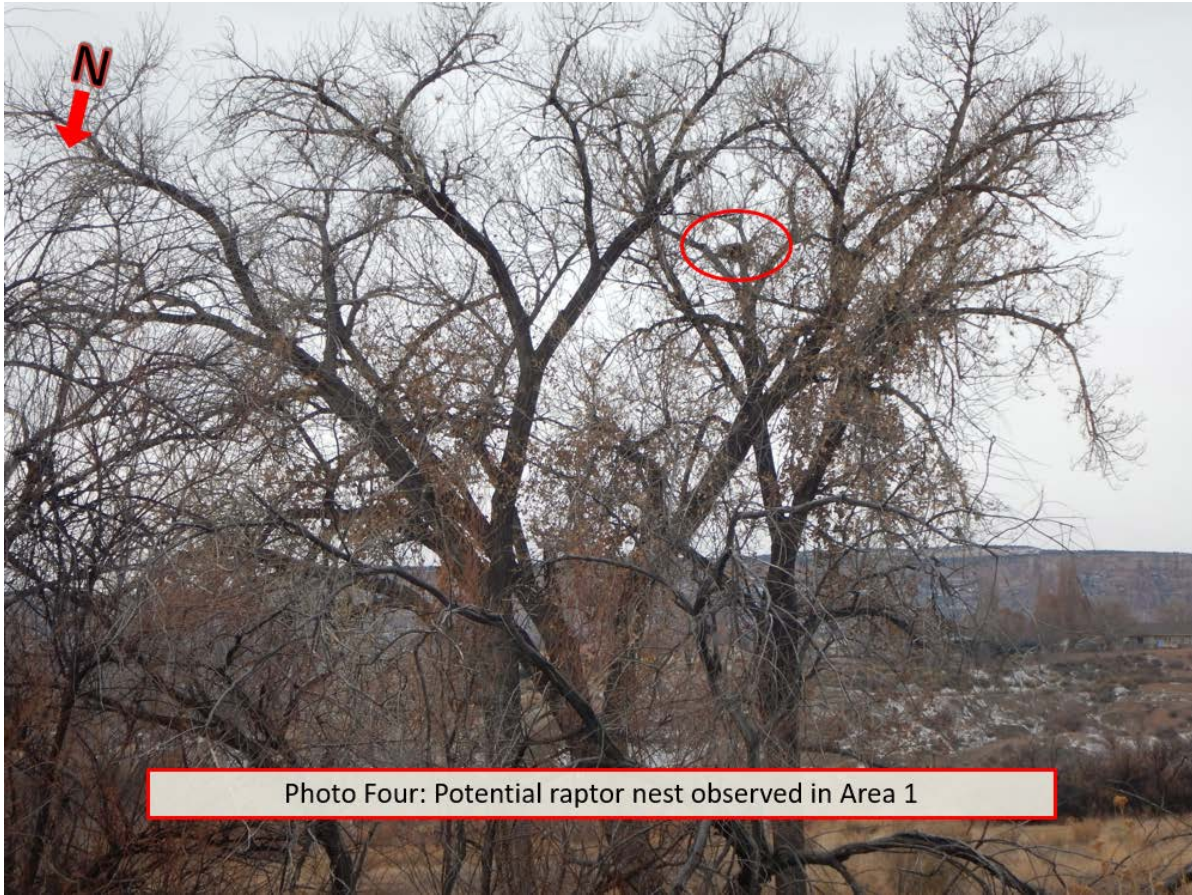
Photo Four: Potential raptor nest observed in Area 1
