COLORADO
Division of Reclamation,
Mining and Safety
Department of Natural Resources

Permit Number: C-1981-028 Mine Name: Keenesburg Strip Mine Operator: Coors Energy Company Operator Address: Mr. Benjamin Moline 1801 California Street Suite 4600 Denver, CO 80202	County: Weld Operation Type: Surface Permit Status: Permanent Cessation Ownership: Private
	Operator Representative Present: None
Operator Representative Signature: (Field Issuance Only)

Inspection Start Date: December 29, 2020 Inspection Start Time: 10:30 Inspection End Date: December 29, 2020 Inspection End Time: 11:30		Inspection Type: Coal Partial Inspection Inspection Reason: Normal I&E Program Weather: Clear	
Joint Inspection Agency: None		Joint Inspection Contacts: 	
Post Inspection Agency: None		Post Inspection Contacts: 	
Inspector(s): Robert Zuber, P.E.	Inspector's Signature: <i>Robert D. Zuber</i>		Signature Date: 12/29/2020

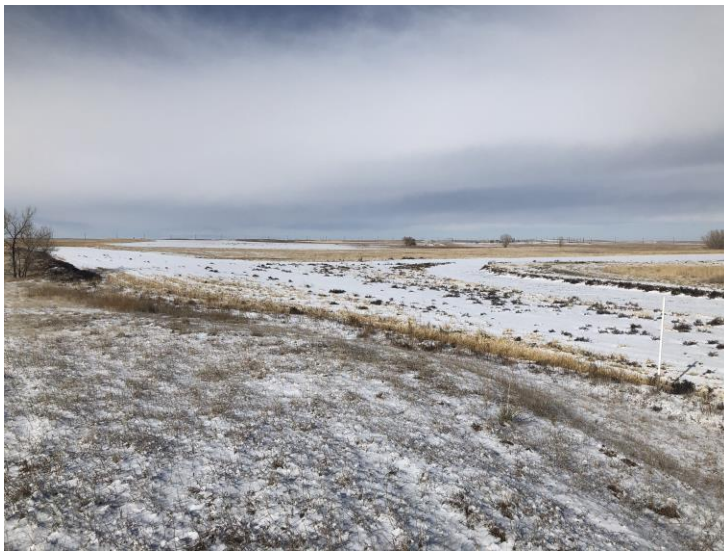
**Looking northwest at reclaimed road south of Area 25
(Long Term Spoil Area in background)**

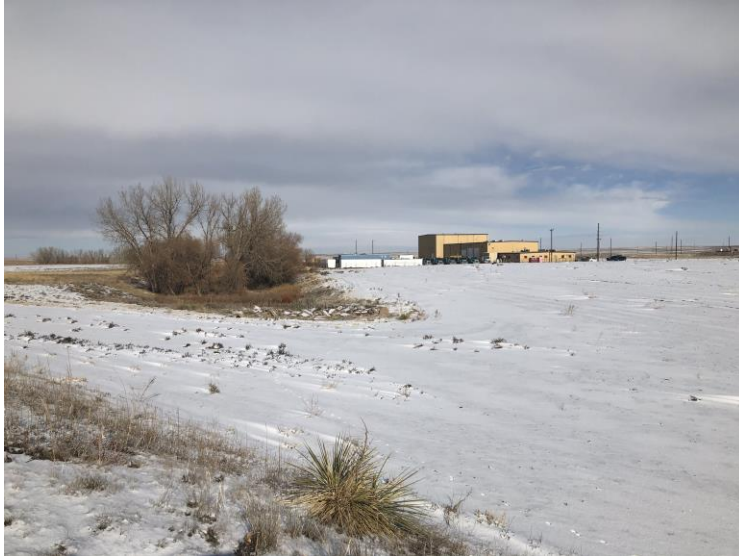
The east portion of the site was observed, and no erosion problems were seen. This includes roads and the relatively steep slope between the Dugout Pond and the area where topsand was stored (reclaimed Topsand Piles A-1 and B-1).

Looking north toward Dugout Pond and reclaimed topsand storage area (Pile B-1)
