Keenesburg inspection

COLORADO
Division of Reclamation,
Mining and Safety
Department of Natural Resources

Permit Number: C-1981-028 Mine Name: Keenesburg Strip Mine Operator: Coors Energy Company Operator Address: Mr. Benjamin Moline 1801 California Street Suite 4600 Denver, CO 80202	County: Weld Operation Type: Surface Permit Status: Permanent Cessation Ownership: Private
	Operator Representative Present: None
Operator Representative Signature: (Field Issuance Only)

Inspection Start Date: December 29, 2020 Inspection Start Time: 10:30 Inspection End Date: December 29, 2020 Inspection End Time: 11:30		Inspection Type: Coal Partial Inspection Inspection Reason: Normal I&E Program Weather: Clear	
Joint Inspection Agency: None		Joint Inspection Contacts:	
Post Inspection Agency: None		Post Inspection Contacts:	
Inspector(s): Robert Zuber, P.E.	Inspector's Signature: <i>Robert D. Zuber</i>		Signature Date: 12/29/2020

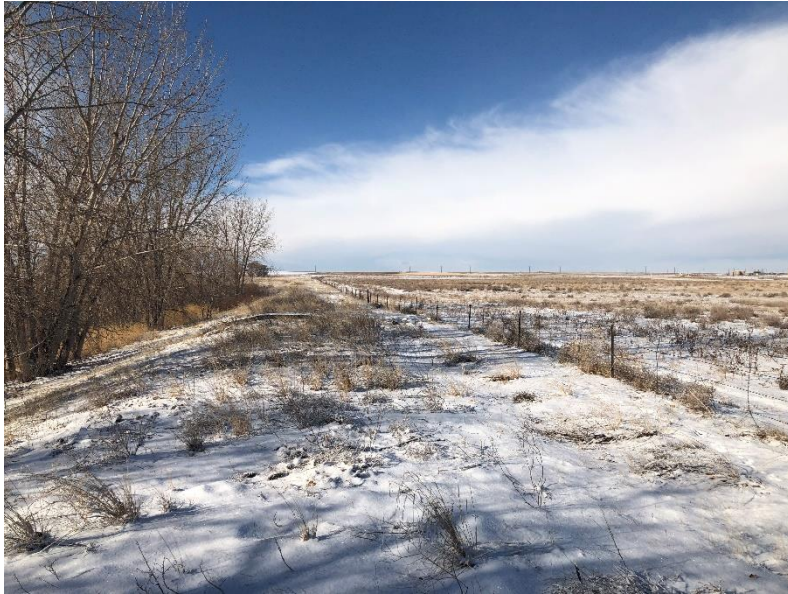
Sediment Pond 2 embankment

Sediment Pond 2 and the Dugout Pond did not contain much water. Neither pond was discharging during the inspection. There were no signs that they had discharged recently. As usual, they both contained large amounts of riparian vegetation. No problems were observed with the two ponds except the two holes in the embankment at Sediment Pond 2 (reported in past inspections). These should be filled.

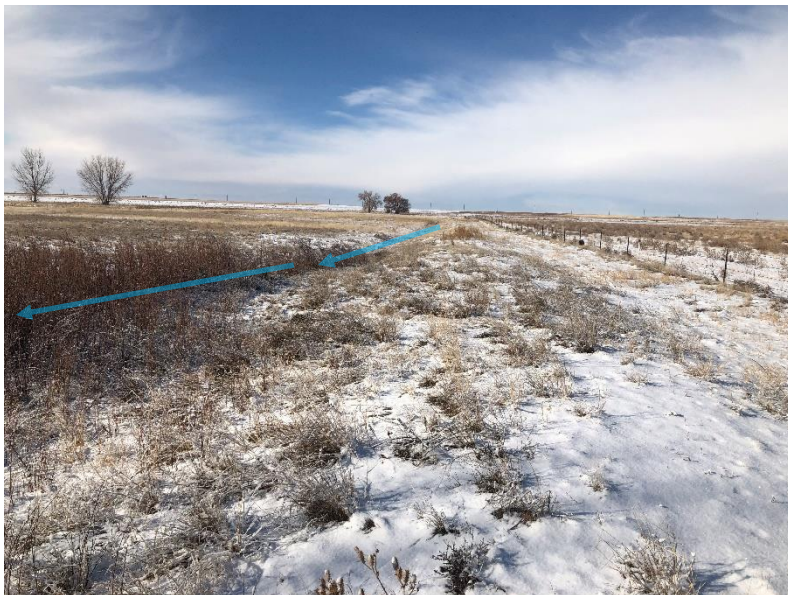
The eastern portion of the northern boundary of the site (including the ditch to Sediment Pond 2) was observed, and no signs of pollutant loading from the mine site, or any other problems, were seen. The eastern portion of the southern boundary was also observed, and no issues were identified there.

Northern boundary of site, just west of Sediment Pond 2 (lines indicate ditch and flow direction)

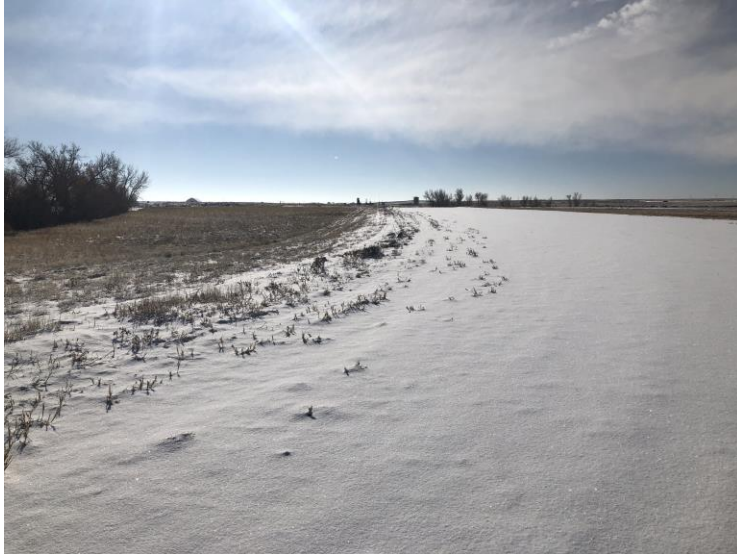
Reclaimed road west of the Dugout Pond

The east portion of the site was observed, and no erosion problems were seen. This includes roads and the relatively steep slope between the Dugout Pond and the area where topsand was stored (reclaimed Topsand Piles A-1 and B-1).
