Minerals Plan of Operations Inspection

U.S. Department of the Interior Bureau of Land Management Royal Gorge Field Office

Date: Jul 22, 2020 Time: 12:35 pm Weather: Sunny Attendees BLM: S. Carter & A. Sanderson Operator(s): J. Widdison & M. Donnelly	Operator: Case Numb	Operation Name: Field of Dreams Mine Operator: Gold Tamers LLC Case Number: COC73930 CDRMS Number: M-2009-056 General Operation(s) are in-compliance with documentation on file \[\sum \text{Yes} \quantom \text{No} \quantom \text{N/A} \]				
Other(s): None		s) and disturband and access on file ⊠ Yes		with the □ N/A		
Inspection Purpose : □ Pre-Operations ⊠ General □ Final ⊠ Compliance □ Trespass □ Complaint						
Inspection Items		Compliant	Non- Compliant	N/A

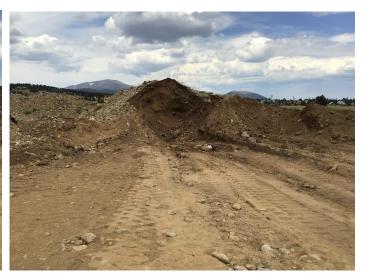
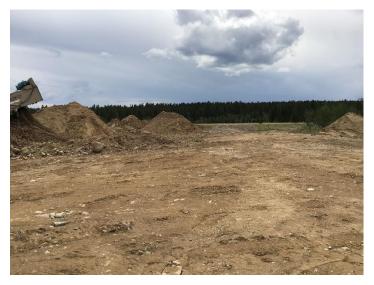
Image(s): 1-3 (Images taken by A. Sanderson, 07/22/20)

Comment: Current disturbance located along the northern storage area. The operator is currently processing material which was mined last operational season.

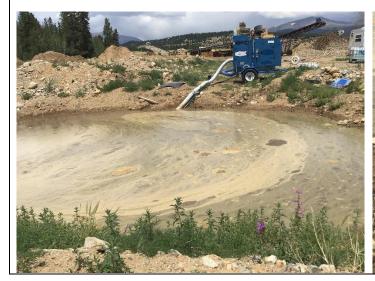
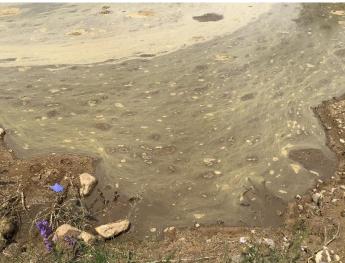
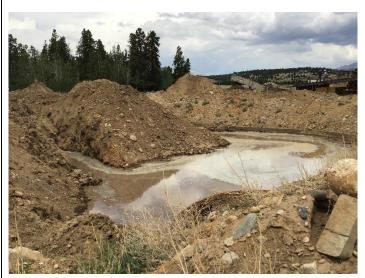
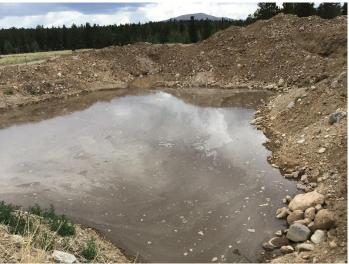
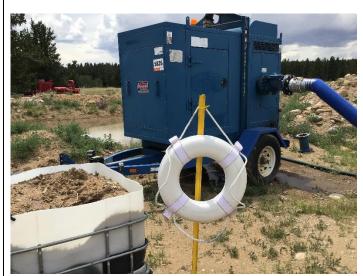
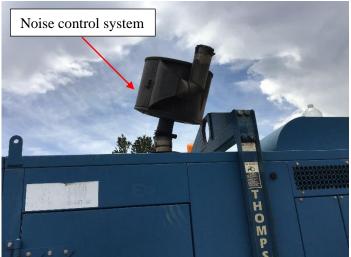
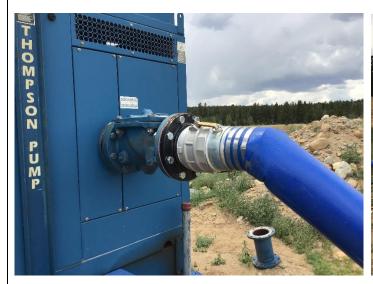
Image(s): 4-11 (Images taken by A. Sanderson, 07/22/20)

Comment: A water circulation pond with a diesel-powered water pump is used to process the ore and sand and gravel materials. The water is sourced from an authorized onsite well (sourced from S. Platte River; SPRAP authorization/use balance) and is pumped from the circulation pond lined with an impermeable clay layer (image 4-7). A noise control system is utilized to mitigate the total accumulated machinery noise (image 9). No oil sheen was visible on the water surfaces and a life preserver was available near the pump as a safety

precaution (image 8). Wildflowers were observed along the southern bermed edges of the pond which was evidence of adequate growing conditions.

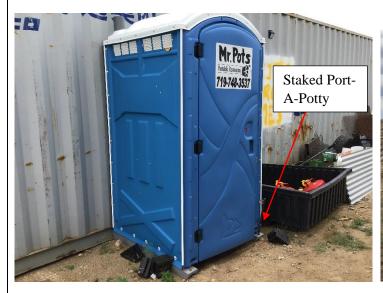
Image(s): 12-13 (Images taken by A. Sanderson, 07/22/20)

Comment: Waste disposal -1) Port-a-Potty located near the watchman's office/camper and was staked to secure the structure to the ground and 2) 3R Dumpster located near the conveyor belts and material storage.

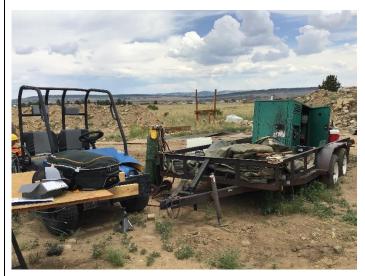
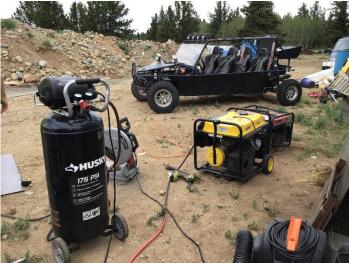
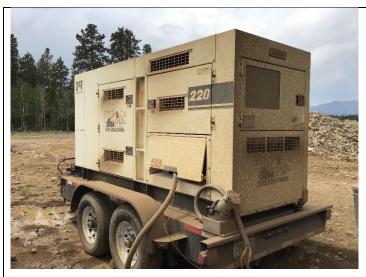
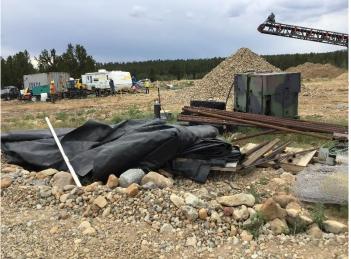
Image(s): 14-18 (Images taken by A. Sanderson, 07/22/20)

Comment: Variety of generators used as the main power source for the processing facility, air compressor and other powered equipment. Inactive generator (image 14), 2 small generators (image 15) and large generators as the main power source (images 16-17).

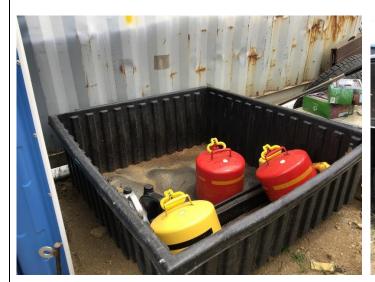
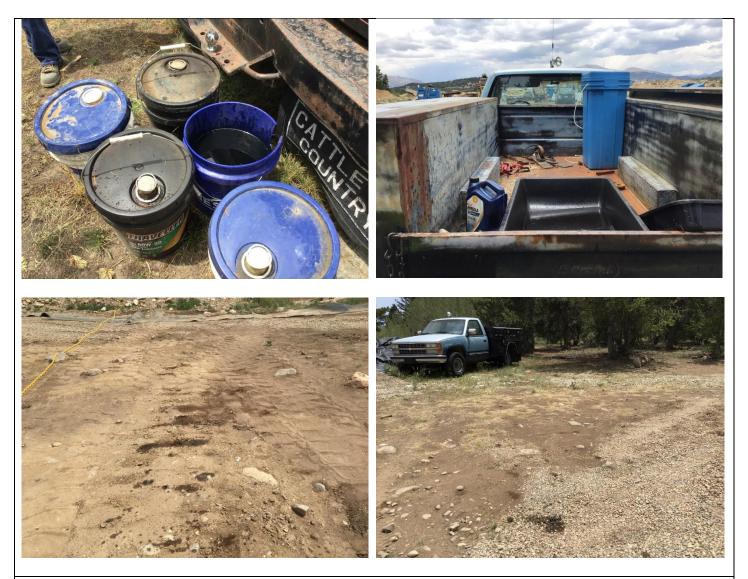
Image(s): 19-24 (Images taken by A. Sanderson, 07/22/20)

• Diesel and oil containers are not properly stored on-site. Multiple open spent oil and diesel containers were stored behind the maintenance truck located along the SE boundary. All POL substances need to be stored in appropriately labeled containers and within secondary containment vessels. Several small oil spills were also observed throughout the site. Best Management Practices suggest storing all POLs away from water resources and within secondary containment. Note: No sheen was observed on water surfaces. *All POLs will need to be removed off-site prior to the seasonal shut-down.

Comment: POL storage and secondary containment. The spent oil located behind the maintenance truck needs to be properly stored and disposed of once no longer in-use. Any POL spills need to be cleaned and disposed of according to the spill contingency plan (ref. map below for oil spill locations).

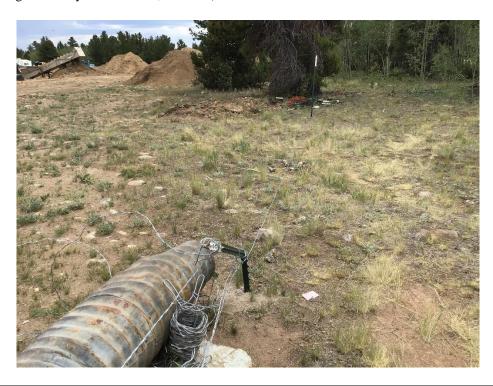
Images(s): 25 (Images taken by A. Sanderson, 07/22/20)

- 5. The mine boundary fence has been installed; however, the western boundary has been illegally cut by unknown trespassers (ref. image 21). The operator was informed to reinstall the fence and post multiple signs along the fence to further inform the public of the mining operation and safety hazards.

Comment: The 3 rung straight wire perimeter fence is completely constructed; however, approximately 15 feet of the western fence has been cut by an unknown trespasser or public land user (ref. red arrow).

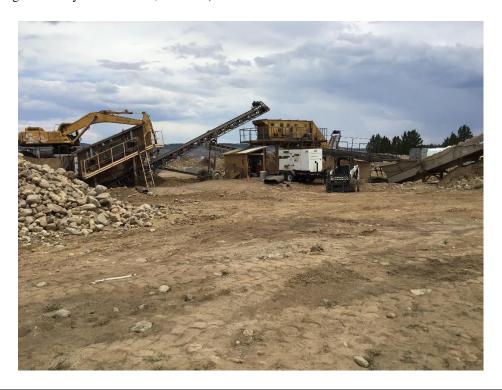
Image(s): 26 (Images taken by A. Sanderson, 07/22/20)

Comment: New wash/processing plant authorized in the Plan of Operations minor modification on 08/15/19. The plant was active during the operations, sorting ore from inert mineral materials. Material is sorted by 3

sizes: medium grained sand (0.25-0.55 mm), roadbase ¾-, pebbles (2-4 mm) and cobble and boulders (ref. 07/22/20 3600 mineral material inspection for details regarding mineral material products).

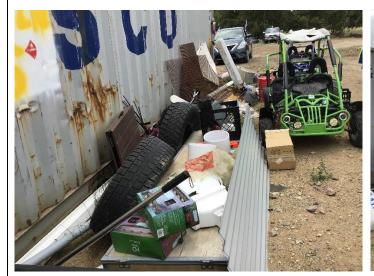
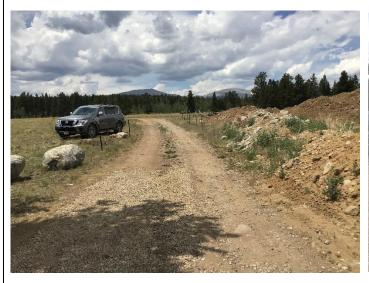
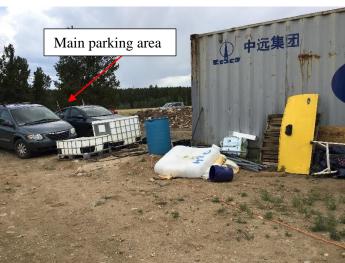
Image(s): 27-30 (Images taken by A. Sanderson, 07/22/20)

Comment: Transportation vehicles onsite include 2 small go-karts and a 4-person UTV. A parking area is located along the southern portion of the site and along the access road.

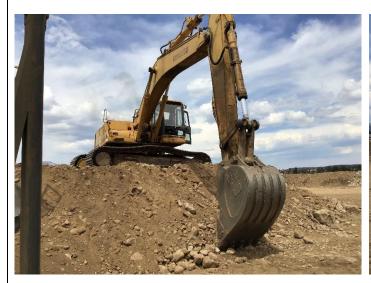
Image(s): 31-32 (Images taken by A. Sanderson, 07/22/20)

Comment: Mining equipment onsite. Reference the 03/25/2020 map for locations of all other structures onsite.

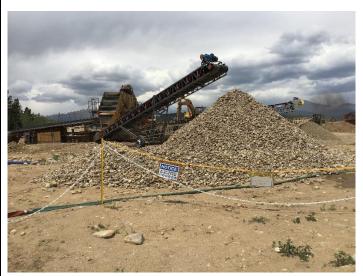
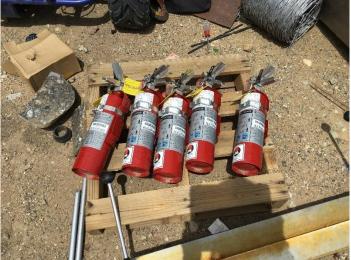
Image(s): 33-34 (Images taken by A. Sanderson, 07/22/20)

Comment: Safety equipment/measures taken at the site -1) chain separates the parking area from the processing area, 2) fire extinguishers and 3) life preserver (image 7).

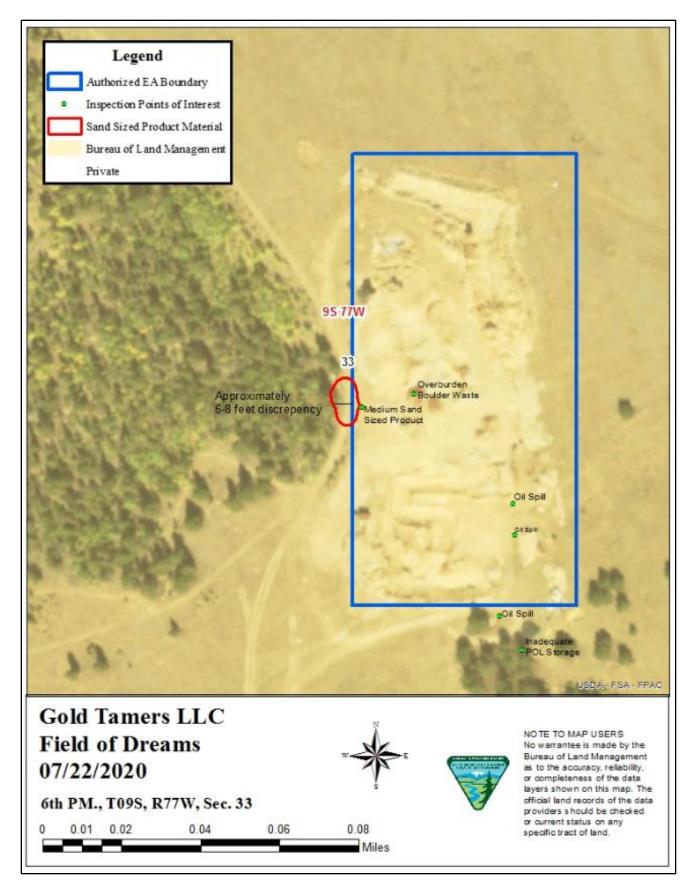
Figure 1: Map of the oil spill and product material locations. The collector app that was used to collect the GPS data has an error of approximately 16 feet; therefore, the product material is most likely within the authorized boundary. (Map created by A. Sanderson, 07/22/20)
