## QUARTERLY POND INSPECTION REPORT

| Operator: | ARC McClane Canyon LLC | Quarter: | Fourth 2020 |
| Mine: | McClane Canyon Mine C-1980-004 | Inspection Date: | 14-Nov-20 |

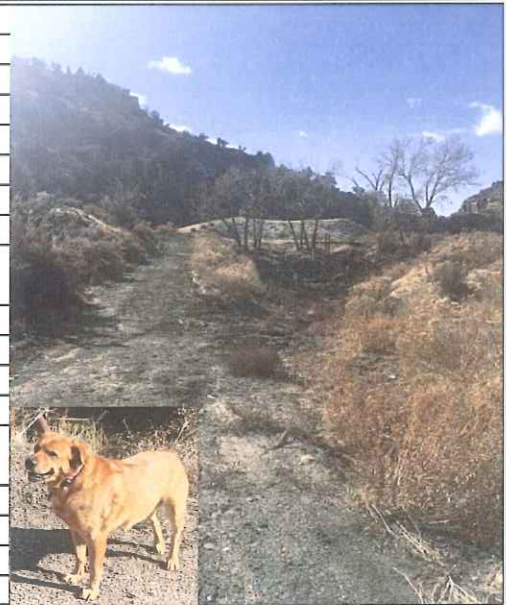
Invert of primary spillway is at elevation 5457.00.

Invert of emergency spillway is at elevation 5462.00.

Pond bottom about 7' below primary spillway

None
