**PERMIT INFORMATION**

<b>Permit Number:</b> C-1981-014 <b>Mine Name:</b> Southfield Mine <b>Operator:</b> Energy Fuels Coal, Inc. <b>Operator Address:</b> Mr John Adams P.O. Box 773457 Steamboat Springs, CO 80477	<b>County:</b> Fremont <b>Operation Type:</b> Underground <b>Permit Status:</b> Revoked <b>Ownership:</b> Private
	<b>Operator Representative Present:</b>  None
<b>Operator Representative Signature:</b> (Field Issuance Only)

<b>Inspection Start Date:</b> December 27, 2020 <b>Inspection Start Time:</b> 13:00 <b>Inspection End Date:</b> December 27, 2020 <b>Inspection End Time:</b> 13:30		<b>Inspection Type:</b> Coal Complete Inspection <b>Inspection Reason:</b> Normal I&E Program <b>Weather:</b> Clear	
<b>Joint Inspection Agency:</b>  None		<b>Joint Inspection Contacts:</b>  None	
<b>Post Inspection Agency:</b>  None		<b>Post Inspection Contacts:</b>  None	
<b>Inspector(s):</b>  Zach Trujillo	<b>Inspector's Signature:</b>

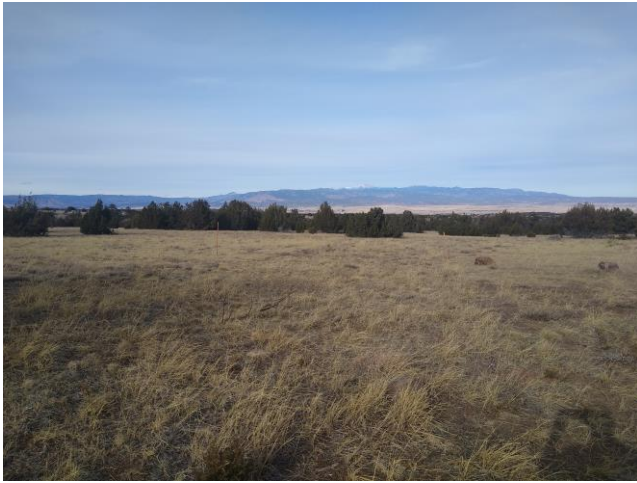
The reclaimed substation pad remains stable and well vegetated. No erosion, noxious weeds or issues were observed.

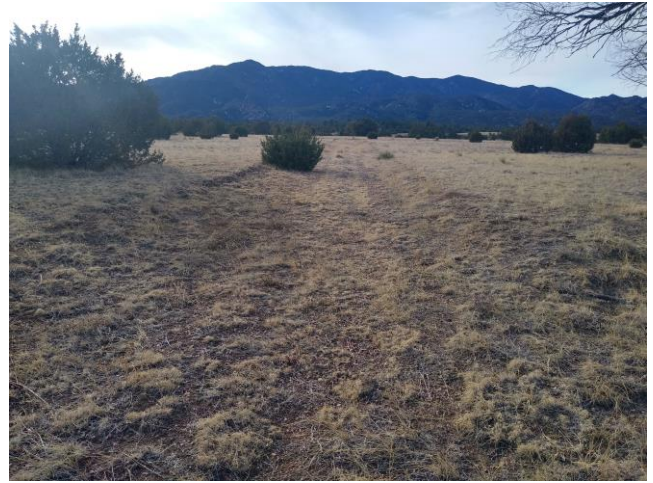
The light use road along the reclaimed substation pad was inspected. Visible vehicle use was observed and it appears that adjacent residents use this road for personal use to access other roads around the site.
