MINERALS PROGRAM INSPECTION REPORT PHONE: (303) 866-3567

MINE NAME:		MINE/PROSPECTING ID#:	MINERAL:	COUNTY:		
Weimer No. 2		M-1996-031	Gravel	Montrose		
INSPECTION TYPE:		INSPECTOR(S):	INSP. DATE:	INSP. TIME:		
Surety Release Inspection		Dustin Czapla	January 8, 2021	10:45		
OPERATOR:		OPERATOR REPRESENTATIVE:	TYPE OF OPERATION:			
Sutherland Brothers, Inc.			110c - Construction Limited Impact			
REASON FOR INSPECTION:		BOND CALCULATION TYPE:	BOND AMOUNT:			
Surety Release Requested		None	\$17,857.00			
DATE OF COMPLAINT:		POST INSP. CONTACTS:	JOINT INSP. AGENCY:			
NA		None	None			
WEATHER:	INSPECTOR'S SIGNATURE:		SIGNATURE DATE:			
Clear	De		January 11, 2021

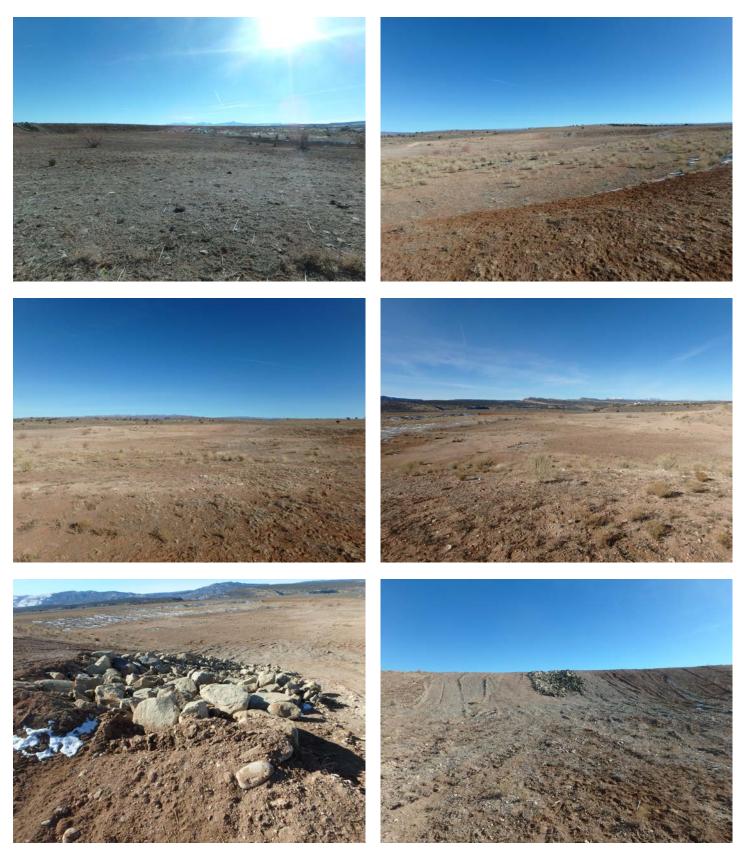
The site has been fully reclaimed. Final grading has been completed. Slopes are 3H:1V or less. The rill noted in the Division's 2019 inspection has been repaired and armored with riprap. Vegetation is becoming well established and cover appears equal in extent to that of the surrounding area.
