MINERALS PROGRAM INSPECTION REPORT
PHONE: (303) 866-3567

MINE NAME: St. Vrain Lakes, Filing 1, Slurry Wall	MINE/PROSPECTING ID#: M-1982-015	MINERAL: Sand and gravel	COUNTY: Weld
INSPECTION TYPE: Surety Release Inspection	INSPECTOR(S): Peter Hays	INSP. DATE: December 3, 2020	INSP. TIME: 10:00
OPERATOR: Carma Bayshore LLC	OPERATOR REPRESENTATIVE: None	TYPE OF OPERATION: 112c - Construction Regular Operation	
REASON FOR INSPECTION: Surety Release Requested	BOND CALCULATION TYPE: None	BOND AMOUNT: \$115,545.00	
DATE OF COMPLAINT: NA	POST INSP. CONTACTS: None	JOINT INSP. AGENCY: None	
WEATHER: Clear	INSPECTOR'S SIGNATURE:

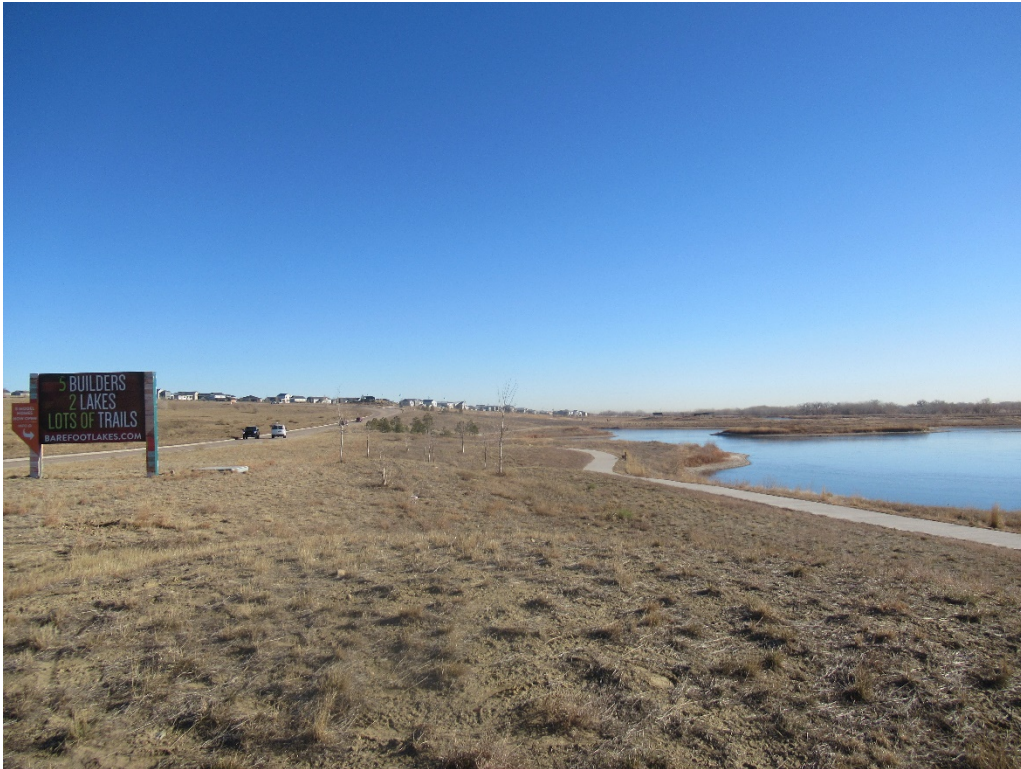
View of the site from the northwest corner looking east

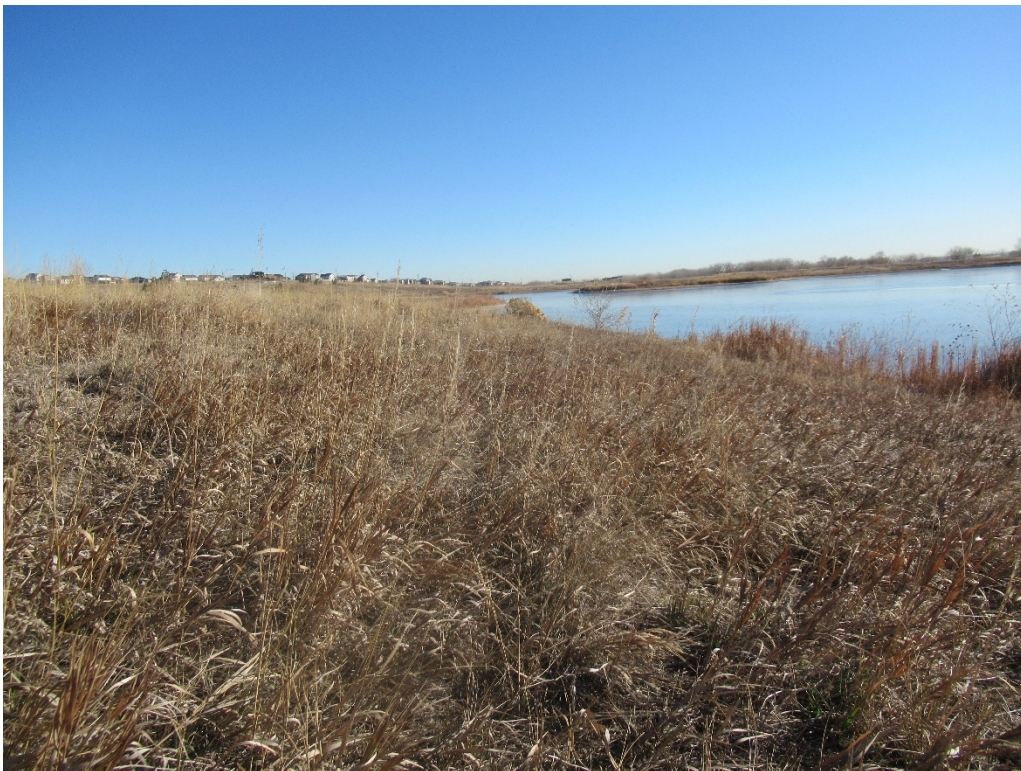
As noted during the last inspection when the reservoirs were dewatered, all slopes were regraded to the approved 3H:1V slope. The shoreline slopes observed during this inspection were stable with no erosion features noted during the inspection. The upland vegetation consisted of well-established dormant grass varieties, including western wheatgrass, thickspike wheatgrass, blue grama, sideoates grama, green needlegrass, buffalograss and swithgrass. The wetland and shoreline vegetation consisted of dormant well-established vegetation, including western wheatgrass, saltgrass, slender wheatgrass, swithgrass, willows and cattails. Landscaping trees were observed along the west, east and north sides of the reservoirs. A park and amphitheater has been constructed in the northwest corner of the eastern reservoir. A concrete or gravel surfaced path has been constructed around the reservoirs for use by the residences of the housing development. Noxious weeds including, kochia and yellow sweet clover were observed during the inspection. The area between the two reservoirs was being interseeded during the inspection. Following the inspection, Mr. Kris Rabida with WSP representing the Permittee stated the site was interseeded in the spring and fall as part of the residential development maintenance program. The site is also treated for noxious and annual weeds by the development company according to Mr. Rabida.

View of upland vegetation in the northwest corner of the site

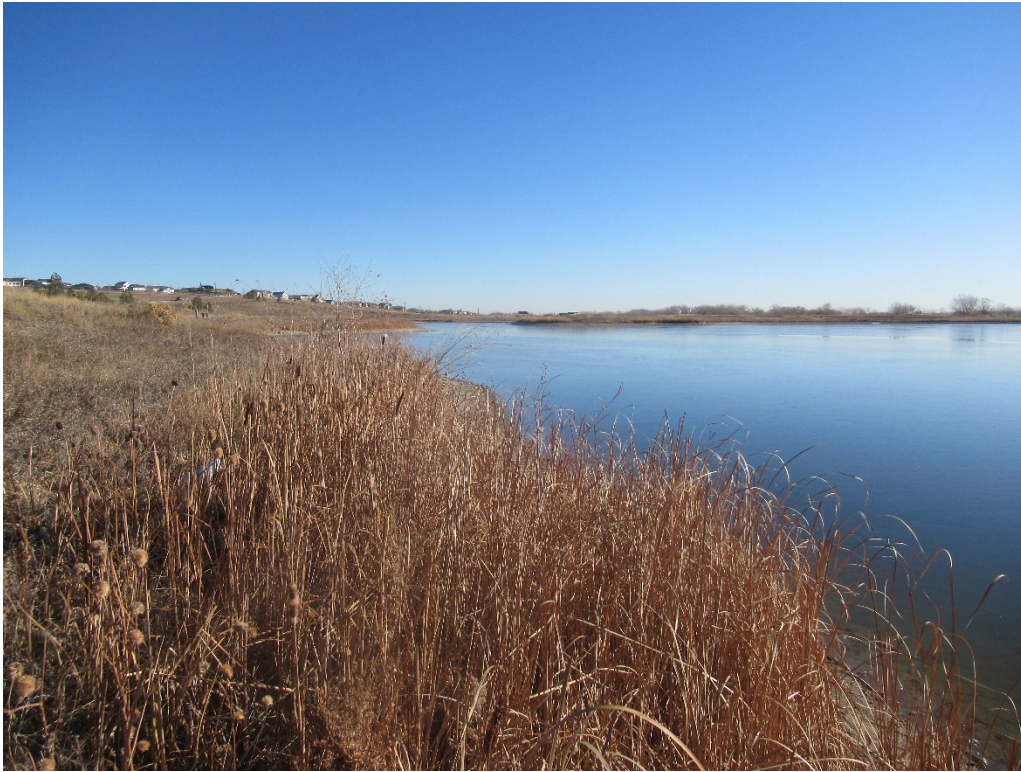
View of shoreline vegetation in the northwest corner of the site

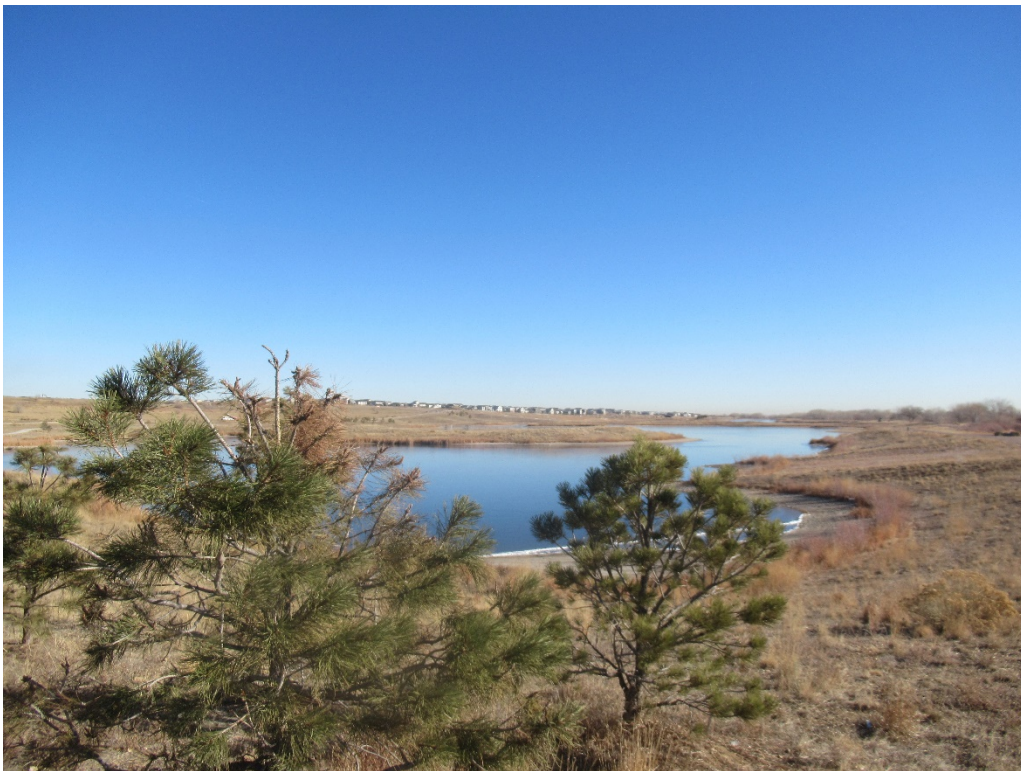
View of the site from the southwest corner looking east

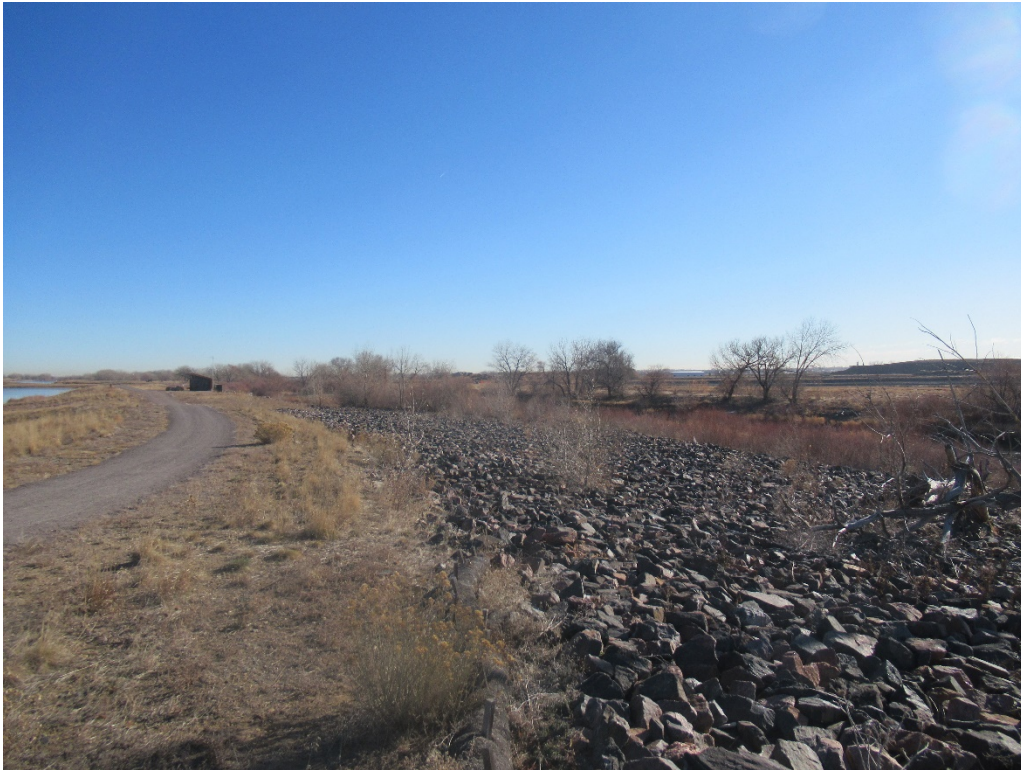
The five (5) spillways constructed in 2015 as part of the 2013 flood repair work were observed during the inspection. Four (4) of the spillways (#1, #2, #3 and #5) are located along the south side of the site adjacent to the St. Vrain River. The last spillway (#4) is located between the eastern and western reservoirs. The spillways were stable and appeared to be constructed according to the approved design.

View of spillway #1 from the west side looking east

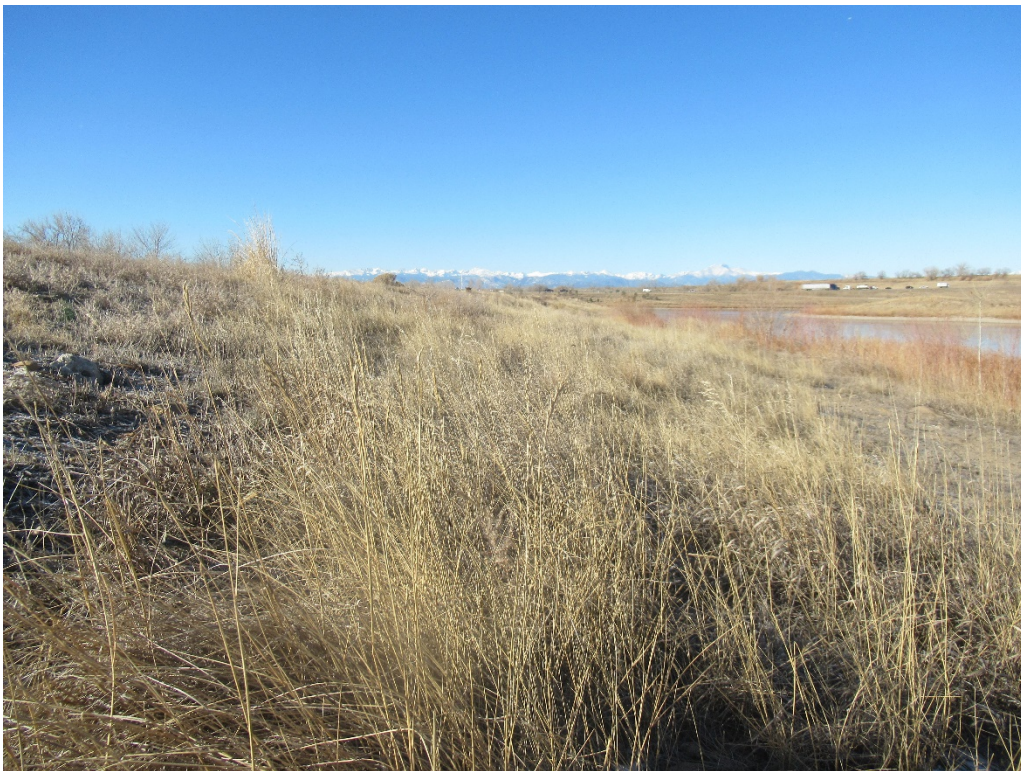
View of the vegetation in the southwest corner of the site

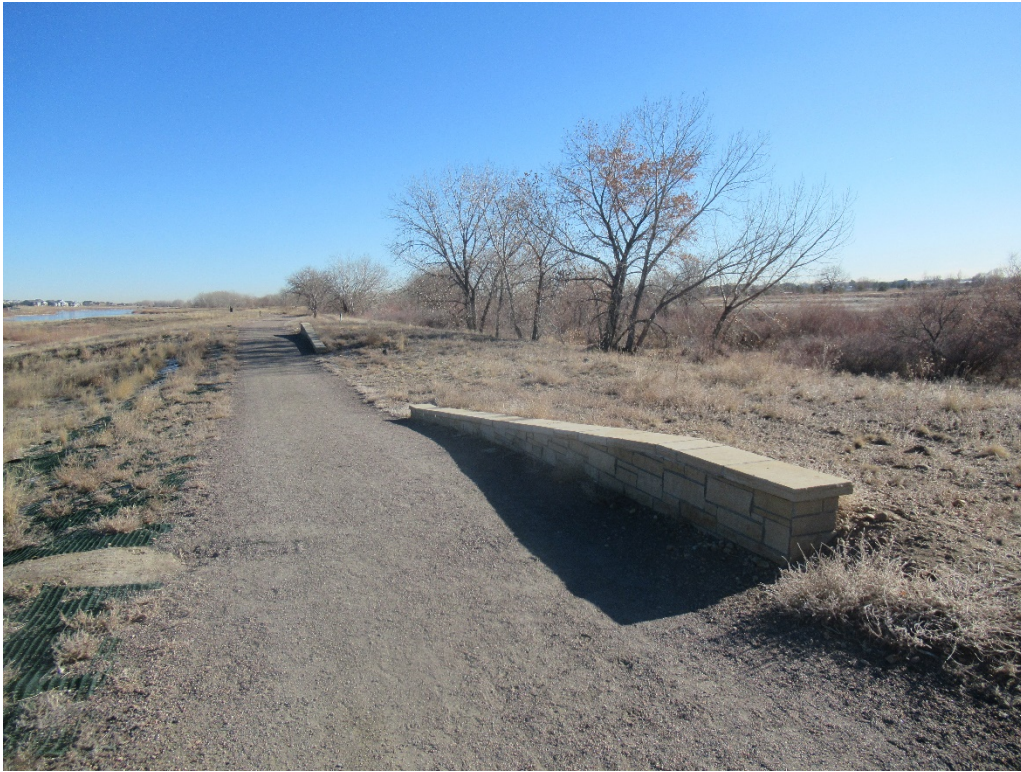
View of spillway #2 from the west side looking east

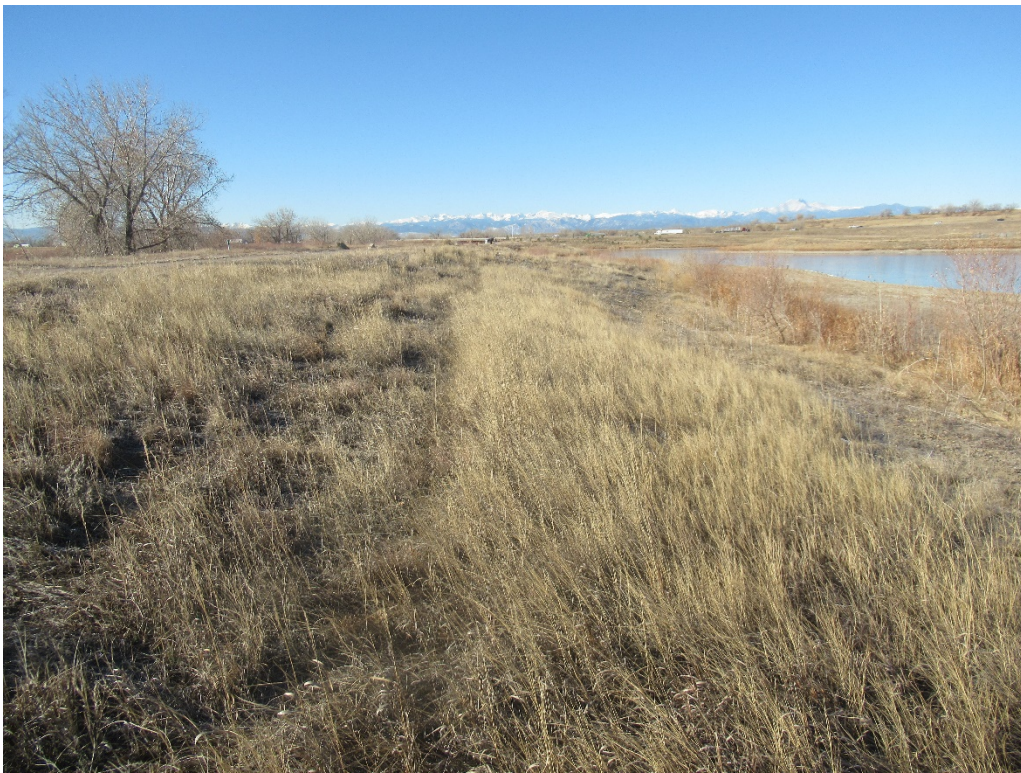
View of the upland vegetation in the southeast corner of the western reservoir

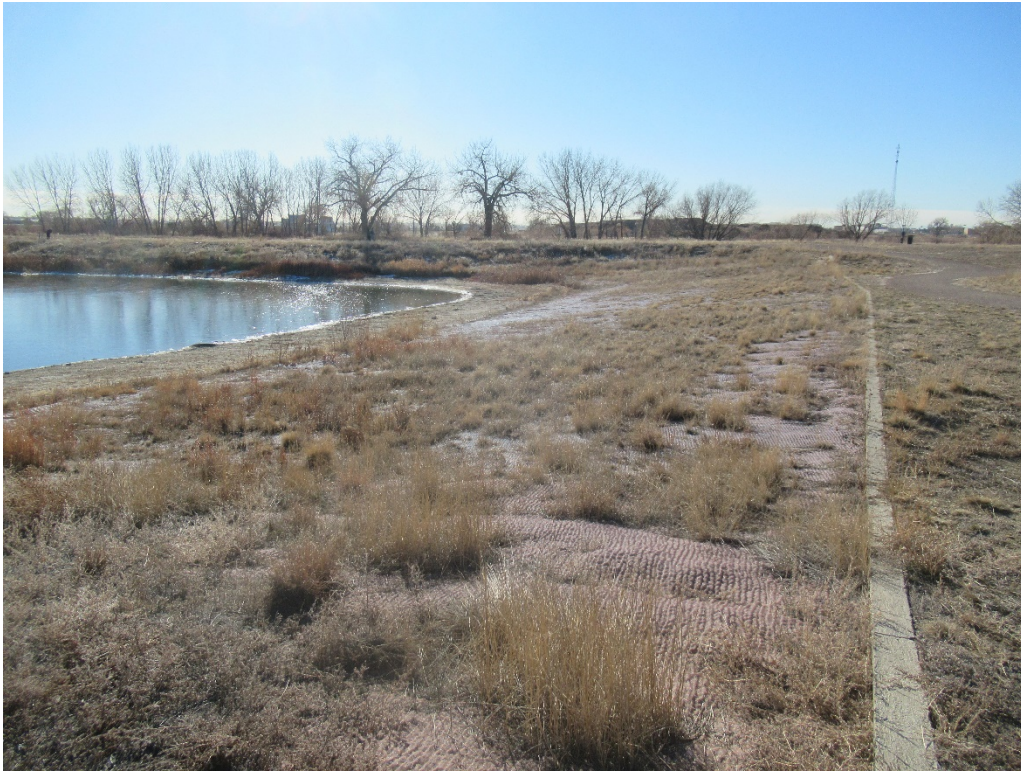
View of spillway #4 from the north end looking south

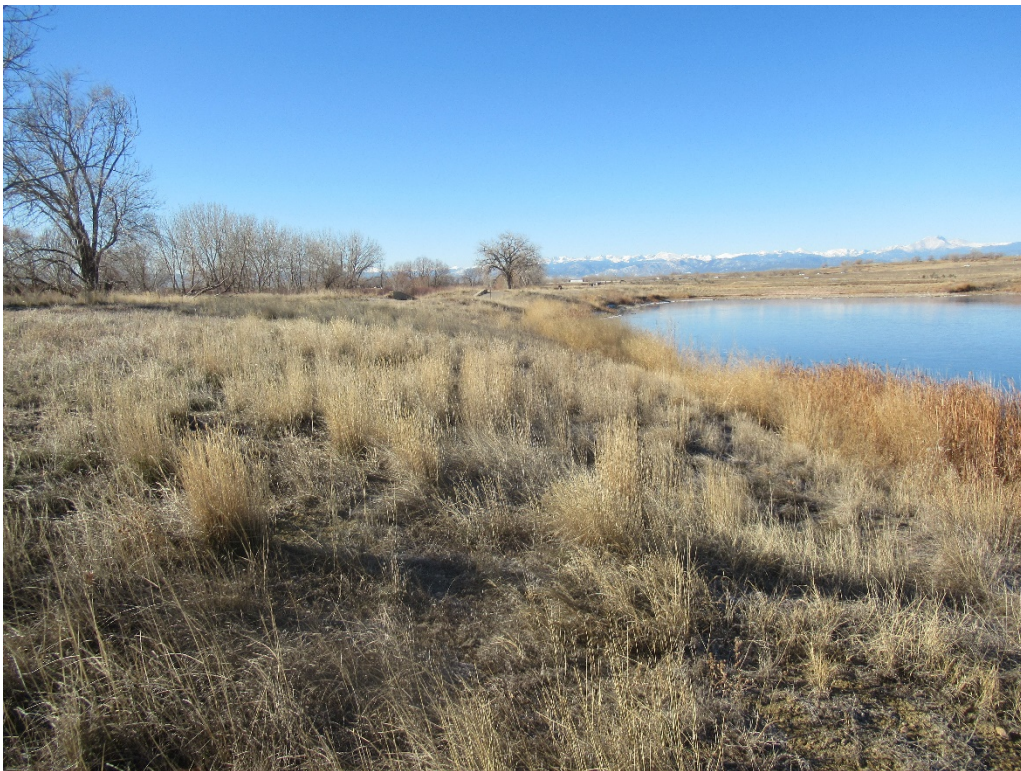
View of the vegetation along the south side of the western reservoir

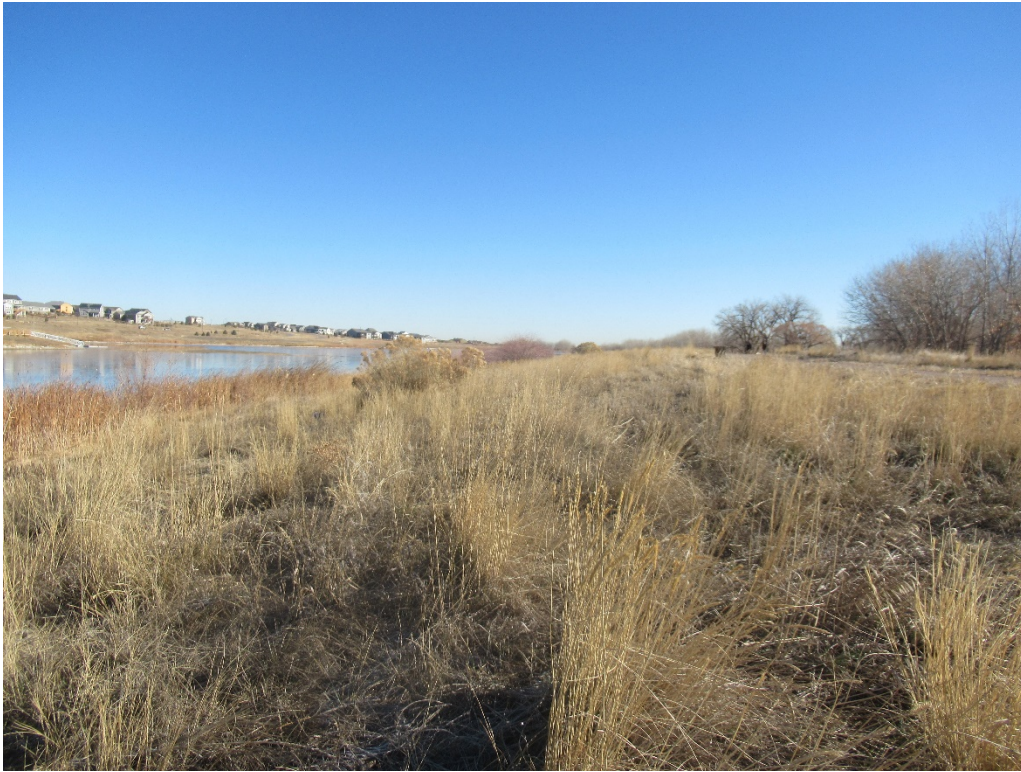
View of the vegetation along the south side of the western reservoir

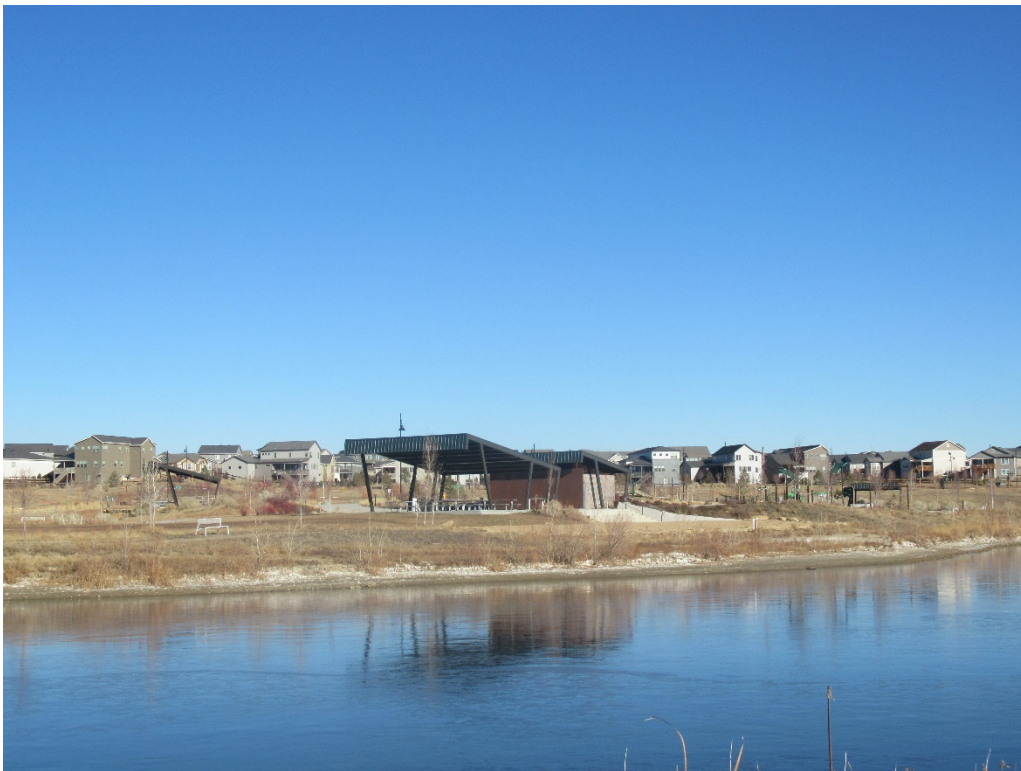
View of the park located in the northwest corner of the western reservoir

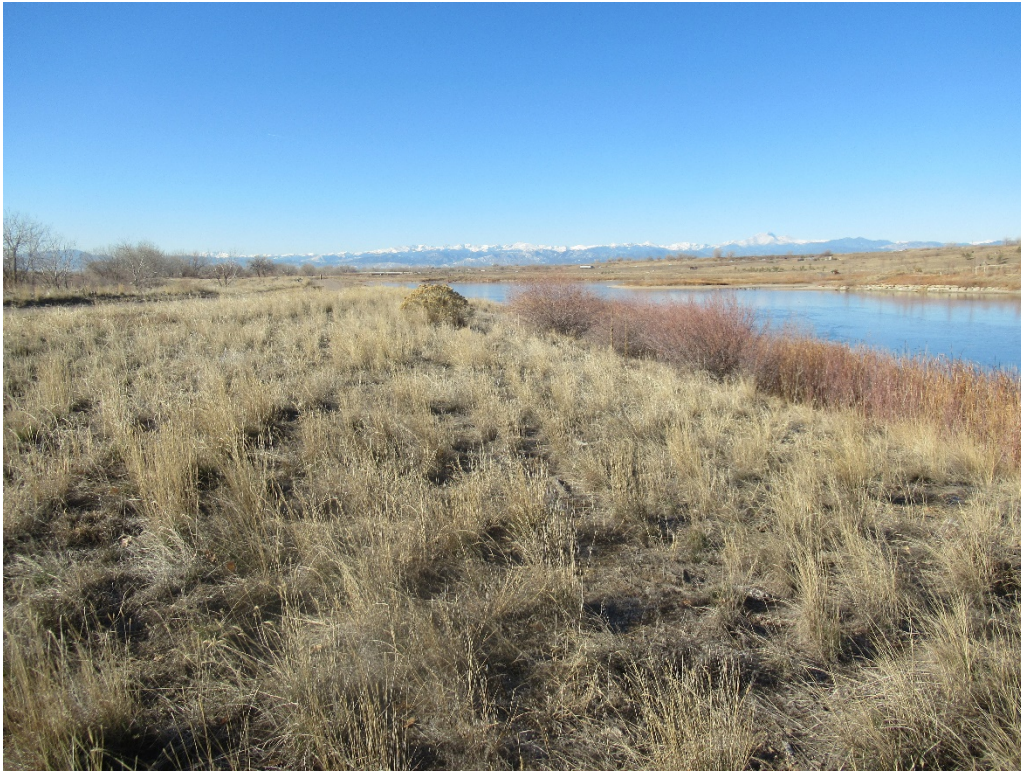
View of the vegetation along the south side of the western reservoir

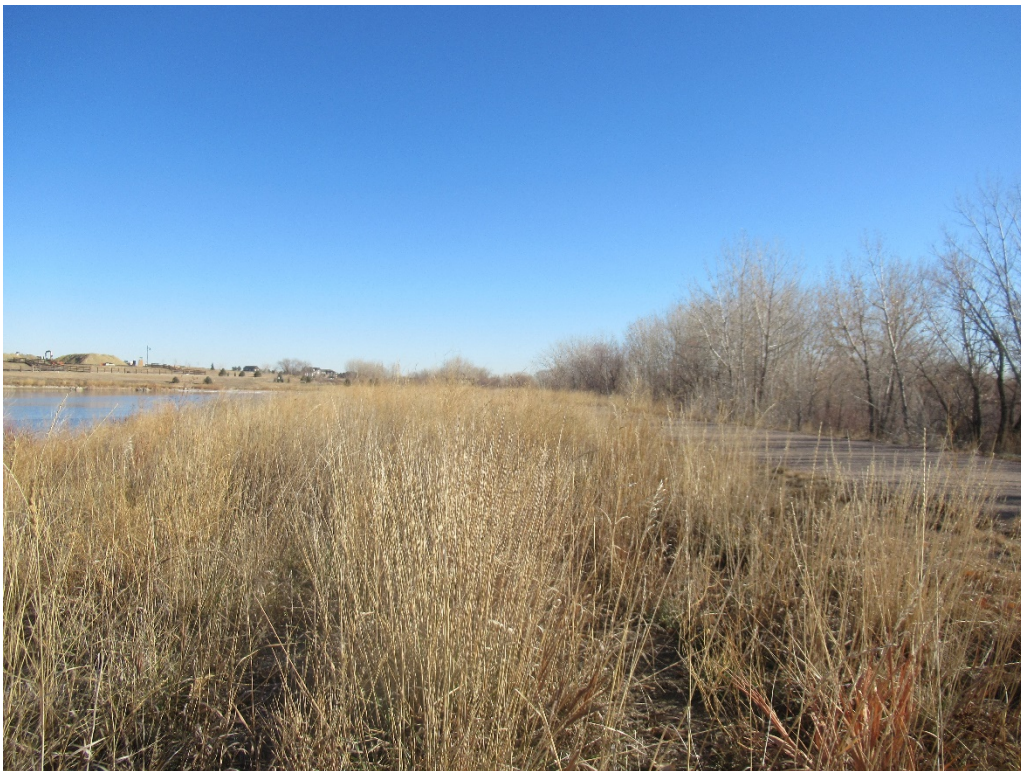
View of the vegetation in the southwest corner of the western reservoir

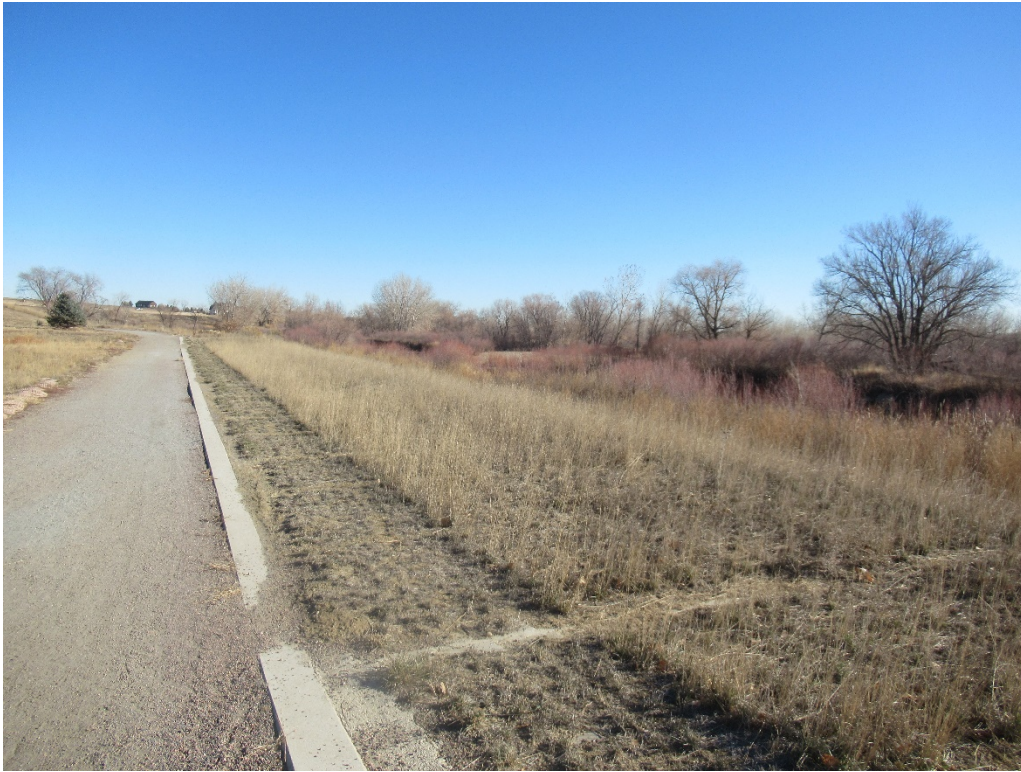
View of spillway #5 from the west side looking east

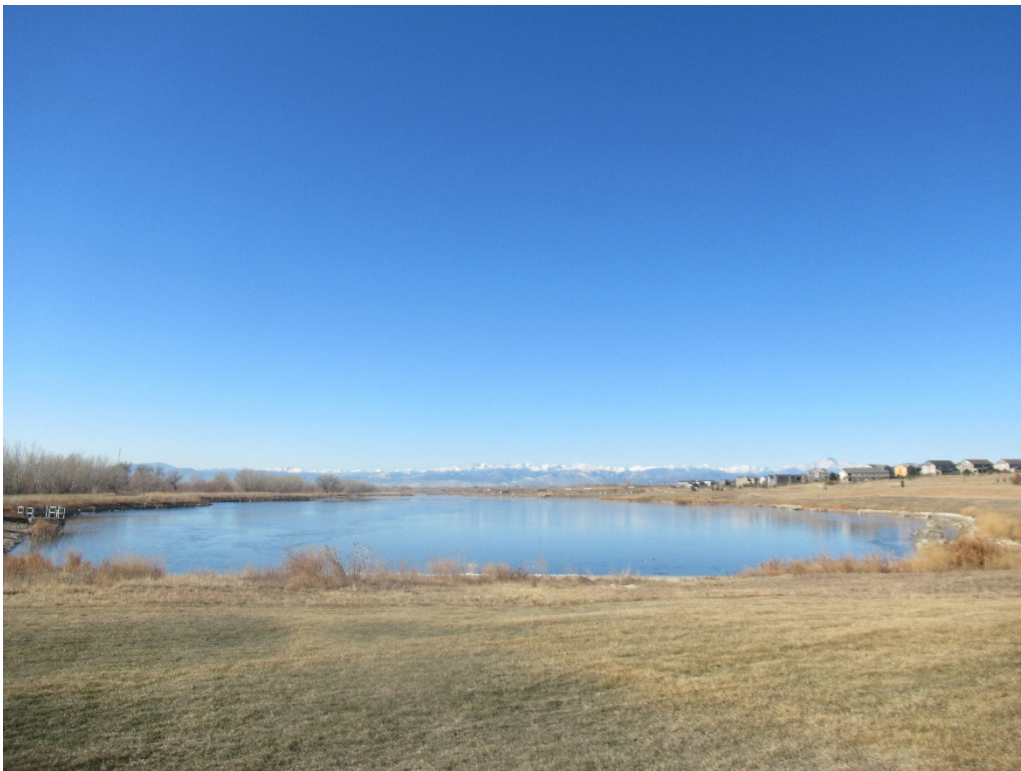
View of the western reservoir from the east side looking west

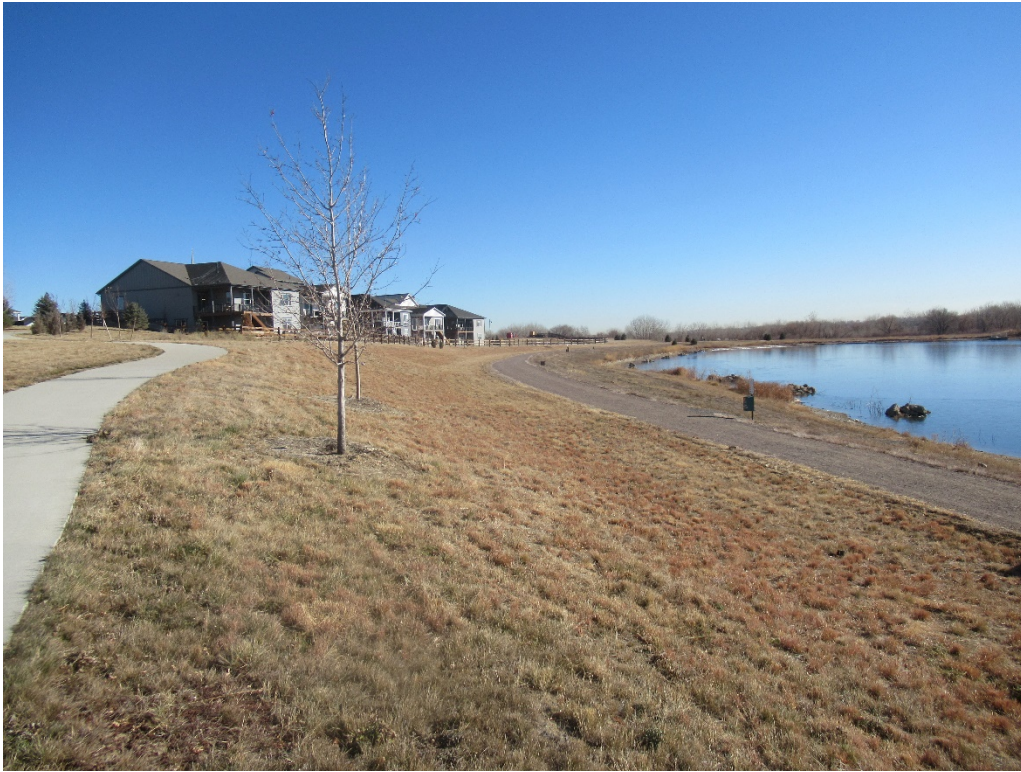
View of the landscaped vegetation located in the northwest corner of the western reservoir

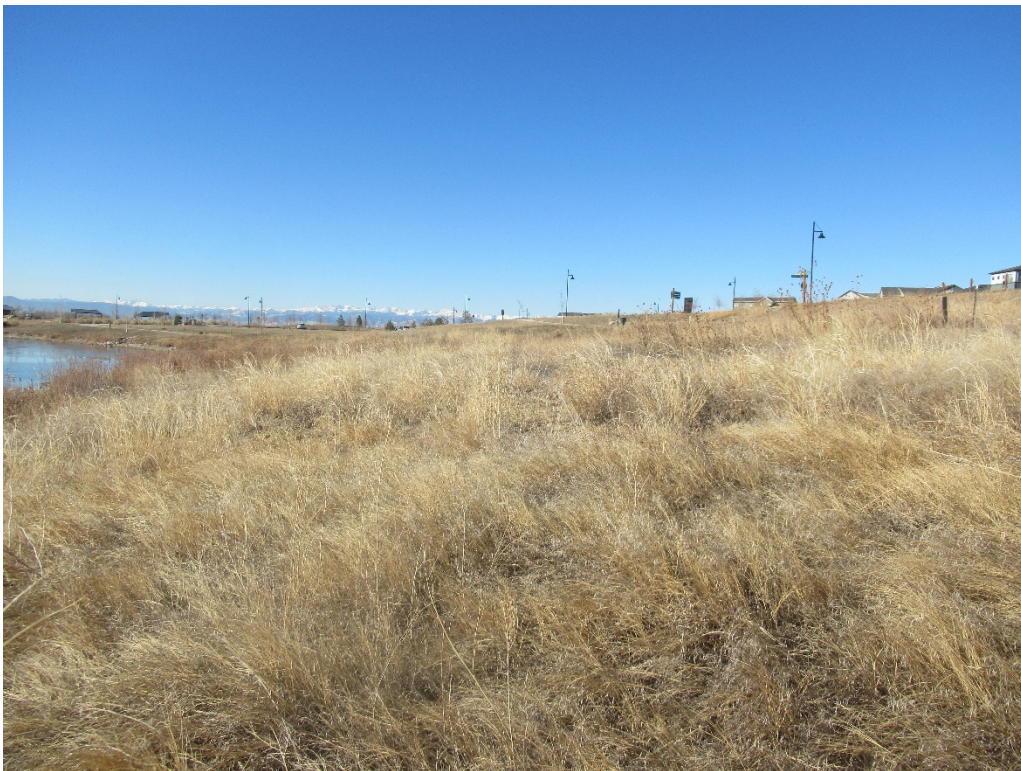
View of the vegetation in the northwest corner of the western reservoir

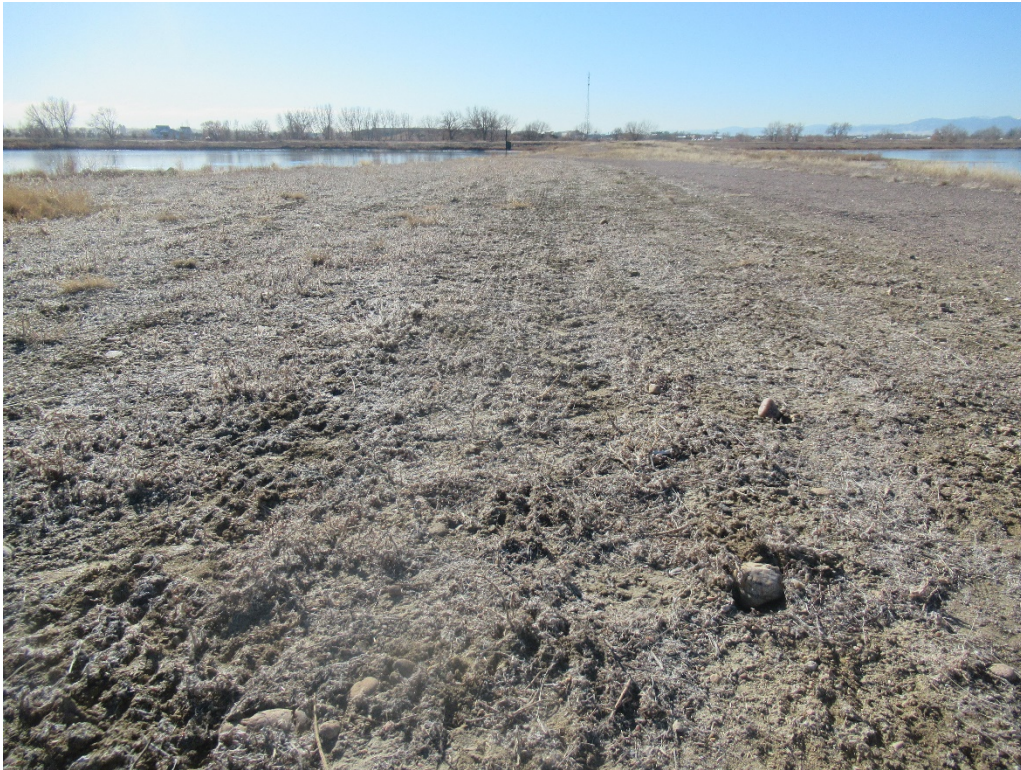
View of the seeded area located between the eastern and western reservoirs

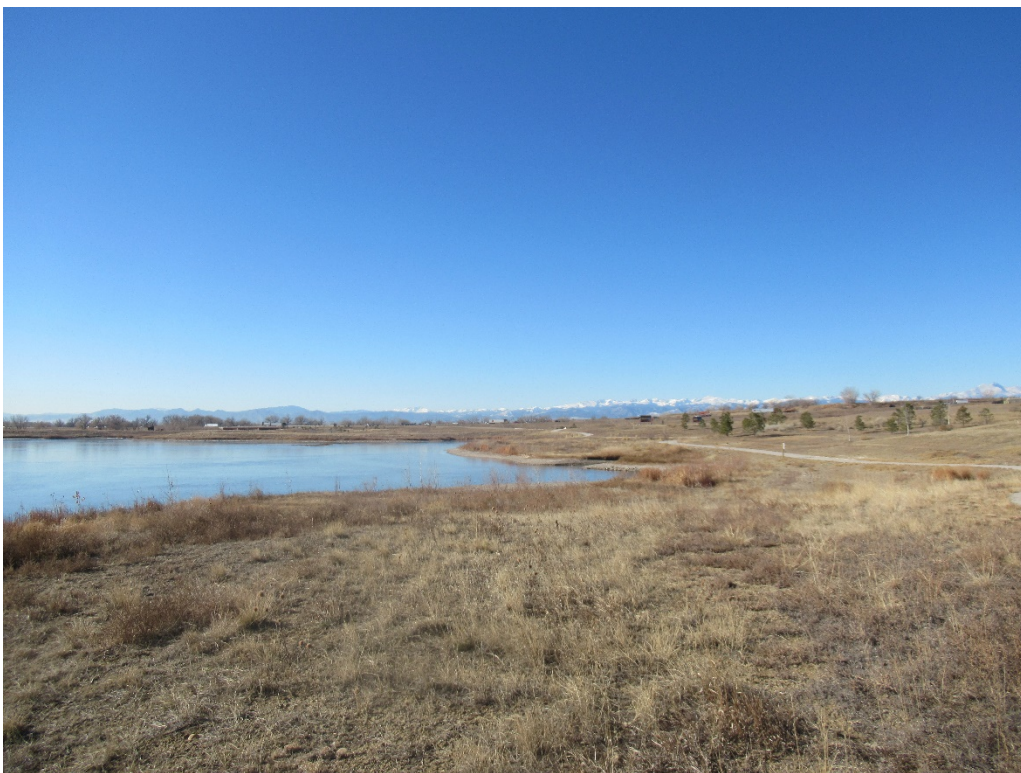
View of the site from the northeast corner of the eastern reservoir looking west
