**COLORADO****Division of Reclamation,
Mining and Safety**

PERMIT INFORMATION

Permit Number: C-1981-041 Mine Name: Roadside Portals Operator: Snowcap Coal Company, Inc. Operator Address: MS Tonya Hammond P.O. Box 1430 Palisade, CO 81526	County: Mesa Operation Type: Underground Permit Status: Active Ownership: Private
	Operator Representative Present: NA
Operator Representative Signature: (Field Issuance Only)

Inspection Start Date: January 11, 2021 Inspection Start Time: 11:00 Inspection End Date: January 11, 2021 Inspection End Time: 11:05		Inspection Type: Aerial Inspection Inspection Reason: Normal I&E Program Weather: Clear	
Joint Inspection Agency: None		Joint Inspection Contacts: None	
Post Inspection Agency: None		Post Inspection Contacts: None	
Inspector(s): Clayton Wein Brock Bowles	Inspector's Signature: <i>Clayton Wein</i>		Signature Date: 1/12/2021

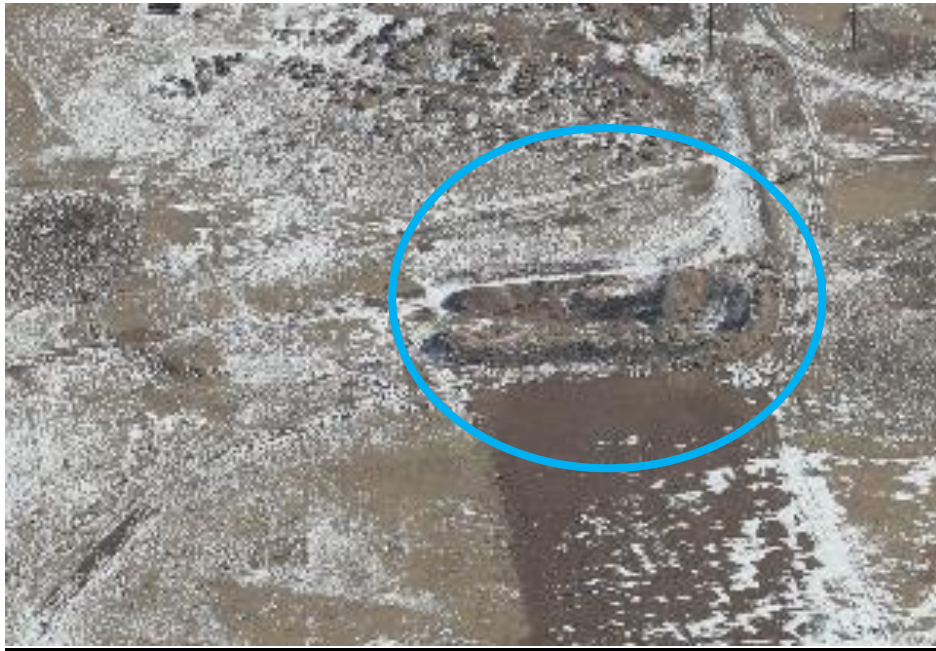
During the inspection the Carey Pit was observed to be dry. The pit is located within the southwest portion of the permit area. A small amount of snow was observed in the bottom of the pit (Photo 1). The landowner's field located within the south/southeast portion of the permit area was covered with snow (Photo 2). There was no evidence of irrigation on the field. The trenches on top off the tract 70 mesa were observed to be covered with snow (Photo 3). There were no indications of recent water applications in the trenches.

Photo 1: The Carey Pit outlined in the blue circle in the photo above.

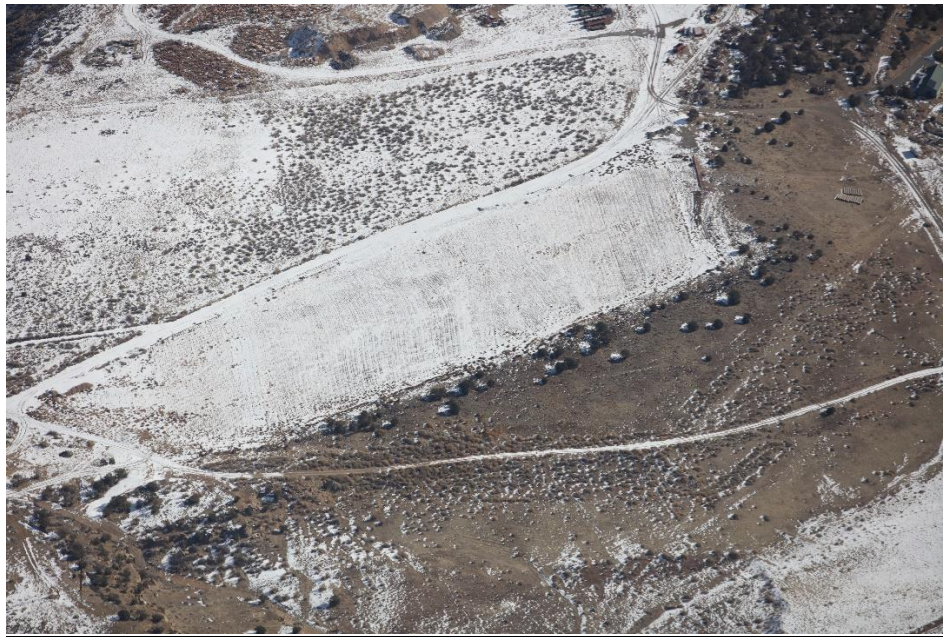
Photo 2: The Landowner's field covered in snow.

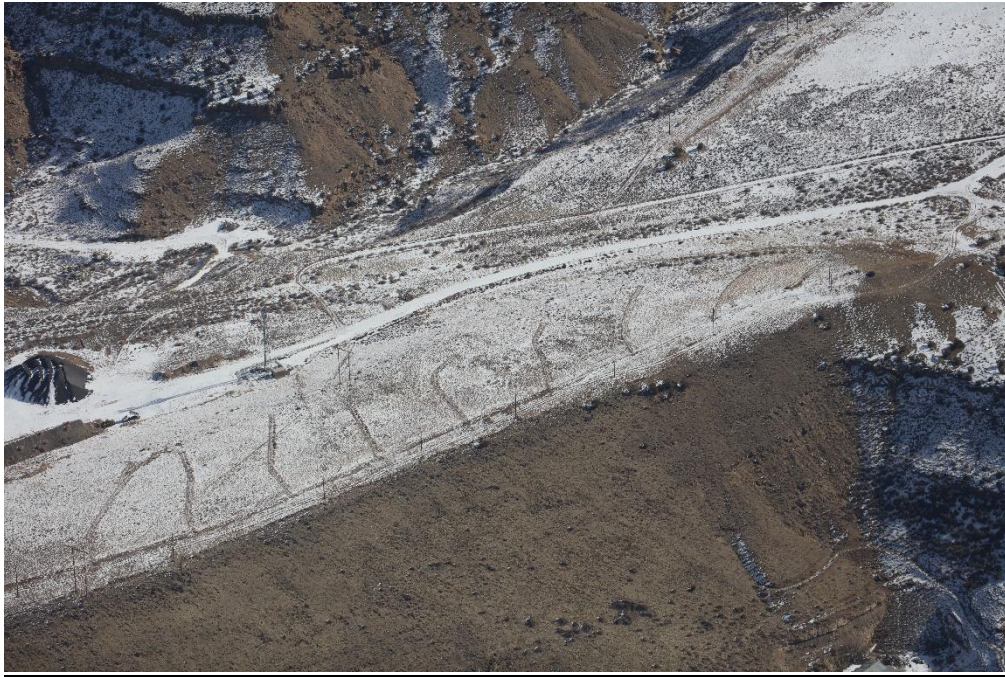
Photo 3: The trenches on the Tract 70 Mesa.

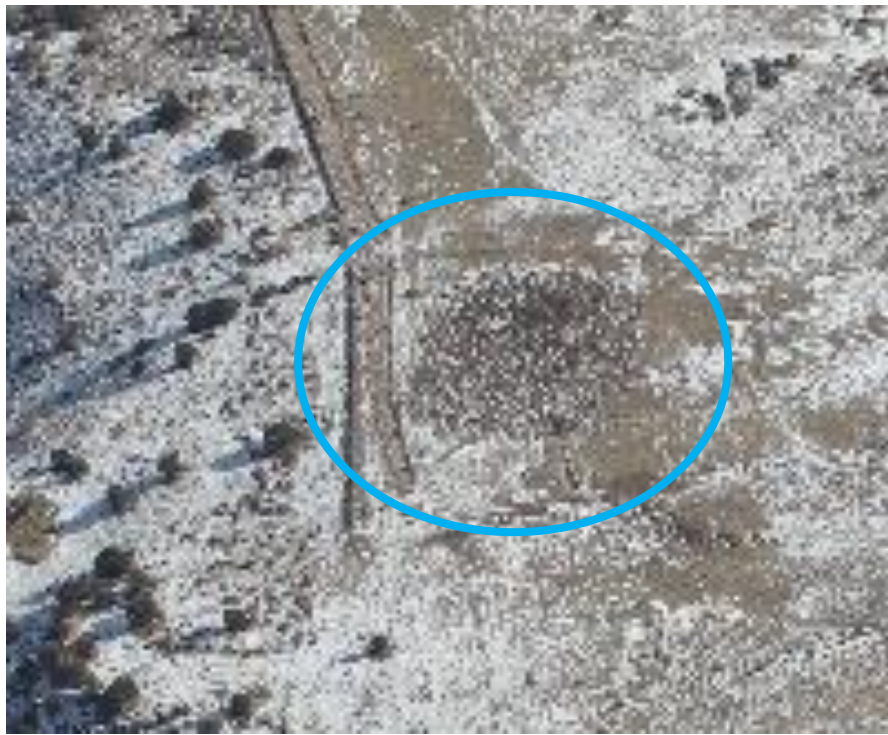
The TR-69 repair site, located in the southwest portion of the permit area, was reclaimed in the fall of 2019. The site was covered with a thin layer of snow at the time of the inspection (Photo 4). The site was stable with vegetative growth. No erosional features were observed. The sediment logs were observed to be intact and in the correct down-gradient positions at the reclaimed site.

Photo 4: The TR-69 repair area was partly covered with snow. The repair area is outlined in the blue circle in the photo above.
