Pikeview monitoring report

To: Jerald Schnabel From: Paul Kos
Continental Materials Corp. Denver, CO 80222
File: November 2020 Monitoring Summary Date: December 31, 2020

Reference: November 2020 Geotechnical Monitoring Summary Pikeview Quarry

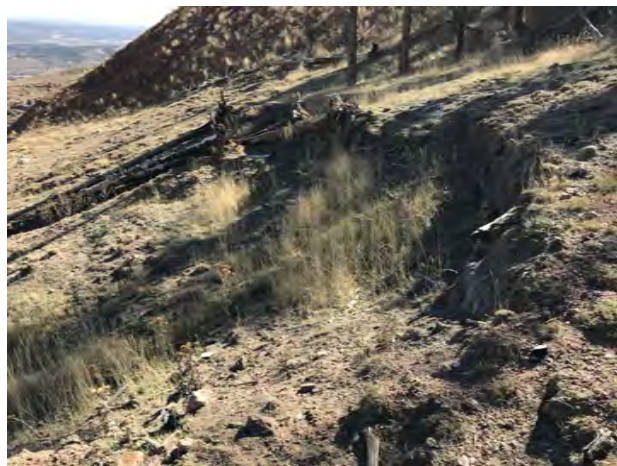
- Healed Cracks: A crack was observed on the slope adjacent to the slide where cracking had previously been observed. This crack runs parallel to the slide and appears to be “healed” and did not indicate any recent movement. (Note 6)

6. HEALED CRACKING ABOVE THE SLIDE AREA

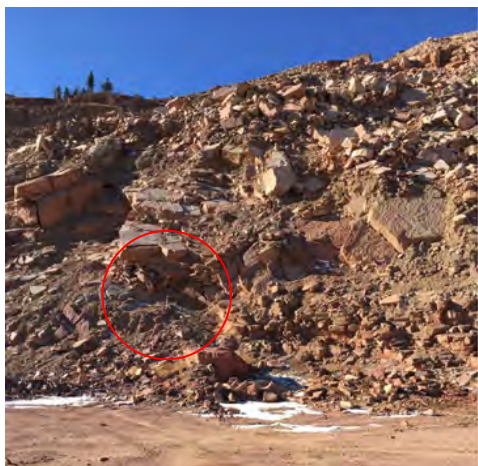
- Several new prisms were in the process of being placed during the site visit and will appear on the next report.
- Gullies: Gullies have formed on the slopes above the slide area as well as in the burn areas above the quarry. (Note 2)

5. NEW PRISM AT THE TOE

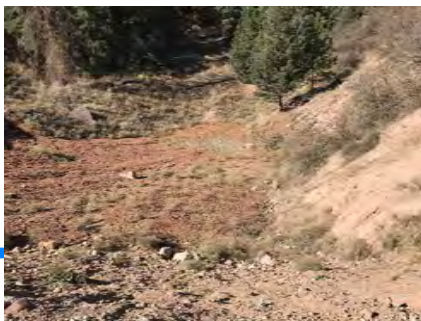
- Culverts: A 6-ft culvert was observed to be blocked on the upstream end. There is evidence that water is collecting at the inlet during rain events and likely seeping through the loose material and through the culvert. During the November visit plans were made for the clearing of the culvert inlet. (Note 1).

1. AREA UPSTREAM OF BLOCKED CULVERT

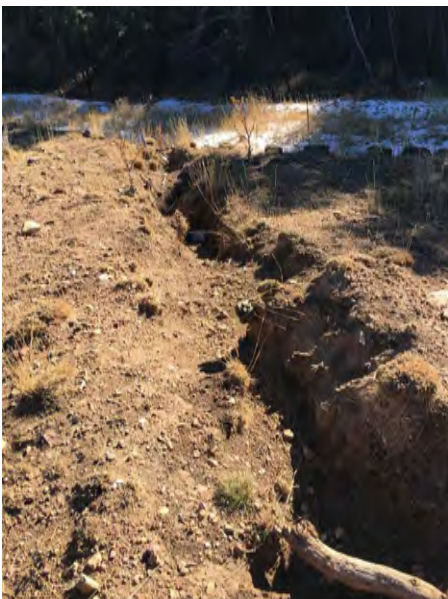
2. EROSION GULLEY

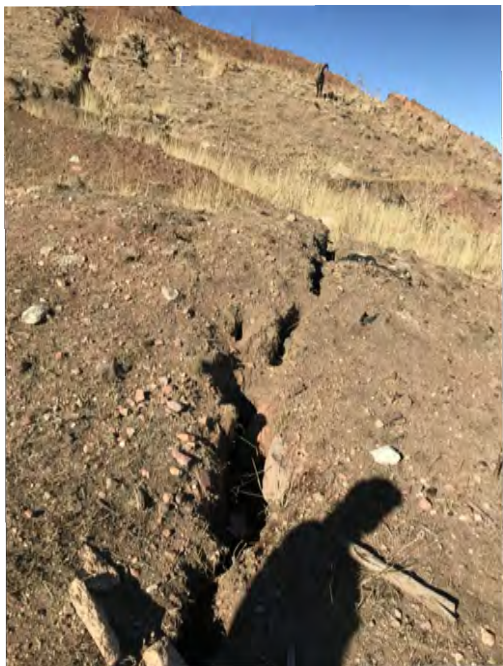
- Fresh Cracks: A crack was observed this feature is in an area where cracking is expected to occur as a result of ongoing slope settlement and relaxation. (Note 7)

7. NEW CRACK PARALLEL TO SLIDE

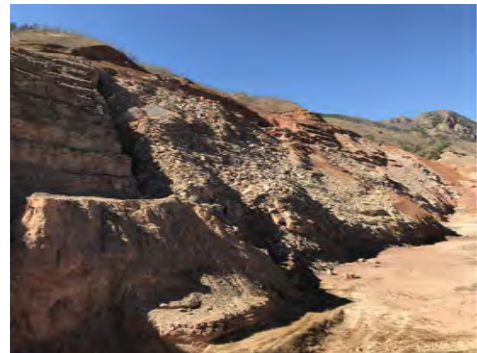
8. VIEW UP SOUTH ESCARPMENT

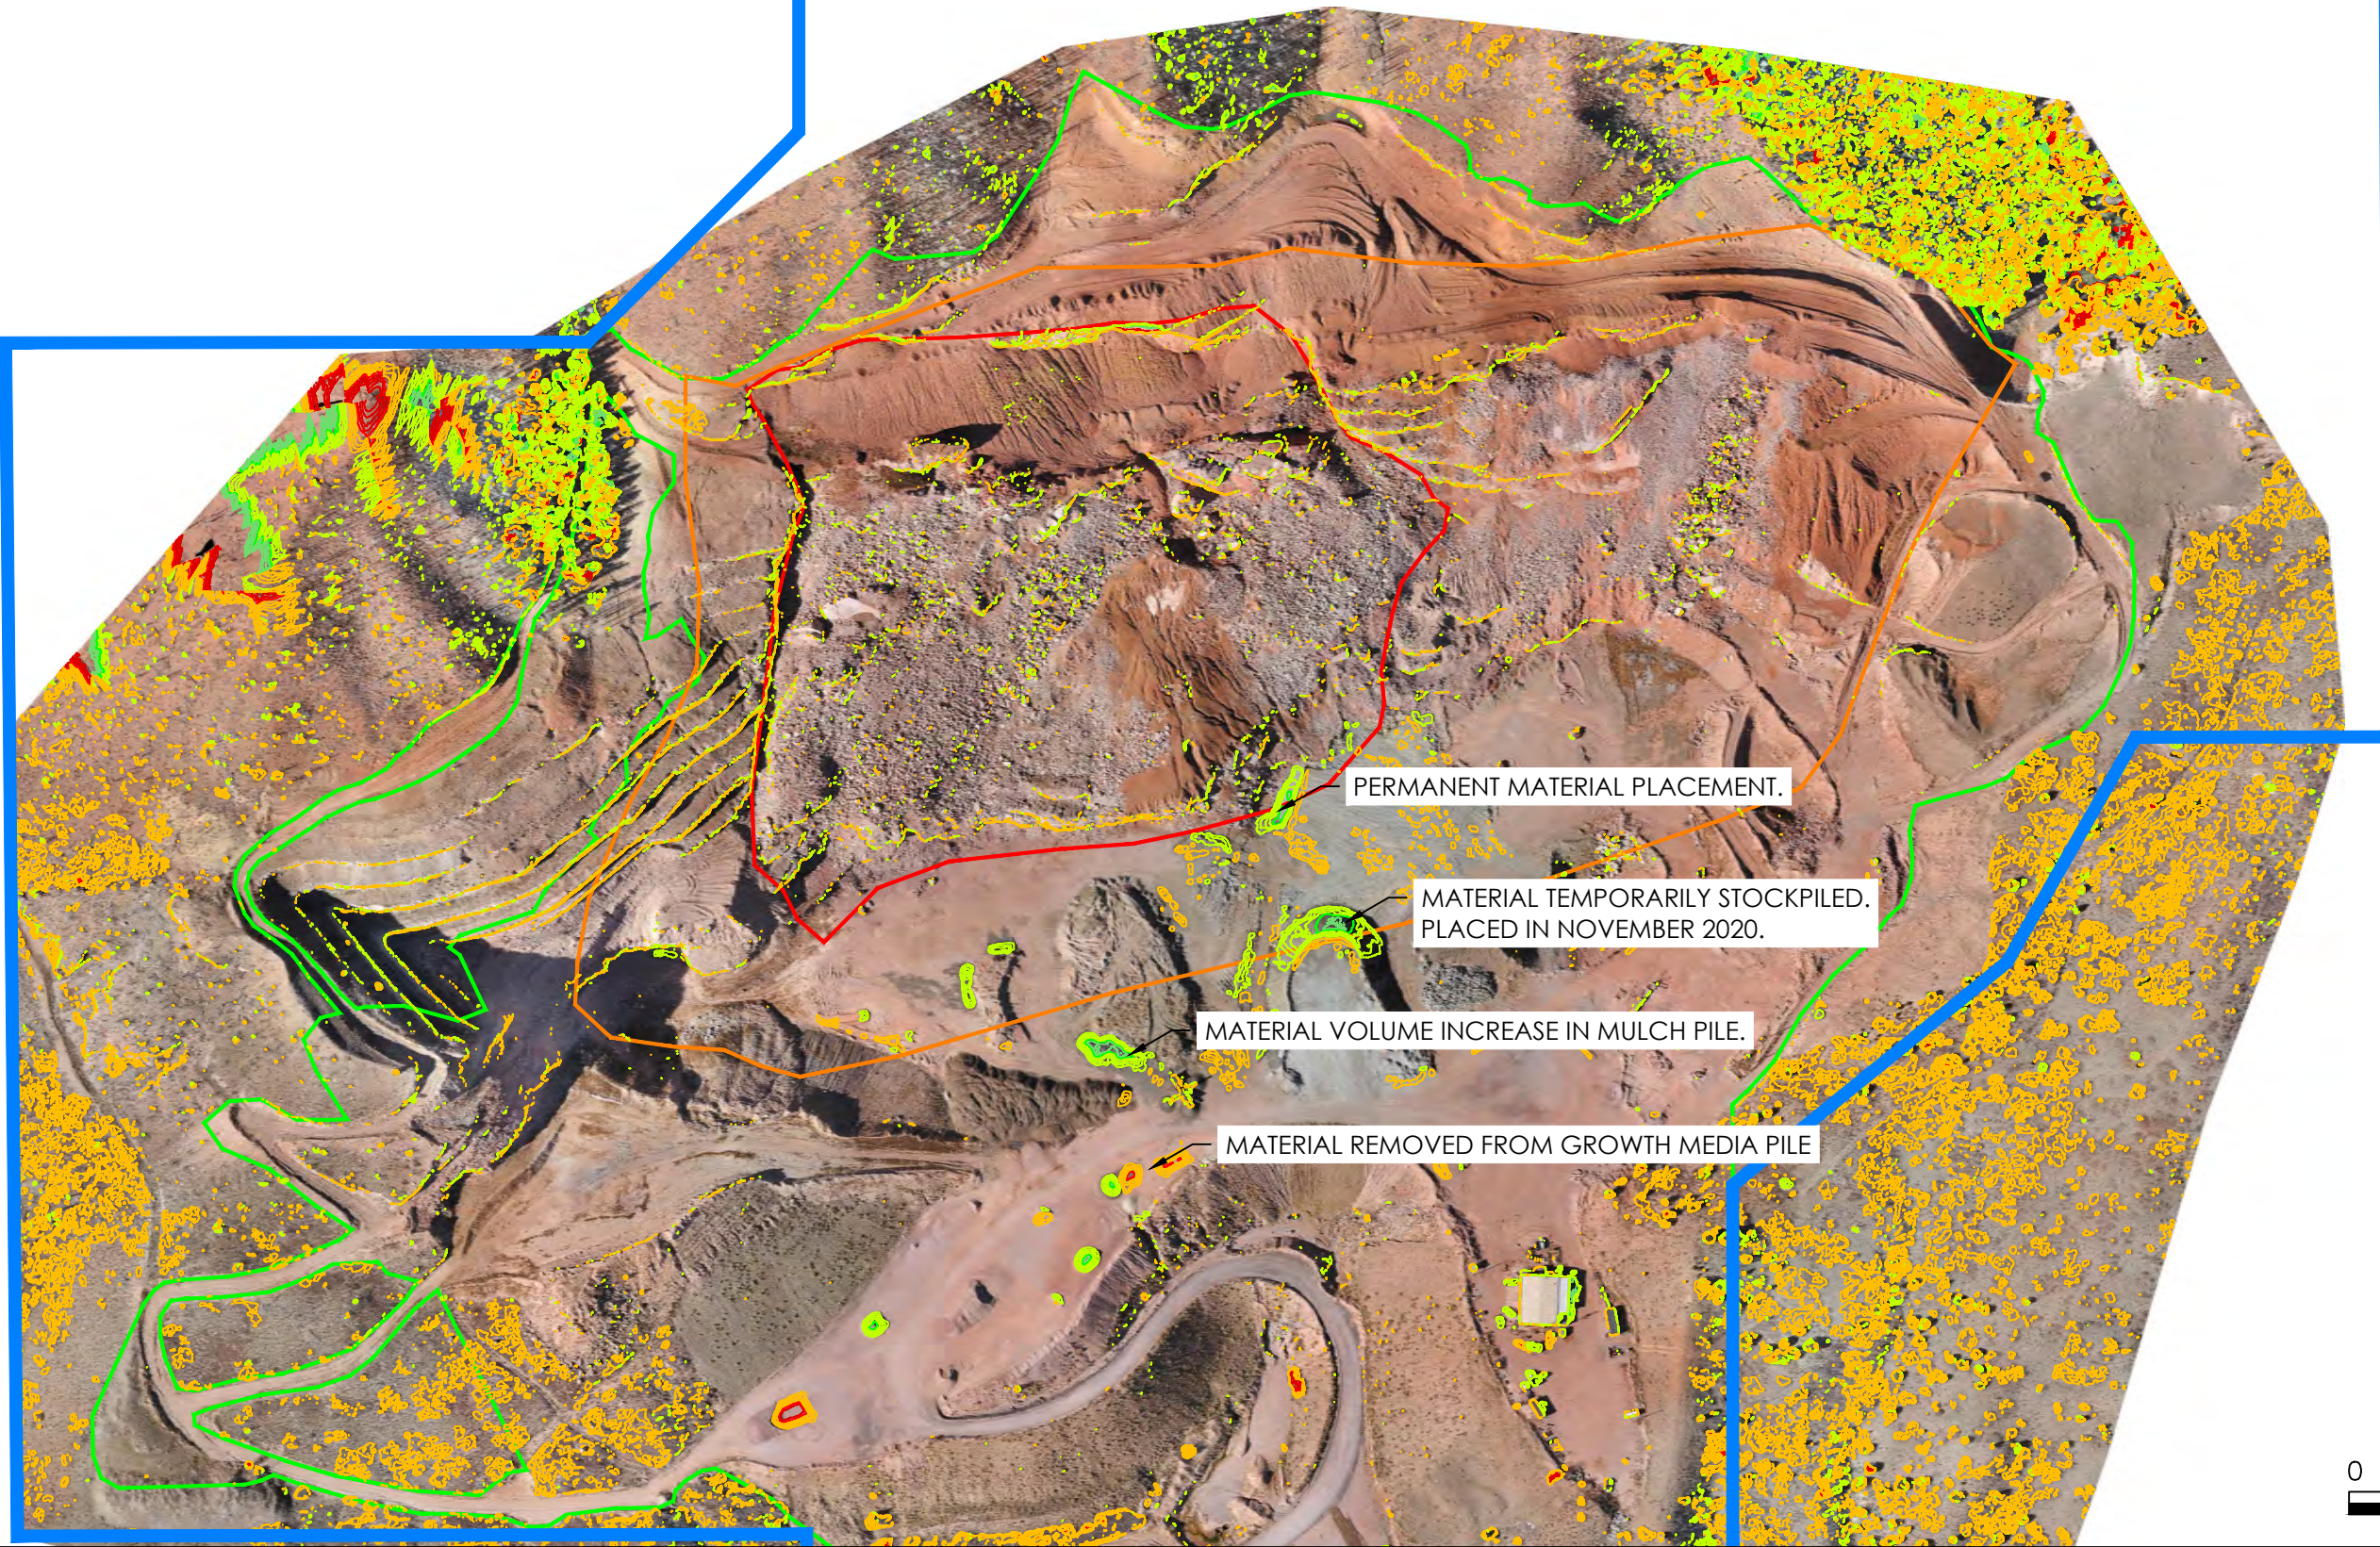
Revision #	Date 2020.12.31
Drawn By PK	Figure No. 5

The October topography was also compared to the November topography to identify changes in the site topography. Comparison of the two surveys showed that approximately 2,510 yd³ of fill had been imported and temporarily placed. Additionally, 810 yd³ of material have been permanently placed. No slope movements or other changes in topography were identified. The current imagery and topography are included in Figure 1, and the comparison surface is included as Figure 5 in Appendix C.

As previously reported in the September 2020 monitoring report, there are limitations with the method of comparing drone surveys from different months. The drone data indicate changes in the slopes along each of the reclamation benches, buildings, and areas with trees or shrubs. These areas are stable, and the changes are the result of survey limitations on or near vertical slopes.
