January 8, 2021

Job Number: 99-3983

Subject: Quarterly Observation Report, Refuse  
Pile, Foidel Creek Mine, Routt County, Colorado.

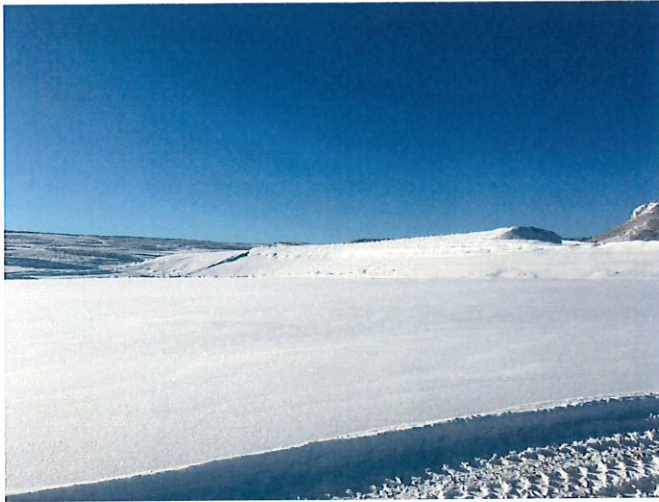
The internal roadways in the new expansion area of the pile are in good condition. The upper haul road to Areas 2, 3 and 4 of the refuse pile was not accessible at the time of our site visit, due to snow.

December 30, 2020- Area 2, 3, 4 from Expansion Area

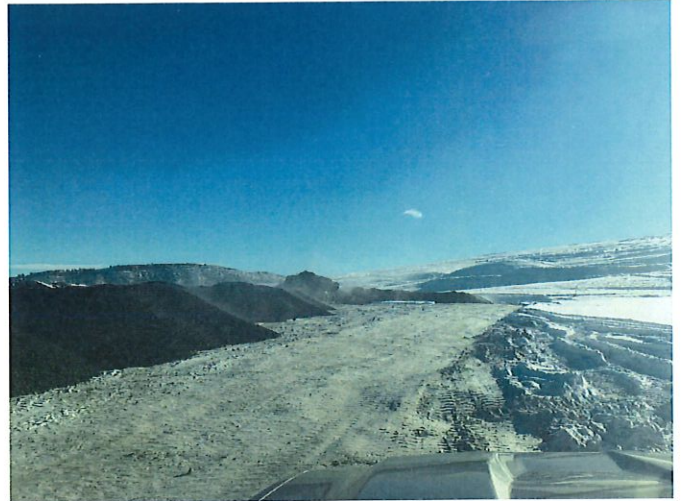
At the time of our site visit on December 30, 2020, NWCC completed a site inspection of the existing refuse pile. Based on our observations made during this visit, it appeared that the contractor was presently stockpiling, grading and compacting refuse coal in the new Expansion Area. At the time of our site visit, the refuse coal had been placed and compacted to an elevation above the third bench situated along the east side of the stockpile. The contractor was in the process of shaping the third bench; however, grading operations were minimal due to snow cover.

December 30, 2020-Stockpiles in Expansion Area

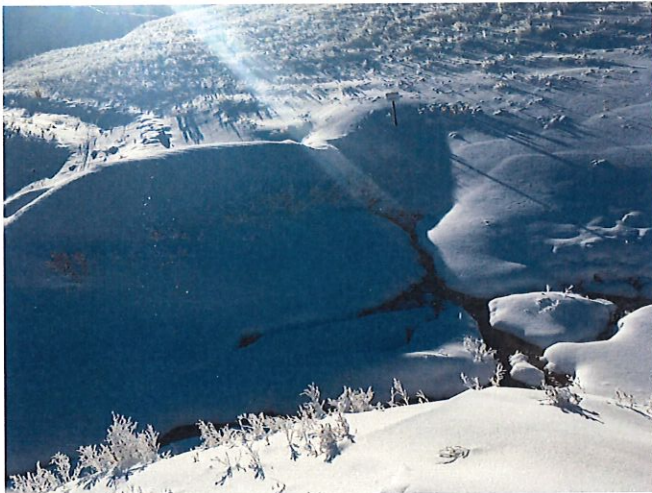
A seepage area at the toe of the northeast end of the refuse pile expansion area, approximately 30 feet northwest of the outlet of the underdrain, developed in fall 2014. At the time of our observations, the seepage was surfacing at the toe of the slope and flowing into the drainage from the undrain outlet then into the existing pond east of the Refuse Pile Expansion Area. The discharge was clear, with no evidence of sediment. No signs of washout, slumps or slope instability were observed at this time. The seepage area will be monitored during future inspections and noted in our inspection reports. Photographs of the seepage area taken at the time of our inspection on December 30, 2020 are attached.

December 30, 2020- Seepage Area and Drain Outlet

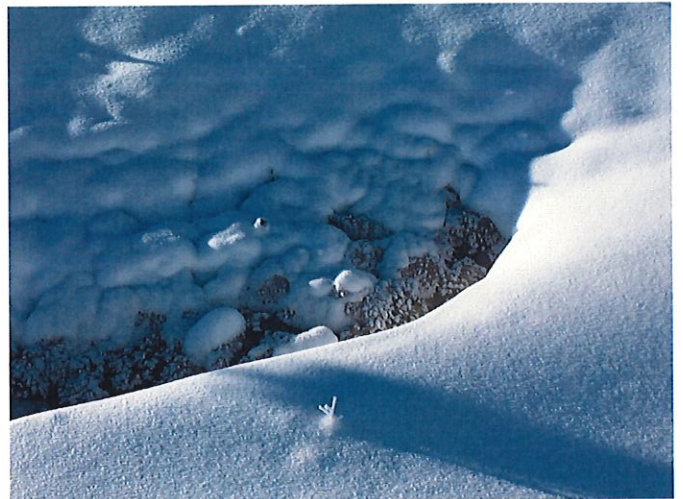
December 30, 2020-Seepage Area

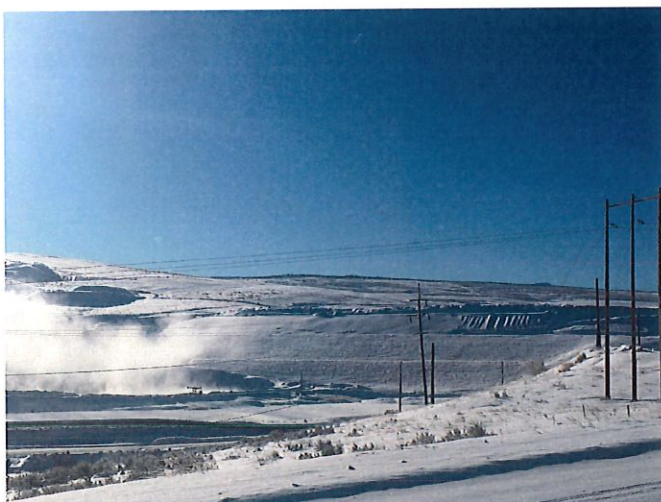
December 30, 2020-Benches-East Side of Expansion Area
