**PERMIT INFORMATION**

<b>Permit Number:</b> C-1982-056 <b>Mine Name:</b> Foidel Creek Mine <b>Operator:</b> Twentymile Coal, LLC <b>Operator Address:</b> Ms Miranda Kawcak 29515 Routt County Road No. 27 Oak Creek, CO 80467	<b>County:</b> Routt <b>Operation Type:</b> Underground <b>Permit Status:</b> Active <b>Ownership:</b> Private
	<b>Operator Representative Present:</b>  Na
<b>Operator Representative Signature:</b> (Field Issuance Only)

<b>Inspection Start Date:</b> January 11, 2021 <b>Inspection Start Time:</b> 10:00 <b>Inspection End Date:</b> January 11, 2021 <b>Inspection End Time:</b> 10:15		<b>Inspection Type:</b> Aerial Inspection <b>Inspection Reason:</b> Normal I&E Program <b>Weather:</b> Clear	
<b>Joint Inspection Agency:</b>  None		<b>Joint Inspection Contacts:</b>	
<b>Post Inspection Agency:</b>  None		<b>Post Inspection Contacts:</b>	
<b>Inspector(s):</b>  Tabetha Lynch  Brock Bowles	<b>Inspector's Signature:</b>

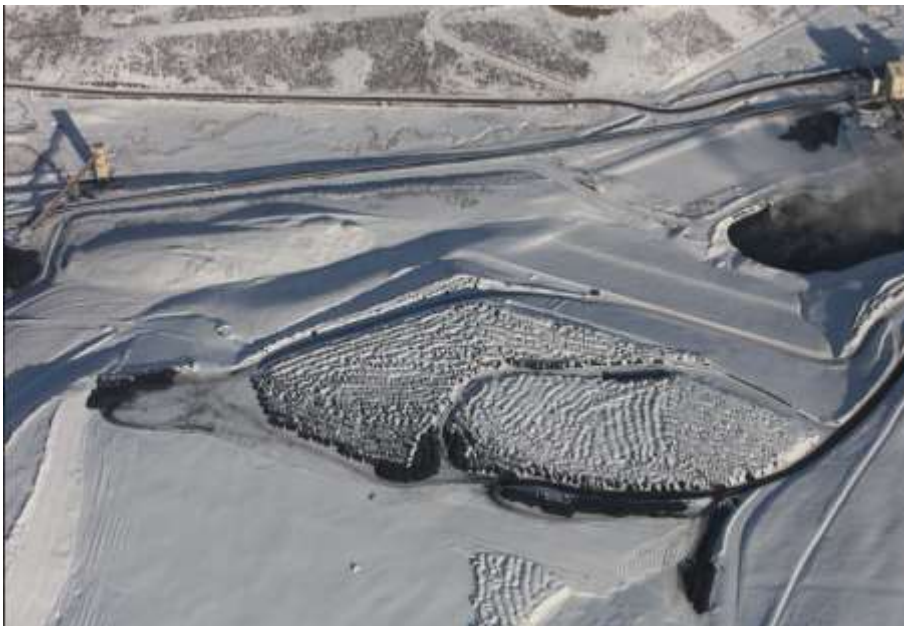
It appears material is being wind rowed on the refuse pile third lift. No standing water was observed. The area is mostly snow covered. Refuse pile and train loadout shown below.

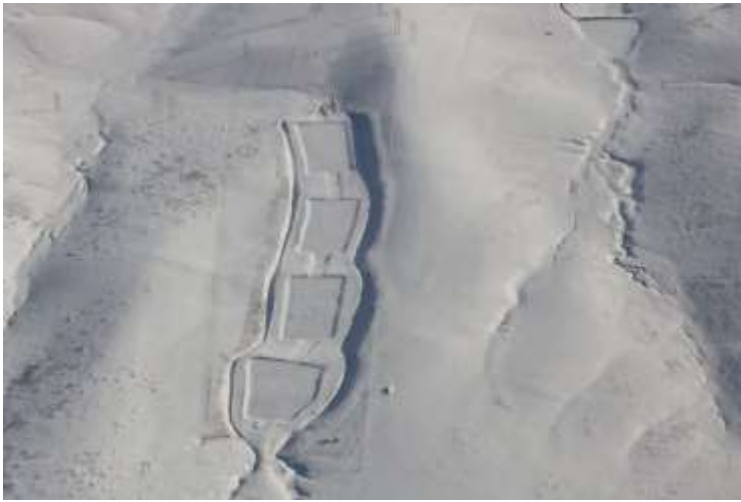
Pit pond and Pond D are observed to be holding water. Other ponds appear to be covered in ice and snow. Wetland ponds at 6MN are snow covered and do not appear to be receiving mine water at the time of the inspection (shown in photo below).

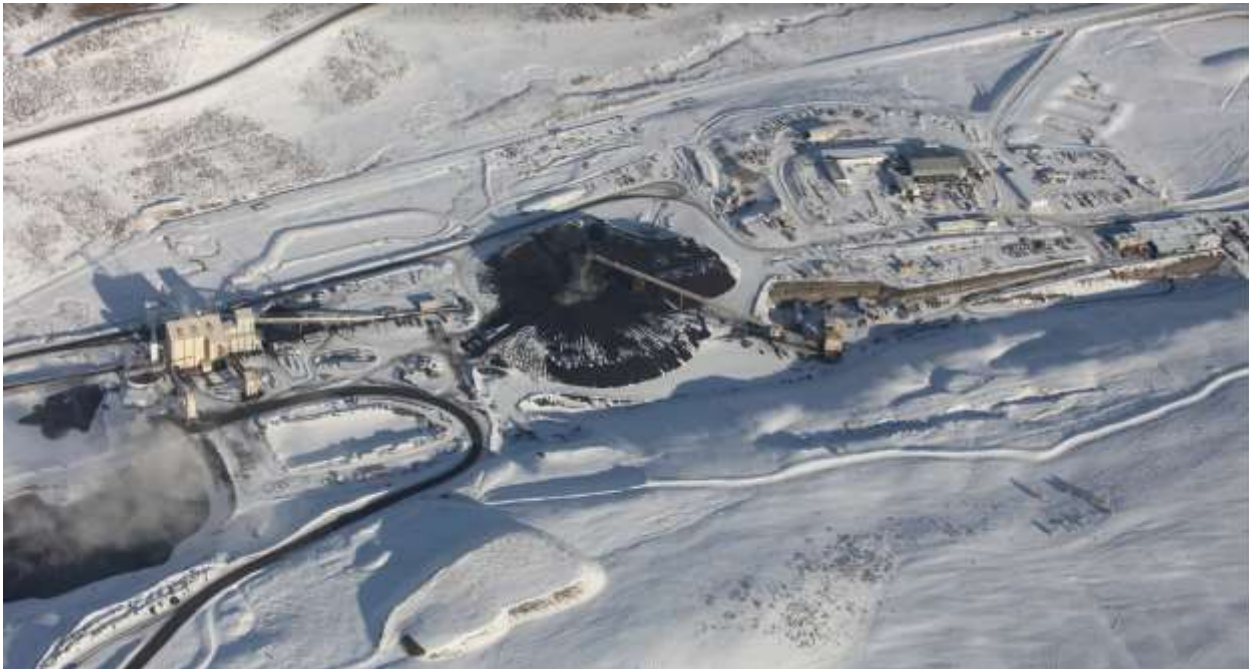
GENERAL MINE PLAN COMPLIANCE: Facilities area is shown below. Ponds are mostly snow covered. Main roads appear to be maintained. Foidel Creek appears to be undisturbed. Topsoil piles are snow covered and appear undisturbed.

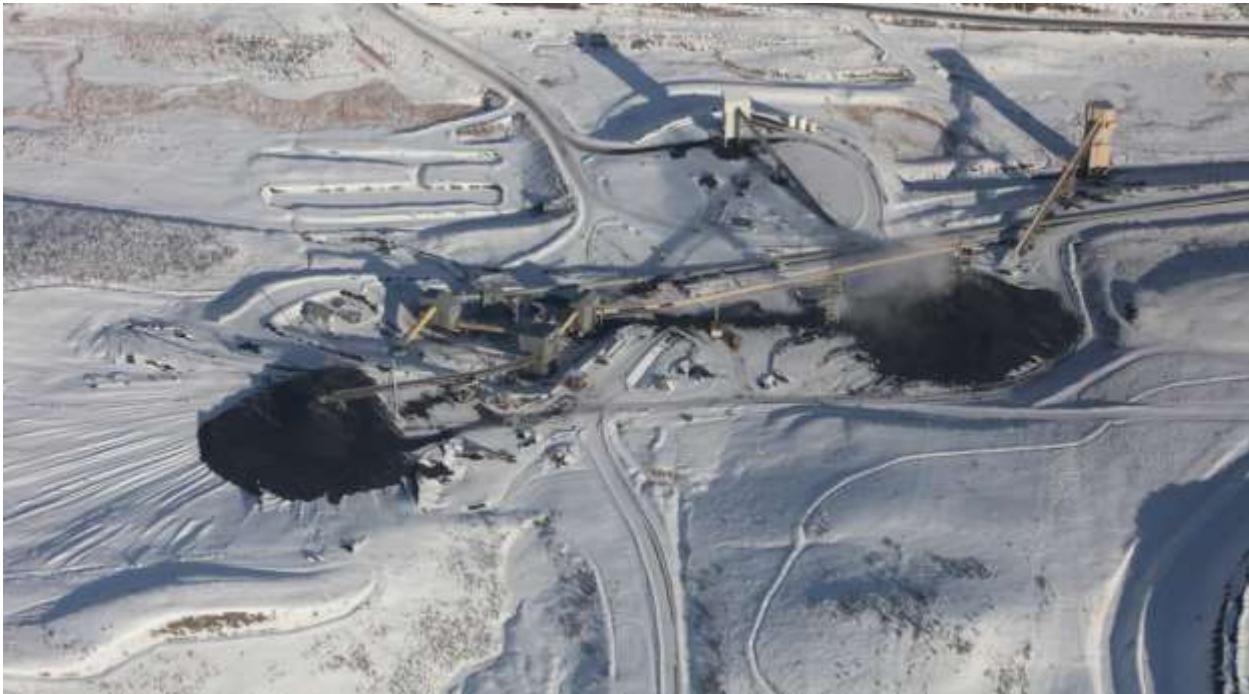
Shown below is the rest of the facilities area on the west side; pond B, pond C appear snow covered. BOB pile is on the left of the photo. The BOB pile topsoil pile appears stable and undisturbed. Truck and train loadouts are on the top right.
